## Reach 1c (County Route 56 Bridge below L.MacGlashen to Peck Road Bridge)

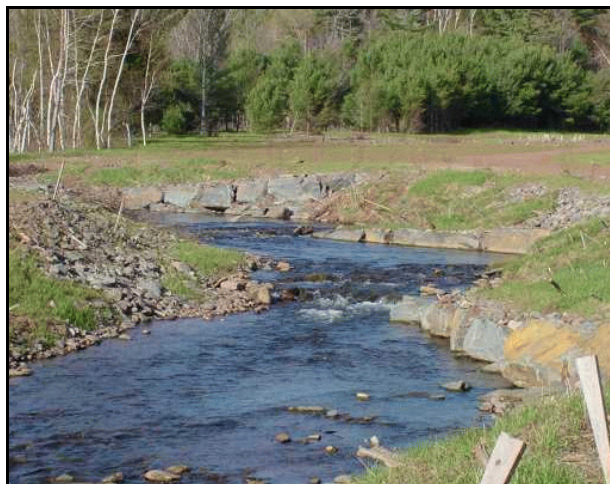
**Figure VI-9:** View of restoration work undertaken in segment 1c during 2001.

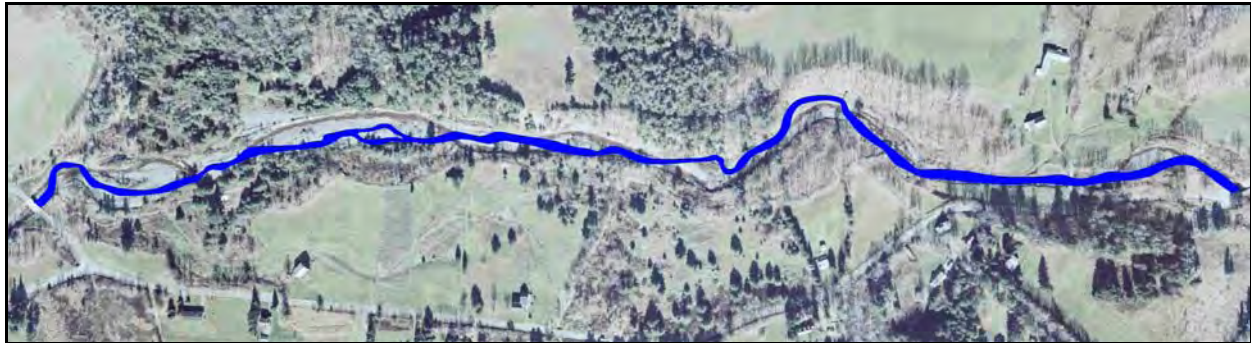
**Figure VI-11:** Aerial view of channel planform changes between 1995 (blue) and 2000 (photo).

At the top of the reach, only minor planform changes were noted between 1959 and 1995, and a healthy riparian buffer was present during the 1997 inventory. Between May 1995 and 1998 when the detailed assessment was initiated, the channel started to experience planform changes. The flood of September 1999 resulted in a substantial channel shift on the right bank, with the channel migrating over 75 feet. The channel avulsion occurred in spite of a dense riparian buffer.

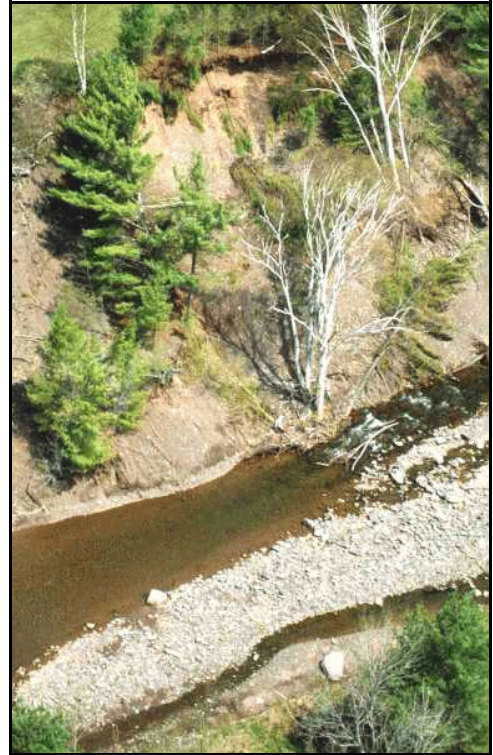
Moving down the reach, the alignment of the channel had migrated to a position against a high terrace on the right streambank (**Figure VI-10, photo B,C**). The terrace averages approximately 55 feet in height, and runs approximately 2200 feet along the center of reach 1c. Prior to restoration, approximately 1,075 feet of stream channel was directly against the high terrace, with large slope failures present. Mast wasting of the high terrace was facilitated by erosion at the toe of the bank (**Figure VI-13**). The low terrace, running along the opposite bank also showed equal signs of instability (**Figure VI-10, photo E**).

**Figure VI-13:** Eroded high terrace at middle of management segment 1c.

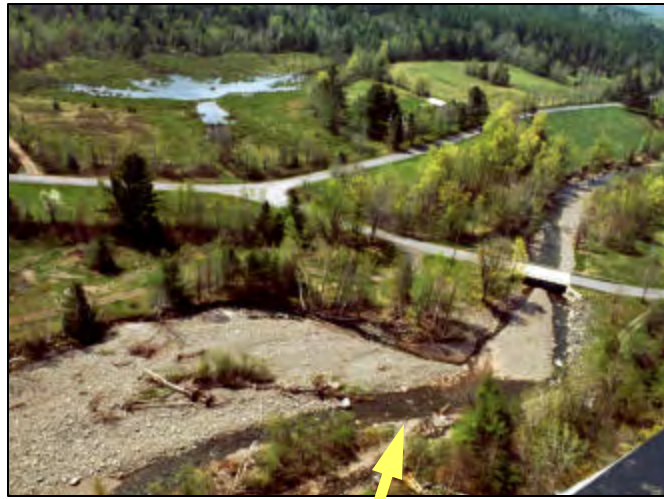
A

The condition of the riparian area in the segment was highly variable. At the head of the segment, much of the riparian area was characterized by open fields, with narrow strips of wooded riparian vegetation (**Figure VI-10, photo A,D,H**). In the lower extent of the reach, the stream was bordered by denser, woody vegetation, however extreme boundary shear stress from channel aggradation and over-widening has resulted in the trees being undercut and lost. While the high terraces in the segment support vegetation at the top of the terrace, and once were stabilized by forest cover, the unstable faces of the terrace are too steep to support bank stabilizing vegetation. The portion of the streambank that is exposed to the erosional forces of the stream is predominantly unprotected by vegetation.

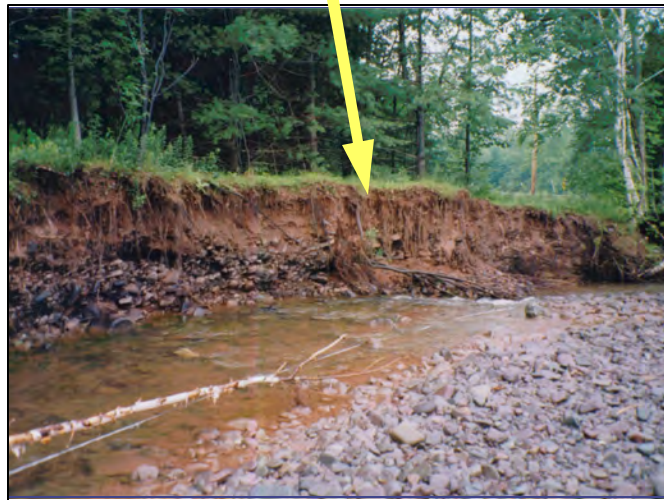
E

The lower half of reach 1c was primarily characterized as an aggradation area, with excessive sediment deposition, multiple channels, and poor riparian conditions. Typical of aggradation areas, channel planform was highly variable, with even small storm events significantly changing the stream pattern. Between 1995 and 2000, some sections of the stream laterally migrated over 100 feet. Additionally, aggradation was transferring erosional forces against the outer banks, with active erosion on both the left and right banks noted during the assessment process (**Figure VI-15**) (**Figure VI-10, photo E**).

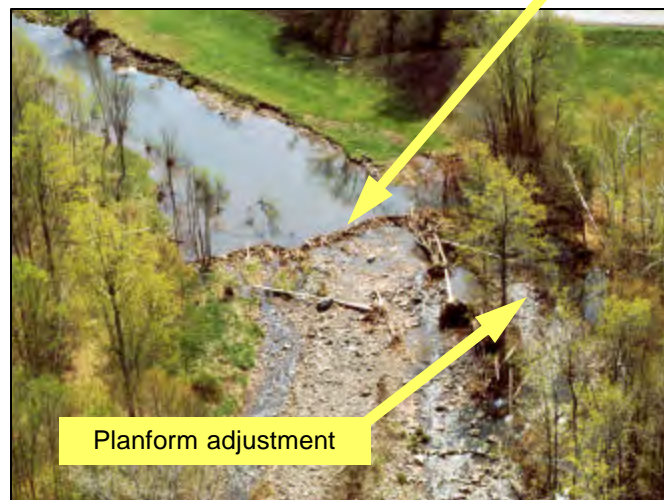
G

Moving down the reach, a beaver dam 300 feet below the town bridge was observed to be impacting sediment transport through the reach (**Figure VI-10, photo G**), with the channel filled with gravel and other sediments. The stream channel was responding to the channel aggradation with lateral erosion as the stream attempted to cut a channel around the beaver dam. Monitoring cross sections showed the development of a divided channel below the dam (**Figure VI-12**), with the main (left) channel incising over one foot, and the right channel almost half a foot during the monitoring period. Further below the beaver dam, the channel was experiencing lateral erosion and over widening, as well as having degraded nearly 2 ½ feet.
