Reach 4c (VanEtten Trucking to County Route 17)

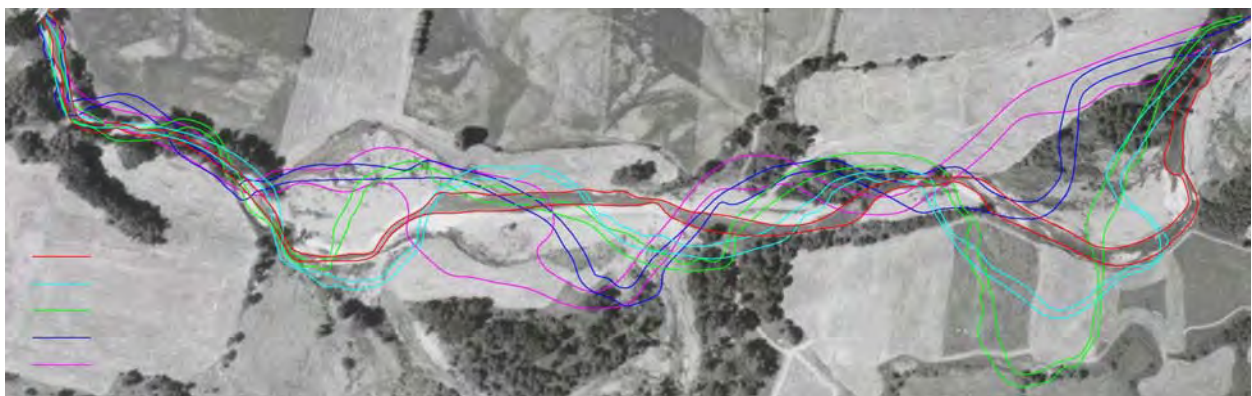
Figure VI-50: 1959 Aerial photograph of reach 4c with 1968, 1980, 1997 and 2000 channel planform locations overlaid. Note extreme channel migration on former farmlands in lower right corner.

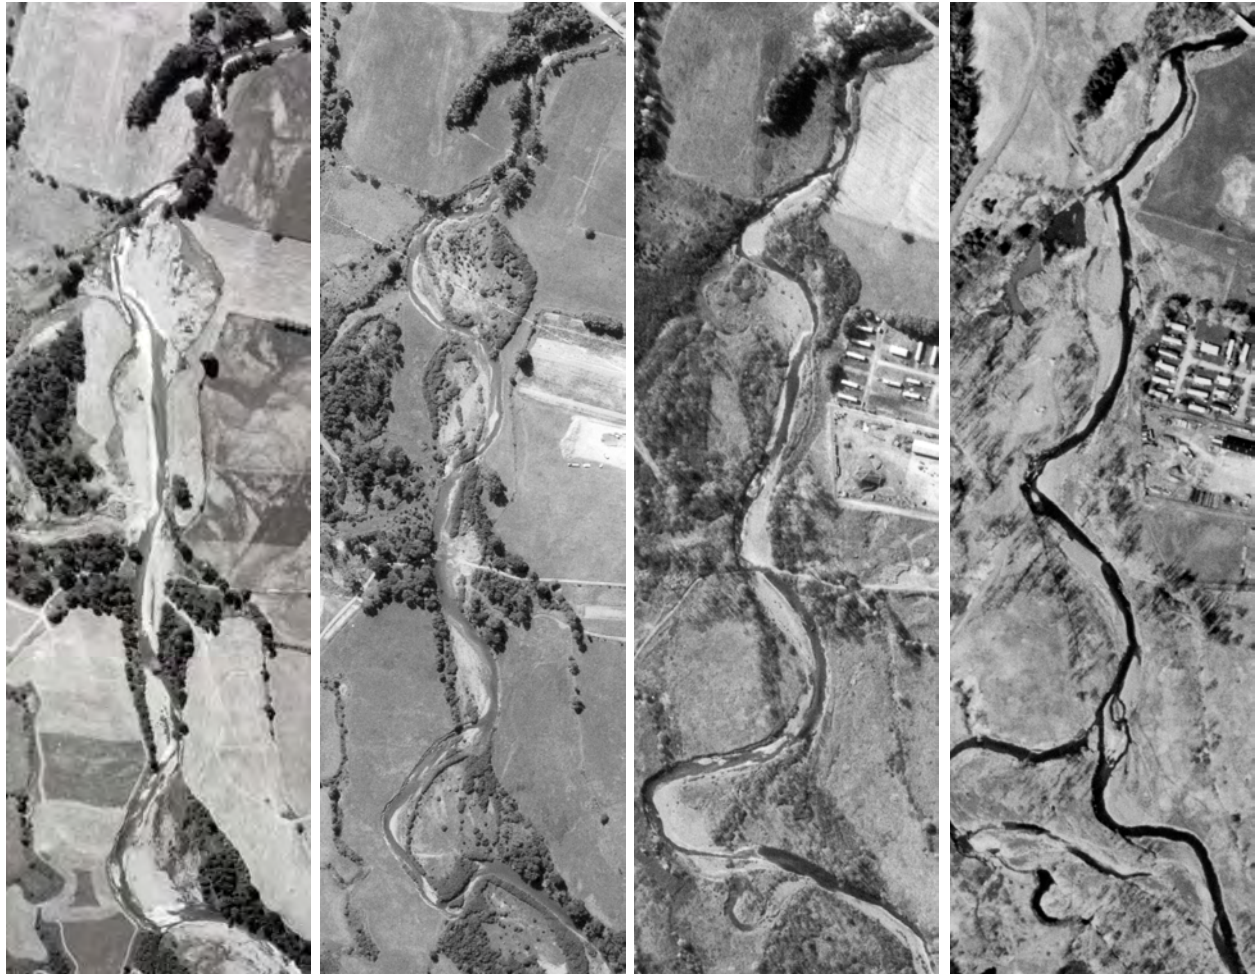
Figure VI-51: Comparison of stream planform in reach 4c. Aerial photographs from right to left include 1959, 1967, 1980 and 1997.

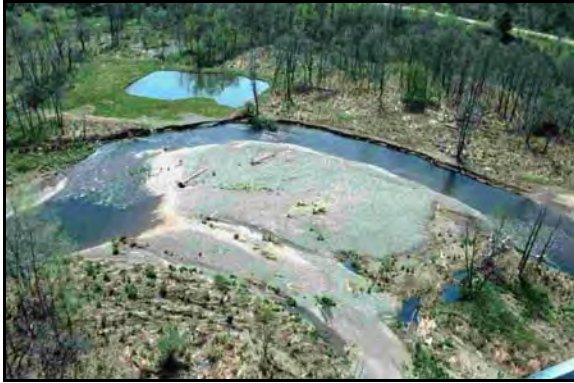
Figure VI-52: Active channel migration threatens this floodplain pond in reach 4c.

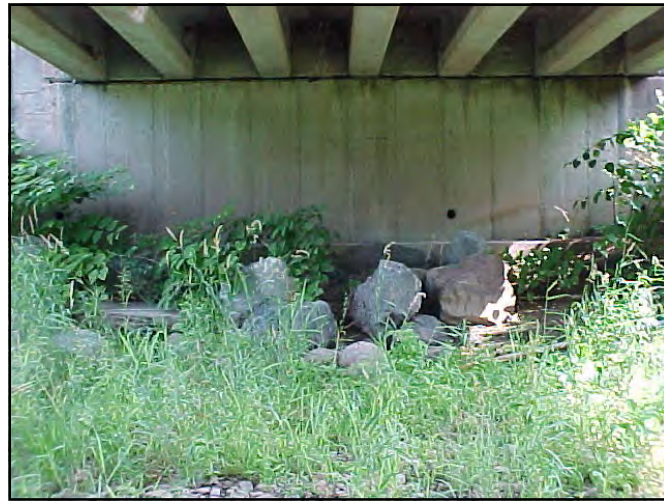
A

Infrastructure issues in reach 4c are limited to the County Route 17 crossing at the bottom of the reach (**Figure VI-53 photo A,E**). At this time, the GCSWCD cannot make a final determination regarding the impact of the bridge on the stream channel. The bridge currently does not appear to have any problems associated with scour or downstream erosion, although aggradation upstream of the bridge may be partially due to a back-water condition at the bridge. While the bridge is wide enough to span the expected bankfull width at this point in the watershed, extensive fill across the north floodplain between the bridge and NYS Route 23 may be contributing to aggradation during larger flood events. The GCSWCD feels the County Route 17 bridge would be an excellent candidate for installation of a large floodplain drain.

Infrastructure	<ol style="list-style-type: none"> 1. The County Route 17 bridge at the bottom of the reach should be closely observed for potential damage by the shifting stream channel. Emergency repairs should be reviewed by the GCSWCD prior to implementation. 2. During the stream restoration project design phase, the GCSWCD will work with the NYCDEP and Greene County Highway Department to evaluate potential benefits of floodplain drains.
Habitat	See General Recommendations; habitat improvements will be an objective in future restoration efforts.
Flooding	<ol style="list-style-type: none"> 1. Avoid additional development within the floodplain limits. Prohibit fill and additional construction in flood vulnerable areas.
Future Assessments	<ol style="list-style-type: none"> 1. Continue to monitor channel instability. Project team will review need to establish level III/IV monitoring cross sections. 2. Evaluate hydraulic impact of County Route 17 bridge, this will be done upon completion of the NYSDEC digital flood mapping project.

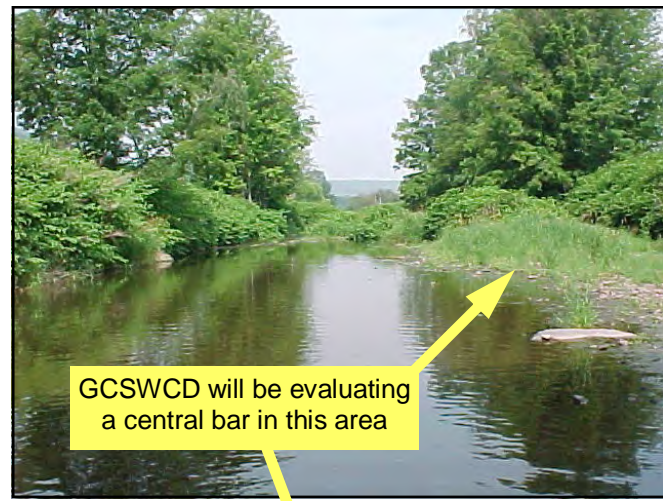
B

GCSWCD will be evaluating a central bar in this area

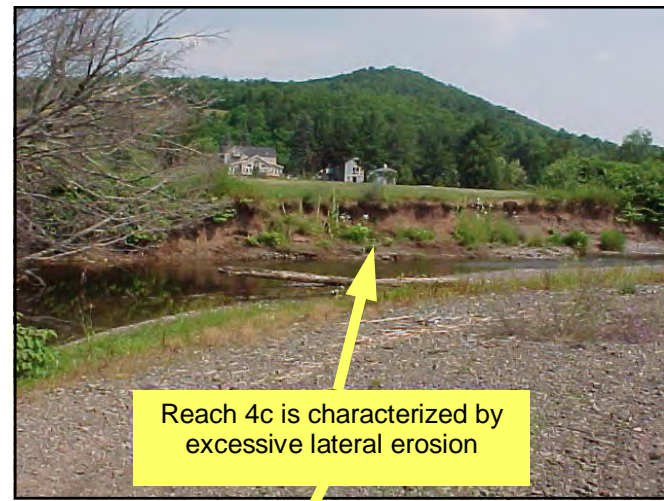
C

Reach 4c is characterized by excessive lateral erosion

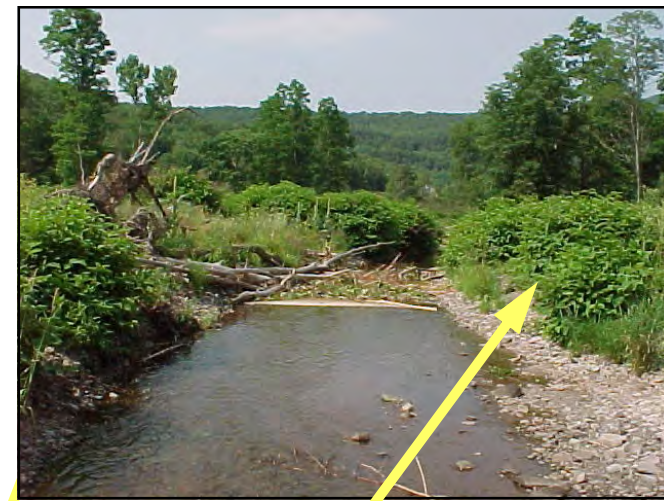
D

Extensive areas of Japanese knotweed is thought to be a significant factor in the reach's instability

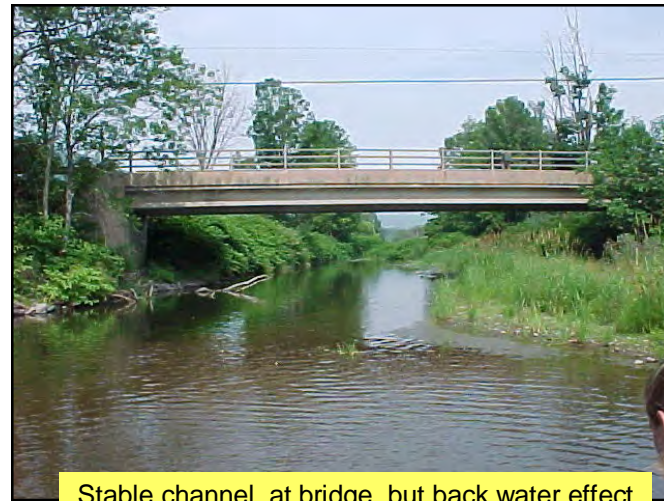
E

Stable channel at bridge, but back water effect may be increasing aggradation upstream

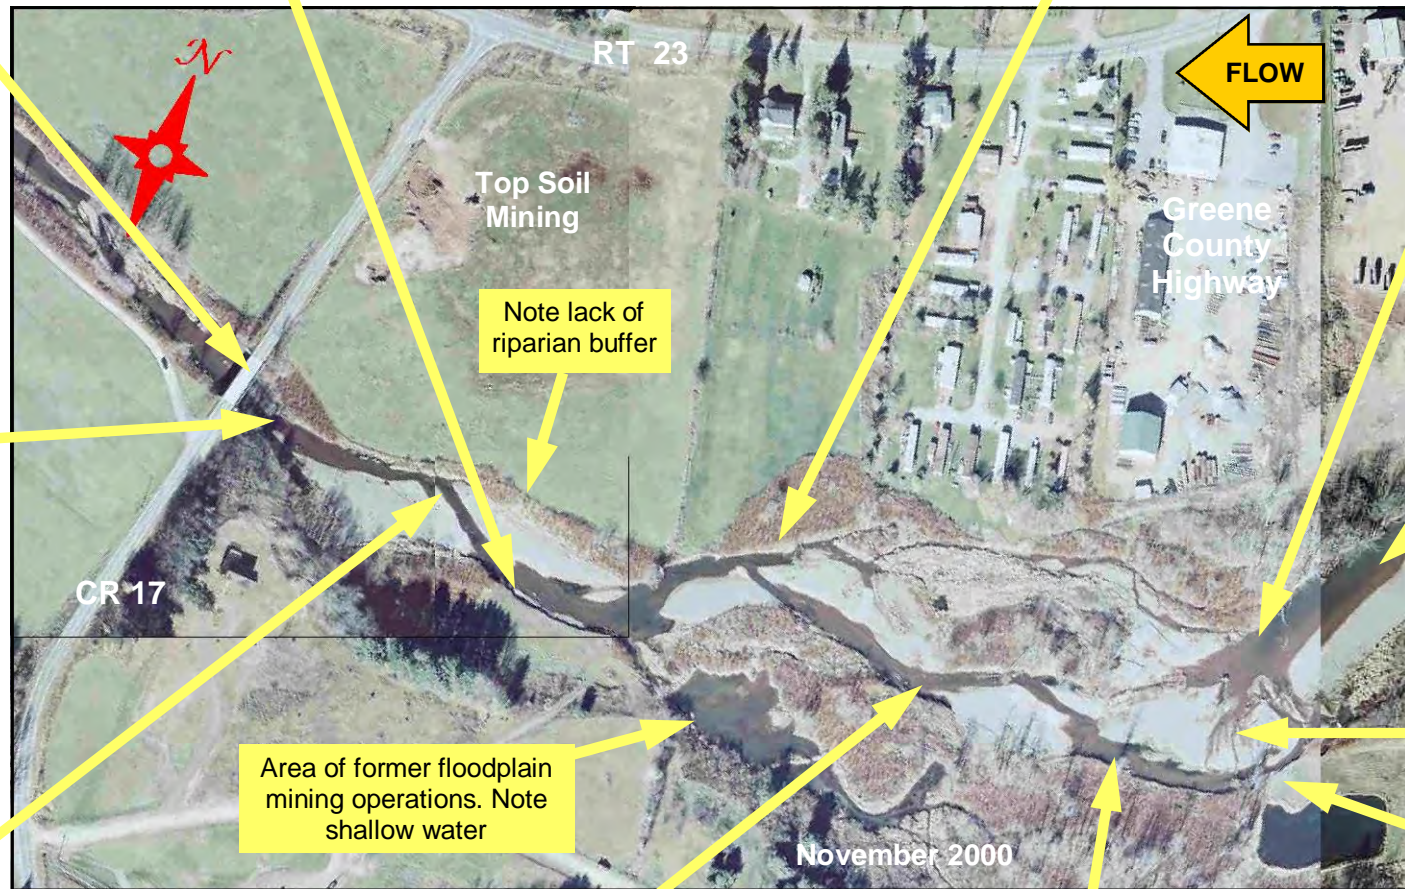
Note lack of riparian buffer

Area of former floodplain mining operations. Note shallow water

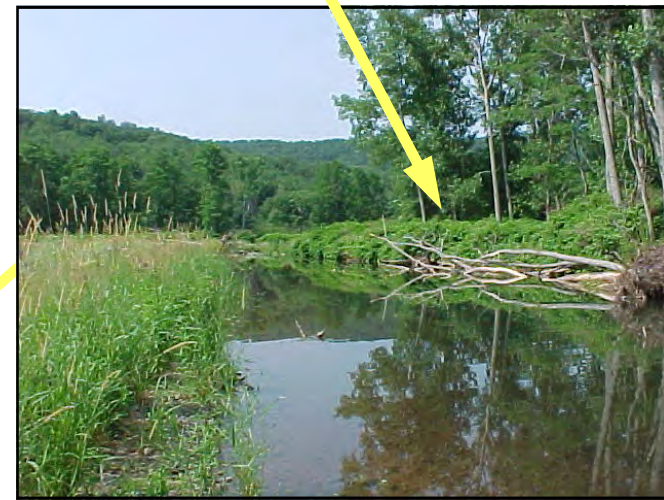
F

Note fresh depositional materials. This is typical of stream channels that are aggrading

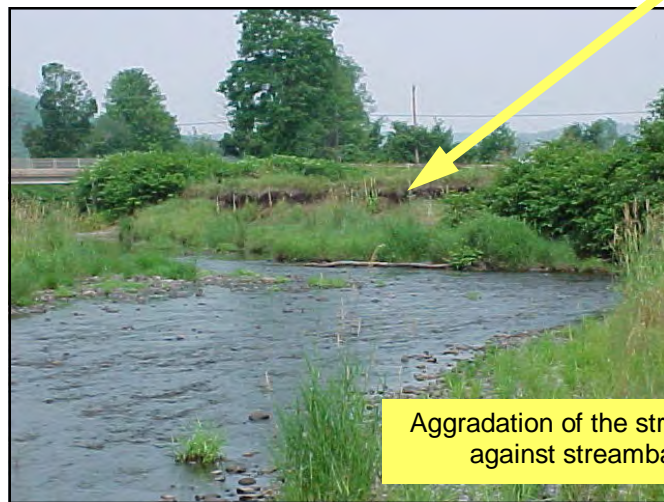
G

Aggradation of the stream channel is forcing stream flows against streambanks resulting in lateral erosion

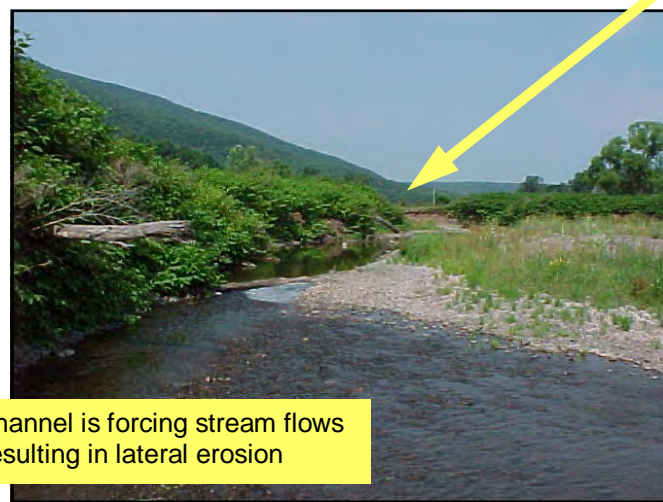
H

Exposed clay layers impact water quality
