Reach 4g (Holden Property to Vogiatz Property)

Stream Morphology/Stability

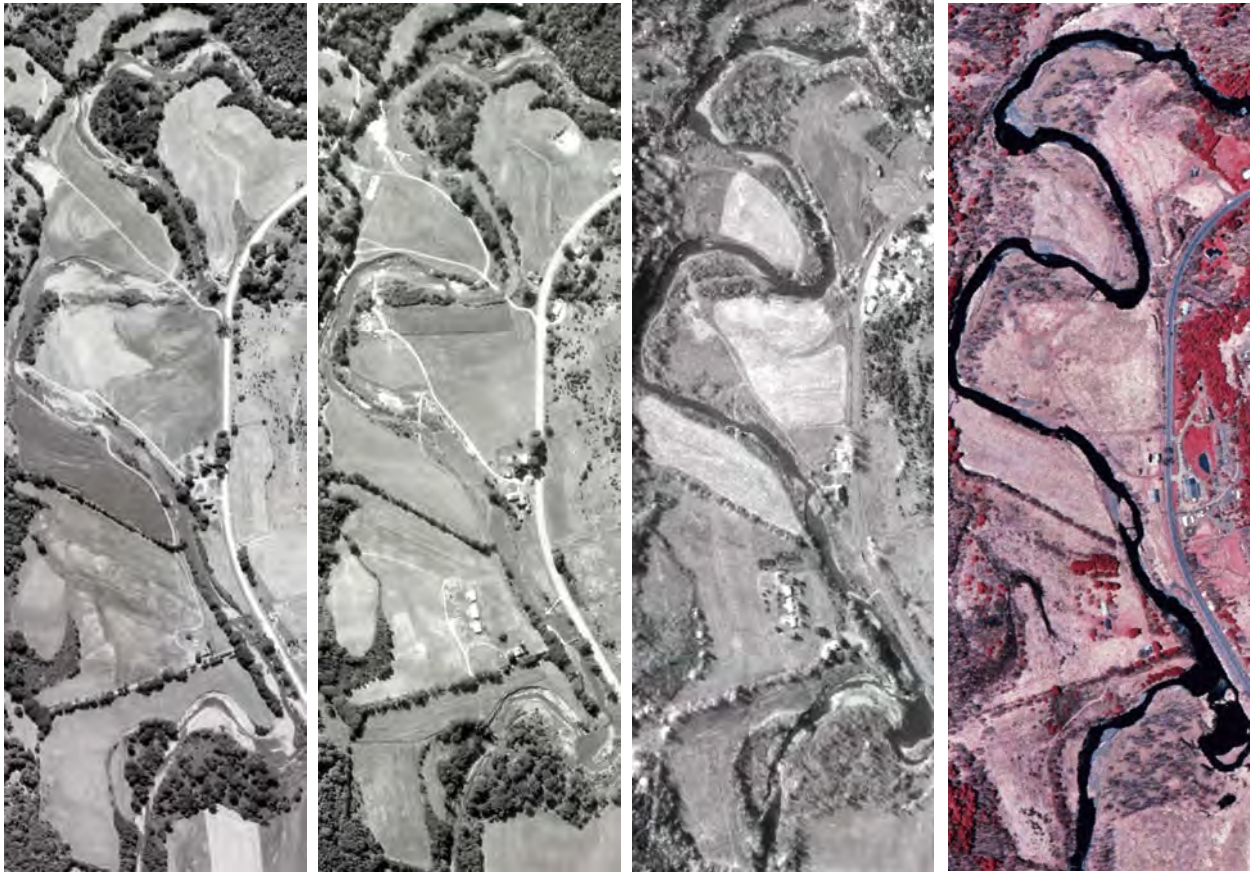
Figure VI-72: Aerial photograph progression of center portion of reach 4g, left to right 1959, 1967, 1980 and 1995. NYS Route 23 can be seen at right of photo, swinging footbridge at lower right corner.

In **Figure VI-73**, the stream water surface from 1959 (blue) has been superimposed on a photo from 2000. The most pronounced channel migration is seen in the upper right hand corner of the photo, where the stream has migrated over 480 feet toward the west since 1959. **Figure VI-74** is a closeup view of this area, showing the current (2000) location of the left (south) streambank superimposed as a yellow line over the 1959 aerial. This area is located just above the swinging footbridge, where NYS Route 23 runs immediately adjacent to the stream. It is interesting to note that in 1959, the stream channel actually meandered backward, up the valley, for a distance of a couple of hundred feet. This is a good indication of how flat the overall valley slope is.

Analysis of aerial photos of the lower sub-reach (**Figure VI-72, Figure VI-74**) shows past channel shifts in some areas to have exceeded 200 feet since 1959. A soil loss estimate was generated by determining the area of channel migration from the aerial photographs and multiplied by the bank height of 13 feet measured at the cross section. The results yielded an estimate that approximately 118,000 cubic yards of material had been eroded from this section of the reach. At the time of the Phase I Inventory, as well as during the monitoring period, the GCSWCD noted numerous locations through the reach experiencing active erosion (**Figure VI-79b photo B,C,G,I**). The channel morphology, soils, riparian vegetation, and other stream corridor features are essentially identical throughout reach 4g, and the observed scope and rate of instability will most likely not be mitigated without intervention.

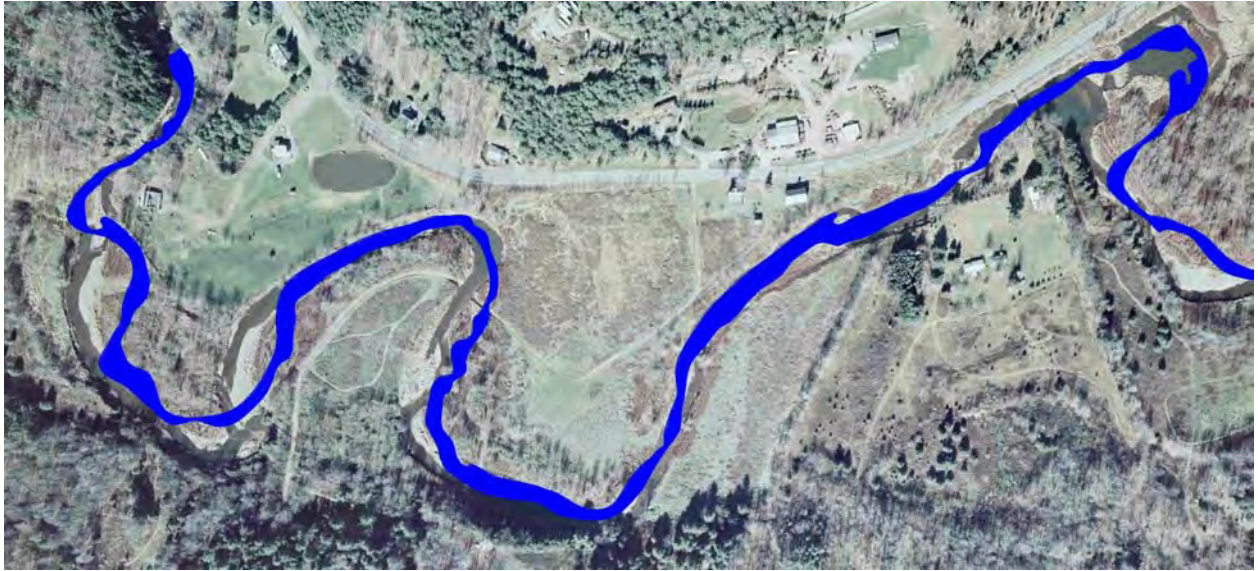
Figure VI-73: Aerial photo overlay of lower end of reach 4g showing 1959 stream channel (blue) superimposed over the 2000 photograph. Note significant meander shift in upper right corner along NYS Route 23.

In order to estimate soil loss from this one channel shift between 1959 and 2000, the plan view area of the channel shift was multiplied by an average bank height of 17 feet as determined from the monitored cross sections. During the 41 year period of interest, it is estimated that nearly 35,000yds³ of material have been eroded from this meander bend. You will also note in **Figure VI-73**, that the lower half of reach 4g has also been experiencing planform changes. In those areas where the channel planform is truncated by the steep mountain slopes, planform has remained relatively stable.

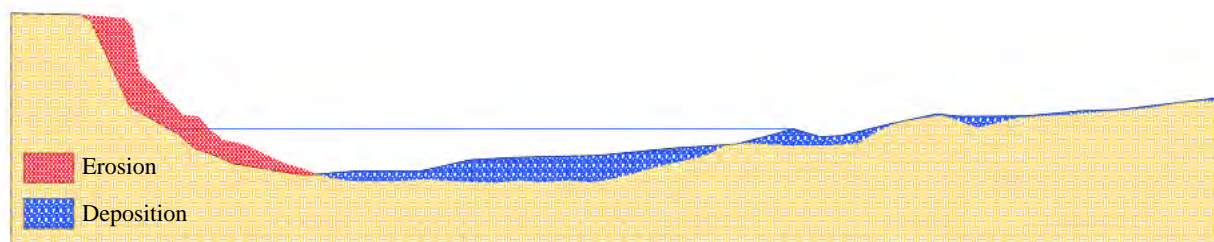
Figure VI-75: Overlay of cross section #2 Holden property, 1998 & 2000.

Cross section #2 is located near the top of the Holden site, at a point where the channel is heading away from the base of the mountain and toward NYS Route 23 (**Map VI-5**). The left stream bank at the cross section is 17 feet high, and has migrated over 5.5 feet during the monitoring period (**Figure VI-75**). The riparian vegetation in this area consists of

mature spruce, but the rooting depth/density is not adequate to provide stability to the bank. The property owner has attempted to address the erosion problem with rip-rap, but many of the boulders have since been dislodged and are currently located in the main stream channel 200 feet downstream. **(Figure VI-71a photo E,F).**

The cross section also indicated that extensive deposition had occurred on the opposite side of the channel. The cross section did not reveal any degradation of the channel, and the deposition was consistent with lateral channel migration. The channel does not appear to be over-widening, with the width to depth ratio and channel cross sectional area remaining fairly constant. The limited period of observation, compounded by the occurrence of a major flood during the period, make it difficult to make a definitive judgement on trends related to the channel dimension.

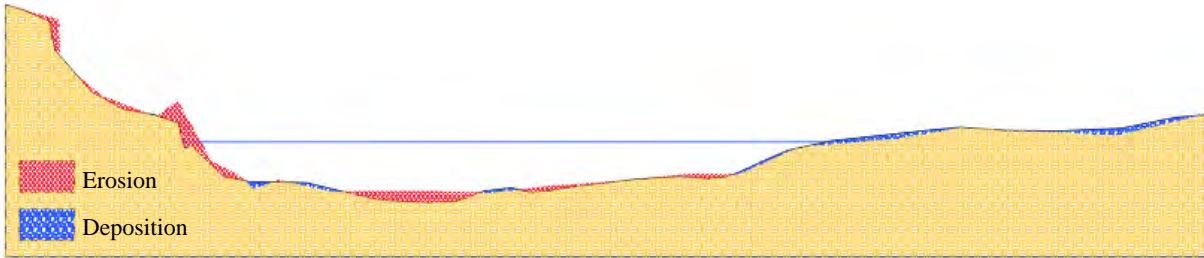
Figure VI-76: Erosion and deposition changes at cross section #5 between 1998 and 2000.

experienced fairly minimal erosion during the monitoring period. **Figure VI-76**, illustrates the surficial erosion measured at cross section #5, which is fairly representative of this section of the reach. In the area covered by these cross sections, the measured erosion was considered insignificant, especially when considering that the September 1999 flood event occurred during the period between the two surveys. The stream banks through the entire Holden site are composed of non-cohesive materials adding to the susceptibility to hydraulic erosion. Evaluation of the longitudinal profile at the lower end of the Holden site has shown that the channel has lost its natural riffle-pool complex through cross sections #7, #8 and #9, with the stream profile changing to a near uniform channel bottom.

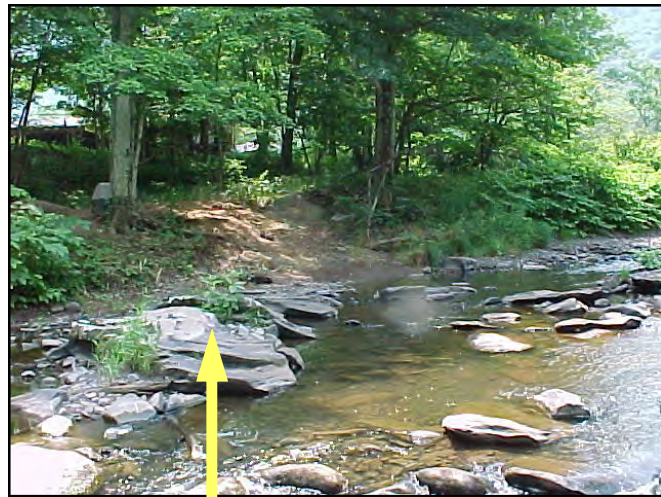
A

Reach becomes more stable as it Transitions to Reach 5a

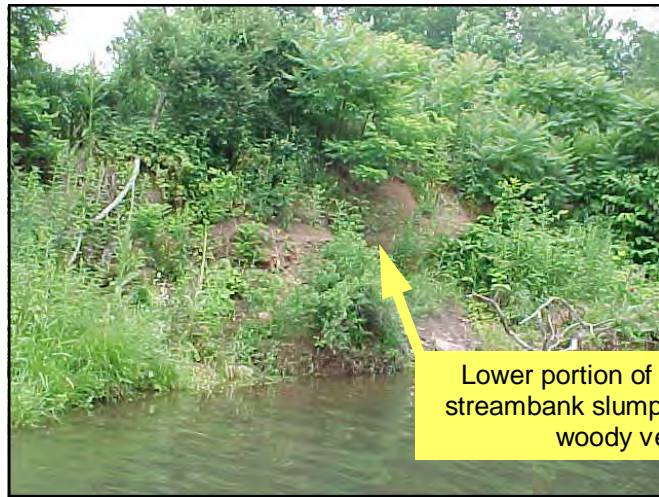
B

Lower portion of reach 4g exhibits extensive streambank slumping. Absence of deep rooted woody vegetation is a factor

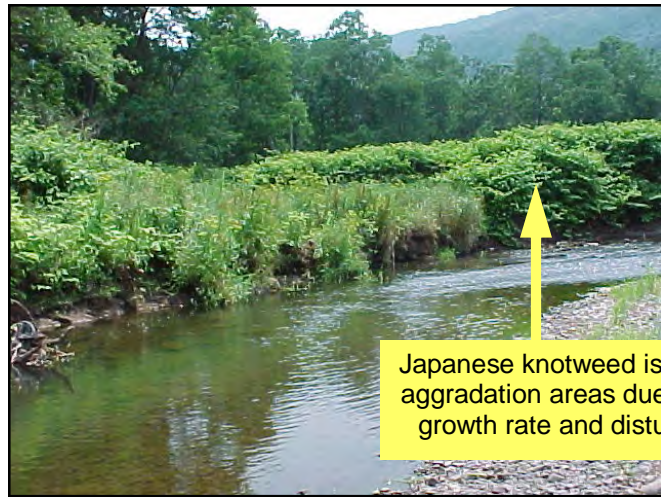
E

Japanese knotweed is common in aggradation areas due to its rapid growth rate and disturbed soils

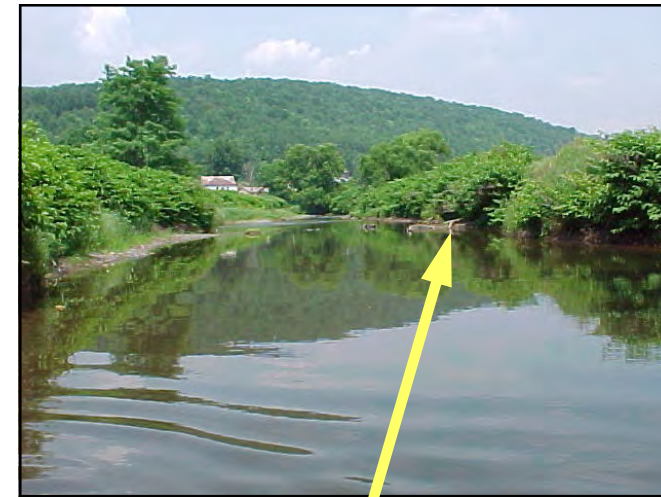
F

Japanese knotweed is common in aggradation areas due to its rapid growth rate and disturbed soils

Poor riparian vegetation is not adequate to resist active meander migration

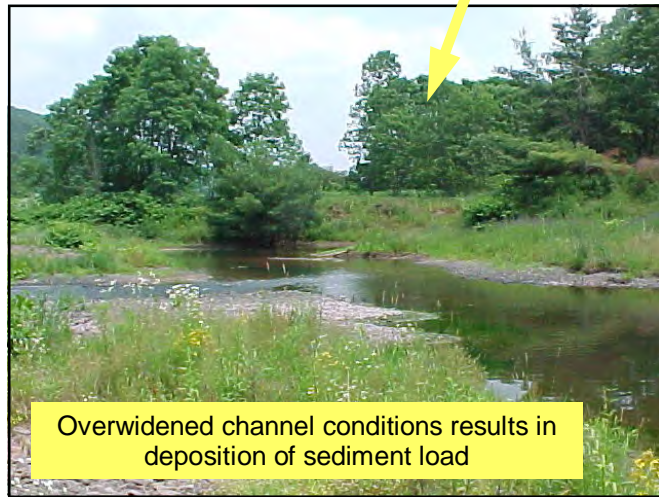
H

Overwidened channel conditions results in deposition of sediment load
