Broadstreet Hollow Management Unit 8

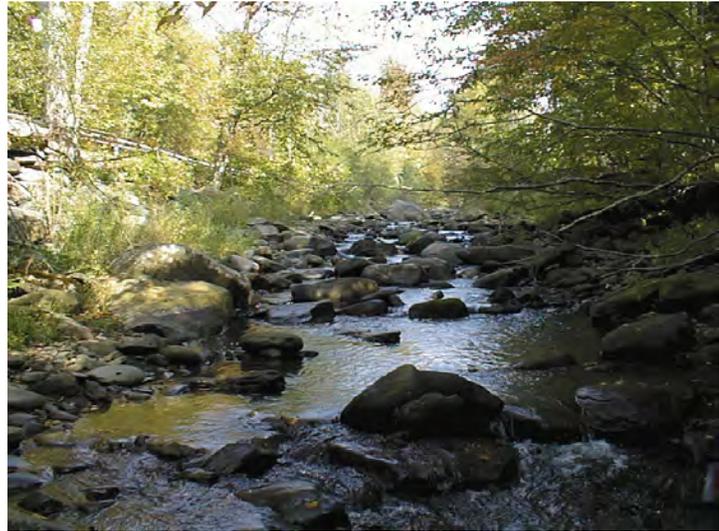
Photo 1. Looking upstream, road at left, in the upstream section of MU8.

The upstream section of MU8 (approximately 838 feet long) is in relatively good condition (*stable*), even though it runs less than 50 feet from the road and contains two short eroding banks.

The structural shape, or *morphology*, of the stream (i.e., slope, width and depth) changes frequently in this section, creating even smaller sections, or *reaches*, that have a discrete character, or *stream type*⁵. The valley in MU8 is particularly narrow in the upstream section. Stable stream types typically associated with this type of valley are relatively narrow and steep, with small waterfalls (“steps”), and stream banks formed into low benches, or *discontinuous floodplains*, that help slow and absorb floodwaters. MU8 seems to retain some of these discontinuous floodplains on the banks near the road, increasing the stability of this section. The fact that the stream shifts rapidly between types over such a short distance, however, and contains artificially narrow valley sections without functioning floodplain benches, suggests potential impact from *road fill*, which further constricts the narrow valley and causes the stream to become *entrenched*.

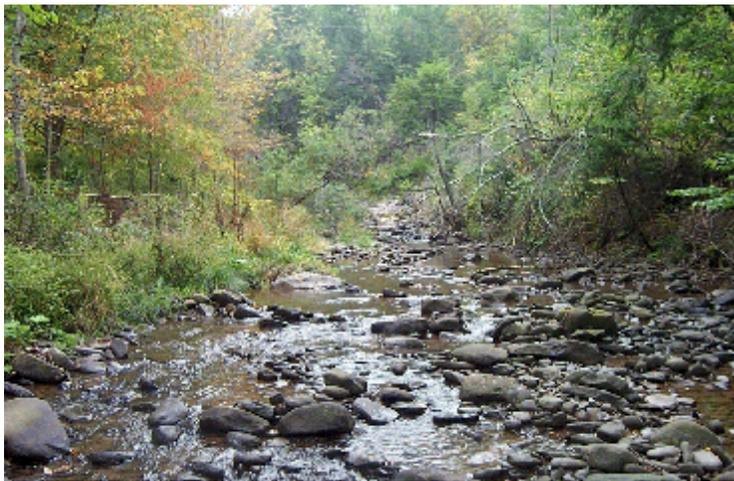
Photo 2. Looking upstream toward the largest eroding bank on Broadstreet Hollow, in the downstream section of MU8.

Two large eroding banks, both on the *left bank* (looking downstream) and away from the road, dominate the 790-foot downstream section of MU8. There is one structure at 202 Broadstreet Hollow Road which is between the road and the stream, on the right bank overlooking the stream. The structure is on a terrace, well above the active floodplain, so is at lower risk of flood damage in all but the most extreme flood events.

The valley in the downstream section of MU8 is somewhat wider compared to the upper section, with the road well away from the stream. The one reach of unstable stream type in this section is associated with the largest eroding stream bank documented in the entire Broadstreet Hollow, on the left bank (looking downstream) near the bottom of MU8, just upstream from where the road and the stream come back together. A long *berm* (a narrow mound of earth along the stream) along the right bank has caused the stream to become entrenched, and may increase flood stage (height) impinging on the opposite bank, increasing bank erosion and instability and perhaps exacerbating flooding damages in downstream areas.

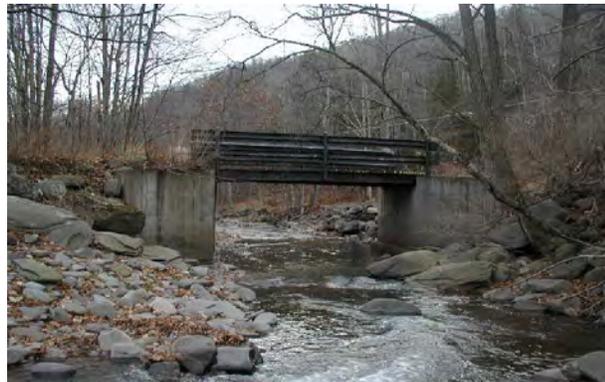
Stream assessment survey data for 2001 show the centerline of Broadstreet Hollow Road ranges from 25 to 95 feet from the stream (measured from the *thalweg*, or the deepest part of the stream). Broadstreet Hollow Road itself does not cross the stream in this unit, hence there are no county or town bridges in MU8. There is one private bridge off the main road, at the upstream end of the upstream section. (Photo 3).

Photo 3. Private bridge near the top of the upstream section of MU8, looking downstream.

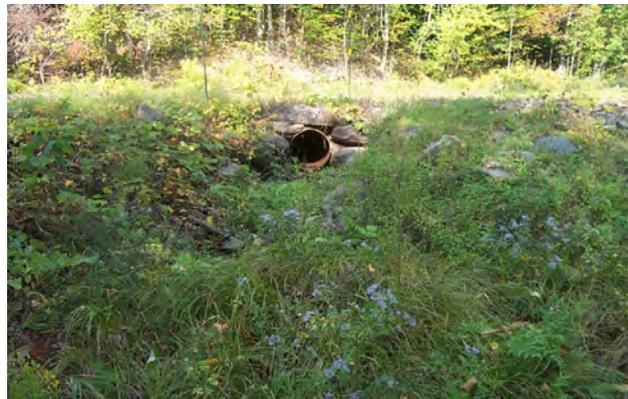
Photo 4. Upstream-most (top) culvert on the right bank, MU8.

The top culvert provides a road crossing for a small tributary.

Culvert inlets were not surveyed as part of the stream assessment, so culvert inlet condition is unknown. Culvert outlets are generally in good condition; with no apparent immediate threat to stream bank or road fill stability. Culverts in this section currently enter the stream at a low angle, with ample vegetation, reducing negative impacts to stream stability in this reach.

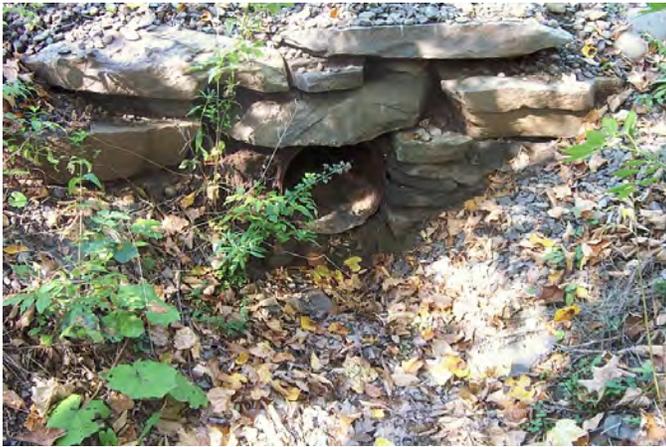
Photo 5. Middle culvert, right bank, MU8.

Middle and bottom culverts in MU8 provide a road crossing for roadside ditch drainage.

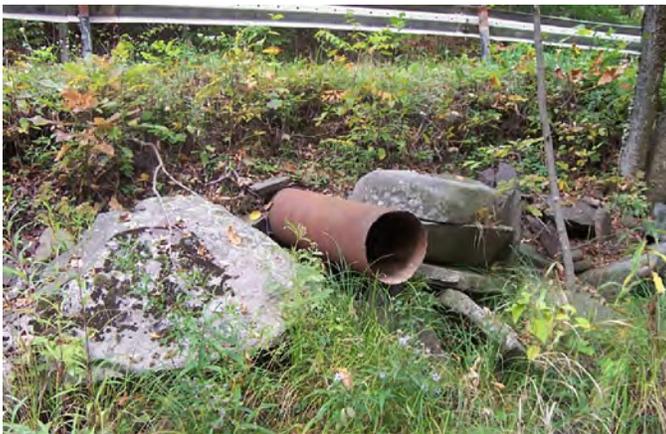
Photo 6. Bottom culvert, right bank, MU8.

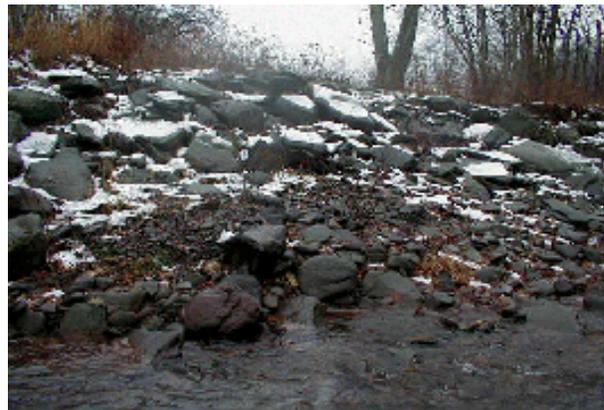
The upper reach of MU8 includes approximately 50 feet of rip-rap upstream of the private bridge on the left bank (Photo 7). This rip-rap is located on the inside of a stream bend.

Photo 7. Boulder rip-rap, left bank, above private bridge at the top of MU8.

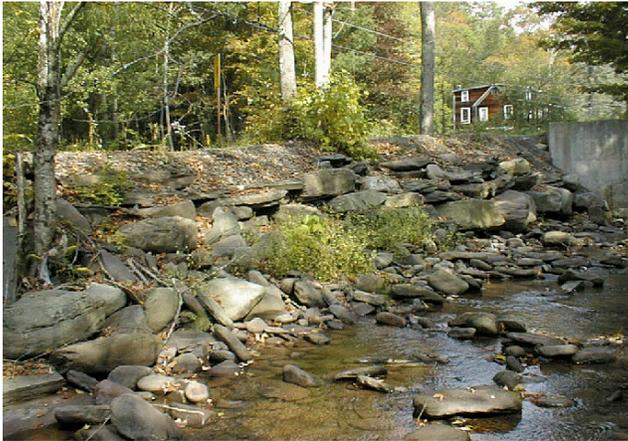
Photo 8. Stacked rock wall, right bank below bridge, MU8.

Approximately 50 feet of stacked rock wall stabilize the stream bank and road fill on the downstream side of the private bridge, on the right bank (Photo 8). Narrow bridges often require bank stabilization, or *revetment*, on the banks both up- and downstream from the bridge, due to increased erosion potential caused by stream constriction at high flow. These areas often require repeated maintenance and repair, which could be reduced by increasing bridge span, improving flood conveyance through the bridge opening, and extending the useful life of the bridge.

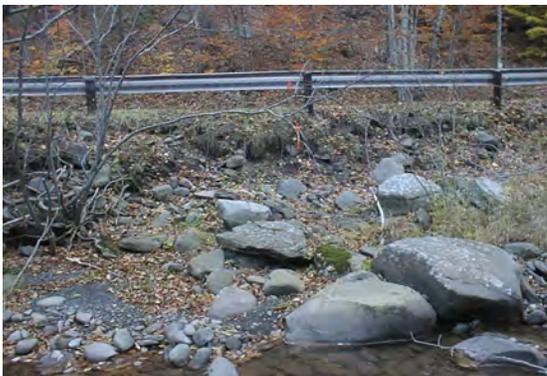
There is a new length of stacked rock wall stabilizing the right bank at *monitoring cross section 15* (Photos 9 and 10) installed by the Town of Shandaken Highway Department in 2002. By using a stacked rock wall, they were able to preserve existing riparian vegetation (note small trees at left, with stones behind them), and as a result, only a minimum of disturbance was made to the stream bed in this area (note boulders and cobbles in the same configuration before and after the work). Augmenting stacked rock walls with *bioengineering*, or re-vegetation, would improve stability and enhance riparian functions in these areas.

Photo 9. Eroding bank at monitoring cross-section 15, MU8, summer, 2001.

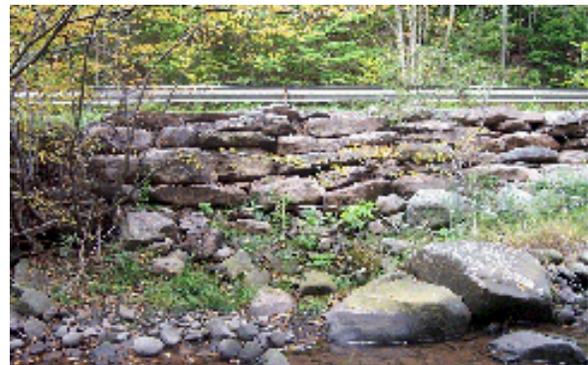
Photo 10. Stacked rock wall at monitoring cross section 15, MU8, 2002.

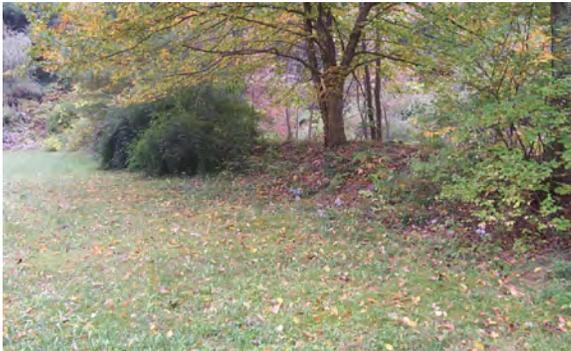
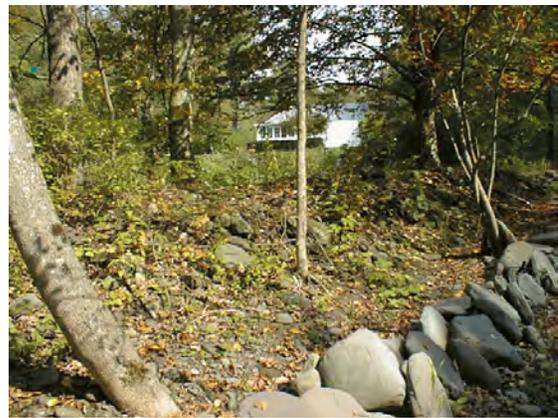
Photo 11. Earthen berm viewed from floodplain (at left), stream is on the other side, at right.

The downstream half of MU8 contains approximately 150 feet of low earthen berm of unknown age (primarily cobble material), along the right bank (looking downstream, see photos 11 & 12). The berm appears to have been constructed to prevent inundation of the floodplain lawn area behind it. This berm is fully vegetated, with some large trees.

Photo 12. Earthen berm viewed from stream (at right), floodplain is on the other side, at left.

Unfortunately, berms like these prevent floodwaters from flowing over the stream’s floodplain, cutting off an important function of these flat areas. Floodplains function to reduce flood velocity, increase absorption of floodwaters, encourage deposition of silts and clay sediments (keeping them from being washed further downstream) and decrease flood stage, or height, in downstream areas. Because the majority of Broadstreet Hollow stream floodplains consist of small, low, discontinuous floodplain benches, larger areas such as this floodplain are influential to the overall flooding capacity of the stream. This berm should be removed or restructured to allow greater access of the stream to the floodplain³.

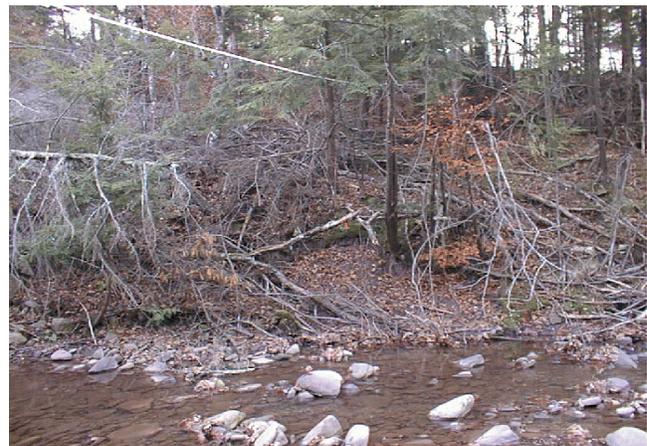
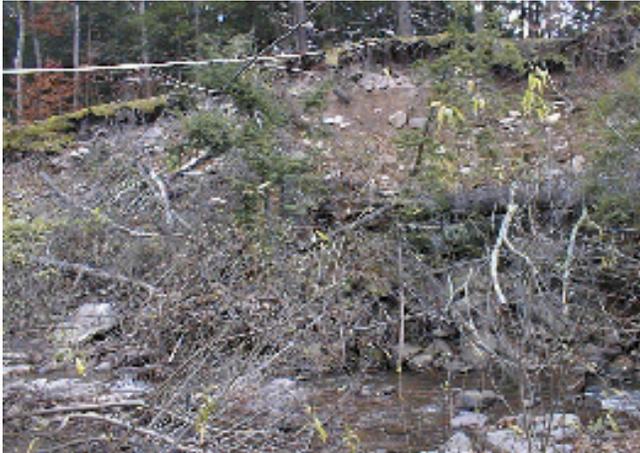
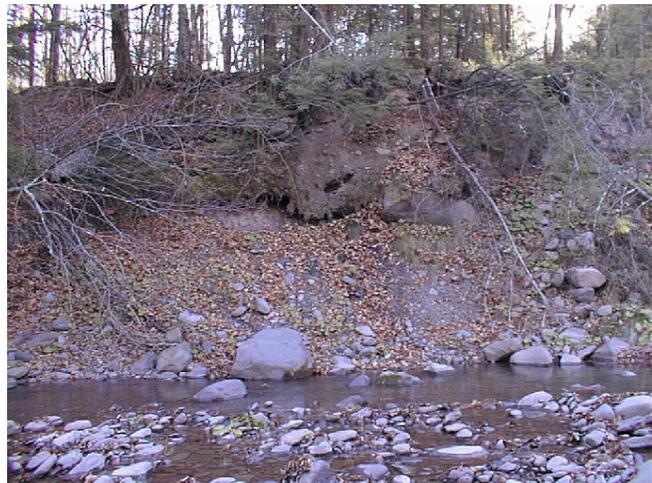
Photo 13. Eroding left bank at high terrace, monitoring cross-section 11, MU8.

Photo 14. Eroding left bank at high terrace, monitoring cross-section 12, MU8.

Monitoring cross sections 11-13 have been set up to monitor a single 200+ foot-long bank, in the lower half of the downstream section, approximately. This bank contains a substantial exposure of a glacial *ice contact deposit* characterized by a poorly consolidated matrix of silty sand supporting *gravel to boulder-sized* rocks.

On the older, downstream portion of the bank *glacial lake clay* is exposed as slumped material as well as *in-situ* (in place) layered clay in the stream bed. The presence of the clay is likely the primary factor contributing to the destabilized bank. The bank is largely un-vegetated on its face, though supports a forested *wetland* on the terrace above. The base of the bank has been partially protected by downed trees, placed there by volunteers from Trout Unlimited in 1999.

Photo 15. Eroding left bank at high terrace, monitoring cross-section 13, MU8.

This eroding bank represents the greatest potential for ongoing stream instability in MU8. This bank received the highest bank erodibility hazard index (BEHI) ranking out of the 28 BEHI sites monitored as part of stream assessments conducted in 2001^{3&4}. The stream bank is very high (approximately 25 feet), the angle of the bank is steep, the material is poorly consolidated, there is very little vegetation to hold bank materials in place. The stream is entrenched in this area, partially due to the presence of the low flood-control berm on the opposite bank (Photos 11 and 12). Additionally, the berm may be increasing flood risk by raising flood stage and increasing stream velocity and erosion at the toe of the opposite bank. This situation could also increase erosion downstream as flood waters are concentrated and accelerated through this reach.

The eroding bank represented by BEHI monitoring cross sections 11, 12 and 13 would benefit from a full-scale stream stability restoration project (one that uses natural stability restoration principles and design) to prevent further erosion of unstable bank materials, and reduce the potential hazard from increased velocity and excessive amounts of *large organic debris*⁸ (i.e., tree trunks and branches). Restoration of this bank should include removal or reconfiguration of the berm on the opposite bank.

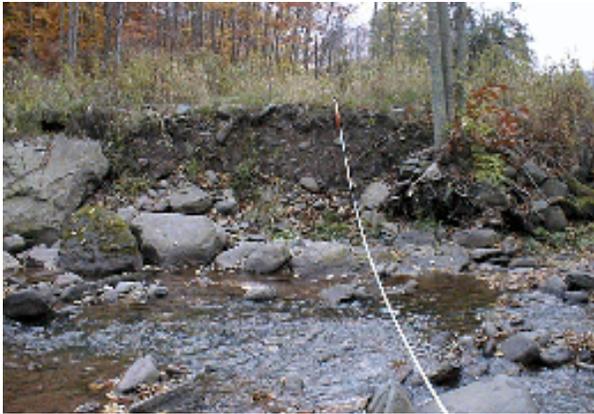
BEHI monitoring cross sections 14, 15 and 16 correspond to small eroding banks in the upstream half of MU8, none of which are associated with glacial lake clay exposures. As previously noted, the Town of Shandaken Highway Department has stabilized the eroding bank at BEHI 15 with a stacked rock wall (see Photos 9 & 10).

Photo 17. Eroding left bank at mowed field, monitoring cross-section 16, MU8.

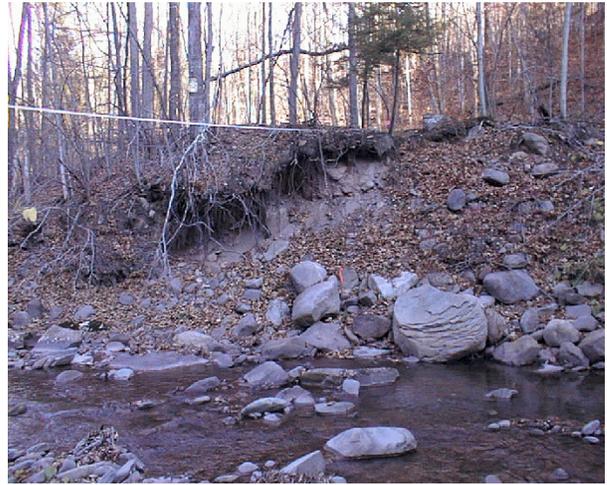
Photo 16. Eroding left bank at wooded area, at monitoring cross-section 14, MU 8.

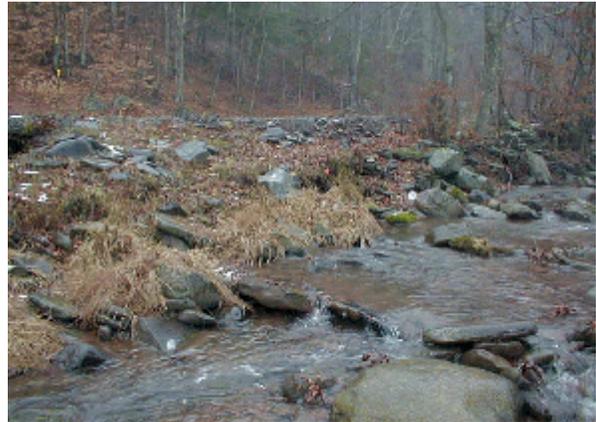
Photo 19. Right bank, under-vegetated riparian area near road, just upstream of the top culvert, MU8.

Stream assessment conducted in 2001 did not investigate specific streamside (riparian) plant species or density, other than to note areas of insufficient or stressed vegetation that could affect stream stability, flooding or erosion threats, water quality or aquatic habitat for trout species. Based on these general, qualitative observations, riparian vegetation in MU8 appears fairly healthy, excepting in the sections containing rip-rap or stacked rock walls, and most notably excepting in the actively eroding areas described above³. Eroding and hardened sections of MU8 have insufficient riparian vegetation to either protect banks from further erosion or improve stream habitat⁷. Under-vegetated areas in the vicinity of stacked rock walls, rip-rap and road fill sections in this reach should be vegetated with a mixture of native riparian species to improve shade, cover and water temperature conditions for aquatic habitat⁹, as well as to improve bank stability and reduce the need for bank stabilization work that could cause stream ecosystem disturbances³.
