Broadstreet Hollow Management Unit 16 -19

Broadstreet Hollow Management Unit 17

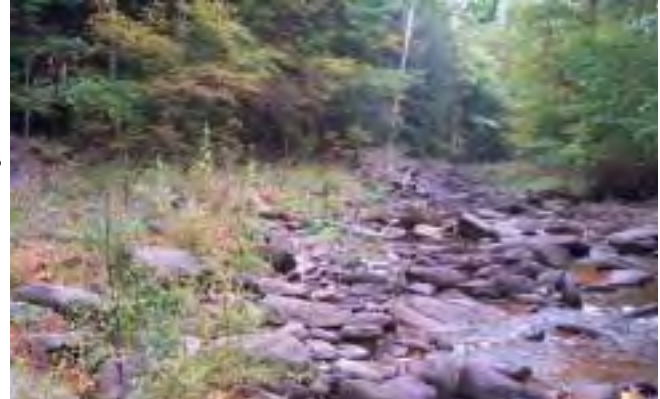
Photo 1. Looking upstream into the top of MU17.

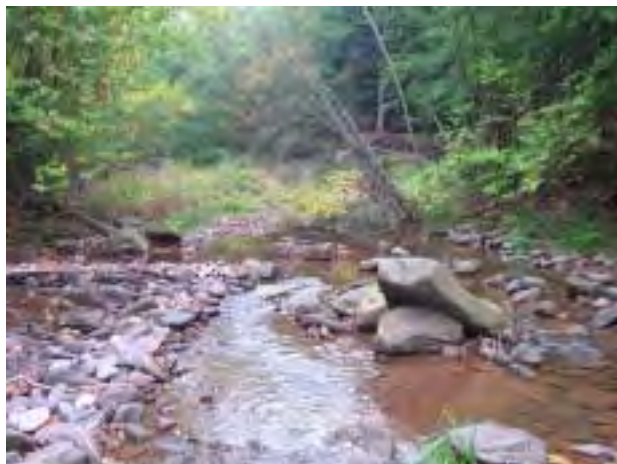
Photo 2. Looking upstream into the middle of MU17, with high eroding valley wall hillside to the right. This reach was chosen to represent an unstable "control" reach, to be monitored as part of the stream stability restoration demonstration project in MU3.

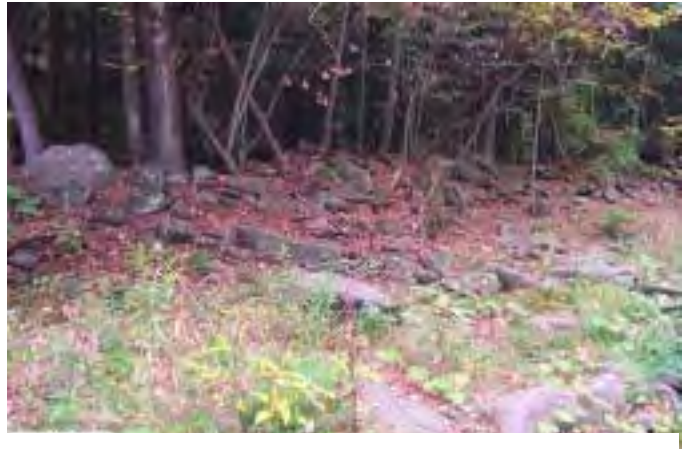
Approximately 470 feet, or 53%, of the stream bank in MU17 has been bermed, in three sections³. The largest section is 275 feet long, on the right bank (looking downstream) along the pond area, roughly from the pond inlet to the outlet (Photos 3 and 4). This berm appears to have been constructed to protect the property and pond from flood inundation and damage, and consists primarily of large cobble and earth material, with some trees and other vegetation.

Photo 3. Cobble and earth berm, on right bank in the pond area. The main stream is behind the viewer, flow is from right to left.

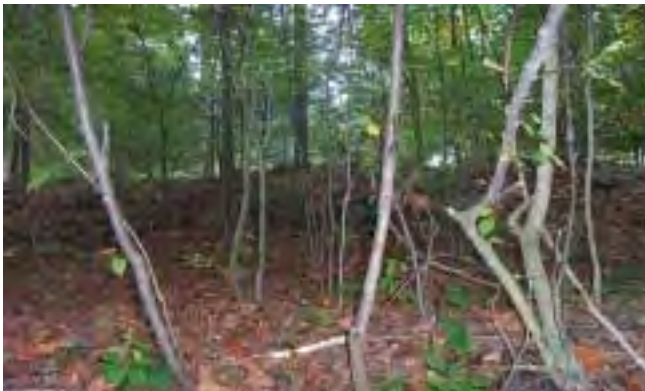
Photo 4. Berm on right bank, set back from the stream, allowing some wooded floodplain access. The main stream is behind the viewer, flow is from right to left.

its entire length, so allows some floodplain area to be available to the stream during high flows (see Photo 4)

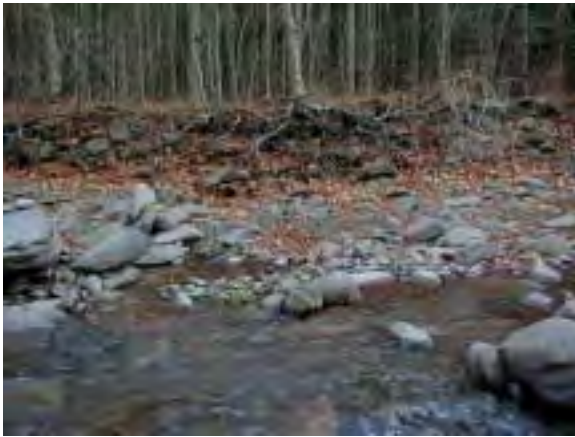
Photo 5. Pushed up cobble berm on the left bank, near the top of MU17 opposite the pond inlet area. Stream flow is from left to right.

The other two berms, both on the left bank, appear to be material pushed up onto the banks in response to 1996 flood damages, and may have been the site of such practice in earlier floods (Photos 5 and 6). One berm is at the top of MU17, across from the right bank berm, and the other is near the bottom of the unit. This practice of “cleaning” the gravel out of a stream in this way is sometimes thought to increase flood capacity by creating a larger stream channel. Unfortunately, berms such as these generally do not offer much if any protection from flooding (inundation), especially if the berm is uneven or ends abruptly. The channel is

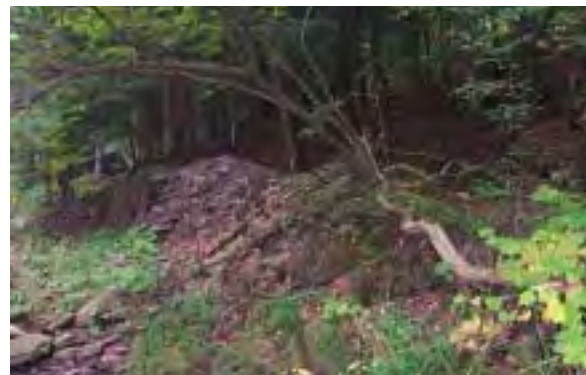
Photo 6. Pushed up cobble berm on the left bank, near the bottom of MU17 across from the pond outlet area. The main stream is behind the viewer, flow is from left to right.

Broadstreet Hollow stream floodplains consist of small, low, discontinuous floodplain benches that perform the important floodplain functions in small mountain streams. MU17 is in a section of the Broadstreet Hollow Valley that would allow the stream to maintain broader areas of floodplain, however, bermed areas limit this feature, potentially increasing the risk of flood inundation. Removal or restructuring of all of these bermed areas should be considered to add floodplain function to this area³. Particularly, the berm on the right bank could be restructured and set back from the stream. Alternatively, inlet and outlet areas could be reconfigured to allow flood waters to pass over and through the pond without damage or excessive sediment deposits from concentrated flows. The other bermed areas could safely be removed entirely, as there are no structures or other development in the floodplains behind them.

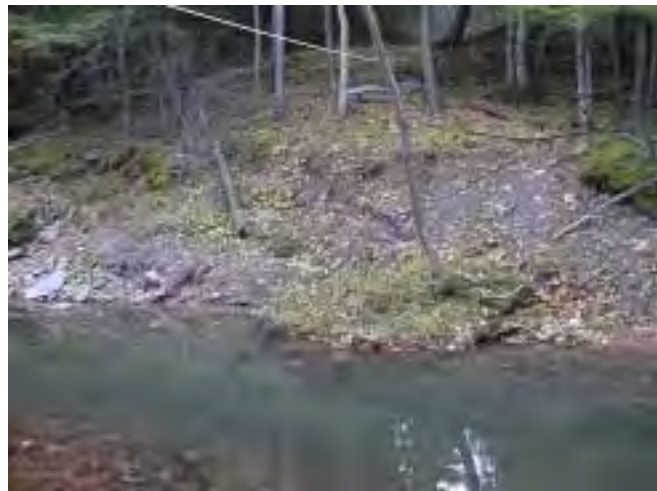
The eroding left bank hillslope at monitoring cross-section 3 has a significant exposure of highly erodible *glacial lake clay* (Photo 7). Mature trees sliding down the hillslope and failure scarps (large cracks in the hillside, parallel to the stream, created as blocks of land slide downhill) show multiple *rotational failures* and bank *slumping*. This failure mechanism is fueled by stream erosion at the bottom, or *toe*, of the slope, continually delivering soil, rocks and vegetation into the stream and preventing an adjustment of the stream channel to a stable shape⁴.

Photo 7. Eroding clay valley wall hillslope, left bank, showing trees sliding downslope into the stream. The white tape across the stream shows the location of monitoring cross-section 3. Stream flow is from left to right.

This clay comprises the entire hillside, similar to the eroding banks at the bottom of MU8 and MU15, and the middle of MU5, over which the riparian forest is sliding and

slumping into the stream in large sections, despite the presence of large healthy trees (see Photo 7).

This bank received a “high” bank erodibility hazard index (BEHI) ranking at both monitoring cross-sections^{3&4}. The stream bank is high (approximately 10 to 13 feet), the angle of the bank is steep, the material is poorly consolidated (especially with clay materials), and there is little stable vegetation with enough root strength

The eroding bank represented by monitoring cross-sections 3 and 3.5 would benefit from a full-scale stream stability restoration project (one that uses natural stability restoration principles and design) to prevent further erosion of unstable bank materials, and reduce the potential hazard from increased velocity and excessive amounts of *large organic debris* (i.e., tree trunks and branches). Restoration of this bank should include removal or reconfiguration of the berm on the opposite bank, to return the stream to a more stable and sustainable stream shape, reducing entrenchment in this section and reducing flood pressure on the opposite bank. Structural re-vegetation, or *bioengineering*, should be considered in conjunction with a full-scale restoration of the stream channel morphology in this reach. Additionally, the hillslope failure should be assessed to determine the extent of *geotechnical* failure mechanisms, as well as to advise the appropriate solution for this continued problem^{7&8}.

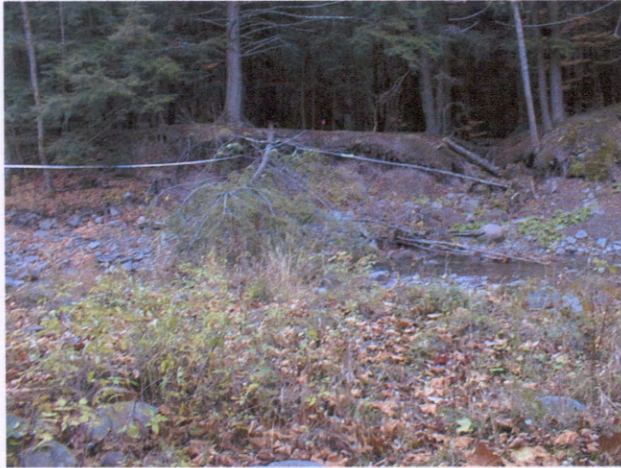
Photo 8. Eroding left bank at wooded terrace bank, just upstream of eroding clay valley wall hillside. White tape across the stream shows the location of monitoring cross-section 3.5. Stream flow is from left to right.

In contrast, the upstream section at monitoring cross-section 3.5 does not contain visible clay, and the valley wall is not as steep (Photo 8). There is one failure surface, on top of which is a fairly stable riparian forest, though the roots of the trees are not deep enough to hold this high bank in place.

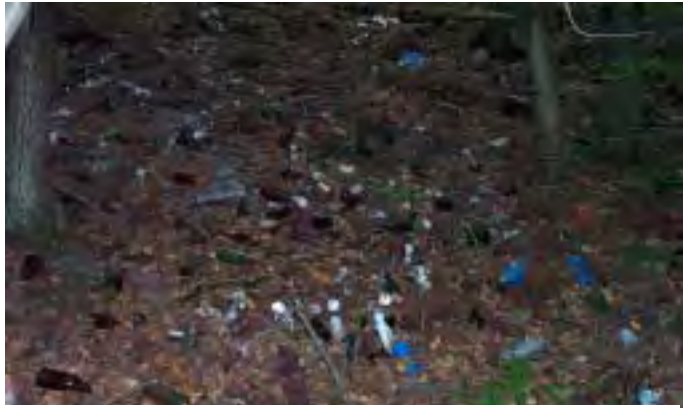
In addition to the small area on the border between MU16 and MU17, the stream assessment survey conducted in 2001 documented one large dumping site, on the hillside on the left bank, behind the downstream-most berm, where the valley broadens and the stream moves away from the valley wall¹ (Photo 9). This area is extensive, composed primarily of glass and metal. This site is about 70 feet in length, and approximately 70 feet from the thalweg. Planning efforts to organize cleanup of sites like this were initiated in 2002, and should continue, as labor and funding are available, though any risk from this site to water quality is probably minor, though no specific analysis of materials was conducted.

Photo 9. Dumping site with glass and metal materials, on the left bank near the bottom of MU17, behind the berm shown in Photo 6.
