Broadstreet Hollow Management Unit 16 -19

Broadstreet Hollow Management Unit 19

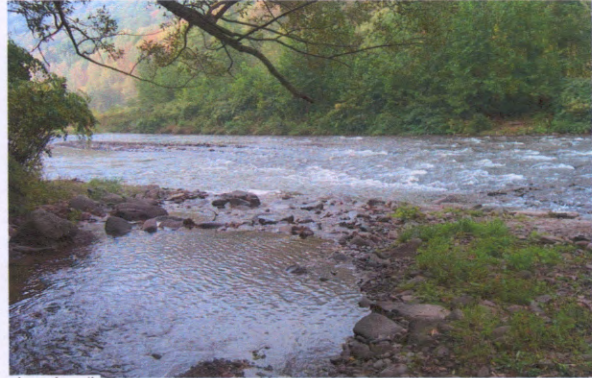
Photo 1. Looking downstream at the bottom of MU19, into the confluence of the Broadstreet Hollow with the Esopus Creek (flowing right to left).

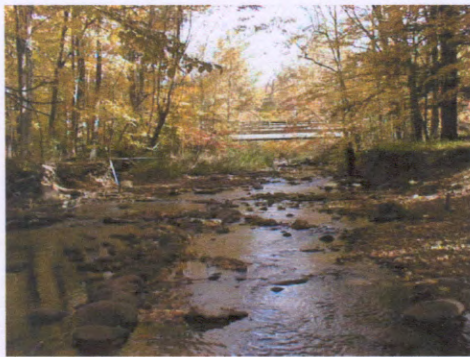
Photo 2. Looking upstream into the top of MU19, showing wide stream shape, with broad flat valley areas on both banks. Route 28 bridge is visible, marking the bottom of MU18.

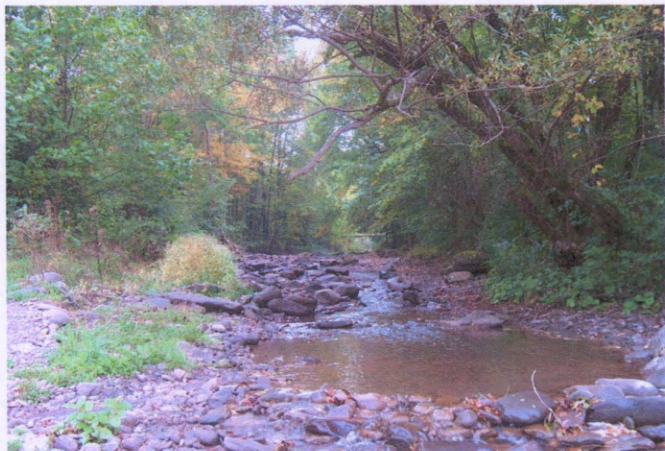
Photo 3. Looking upstream from the bottom of MU19 at the confluence with Esopus Creek. Note healthy riparian vegetation on both banks, with some floodplain bench features visible to the left.

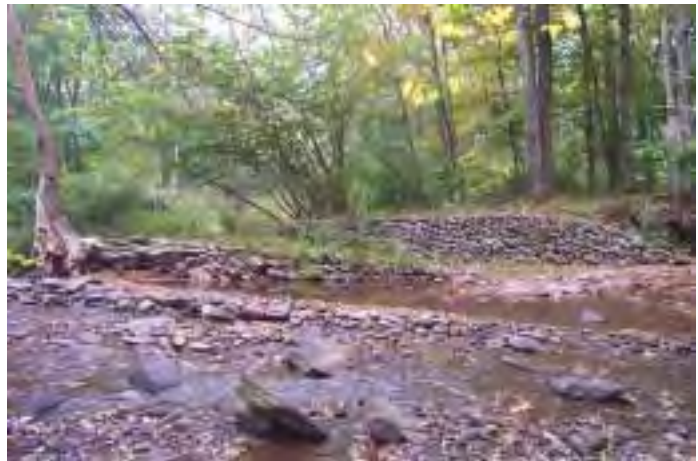
A privately maintained pond has been constructed in the Esopus floodplain, just off the Broadstreet Hollow stream, with two small rock walls and a 73-foot section of mounded earth material, or *berm*, to protect the pond inlet (Photo 4). Though bermed areas typically constrict the stream, causing entrenchment and reducing floodplain functions, the short length of this berm, and the floodplain access maintained on the opposite bank reduce potential impacts from the berm structure alone. However, stream confluence areas are unstable by nature's

Photo 4. Hand laid stone walls at the pond inlet, pond is behind the walls. Note the angled structure of the wall, which mimics the natural stable structure of stream laid stones (as a fish scale pattern, called "imbrication"). Stream flow is from right to left.

design, as the tributary stream delivers sediment and flood pulses to the main stream, and the interaction of floods on the main stream cause added stress and sometimes unpredictable impacts to the stream bed and banks of the tributary stream^{3&5}.

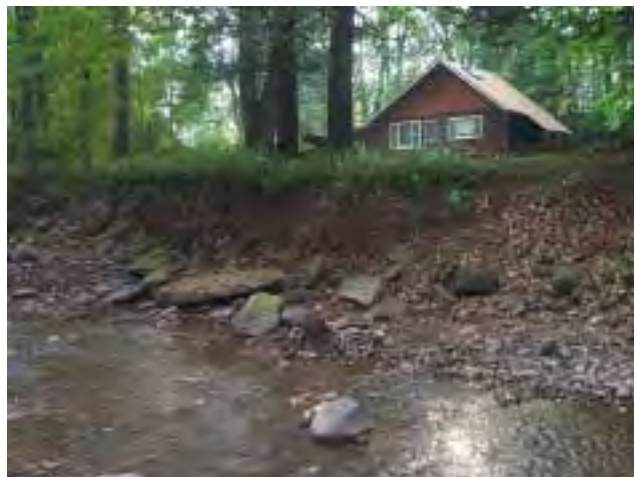
Stream assessment conducted in 2001 revealed approximately 350 feet (40%) of the stream bank in MU18 is actively eroding, in two sections on opposite sides of the stream near the top of the unit (Photos 5 and 6). A representative location was chosen and permanently marked, or *monumented*, for future monitoring (designated as "monitoring cross-section 1) to determine erosion rate and priority for potential restoration³. This site has been assessed and ranked based on calculation of a *Bank Erodibility Hazard Index* (BEHI) using data collected at the time of the stream

Photo 5. Eroding left bank at residential lawn area, monitoring cross-section 1. Stream flow is from left to right.

assessment survey in 2001⁴. This site received a BEHI ranking of “moderate” for potential for further erosion.

The left bank appears to be eroding primarily due to a lack of deeply rooted riparian vegetation, despite a few large trees set back from the face of the bank. Erosion on the right bank opposite is not as severe, and really represents an extended undercut bank, held in place by a more dense network of various sized riparian tree roots, and probably adds to aquatic habitat quality in this area⁹.

The eroding left bank in MU19 may contribute to increased turbidity from fine sediment sources from stream bank and bed material, especially during high flows. The amount of sediment available from the right bank is probably not significant, due to the mitigating influence of the riparian vegetation⁵.

Japanese Knotweed, a non-native, invasive plant, was documented along 15 feet (2%) of the banks in this unit during stream assessment in 2001, in the middle of the left eroding bank area at monitoring cross-section 1. This species is an invasive exotic, and damaging to riparian integrity⁷. Japanese Knotweed is fast growing, can crowd out native vegetation and the roots provide little or no soil-anchoring action.

Japanese Knotweed is aggressive and spreads easily; pieces break off, wash downstream and can take root where they land, especially in disturbed areas (such as eroding banks or continually disturbed maintenance areas). To avoid further spread of this plant to downstream areas that may be vulnerable to colonization and further spread in this disturbed eroding bank area, Japanese Knotweed at this reach should be removed, and the area replanted with a mix of competitive native species to prevent re-colonization. Additional maintenance of this area may be needed, as Japanese Knotweed is very difficult to remove successfully.

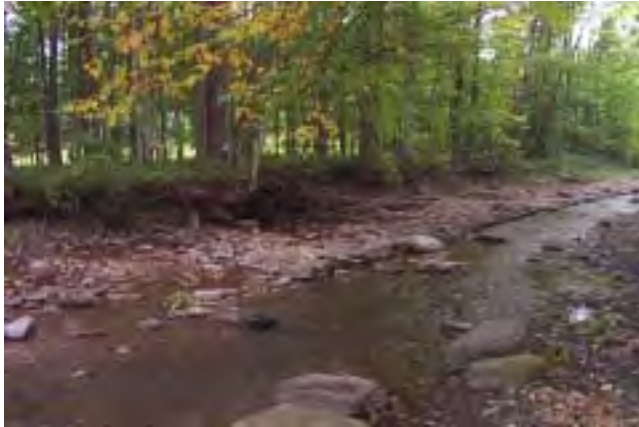
Photo 6. Mildly eroding left bank at forested terrace (Esopus Creek floodplain), monitoring cross-section 1. Stream flow is from right to left.
