## D. Chestnut Creek Management Unit 4

### 1. Summary Description

## Chestnut Creek Stream Management Plan

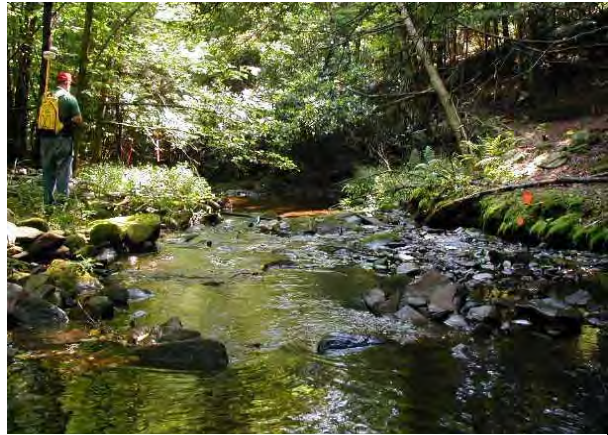
Photo 1. Cross section 58– view looking downstream behind Revolutionary War graveyard.

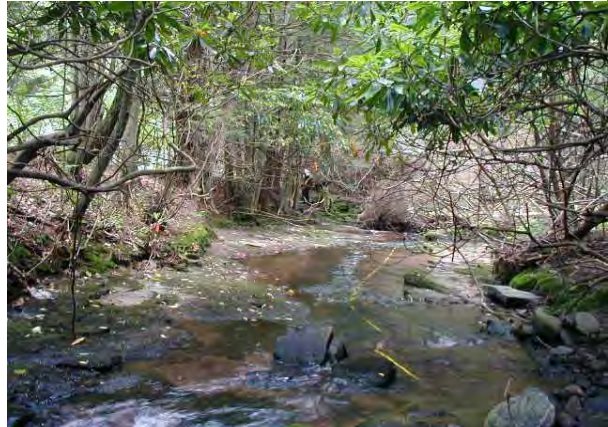
Photo 2. Cross section 63– view looking downstream.

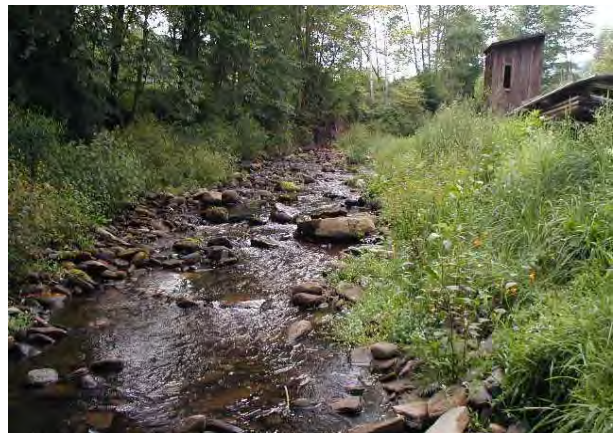
Photo 3. View looking upstream -Rt. 55 to the right of view.

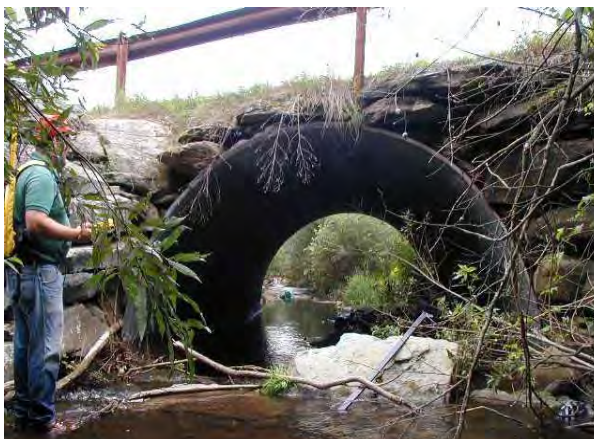
Maintenance of infrastructure is a concern for local municipalities as well as landowners. There are four stream crossings and four drainage culverts in MU4. The stream crossing at Slater Road culvert is a 9 x 15 foot corrugated metal elliptical pipe (Photo 9). The cross-section of the culvert is narrower than the *bankfull* channel upstream and downstream of the culvert. Downstream landowners have reported erosion and maintenance problems. According to residents, an old culvert in the same location had been

Photo 9. View looking downstream at inlet of culvert under Slater Road.

placed to direct streamflow towards the center of the channel. The old culvert was replaced in the mid to late 1980's with a new culvert that was shorter and placed at a skew relative to the stream channel. This skewed position resulted in storm flows being directed against the downstream *meander* bend contributing to *erosion* of the banks. In 1996, the Town repaired the culvert and stabilized 50 feet of banks downstream of the crossing. Subsequently, the landowner placed additional *riprap* along downstream sections.

4. In combination with recommendation 3, above, evaluate the Slater Road culvert and Botsford/Scheirer bridge to determine the best method for reducing bank erosion and improving sediment transport under

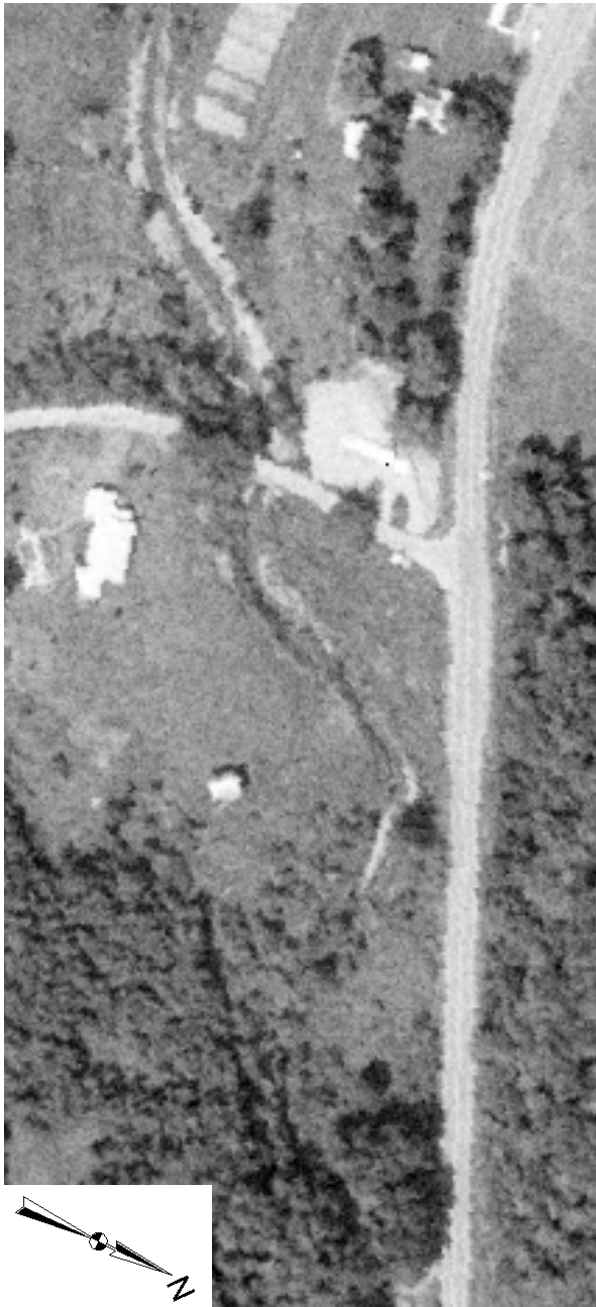
Photo 4. 1974 Aerial Photograph of the upstream section of MU4.

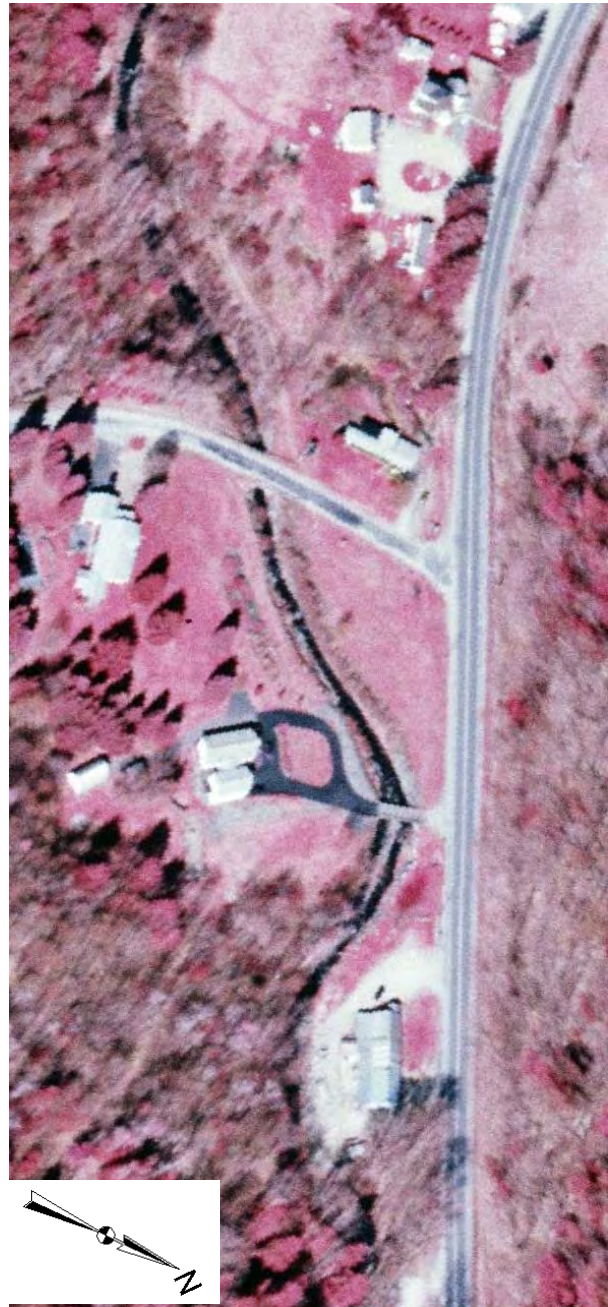
Photo 5. 2001 Aerial Photograph of the upstream section of MU4.

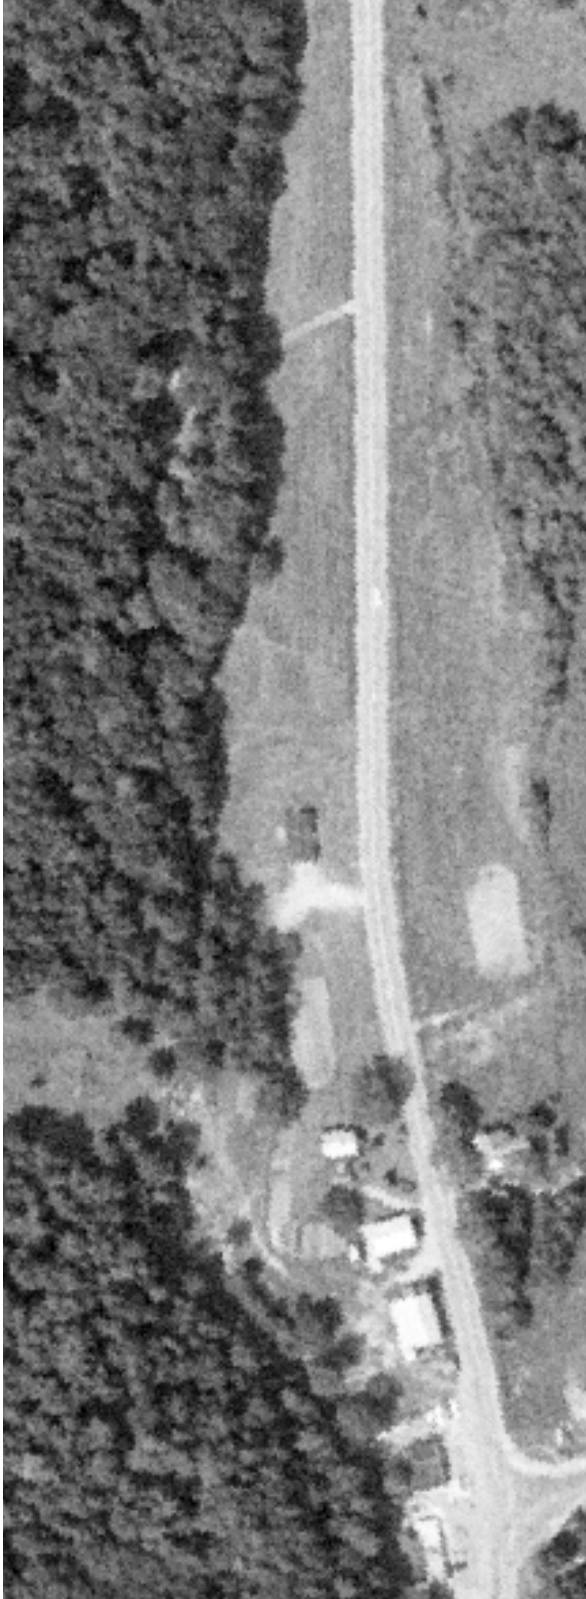
Photo 6. 1974 Aerial Photograph of the downstream section of MU4.

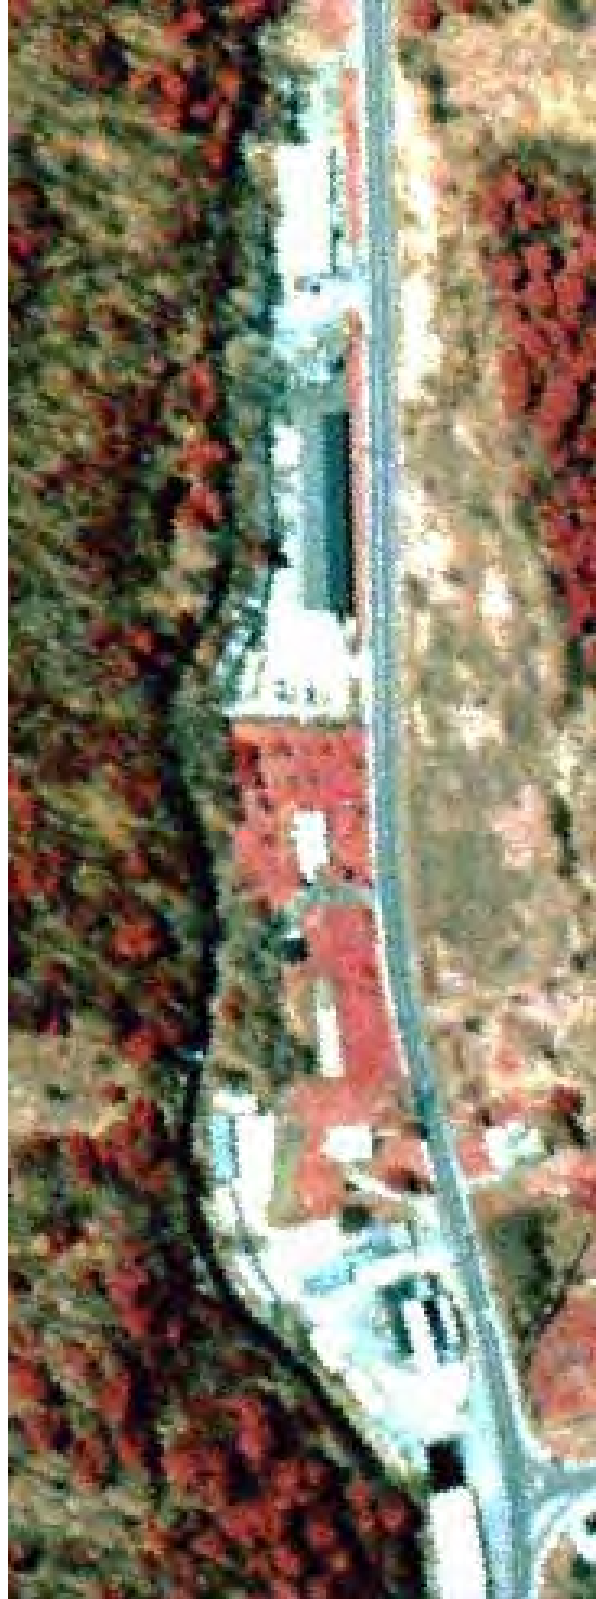
Photo 7. 1995 Aerial Photograph of the downstream section of MU4.

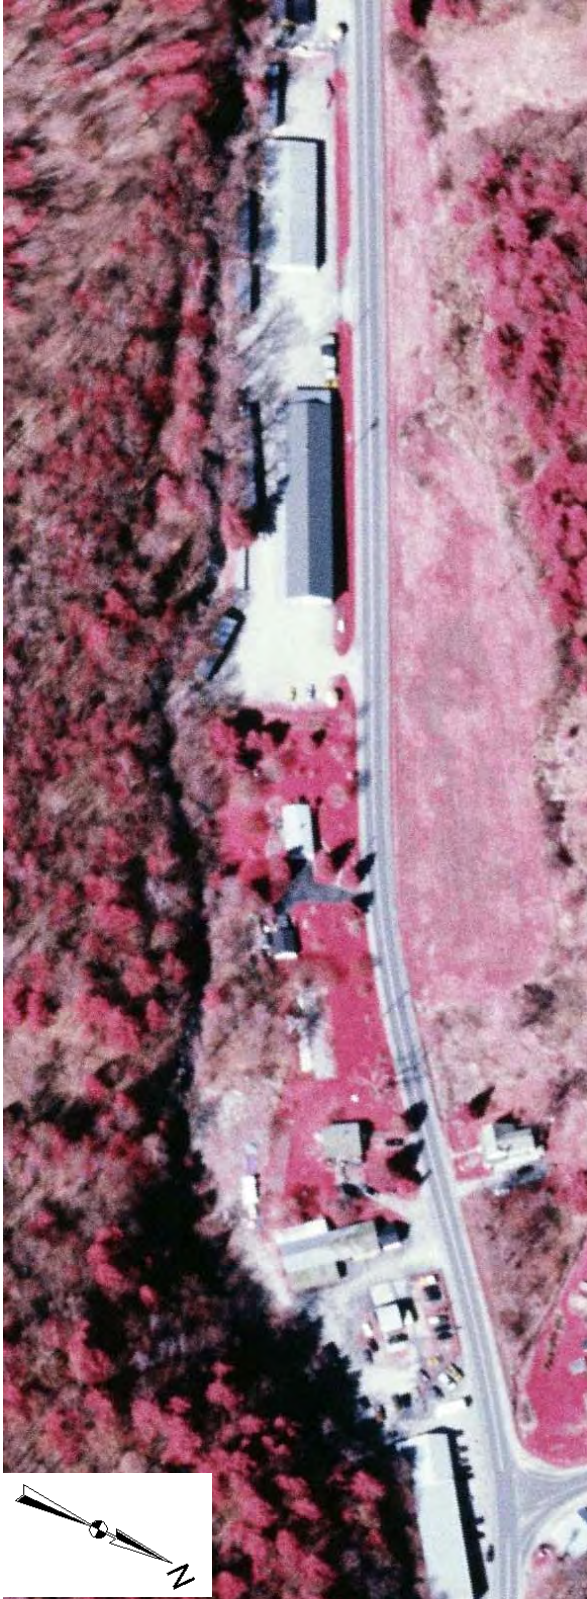
Photo 8. 2001 Aerial Photograph of the downstream section of MU4.

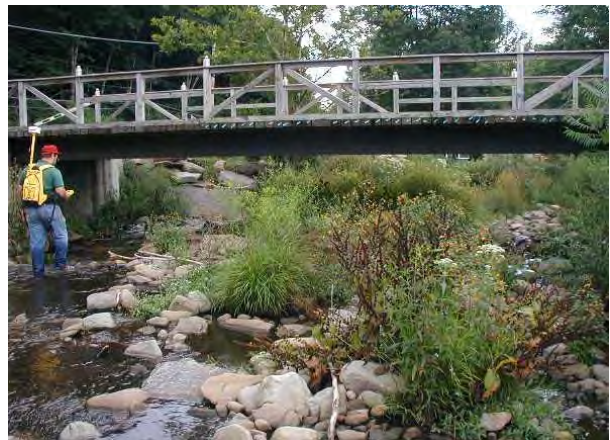
A privately owned bridge is located at the Botsford/Scheirer Property (Photo 10) approximately 380 feet downstream of the Slater Road culvert. The bridge appears to be in good condition, and consistent with the bankfull channel width in the immediate upstream and downstream cross sections. However, landowners have reported maintenance problems and development of a mid-channel bar downstream of the bridge as well as a gravel bar along the right bank upstream of

Photo 10. View looking downstream at private crossing below Slater Rd. Channel is split with a center island. The banks and island are well-vegetated with willows, but stream seems to be choked into the right bank.

and through the bridge opening. The reason for the sediment deposits is not conclusive. However, reports of improper alignment of the upstream culvert crossing, presence of a debris jam downstream, ongoing maintenance creating overwidened conditions and sediment deposition appear to be inhibiting the stream's ability to transport its sediment. Reduction or changes in hydraulic opening under a bridge can cause ongoing maintenance problems and potentially result in higher stress on the bridge or structure. Evaluation of bridge alignment could benefit redesign and maintenance of the bridge and stream in this reach.

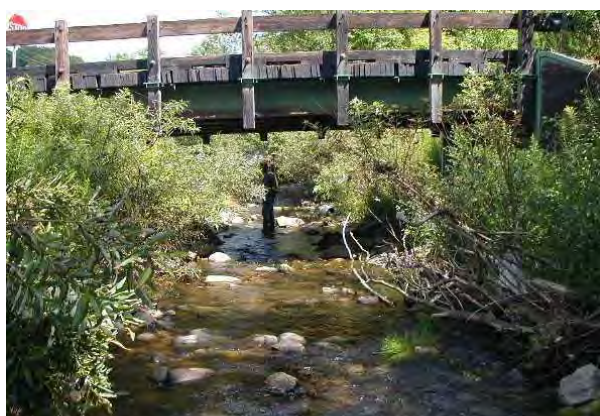
The County bridge at Kelly Road (CBN: 386, BIN: 3229170) was built in 1979 (Photo 11). It appears that the bridge was designed to convey larger, less frequent storm flows, probably the 25-year event. The bridge is subject to a biennial inspection by NYSDOT, which indicates that the decking, abutments, and wing walls are in good condition with no significant changes in scour. The bankfull cross sectional width both upstream and downstream of the bridge are only slightly larger than the span of the bridge itself.

Photo 11. Looking downstream at Kelly Road Bridge.

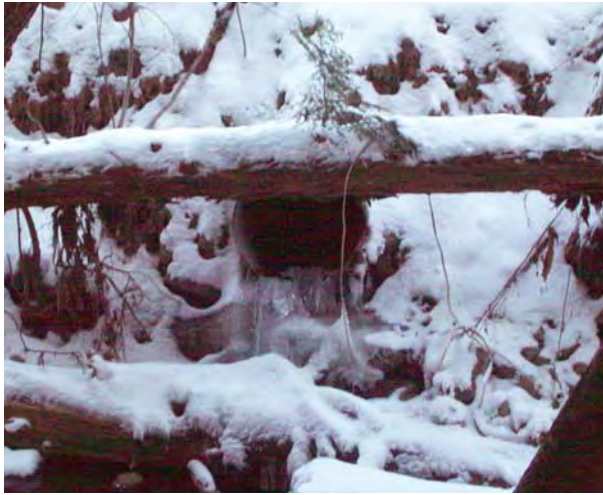
As noted above, storm drainage culverts convey storm water runoff from parking lots and equipment/materials storage areas directly to the creek. Three storm drainage culverts were identified in this management unit during the 2001 Stream Assessment Survey (Photo 12).

Photo 12. Storm drain outfall behind Zanetti's along Route 55.

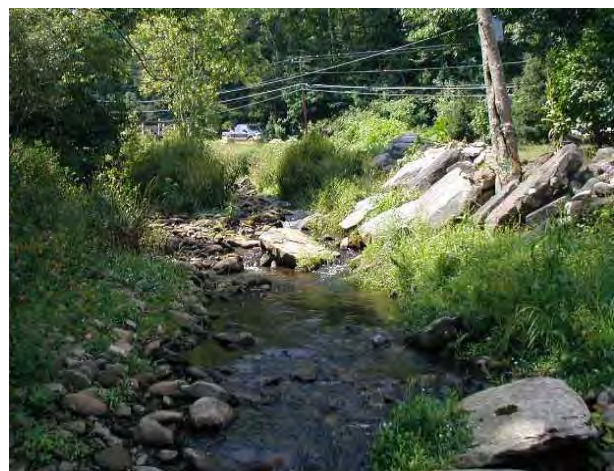
Efforts by the Town, as well as landowners focused on protecting infrastructure and property have involved the installation of *riprap* (Photo 13), stacked rock walls, and a log cribwall along 14% of the channel length through

Photo 13. View looking upstream– rip-rap on left bank– Rt. 55 is on the right side of the picture.

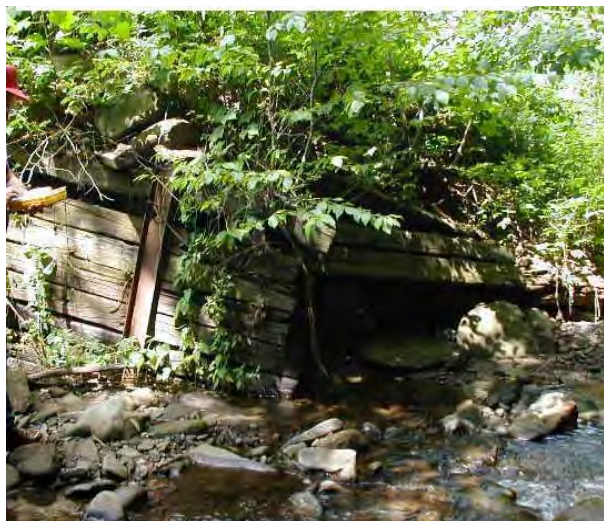
this management unit. These protective measures appear to have been relatively successful in some areas, while less successful in other areas. For example, a section of a log cribwall installed near the downstream end of the unit is failing (Photo 14).

Photo 14. Beginning of log crib wall on left bank view from right bank near bottom of MU4, before the entry of the Claryville Road tributary.

10. Monitor areas with debris jams and channel blockages for changes in channel stability and threat to infrastructure.
11. Evaluate failing revetment for replacement with stabilization structure to maintain naturally functioning channel. Should include bioengineering and/or re-vegetation.

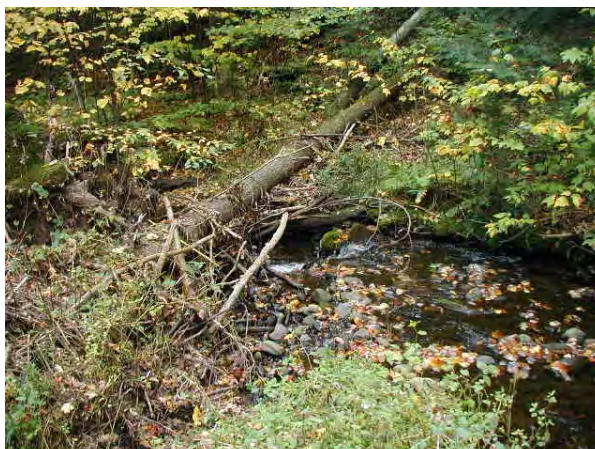
Debris jams and other channel obstructions can cause problems by trapping sediment which initiates and/or accelerates the development of gravel bars and reduces channel capacity. Subsequent bed erosion and removal of the deposited gravel contributes sediment to downstream reaches. The 2001 Assessment Survey identified the largest debris jam, located at the upstream end of the Grey/Mickelson Property, has contributed to *aggradation* along approximately 800 feet of stream channel (Photo 15). The accumulated material has flattened the channel gradient and reduced channel capacity thereby contributing to flooding of adjacent properties as well as bank erosion in this area. Immediately downstream of the jam the streambed drops sharply in a step. A *headcut* or sharp step in the stream bed, tends to continue to erode, moving the entire step upstream as it cuts into the bed and into the fine sediment accumulated behind the debris jam. Information obtained from interviews with residents and town officials indicates that this and the surrounding area has been an on-going maintenance problem for more than 17

Photo 15. Debris jam and *head cut* behind Grey's Woodworking just upstream of XS180.

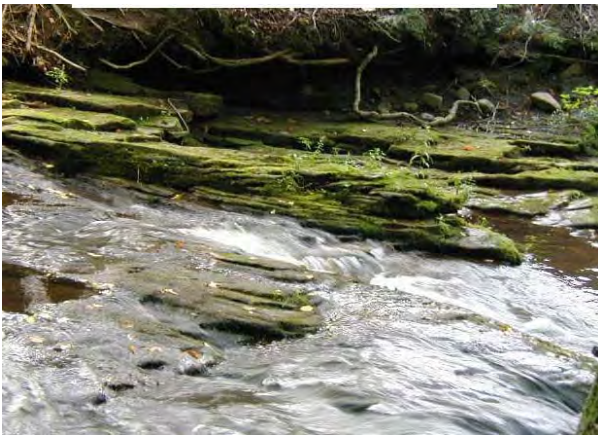
Historic bed *degradation* and floodplain fill contribute to the current entrenched situation along Reaches 1, 4, 6, 7, 9 and 10. Exposed bedrock currently provides grade control along a significant portion of the unit, thereby preventing further widespread channel degradation (Photo 16).

Photo 16. View looking towards left bank at bedrock stream bed MU4.

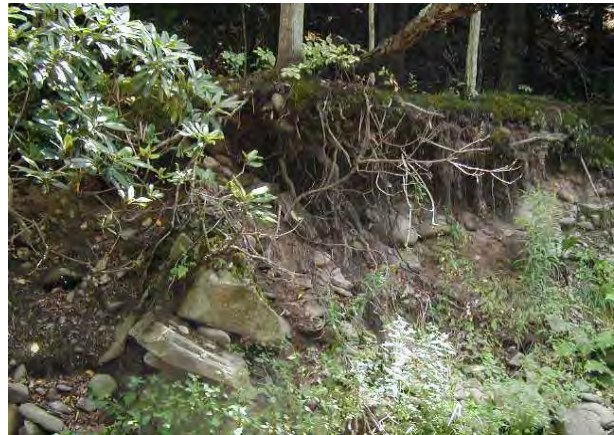
Preliminary observations indicate that the most of the channel along this management unit is laterally stable. Lateral control along the majority of the management unit is provided by mature trees and shrubs. The 2001 Stream Assessment Survey determined that there is a moderate amount of erosion however, 926 feet (17%) of the streambanks are actively eroding (Photo 17). Bank to bankfull height ratios along this unit ranged from 1.1– 5.5, confirming that a significant length of the channel is *incised*. Rosgen (2002) notes that bank to bankfull height ratio is a good measure of vertical stability, as well as an indicator of *sediment* supply potential. Results of the

Photo 17. Eroded right bank – view looking upstream near the bottom of MU4.

stability assessment show that the banks along the actively eroding areas have very high bank erosion potential, meaning that the potential for continued bank erosion, loss of trees and channel migration and bank erosion potential is very high compared to other sites. Because the channel is cutting into terraces and fill slopes in some areas they will continue to be a significant source of sediment for downstream reaches.

6. Establish a better angle of repose on unstable banks and lower the bankfull to bank height ratio by grading high, vertical banks. Stabilize the banks and provide long-term lateral control by reestablishing bank vegetation composed of native trees, shrubs and grasses.

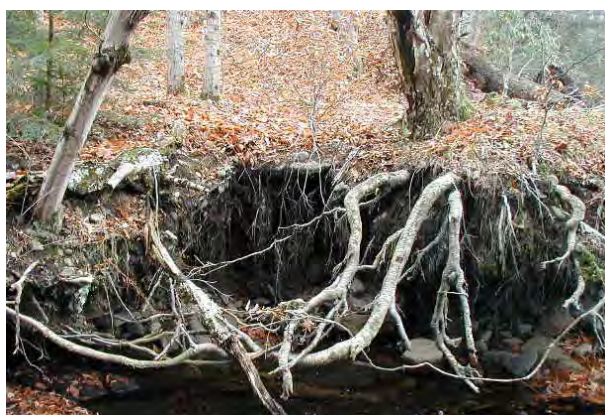
Photo 18. Monitoring cross section 2, left bank above the confluence of Scott Brook with the Mainstem Chestnut Creek. Tree roots and rocks are providing some protection and good habitat.

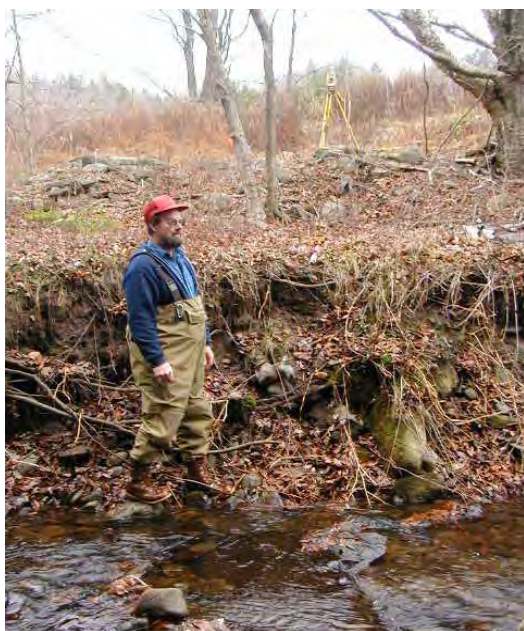
Photo 19. Monitoring cross section 3, below confluence of Scott Brook with the Mainstem Chestnut Creek. Stream flow is from left to right.
