East Kill Management Unit 4

Town of Jewett – Station 62465 to Scribner Hollow Road Bridge (Station 51119)

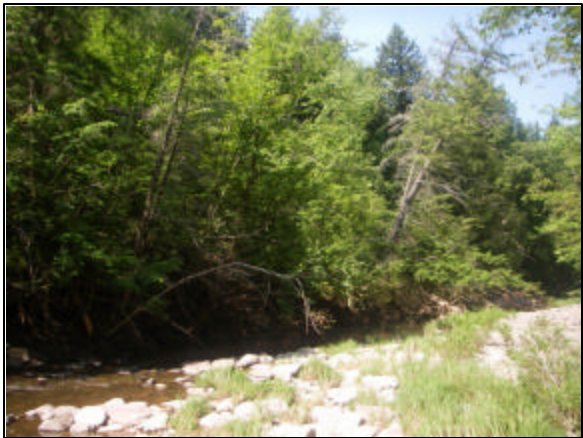
Erosion at Stations 62550 - 61905

This management unit began with an eroding bank; starting near the end of management unit # 3 there was some minor hydraulic erosion and scour (Stations 62550 – 61905) along the left stream bank, for approximately 87 feet, that continued into management unit # 4 for an additional 558 feet. Along the eroding bank, mature trees had been compromised and were hanging over the stream channel. In one location (Station 62435) along the bank, several large trees were lying across the channel, providing an obstruction to flow that contributed to aggradation upstream of the debris and scour downstream. There was mixed till throughout the bank, a pool along the toe, and excessive sediment deposition in the form of side and point bars along the right bed and bank, opposite the erosion. An unnamed intermittent tributary entered from the left through the eroding bank, possibly contributing to the erosion along the bank and aggradation in the stream channel; there was no flow at the time of the assessment.

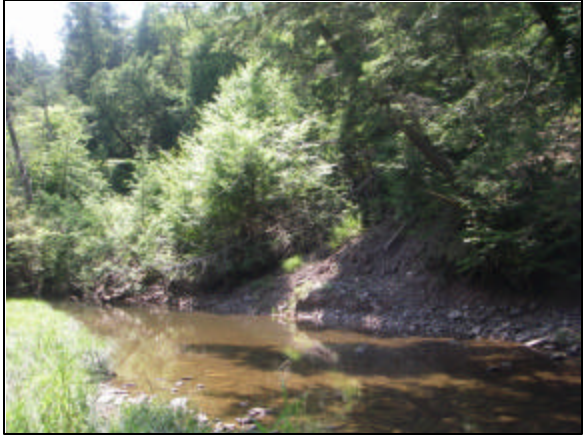
Mass failure at Stations 61894 - 61677

The hydraulic erosion on the left streambank was followed by a *mass failure* (Station 61894 to Station 61677). Streambank erosion often occurs on the outside of meander bends where the stream velocity is greatest during high flows; along this section of stream, the thalweg flowed up against the toe of the bank undermining the steep slope, resulting in an erosion area of approximately

9,784 ft², exposing mixed till and compromising mature trees along the bank. Along the upstream end of this erosion, there was a clay exposure and seepage along the left bank at station 61881. The seepage may further exacerbate the erosion at this site. Clay inputs into a stream are a serious water quality concern because they increase *turbidity*, degrade fish habitat, and can act as a carrier for other pollutants and pathogens. There were two aggradational areas downstream of the eroding bank, a side bar along the left bed and a point bar along the right bed of the channel. Both bars were well vegetated with sedges and willows.

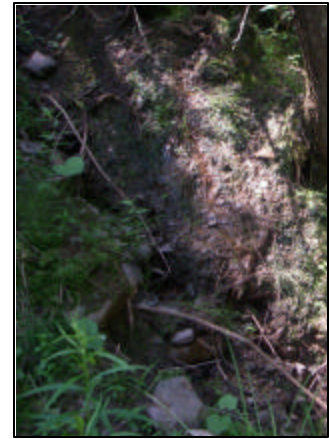
Clay exposure & seepage at Station 61881

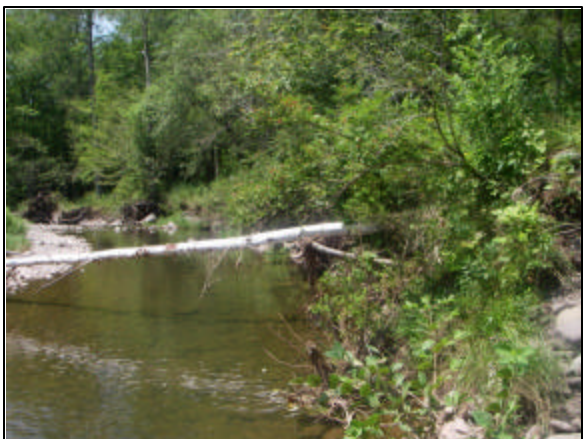
As the stream meandered to the left, there was minor scour and the right bank was undercut (Stations 61122 – 60802) resulting in an erosion area of approximately 2,243 ft².

Erosion at Stations 61122 - 60802

Along the downstream portion of the erosion, there was a large tree and a root wad beside the right bank (Station 60930) that appeared to be contributing to bank scour upstream and downstream of the debris.

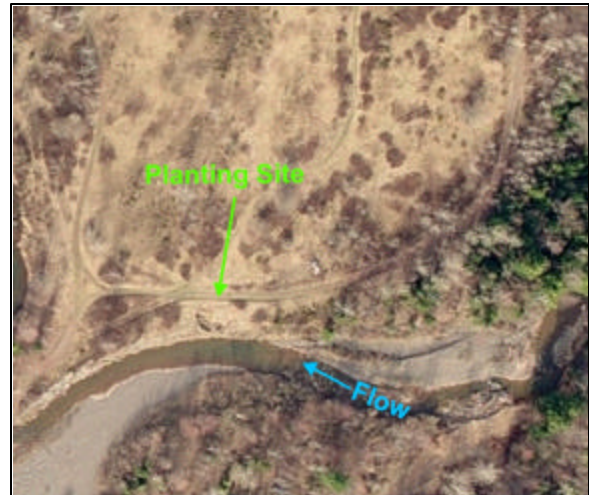
Downstream, the land cover on the right stream bank changed from forested to an open field, with herbaceous vegetation and a few scattered shrubs and trees. This site is

Riparian planting site at Station 59700

ideal for improving the riparian zone through plantings because the streambank appeared to be relatively stable despite the lack of mature deep-rooted vegetation. Recommendations for this site include establishing a riparian buffer with the planting of native trees and shrubs along the streambank and the upland area (Figure 4.4.1 Inset D, Station 59700). Buffer width should be increased by the greatest amount agreeable to the landowners. Increasing the buffer width to at least 100 feet will increase the buffer functionality such as filtering

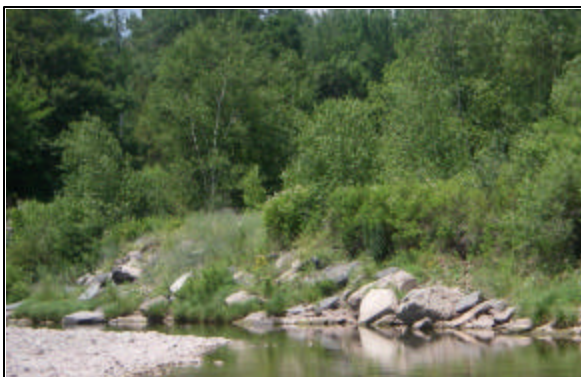
Rip-rap at Stations 59612 - 59066

Just downstream of the recommended riparian planting site, the streambank was reinforced with rip-rap along the right bank (Stations 59612 – 59066). The rip-rap was in fair structural and functional condition. It is

recommended to interplant native shrub and sedge species through the rip-rap and along the toe of this stream bank. This planting will help to strengthen the revetment, while enhancing aquatic habitat.

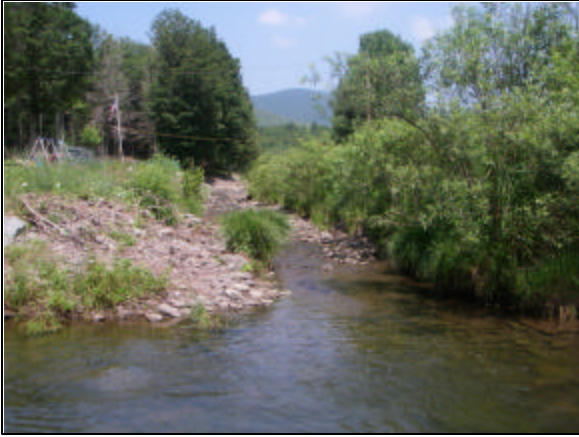
Tributary at Station 59423

There was a gap in the rip-rap along the right bank at the confluence of an unnamed tributary (Station 59423) with the East Kill. This tributary drains the lower

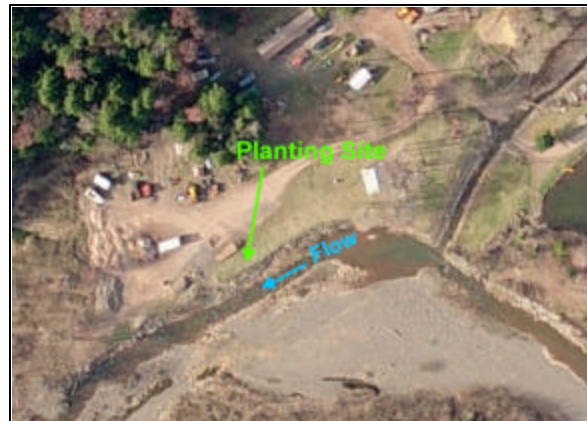
Downstream of the tributary and upland from the revetment, there was a sparsely vegetated field that was serving as a storage location for heavy equipment and machinery. There was bare soil or herbaceous vegetation to the edge of this revetted bank. As mentioned previously, inter-planting of the rip-rap is recommended here. Recommendations for this site also include establishing a riparian buffer with the planting of native trees and shrubs in the upland area (Station 59200). Buffer width should be increased by the greatest amount agreeable to the landowners. Increasing the buffer width to at least 100 feet will help to stabilize the stream bank and protect water quality through this reach by slowing stormwater runoff and filtering pollutants associated with nearby land use.

Riparian planting site at Station 59200

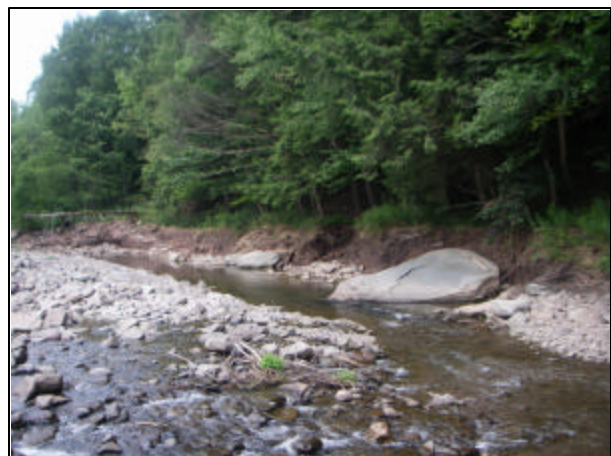
Downstream of the wetlands, there was 1,043 ft² of erosion (Stations 58535 – 58334) along the right bank, exposing approximately 113 cubic yards of lacustrine clay. The stream bank was forested and at the time of the assessment, it appeared as though clear-cutting had taken place upland from the stream’s edge. That may have contributed to an increase in surface runoff entering the stream and potentially exacerbating the erosion at this site.

Erosion & clay exposure at Stations 58535 - 58334

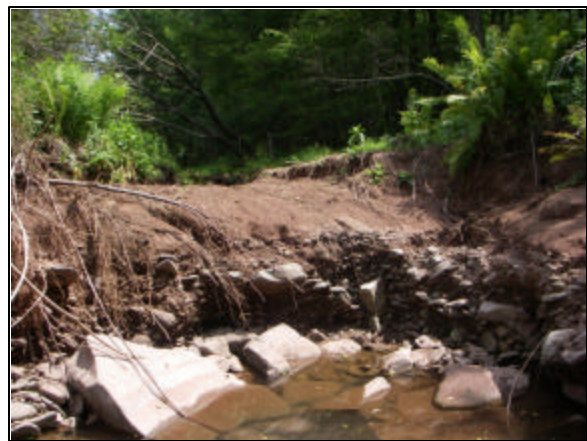
Flood chute and scour hole at Station 57913

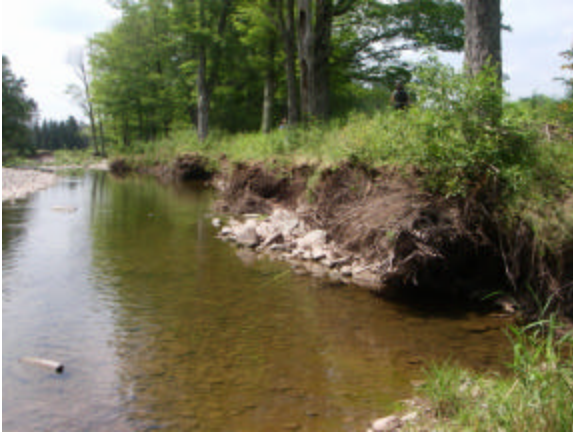
*Erosion at Stations 57700 – 577478
Riparian planting site*

excessive sediment deposition (Stations 57700 – 56800) including, a point bar along the left channel bed, two side bars and two point bars along the right channel bed. The stream flow scoured and undercut the right bank causing approximately 1,306 ft² of erosion (Stations 57700 – 57478). Deep-rooted vegetation was sparse along this stream bank; there were a few mature trees at the top of the bank and an open field with herbaceous vegetation. It is

recommended that this site be considered for riparian plantings including, reinforcing the toe of the bank with sedges, augmenting the existing buffer and increasing the buffer width by the greatest amount agreeable to the landowner, through plantings of native tree and shrub species. Due to the erosion along the bank, this site may require a more detailed site assessment prior to proceeding with any work. Opposite the erosion, the left bank had been reinforced with a stacked rock wall (Stations 57532 – 57386) that was in poor condition and provided minimal protection for the toe of the stream bank.

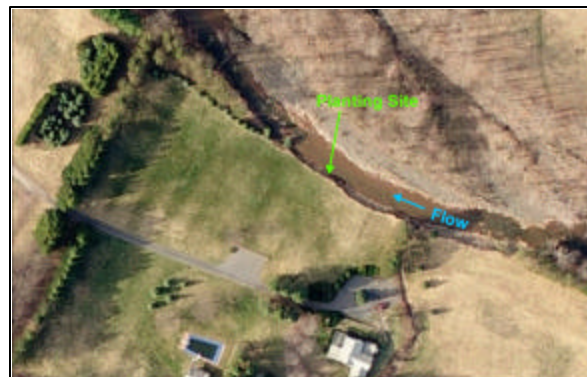
Just down stream of the stacked rock wall, along 651 feet of stream bank, there was an erosional area (Stations 57381 – 56730) of approximately 3,904 ft² on the left. Some mature trees were being compromised along the upstream portion of this erosion, while the remainder of the bank had mown lawn to the top of the stream bank, with a few scattered trees. At the end of the erosion, there was a fallen tree across the stream channel that provided a minor obstruction at low flows; it may pose a more significant obstruction during higher flows. Entering along this bank, there was a piped outfall that drained nearby residential land use and Shadow Mountain Road; it appeared to exacerbate the erosion along the stream bank. This site (Station 57071) was also identified as a site that would benefit from riparian plantings.

Riparian planting site as Station 57071

Recommendations are similar to those of previous planting sites within this management unit including, reinforcing the toe with sedges and establishing a riparian buffer of an appropriate width by planting native shrub and tree species. Careful consideration should be given to the eroding condition of the bank prior to beginning riparian plantings.

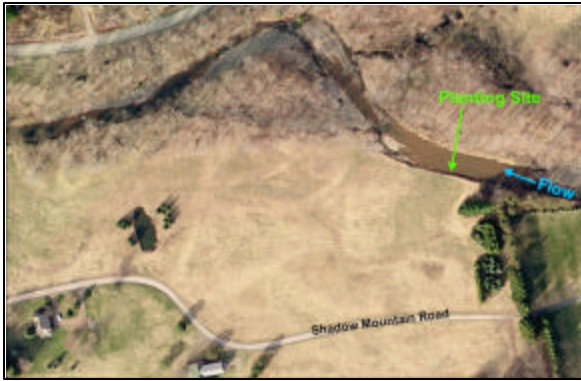
Riparian planting site at Station 56670

Continuing downstream, there was a fourth recommended riparian planting site (Station 56670) along the left bank. There was an open field at the top of the stream bank and a riparian buffer was absent. Again, recommendations include establishing a

riparian buffer with deep-rooted, native tree and shrub species. Buffer width should be maximized to improve stability of the stream bank and to protect the stream from the impacts of nearby land use.

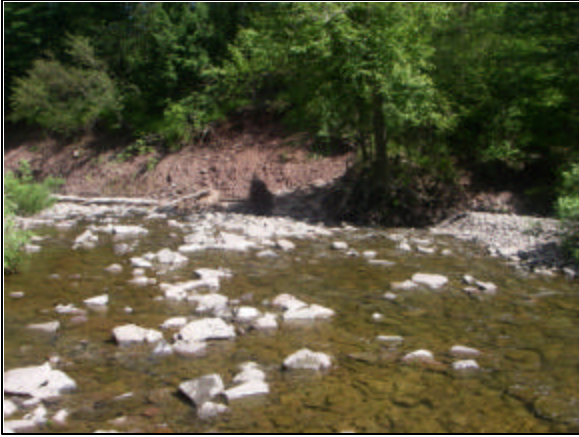
Erosion at Stations 56223 - 55909

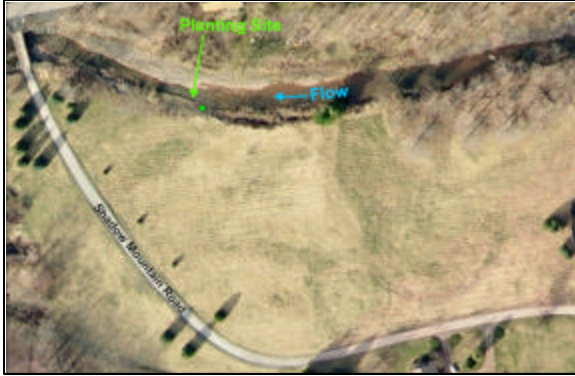
Riparian planting site at Station 55241

there was an open field with maintained herbaceous vegetation to the top of the stream bank. It is recommended that this location be considered for riparian planting enhancement (Station 55241). This was the sixth riparian planting site identified within this management unit during the stream assessment. As with previous planting sites, it is recommended that riparian buffer improvements include, reinforcing the toe of the bank with sedges and establishing a riparian buffer through plantings of deep-rooted, native tree and shrub species. The buffer width should be increased by the greatest amount agreeable to the landowner.

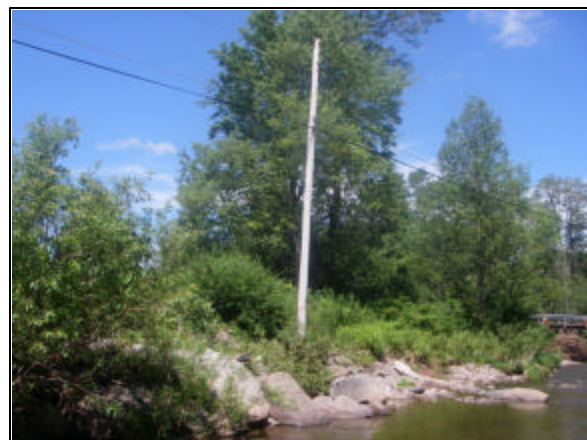
Along this planting site, the stream bank was reinforced with a short length of rock rip-rap just before the utility crossing (Station 55120). The utility pole is close to the stream edge and may be compromised during high flows. In order to maintain utility crossings, utility companies cut swaths through the riparian vegetation at each crossing, thereby fragmenting riparian vegetation. The activities of the utility company at this site should be considered before beginning riparian plantings. It may be appropriate to enhance the riparian buffer upstream and downstream of the crossing with a combination of shrub and tree species, while planting only shrub species within the utility right-of-way.

Rip-rap and utility crossing at Station 55120

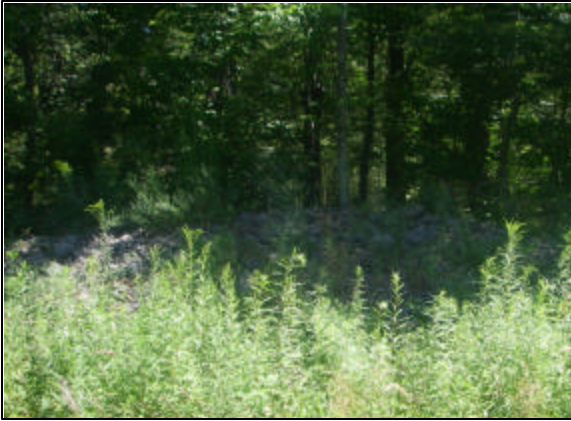
*Berm at Stations 55154-55034
Photo orientation – looking at*

As State Route 23C encroached upon the stream, there was a *berm* (Stations 55154 – 55034), or a linear mound of earthen materials and rock, along the right bank protecting the road embankment for approximately 120 feet. The berm was constructed along a thin line of trees between the streambank and the roadway. While flow through this stretch of stream was confined by the adjacent roadway, the berm may further constrict flow and

interfere with floodplain function.

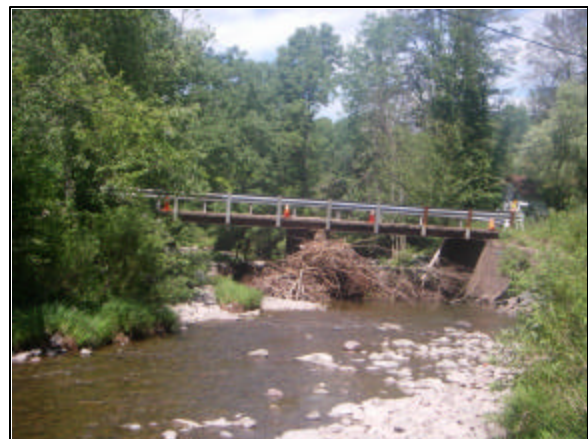
As the stream approached Shadow Mountain Road Bridge (#3201190, Station 54983), the right stream bank was reinforced with approximately 120 feet of rip-rap and the left bank was reinforced with approximately 25 feet of rip-rap, both revetted banks continued to the bridge abutment. The bridge had a center pier that posed an obstruction to flow, which is of particular concern during high flow periods when the stream tends to transport considerable sediment and woody material. At the time of the assessment, the bridge was closed and there was abundant woody debris that had become blocked by the center pier and which was causing an obstruction to flow under the span of the bridge. The bridge openings may be inadequate for conveying higher flows. As mentioned previously, there was excessive aggradation throughout this reach, upstream of the bridge. Sediment deposits are commonly caused by the inadequate sizing of bridge openings. An undersized bridge opening causes water to back up upstream of the bridge, reducing stream velocity, which results in sediment deposition. The Shadow Mountain Road Bridge is scheduled for replacement in 2007. The new bridge will no longer have a center pier, which will help to alleviate the aggradation and woody debris obstructions that have occurred during high

Shadow Mountain Road Bridge at Station 54983

flows. The bridge span is expected to be adequate for conveying flood flows through the opening.

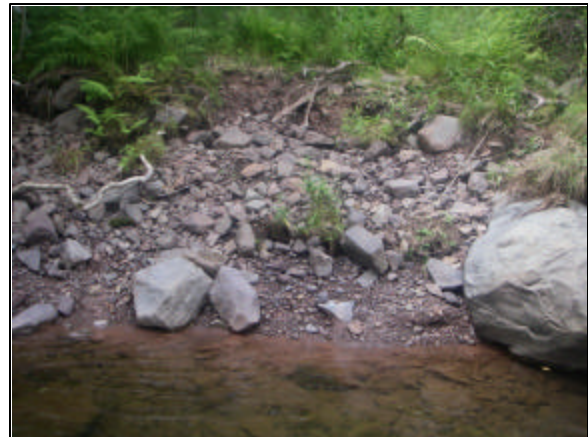
Opposite the confluence of the flood chute, the right stream bank was eroding (Stations 53823 – 53743). The stream flow had caused scour along the toe of the bank resulting in 1,205 ft² of erosion, exposing lacustrine clay (Stations 53823 – 53754) and compromising mature trees along the bank. There was also an accumulation of woody debris along the bank that appeared to exacerbate the erosion at this site.

*Clay exposure between Stations 53823 – 53754
photo orientation – looking at*

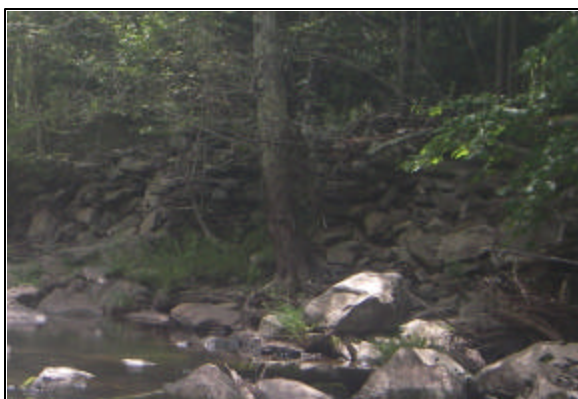
Stacked rock wall at Stations 53332 - 53288

rock wall appeared to be in fair structural and functional condition. Opposite the downstream end of the rock wall, there was a small clay exposure at the toe of the right bank and a failing stacked rock wall (Stations 53332 – 53288) reinforcing the right bank for approximately 44 feet. Although the rock wall was in poor structural and functional condition at the time of the assessment, it

appeared to provide lateral control of stream flow which disconnected the stream from its floodplain on the right bank.

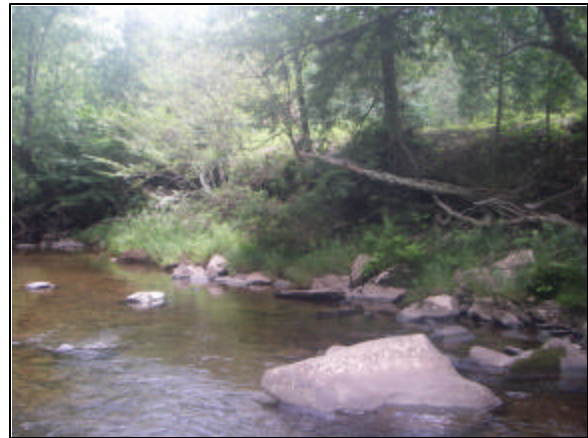
Further downstream, along 148 feet of stream bank, there was an erosional area (Stations 52966 - 52818) of approximately 1,773 ft² on the right. There was a narrow forested riparian buffer along the bank, beyond which there was an open field with some shrubby vegetation. Widening the riparian zone by the greatest amount agreeable to the landowner, by planting native tree and shrub species is recommended along this site.

Erosion at Stations 52966 - 52818

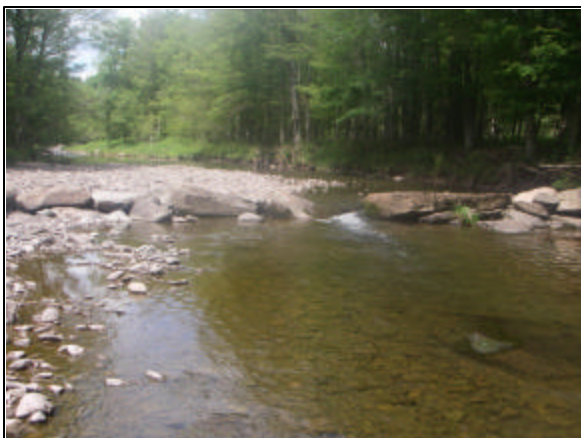
Downstream, there was a manmade structure composed of large boulders that provided grade control across the stream channel. At the time of the assessment, this structure provided an obstruction to flow, with a significant amount of the main channel flow passing through a narrow gap in the structure. The grade control appeared to contribute to the upstream aggradational conditions; as stream flow was constricted through the structure and velocity slowed, the stream had lost its ability to transport sediment leading to excessive deposition. This structure does not provide lateral control; therefore, higher stages may flow around the sides of the structures, potentially contributing to stream

Grade control structure at Station 52653

bank erosion or lateral movement of the stream channel.

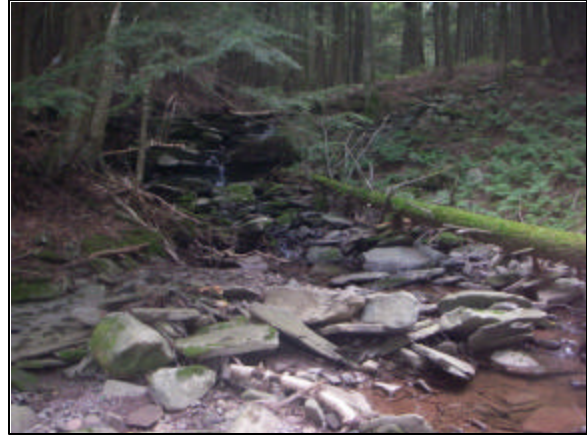
As the stream meandered sharply to the right, an unnamed tributary entered from the left stream bank (Station 52367). This tributary drains the lower slopes of East Jewett Range and Onteora Mountain before it enters the East Kill. The tributary was entrenched, or had eroded downward, and was contributing a large sediment load into the

*Tributary at Station 52367
photo orientation – looking at*

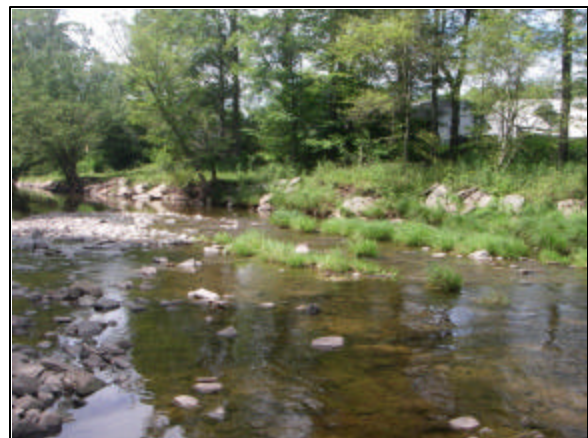
Continuing downstream, the toe of the right bank was reinforced with rip-rap (Stations 51796 – 51200) along approximately 596 feet of stream. The rip-rap was in poor structural and functional condition. There was a thin line of trees at the top of the bank; beyond the trees, there was mown lawn, a barn and associated residential structures. Interplanting the rip-rap with native sedge species is recommended at this site; this will serve to strengthen the rip-rap and improve aquatic habitat. Although the riparian buffer may not be widened significantly due to the proximity of the buildings, native shrub and tree species should be planted here to

Rip-rap at Stations 51796 - 51200

augment the buffer and provide improved buffer functionality to protect the stream from the nearby land use. Opposite the upstream portion of this rip-rap, woody debris had accumulated along the left bank and was contributing to localized scour of the bank.

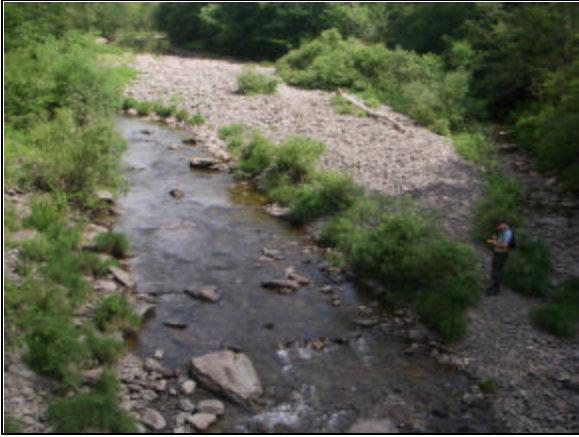
*Side bar at Stations 51400 -51171
photo orientation – looking upstream*

Continuing downstream, there was excessive sediment deposition, with a side bar along the left bed of the stream channel (Stations 51400 – 51171) forming upstream of

the Scribner Hollow Road Bridge. There was a secondary channel (Stations 51364 – 51171) that received intermittent flows during periods of high water that formed along the left of the side bar.
