Schoharie Creek Management Unit 4

Town of Hunter - Station 138610 to Station 124311

Schoharie Creek Management Unit 4 Stream Feature Inventory

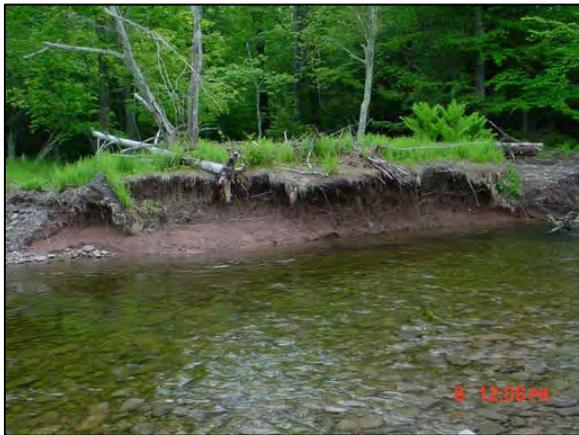
Clay exposure and bank erosion at Station 138500

At the beginning of the unit the stream channel was wide and shallow. Approximately 500ft of the left streambank was experiencing scour during high flow events (Inset A, Station 138500). As a result two areas totaling 92ft² of glacial lake silt/clay had been exposed. Fine sediment inputs into a stream can be a serious water quality concern because they increase turbidity, degrade fish habitat, and can act as

a transport mechanism for other pollutants and *pathogens*. This type of erosion is common and part of natural stream process. In stable watersheds, the rate of erosion is slow and a natural healing process usually follows.

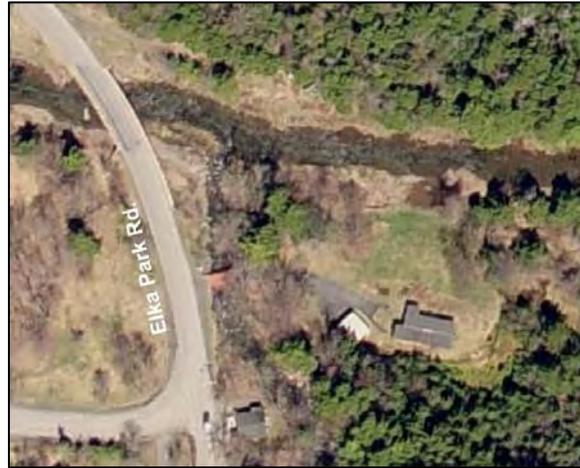
Beginning at Station 134700, the stream channel became confined by the valley form. At Station 134440, there was an approximately 173 ft² area of scour on the left streambank of a residential property. The top of the bank consisted of mown lawn which does not provide as much resistance to streambank erosion as the deep and dense root structure found in streamside forest. Recommendations for this site include planting native trees and shrubs along the edge of the streambank and increasing the upland area buffer width by the greatest amount agreeable to the landowner. To provide protection from future erosion, native willows and sedges should be planted along the streambank toe.

Planting site at Station 134440

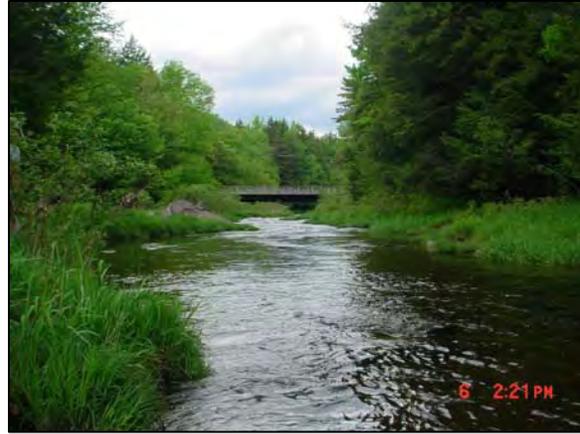
At Station 134100, the stream passed under the Elka Park Rd. Bridge (BIN 3201010). This bridge may constrict the floodplain at very high flows, but appeared to pass most flows effectively. The bridge appeared to be in both good structural and functional condition. Flood damage to bridges is typically caused by inadequate hydraulic capacity of the bridge, misaligned piers and/or abutments, or accumulation of debris. As bridges are replaced over time, these issues should be evaluated and adjusted if necessary to lessen the probability of flood damage by providing a more effective conveyance channel that promotes water and sediment flow through the bridge opening.

Bridge at Elka Park Road at Station 134100

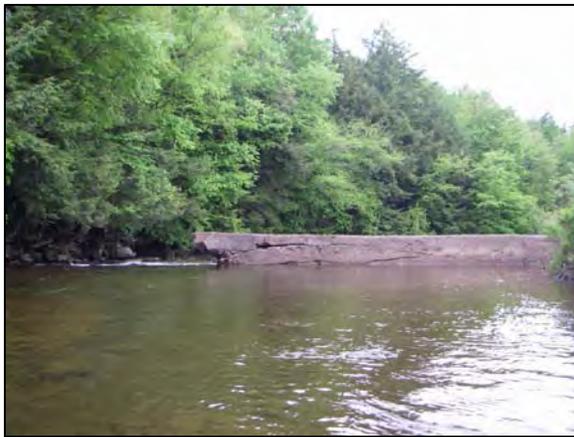
Approximately 400ft downstream there was a failed dam across the Schoharie Creek (Inset C, Station 133700). According to a local landowner, a saw mill was built on this site in the late 1800's. Sometime prior to the 1920's the mill disappeared but the dam

Dam remnants at Station 133700

could be pumped directly up to the reservoir, allowing it to be filtered and sanitized before use. A flood event in the late 1980's broke the dam, but a large section of the concrete sill jutting out from the right streambank across approximately 75% of the active stream channel remained. Stream flow was forced to the left side of the stream channel before it flowed over the large bedrock waterfall.

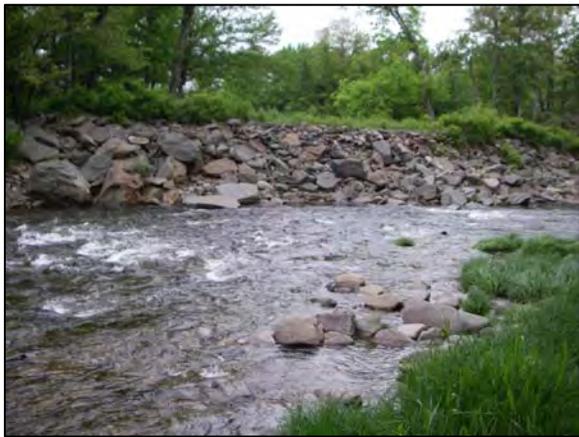
At Station 130850 rip-rap had been installed along 119ft of the left streambank. While rip-rap and other hard controls may provide temporary relief from erosion, they are

Rip-rap at Station 130850

expensive to install, degrade habitat, and require ongoing maintenance and may transfer erosion problems to upstream or downstream areas. Alternate stabilization techniques should be explored for stream banks whenever possible. Interplanting of this rip-rap, by inserting native shrub plantings into the soil between the rocks, could strengthen and increase its longevity.

These plantings would also improve the aquatic habitat by providing shade, resulting in cooler water temperatures. To provide protection against toe erosion, sedges or willows could be planted along the toe of the streambank.

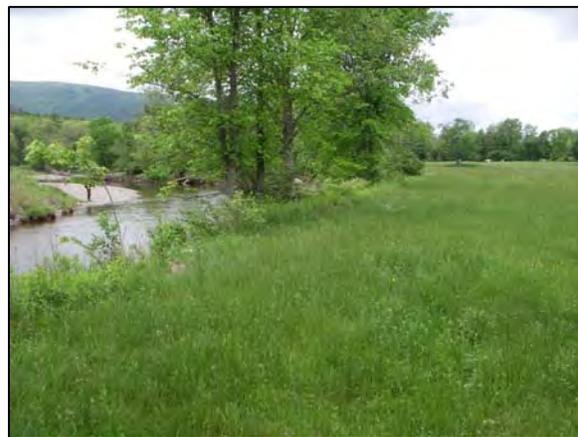
As the land use on the right streambank changed from forested to residential, *herbaceous* vegetation replaced mature trees in the riparian zone (Station 129200). Mown lawn or pasture does not provide as much resistance to streambank

Planting site at Station 129200

erosion as a streamside forest. The complex root systems of trees may also act to filter nutrients and pollutants, if any, from the adjacent fields. Areas where the riparian zone has been maintained in pasture or lawn present opportunities to improve the streamside buffer with tree plantings in order to promote a more mature vegetative community along the streambank and in the floodplain. Recommendations for this site include planting native trees and shrubs along the edge of the streambank and the upland area. Buffer width should be increased by the greatest amount agreeable to the landowners, but increasing the buffer width by at least 100ft will increase the buffer functionality.

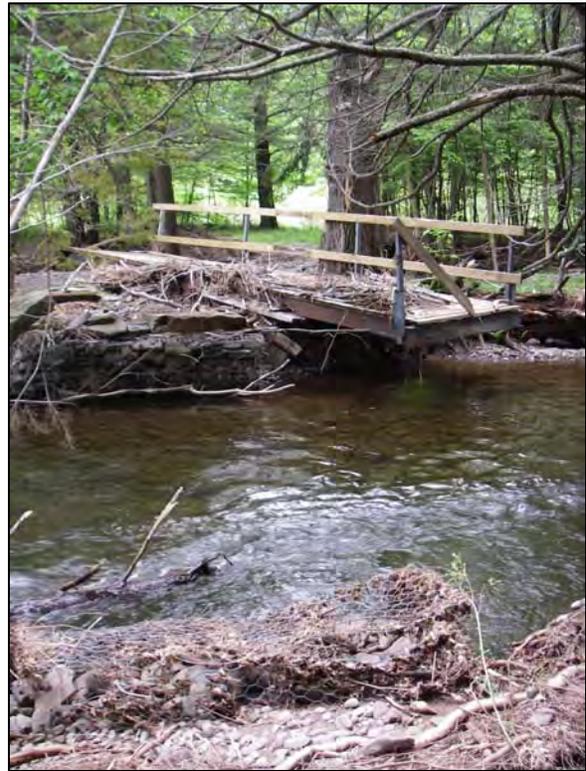
Downstream, the stream channel splits into two separate channels, both of which experienced erosion during high flow events. In the right stream channel a small private bridge had been destroyed (Station 128070). This bridge was undersized and could not convey flood flows. Gabion baskets had been installed as abutments. Rock-filled gabions are not generally recommended because have a tendency to be unsightly and when installed incorrectly, they frequently blow out of the bank and scatter rocks and cages downstream. Their correct use requires professional installation. Further downstream a smaller foot bridge had also been destroyed and was partially buried in the stream channel.

Bridge at Station 128070

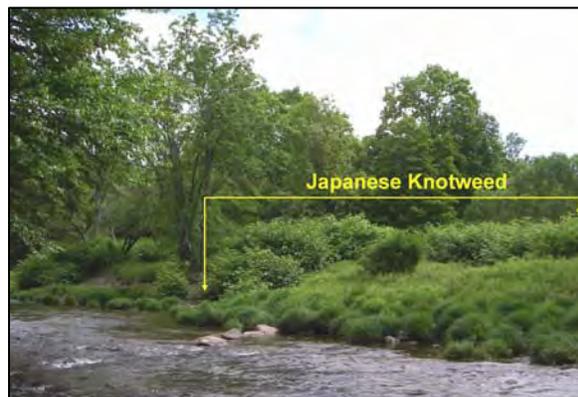
A large stand of Japanese knotweed (*Fallopia japonica*) had established along the right streambank upstream and downstream from the Gooseberry Creek confluence (Station 12600). Japanese knotweed is an invasive non-native species which does not provide adequate erosion protection due to its very shallow rooting system and also grows rapidly to crowd out more beneficial streamside vegetation. Although small Japanese Knotweed

Japanese Knotweed at Station 126000

plants were documented throughout the management unit, this large stand is of greater concern because this area is prone to scour during high flows and may act as a source to spread Japanese Knotweed downstream. Removal of this Japanese Knotweed plant is recommended to prevent the spread of this invasive species (See Section 2.7 Riparian Vegetation).
