Schoharie Creek Management Unit 5

Town of Hunter - Station 124311 to Klein Ave. (Station 108605)

2006 Stream Feature Statistics

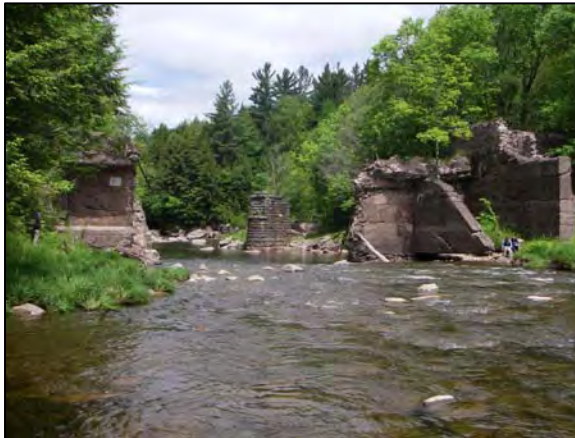
Old dam at Station 123240

At the downstream end of this wetland was an old compromised dam (Station 123240). The remains of this structure extended into the active stream channel causing a backwater effect during high flow events, resulting in some upstream aggradation. The concrete sill across the stream remains in-tact providing grade control and forming a large deep pool below.

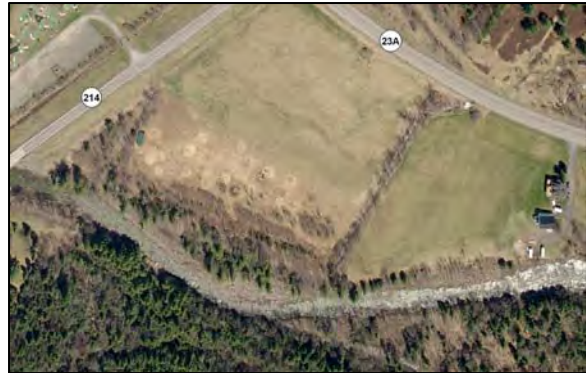
Downstream the land use on the right streambank changed from forested to agricultural, with herbaceous vegetation and several mature trees in the riparian zone. A vigorous buffer with mature trees is important at this site because it may also filter nutrients and pollutants, if any, from the adjacent agricultural fields.

Planting site at Station 121100

Recommendations for this site include augmentation of existing buffer with the planting of additional native trees and shrubs along the streambank and the upland area (Station 121100). Buffer width should be increased by the greatest amount agreeable to the landowners. Increasing the buffer width to at least 100 feet will increase the buffer functionality.

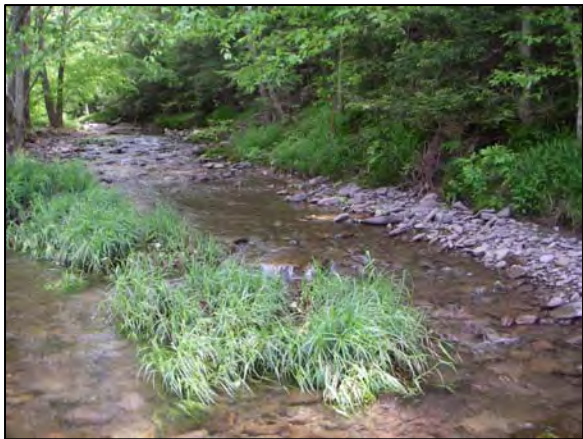
Tributary at Station 120500 - looking upstream

On the right streambank an unnamed tributary entered the Schoharie Creek (Station 120650). This tributary drains the lower slopes of Onteora Mountain before crossing under Route 23A, flowing through pastures before entering the Schoharie Creek. The New York State Department of Environmental Conservation classifies streams and rivers based on their “best use” (NYSDEC, 1994). The headwaters of this

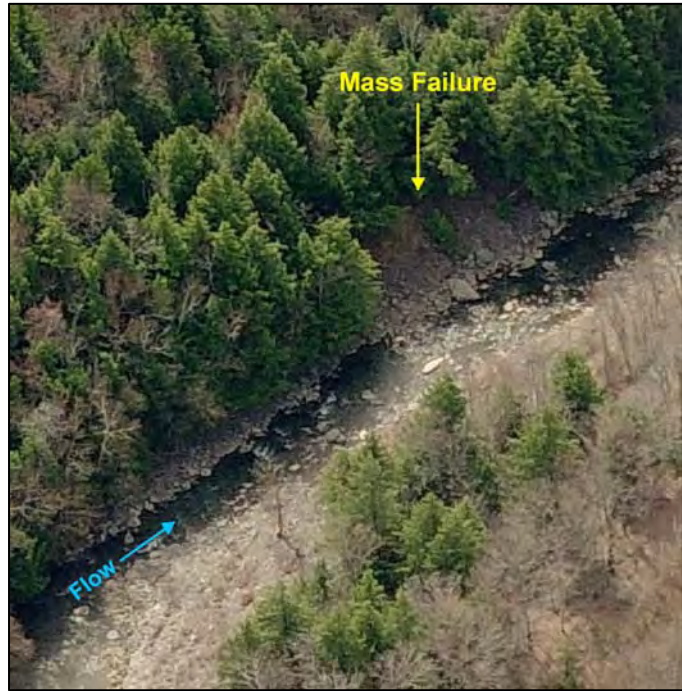
The increase in water and sediment loading from these tributaries, combined with entrenchment of the Schoharie, may have contributed to the streambank erosion directly downstream of the Schoharie's confluence with the two tributaries. An area of approximate 7,099ft² of the left streambank was experiencing erosion (Station 120200). The hillslope had been undermined by toe erosion, resulting in the mass wasting of the bank. This erosion had left the face of the stream bank unvegetated and highly susceptible to future erosion.

Bank erosion at Station 120200

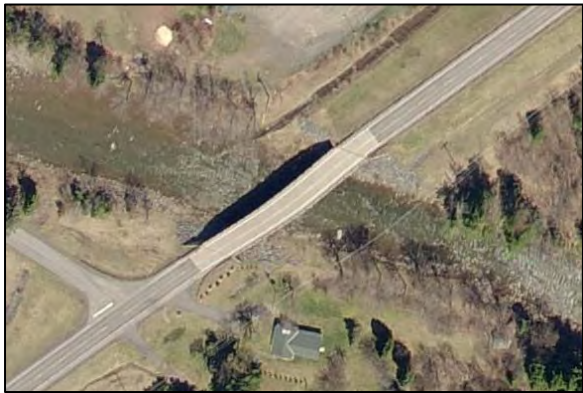
Downstream, the stream passed under the NYS Route 214 bridge (Inset C, Station 119600) (BIN 1041310). This bridge may constrict the floodplain at very high flows, but

NYS Route 214 bridge at Station 119600

appeared to pass most flows effectively. Flood damage to bridges is typically caused by inadequate hydraulic capacity of the bridge, misaligned piers and/or abutments, or accumulation of debris. As bridges are replaced over time, these issues should be evaluated and adjusted if necessary to lessen the probability of flood damage by providing a more effective conveyance channel that

promotes water and sediment flow through the bridge opening. Rip-rap was installed on both the upstream and downstream streambanks to provide scour protection. While rip-rap and other hard controls may provide temporary relief from erosion, they are expensive to

install, degrade habitat, and require ongoing maintenance or may transfer erosion problems to upstream or downstream areas. Alternate stabilization techniques should be explored for streambanks whenever possible. Two stands of Japanese knotweed (*Fallopia japonica*) had established in the rip-rap along the right streambank upstream and downstream from the bridge. Japanese knotweed is an invasive non-native species which does not provide adequate erosion protection due to its very shallow rooting system and also grows rapidly to crowd out more beneficial streamside vegetation. Removal of these Japanese Knotweed plants are recommended to prevent the spread of this invasive species (See Section 2.7 Riparian Vegetation), and native shrub and sedge species should be interplanted through this rip-rap to help strengthen the revetment, while enhancing aquatic habitat.

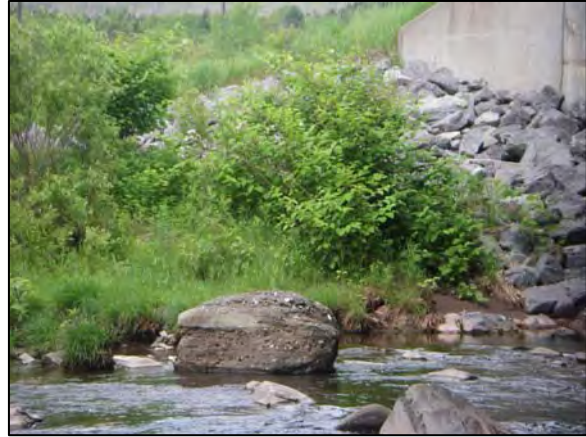
Japanese Knotweed at Station 119600

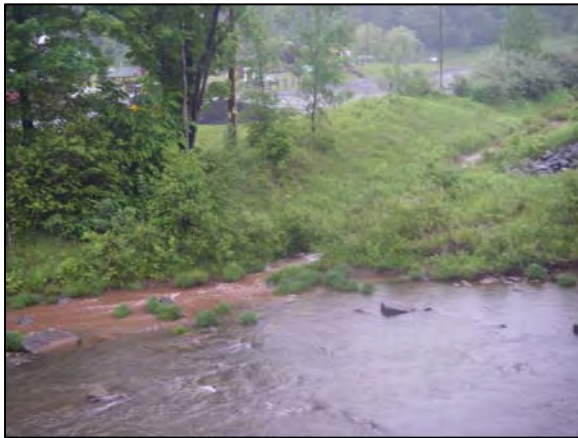
Stormwater drainage ditch at Station 119550

Approximately 50ft downstream from this bridge, a stormwater drainage ditch entered the Schoharie Creek on the right streambank (Station 119550). As shown in the photo to the left, during rainfall events *turbid* water flows into the Creek from this ditch. Turbidity is basically cloudiness of a body of water caused by the suspension of organic and inorganic particles. Turbidity can be a significant problem as these

particles absorb and transport contaminants, and make the disinfection for water supply process more difficult. In addition to public health risks, turbidity also impacts ecological integrity in the streams and reservoirs. Potential water quality impacts of stormwater inputs at this site should be evaluated. This evaluation could be achieved as part of an initiative to conduct a detailed and comprehensive assessment of existing community stormwater

infrastructure with the goal of identifying and prioritizing potential areas for installation of stormwater *best management practices* (BMP's).

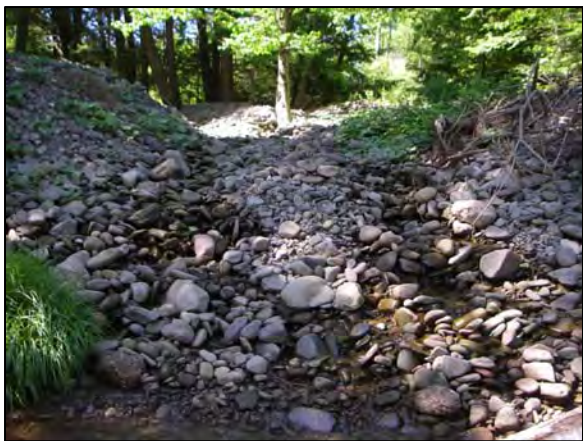
Tributary confluence at Station 118700 looking upstream

The next unnamed tributary entered the Schoharie Creek at two locations on the left streambank (Stations 118700 & 118500). This tributary begins in the Stony Clove Notch, the valley in between Plateau and Hunter Mountains. The headwaters was classified B by the NYS DEC which indicates a best usage for swimming and other contact recreation until the last 2,670ft where the classification changed to C(ts), or a best use of supporting fisheries and other

non-contact activities, including trout spawning. The confluence at station 118700, most likely created during a flood event, was choked with gravel. The second confluence of this

tributary, which also showed signs of high sediment load, was at Station 11870. The left streambank between these two confluences was undercut. This type of bank generally provides good cover for macroinvertebrates and fish and is resistant to erosion. However, if the bank becomes seriously undercut it might be vulnerable to collapse.

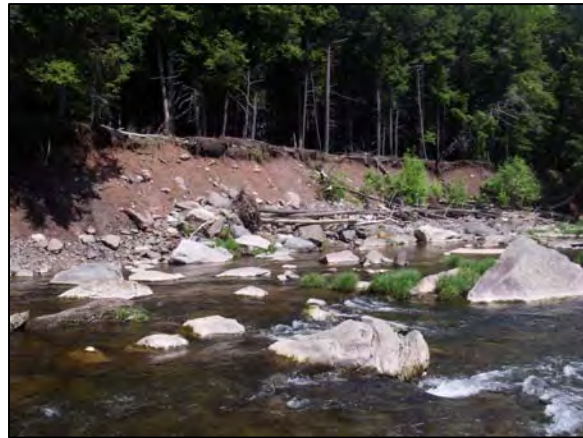
As stream's *sinuosity* increased downstream, the erosive forces on the outside bank also increased causing the mass wasting of the left streambank (Station 117860). This erosion wiped out many large trees from the streamside and exposed a 9,686ft² area of clay and silt. Woody debris and larger rocks deposited at the streambank toe may provide some erosion protection. On the opposite streambank

Bank erosion at Station 117860

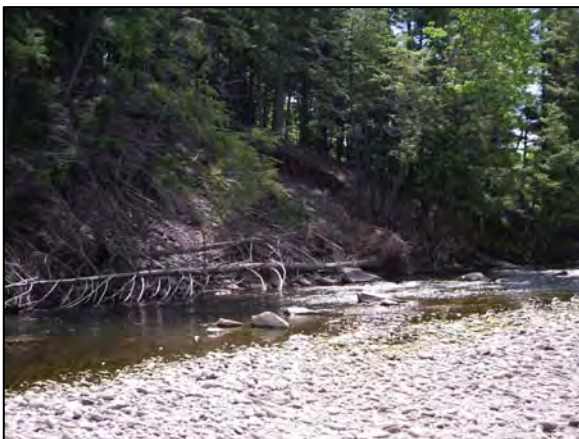
Bank erosion at Station 117320

As the stream continued to meander the erosive forces were transferred to the right streambank triggering another mass failure (Station 11730). The stream flowed directly against the valley wall, increasing the *shear stress*, or force of flowing water, on the stream bank during high flow events and had severely eroded the toe exposing a 9,123ft² area of soil with some clay in the substrate.

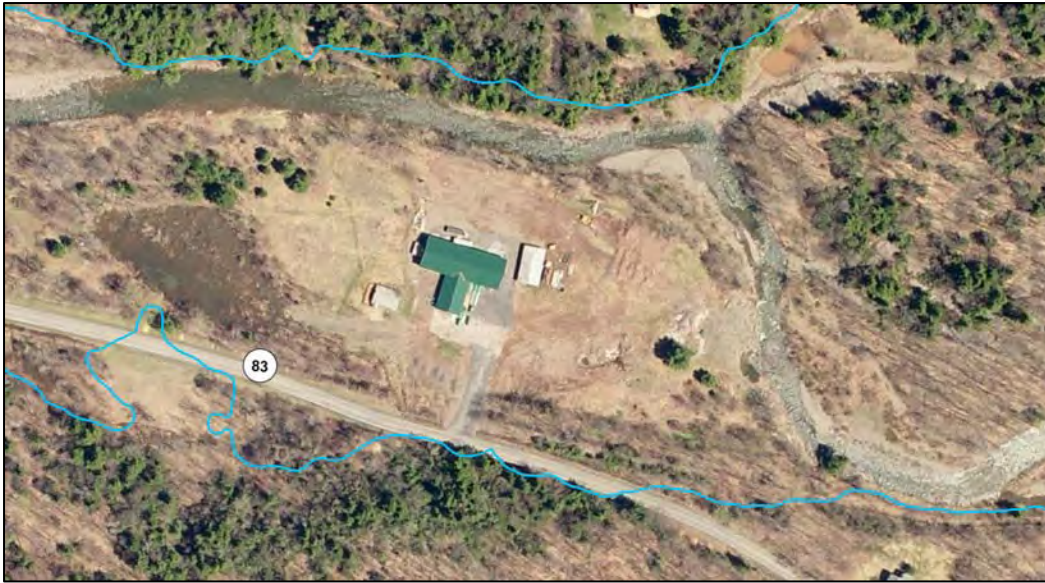
As commercial development of the left streambank began revetment had been placed on the bank (Station 114300-113200). This entire property is located within the 100-year flood boundary, or the area which has a 1% chance of being inundated in any given year. The 1959 historical aerial photographs show this bank was once lined with buildings which were probably subjected to frequent flooding. In 2006, only three structures were located on the property and were set back from the streambank. To resolve flooding issues, the best solution at this site would be to relocate these structures outside the 100-year floodplain to allow the stream to utilize its floodplain without causing property damage. However this option seems unlikely. An alternative measure which may help

*Planting site at Station (114300-113200)
2006 aerial photograph with 100-year flood boundary represented by blue line*

decrease flooding would be to increase the quality of the stream buffer. Plantings of native trees and shrubs in the riparian zone would help to slow the flow of run-off from the floodplain and allow sediment and its attached pollutants, if any, to settle out before reaching the stream. The increased vegetation would also slow flood waters and trap large woody debris. The right streambank was also eroding. As the stream took a sharp turn, the thalweg flowed directly into the right streambank resulting in the largest mass failure in this management unit (Inset B, Station 113700). This erosion had exposed an estimated area of 14,585ft² with some clay in the substrate, and led to the loss of many mature trees. Although the house on this residential property is not threatened the loss of land is a concern. Restoration of this streambank would require an in-depth survey and design.

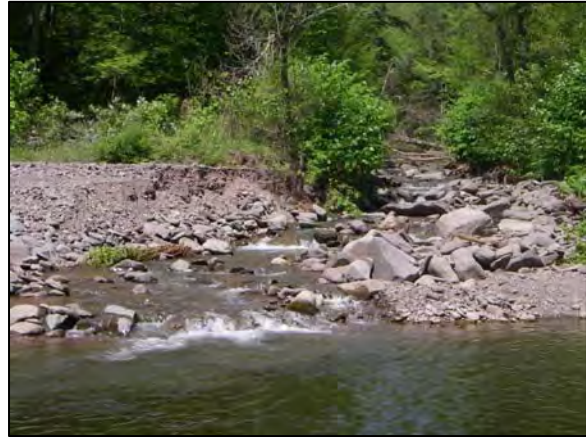
Downstream, Red Kill entered the Schoharie on the right streambank (Station 112400). This tributary drains the slopes of the East Jewett Range and Onteora Mountain before it reaches the flatter topography of the valley floor where it flowed into the Schoharie Creek. As a result of this change in stream slope, the tributary lost its ability to transport sediment gathered from the mountain slopes, and began to deposit sediment at its mouth and into the more gently sloped Schoharie Creek.

Red Kill Creek tributary at Station 112400 looking upstream

This is a common feature of confluence areas, which often contain extensive sediment bars

and function as important sediment storage areas. These areas are typically among the most dynamic and changeable areas in the stream system. This tributary was classified by the NYS DEC as C(ts) indicating it supported fisheries and other non-contact activities, including trout spawning. On the opposite bank two small *lacustrine* clay exposures (Station 112400) and minor scour (Station 112200) were documented. A 7 acre wetland within the stream

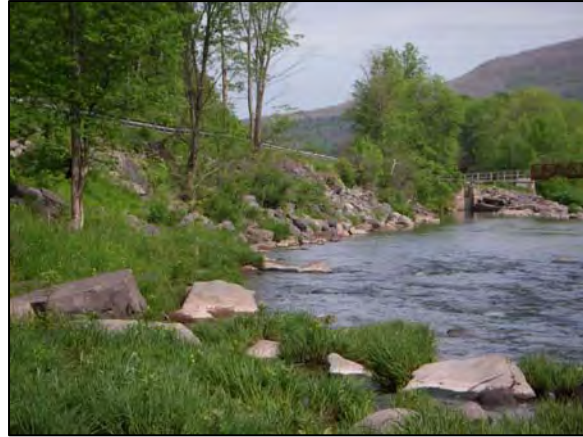
Rip-rap had been installed on the County Route 83 embankment on the left streambank (Station 111140). Some vegetation was growing within this rip-rap, however this site's stability and habitat value would benefit from additional plantings of native trees and shrubs. Two piped outfalls were located along this rip-rap (Station 110600). Stormwater runoff from these outfalls discharged onto the rip-rap rocks, reducing the risk of bank erosion, but heating the water in the summer.

Rip-rap at Station 111140

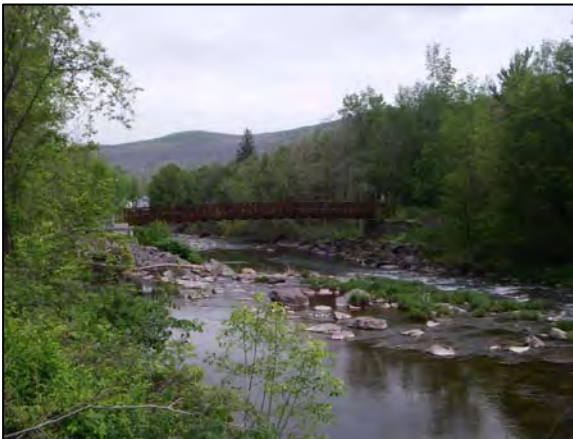
As the stream approached a pedestrian foot bridge a grade control structure, constructed by placing large stream boulders diagonally across the stream channel, funneled part of the stream flow into Dolan's Lake (Station 110775-110500). This lake was

Foot bridge at Station 110470

originally constructed by Michael B. Dolan, a resident of Hunter, for his ice business. Dolan's Lake recreation area now offers public swimming, fishing and picnic facilities. The foot bridge (Station 110470) may constrict the floodplain at very high flows as evidenced by some upstream deposition, but appeared to pass most flows effectively.

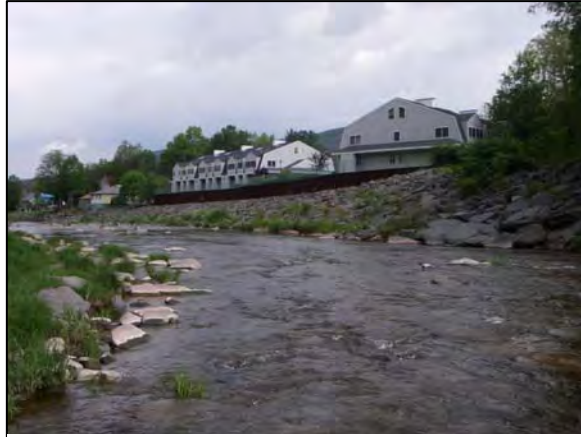
agencies, 3 federal agencies and a number of local municipal units, the project was extremely complex and risky. In 1997, construction was completed on a steel sheet piling and stacked rock rip-rap wall designed to protect the site from 100-year floods. Due to the hard work and diligent effort of the many project partners, the project was completed under budget and on schedule in the fall of 1997. Since that time, the site has experienced several floods with no additional damage to the buildings.

*Melody Woods Complex 2006
(Station 109900-109350)*
