Schoharie Creek Management Unit 6

Town of Hunter – Klein Ave. (Station 108605) to Bridge St. (Station 104521)

Stream Channel and Floodplain Current Conditions (2006)

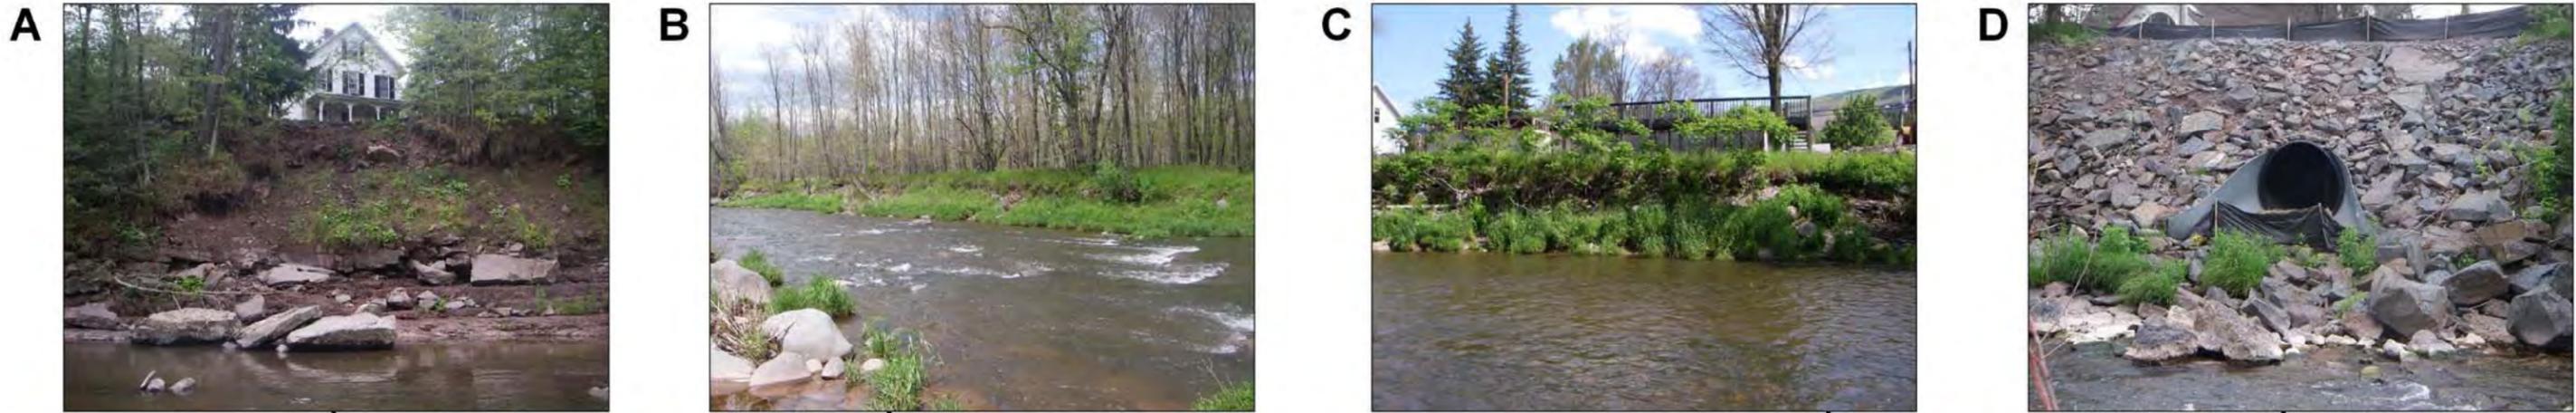
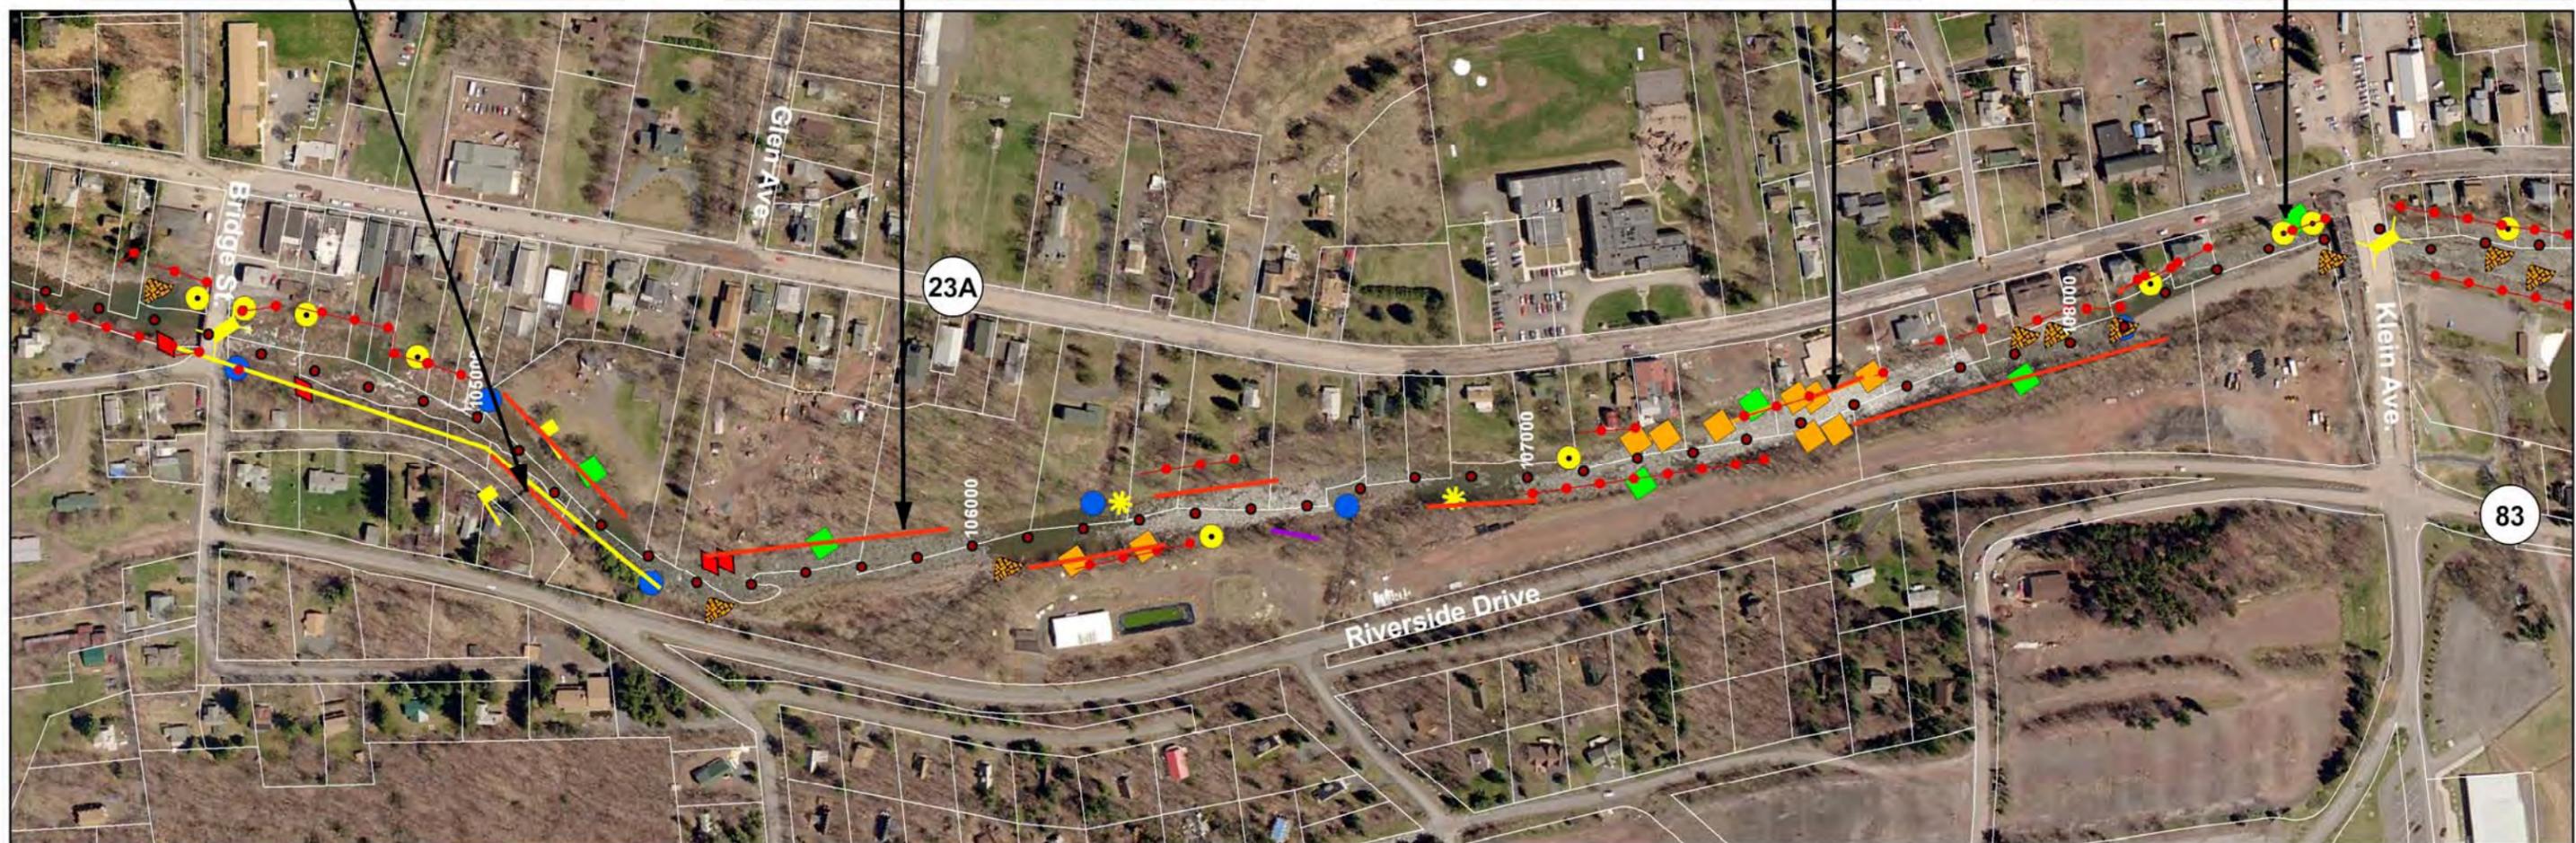
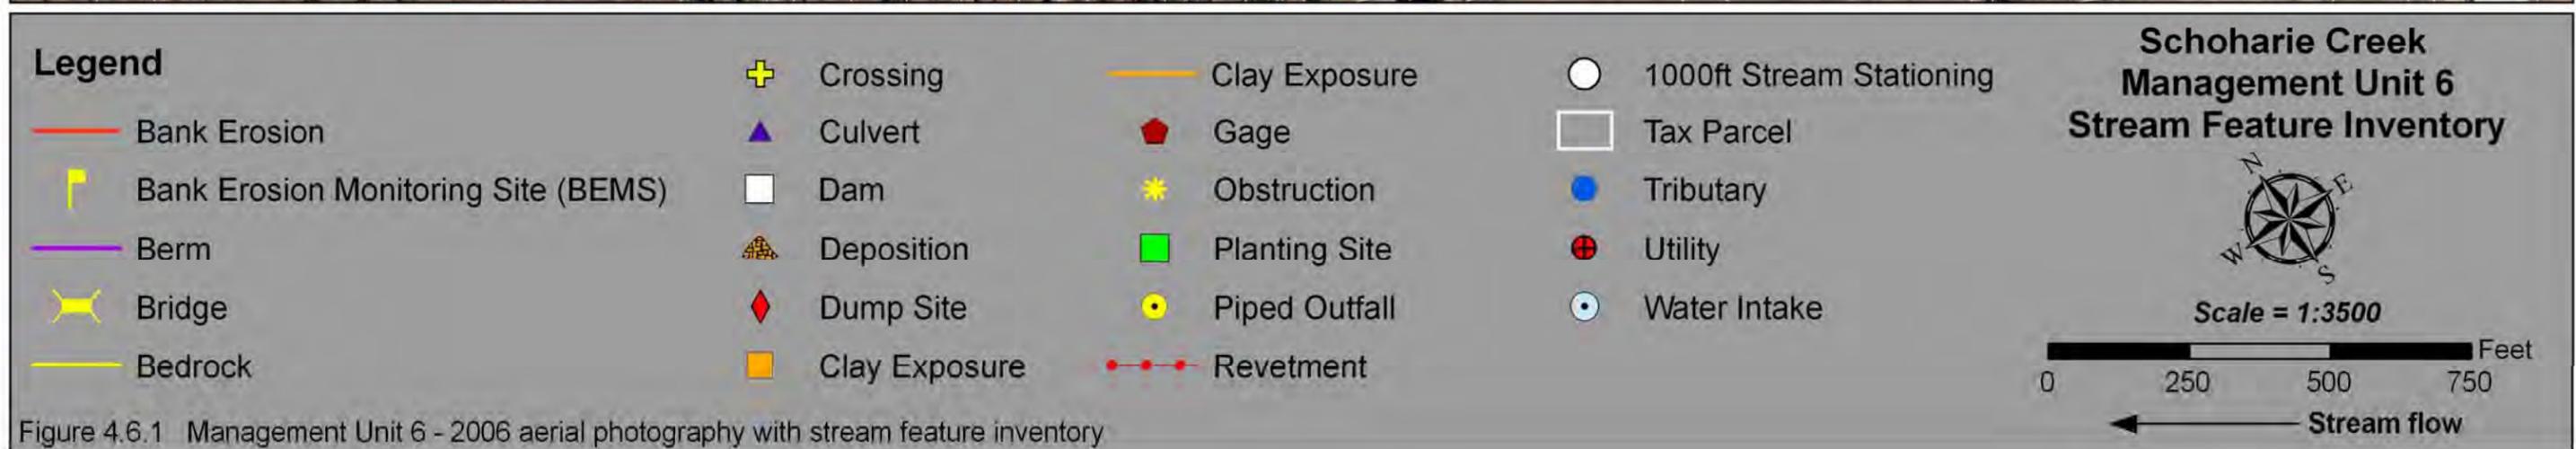
Figure 4.6.1 Management Unit 6 - 2006 aerial photography with stream feature inventory

The 2006 stream feature inventory revealed that 28.3% (2,316 ft) of the streambanks exhibited signs of active erosion along the 8,170 ft of total channel length in the unit (Figure 4.6.1). The total surface area of active erosion totaled approximately 23,034 ft². *Revetment*

Summary of Recommendations Management Unit 6	
Intervention Level	Passive, Assisted Self-Recovery, Full Restoration
Stream Morphology	No recommendations at this time
Riparian Vegetation	Interplanting of rip-rap at Station 108500, plantings for assisted self-recovery of eroding banks at Stations 108100, 107630, 105960, 105140, and enhancement of riparian buffer at 107430.
Infrastructure	Full restoration of failing streambanks at Station 105140
Aquatic Habitat	Watershed Aquatic Habitat Study
Flood Related Threats	No recommendations at this time
Water Quality	Evaluate potential water quality impacts of stormwater inputs from Shanty Hollow Brook at Station 108100.
Further Assessment	Community-Wide Stormwater Infrastructure Assessment & Planning Resurvey of bank erosion monitoring site at Station 105300 to assess erosion rate.

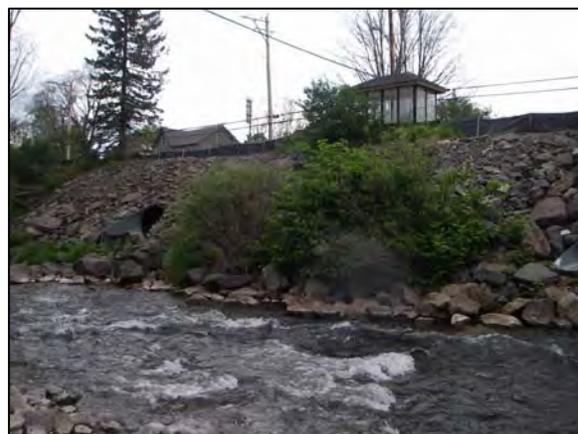
Rip-rap at Station 108500

Rip-rap with two stormwater outfalls had been installed on the right streambank downstream from the bridge (Inset D, Station 108500). A stand of Japanese knotweed (*Fallopia japonica*) had established in the rip-rap. Japanese knotweed is an invasive non-native species which does not provide adequate erosion protection due to its very shallow rooting system, and also grows rapidly to crowd out more beneficial streamside vegetation. Removal of this Japanese Knotweed stand is

recommended to prevent the spread of this invasive species (See Section 2.7 Riparian Vegetation) and native shrub and sedge species should be interplanted through this rip-rap to help strengthen the revetment, while enhancing aquatic habitat.

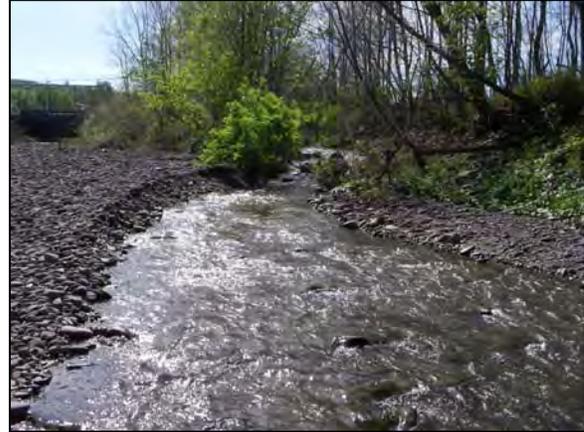
*Shanty Hollow Brook (Station 108100)
looking upstream*

Shanty Hollow Brook entered from the left streambank (Station 108100). This tributary drains the slopes of Hunter Mountain before it reaches the flatter topography of the valley floor where it enters the Schoharie Creek. As a result of this stream slope change, the tributary lost its ability to transport sediment gathered from the mountain slopes, and began to deposit sediment at its mouth and into the more gently

sloped Schoharie Creek. This is a common feature of confluence areas, which often contain extensive sediment bars, function as important sediment storage areas, and are typically among the most dynamic and changeable areas in the stream system. The New York State Department of Environmental Conservation classifies streams and rivers based on their “best use” (NYSDEC, 1994). The headwaters and majority of this tributary were classified as A by the NYS DEC, indicating that the best use is as a source of drinking water. The last 2,473ft of this tributary was classified as C, or its best use is supporting fisheries and non-contact activities.

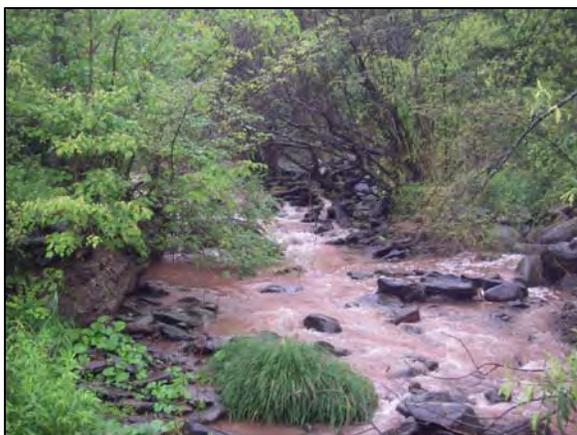
*Shanty Hollow Brook after rainfall event
Station 108100 - looking upstream*

As shown in the photo, during rainfall events *turbid* water flows into the Schoharie from Shanty Hollow Brook. Turbidity is basically cloudiness of a body of water caused by the suspension of organic and inorganic particles. Turbidity can be a significant problem as these particles absorb and transport contaminants, and make the disinfection process more difficult. In

addition to public health risks, turbidity also impacts ecological integrity in the reservoirs and streams. The turbidity source and potential water quality impact at this site should be evaluated. This evaluation could be achieved as part of an initiative to conduct a detailed and comprehensive assessment of existing community stormwater infrastructure with the goal of identifying and prioritizing potential areas for stormwater *best management practices* (BMP's).

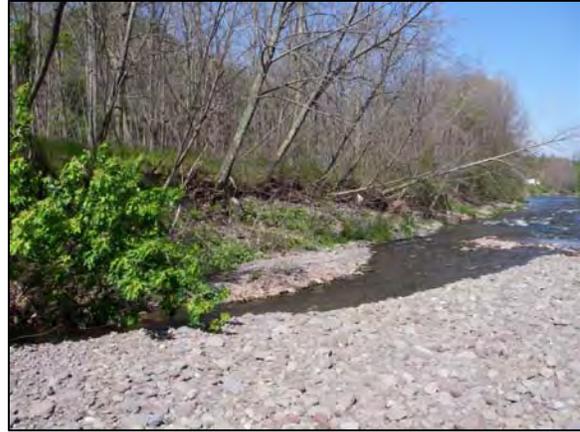
Bank erosion at Station 108100

This increase in runoff and sediment load from this tributary may have contributed to the streambank erosion on the left streambank (Station 108100). An area of approximately 4,072 ft² was experiencing erosion, resulting in the loss of some mature trees along the bank. To prevent future erosion, native vegetation plantings are recommended for site, including vegetative protection of the toe.

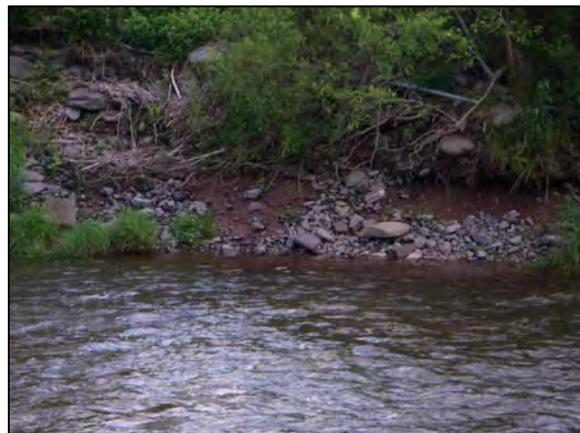
Clay/silt exposure at Station 107630

Downstream of the revetment, the right streambank had been scoured causing numerous clay/silt exposures posing a potential threat to water quality (Inset C, Station 107630). Fine sediment inputs into a stream increase *turbidity* and can act as a transport mechanism for other pollutants and pathogens. Planting of willow *fascines* and

sedges along the toe of the bank is recommended to provide protection against erosion. Native trees and shrubs, including willows should also be planted on the face of streambank to improve stability.

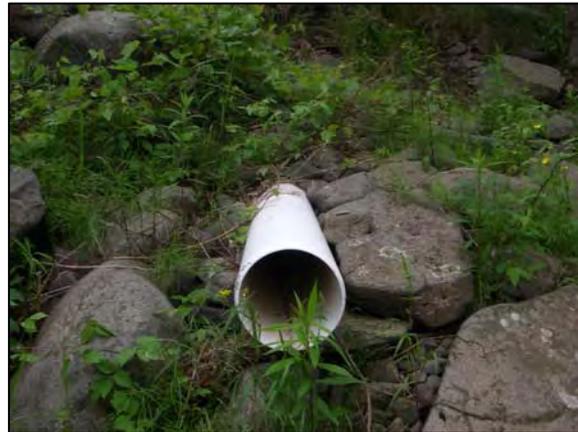
SPDES outfall at Station 106425

Near the upstream end of the stacked rock wall, at Station 106425, was an NYS permitted discharge point, permitted to the Hunter Liftside Transportation Corporation (SPDES permit# NY0212288). This permit allowed for the discharge of 0.0810 million gallons per day of treated sanitary wastewater to Schoharie Creek from the Hunter Mountain wastewater treatment plant. This wastewater treatment plant was

decommissioned in 2006 and replaced by the Village of Hunter sewage treatment facility, eliminating this discharge to the Schoharie Creek. The State Pollutant Discharge Elimination System (SPDES) program, administered by NYS Department of Environmental Conservation (DEC), governs discharges to surface and ground waters through the issuance of wastewater and stormwater discharge permits.

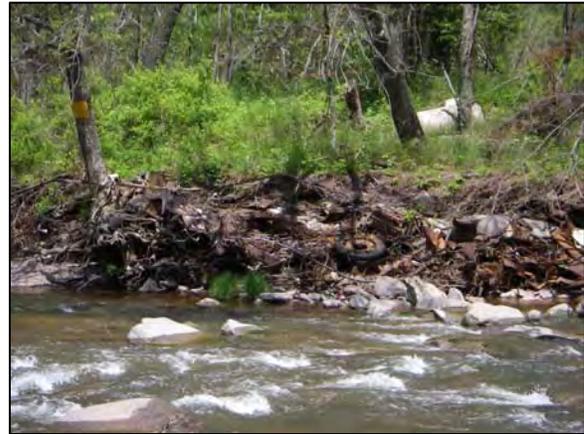
Dump at Station 105550

Downstream, the right streambank showed signs of scour during past high water events (Inset B, Station 105960). Grasses have begun to revegetate the bank face, however, additional plantings of native shrubs and sedges would increase bank stability. At the downstream end of this erosion, an old dump site was documented along the streambank (Station 105550). To prevent introduction of his material, and any possible pollutants, into the stream the dump should be removed.

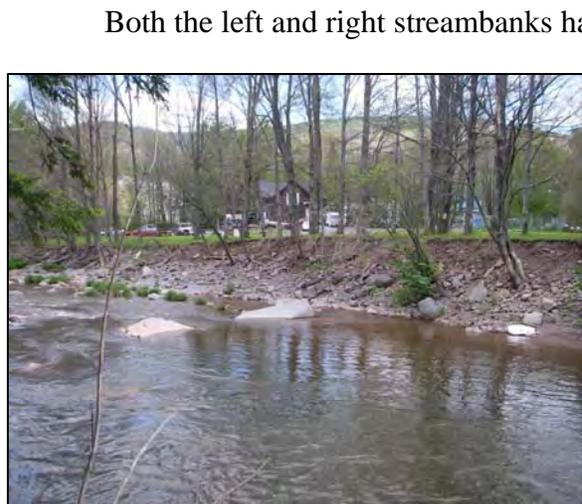
Bank erosion on right streambank at Station 105140

Both the left and right streambanks have been eroded downstream (Inset A, Station 105140). A Bank Erosion Monitoring Site (BEMS) was monumented to study erosion along this reach at Station 105300. A cross-section and long profile survey were conducted to collect baseline data. In the future this cross-section can be resurveyed to calculate the bank's erosion rate. Erosion at this site had fractured the lower shale bedrock bank and exposed a large 9,432ft² erosional area on the upper hillslope. At the top of the

slope, the end of Schoharie Avenue has been forced to close due to safety concerns. Erosion along the right streambank has scoured an area of 2,179ft².

Full restoration of the site is recommended, including the use of vegetated reinforced soil slope (VRSS) soil bioengineering system to stabilize the upper bank and grout to address the crack in the bedrock and increase the longevity of the project. VRSS is an earthen structure constructed from living, rootable, live-cut, woody plant material branches, bare root, tubling or container plant stock, along with rock, geosynthetics, geogrids, and/or geocomposites. The VRSS system is useful for immediately repairing or preventing deeper failures, providing a structurally sound system with soil reinforcement, drainage, and erosion

control (typically on steepened slope sites where space is limited). With this system, living cut branches and plants are expected to grow and perform additional soil reinforcement via the roots and surface protection via the top growth (Sotir and Fischenich, 2003).

Recommendations for the right streambank include planting native trees and shrubs along the streambank and the upland area. Buffer width should be increased by the greatest amount agreeable to the landowners, but increasing the buffer width by at least 100 feet will increase the buffer functionality. In-depth survey and engineering design would be required to plan a stream restoration project at this site. This survey and design started in early 2007.

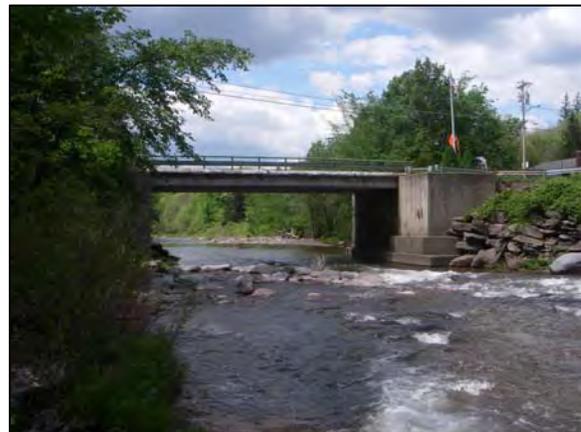
Bridge at Bridge Street – Station 104521

At the downstream end of this management unit the stream passed under the county bridge at Bridge Street in the Village of Hunter (BIN# 3201430). This bridge may constrict the floodplain at very high flows, as evidenced by minor deposition upstream, but passes most flows effectively. Flood damage to bridges is typically caused by inadequate hydraulic capacity of the bridge, misaligned piers and/or abutments, or accumulation of debris. As bridges are replaced over time, these issues should be evaluated and adjusted if necessary to lessen the probability of flood damage by providing a more effective conveyance channel that promotes water and sediment flow through the bridge opening.
