# Schoharie Creek Management Unit 9

Town of Jewett – Carr Road Bridge (Station 83957) to County Route 17 (Station 70652)

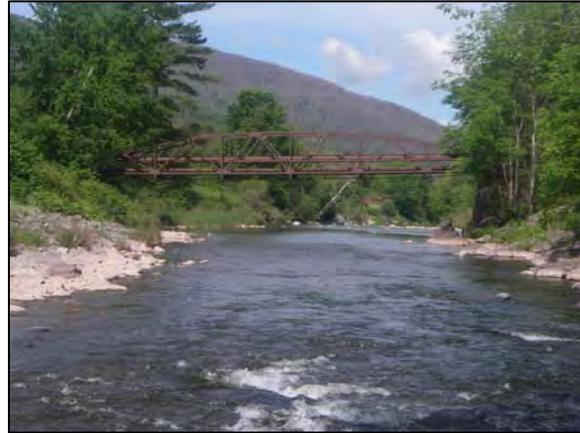
*Bridge at Carr Road (Station 83957)*

This management unit began as the stream passed under the Carr Road bridge. While *bankfull* flows appeared to flow freely through this bridge, higher flows overtop the bridge and flow over Carr Road rendering the bridge impassable. This bridge is the sole access residents have to cross the Schoharie Creek and during floods residents are cut off from emergency services. Repeated repair of Carr Road after

flood events has also been very costly. Installation of *floodplain drainage*, using culverts set at the floodplain elevation under the bridge approach, would increase hydraulic capacity of the bridge and help mitigate this problem. A hydraulic analysis of Carr Road bridge and upstream floodplain is the first step necessary to begin planning for remediation of flood concerns in this area (see Section 4.8 for recommendations).

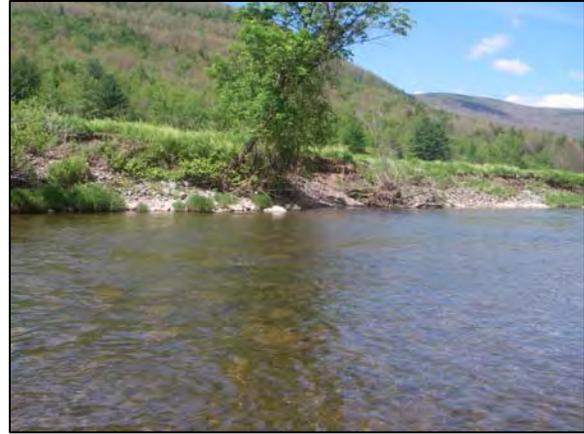
*Bank erosion at Station 83400*

Downstream, approximately 276ft of the left streambank had suffered minor erosion during high flow events (Station 83400). A piped outfall, which discharged stormwater from Little Timber Road onto this streambank, may exacerbate erosion at this site. The stability of this streambank could be improved with plantings of willow *fascines* and sedges along the toe of the bank coupled with trees and shrubs along the bank. These plantings would also improve the aquatic habitat within this reach. Erosion continued downstream for 331ft of the left streambank (Station 82830). This site was also a good candidate for *bioengineering* stabilization techniques.

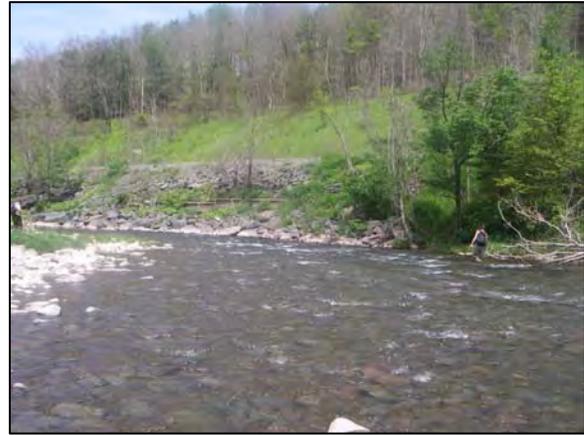
*Revetment at Station 82300*

As the stream flowed directly towards the County Route 23A embankment, revetment including 767ft of rip-rap and 90ft of T-wall had been installed along the right streambank (Station 82300). Interplanting of the existing rip-rap, by inserting plantings into the soil between the rocks may help to strengthen and increase the longevity of this rip-rap. These plantings will also improve the aquatic habitat by providing shade, resulting in cooler water temperatures.

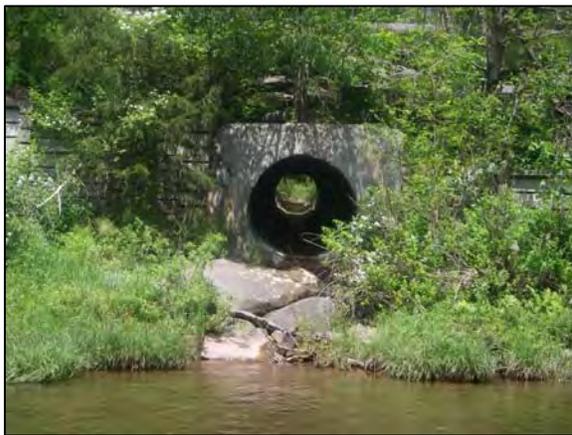
*Culvert and Tributary at Station 80800*

providing a good example of interplanted revetment. At the middle of this rip-rap, an unnamed *tributary* entered the Schoharie Creek (Station 80800). This tributary drained the mountain on the opposite side of County Route 23A, before passing under the road and joining the Schoharie Creek through a large concrete culvert. The New York State Department of Environmental Conservation classifies streams and rivers based on their

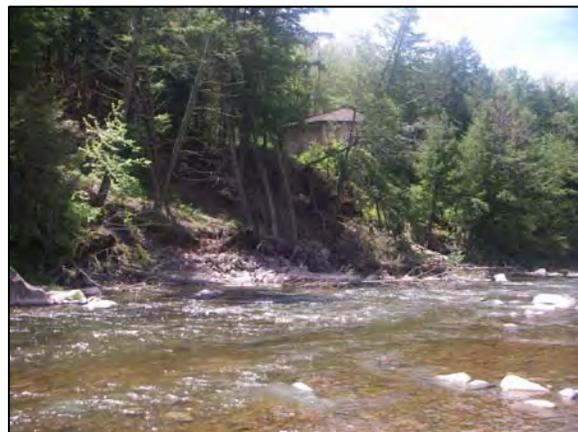
Bank erosion at 78900

Along the outside meander of this bend the *thalweg*, or deepest part of the stream channel, flowed up against the left streambank causing significant bank erosion (Station 78900). Streambank erosion often occurs on the outside of meander bends where the stream velocity is greatest during high flows. A 19,823ft<sup>2</sup> area of streambank had been left unvegetated, exposing a glacial lake silt/clay deposit. Fine sediment inputs from eroding bank can be a water quality concern because they increase *turbidity* and can act as a transport mechanism for other pollutants and pathogens. Sheet piling had

been installed along 30ft of this bank in efforts to protect a home on the streambank (Station 78760). This home could be threatened in the future if this bank continues to erode.

A bank erosion monitoring site (BEMS) was installed along this bank to study this erosion (Station 78870). A cross-section and long profile survey were conducted to collect baseline *morphology* data. In the future this cross-section can be resurveyed to calculate the bank's erosion rate. If the erosion rate accelerates significantly, full restoration to address property loss and water quality threats should be considered for this site. This would likely involve establishment of a well-vegetated bench on the right bank with rock vanes to direct stream flows away from the bank, regrading and then revegetation of the bank face, and establishment of channel geometry throughout the unit to more effectively convey the *sediment load*.

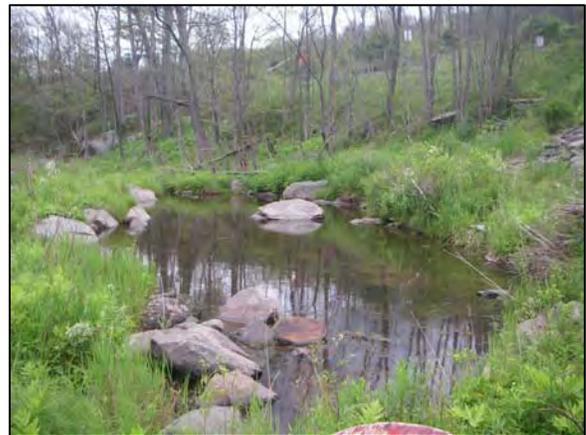
*Detention basin at Station 76700*

At the next downstream meander bend, the stream was once again pushed against the County Route 23A embankment. Rip-rap had been installed along 312ft of this embankment and was in good structural condition with shrub and herbaceous vegetation growing throughout (Inset B, Station 76900). Several hillside seeps, along with road drainage, entered Schoharie Creek along this bank. A small detention pond designed to retain stormwater runoff, and remove sediment within the stormwater by settling, had been installed on the streambank terrace (Station 76700).

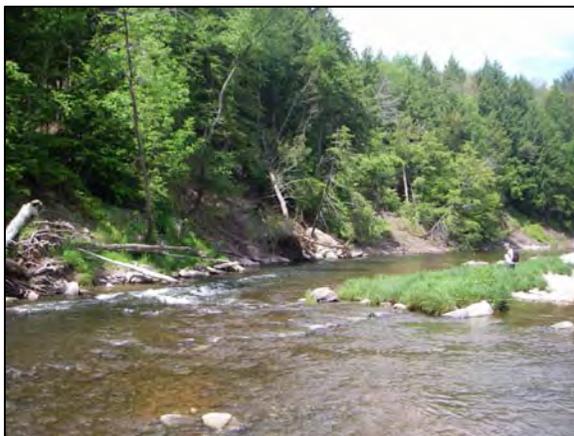
Bank erosion at Station 73100

At the next meander bend downstream, the channel flowed up against the valley wall on the left bank causing a 40,613ft<sup>2</sup> mass failure (Station 73100). The *thalweg* pushed up against the high hillslope which caused toe erosion that resulted in the loss of the mature forested vegetation, leaving much of the streambank unvegetated. The exposed *mixed till* soils had a high silt and clay content, which likely contributed a significant sediment load during high flows.
