# Schoharie Creek Management Unit 10

Towns of Jewett and Lexington – County Route 17 (Station 70652) to  
Bush Road Bridge (Station 63446)

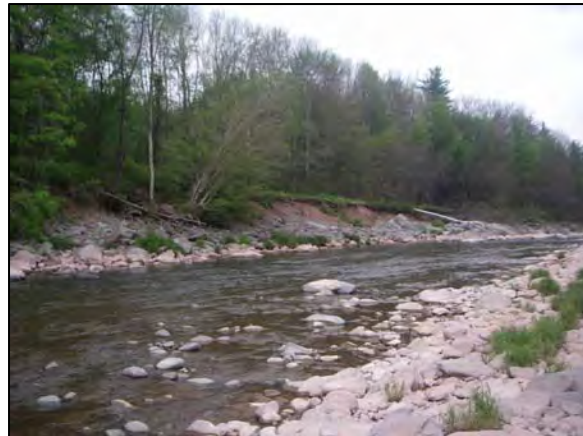
Just downstream, along the outside meander of this bend the *thalweg*, or deepest part of the stream channel, flowed up against the left streambank causing significant bank erosion (Station 70450). Streambank erosion often occurs on the outside of meander bends where the stream velocity is greatest during high flows.

*Bank erosion at Station 70450*

Many mature trees had fallen from the top of the bank and a 10,876ft<sup>2</sup> area of streambank had been left unvegetated. This site may stabilize on its own over time. It appeared that a low bench had begun to develop at the toe of the eroding bank which may act to reduce flood water velocities near the bank. As the bank stabilizes native vegetation will reestablish. A bank erosion monitoring site (BEMS) was installed along this bank to study this erosion (Station 70230). A cross-section and long profile survey were conducted to collect baseline *morphology* data. In the future, this cross-section can be resurveyed to calculate the bank's erosion rate and document its potential recovery.

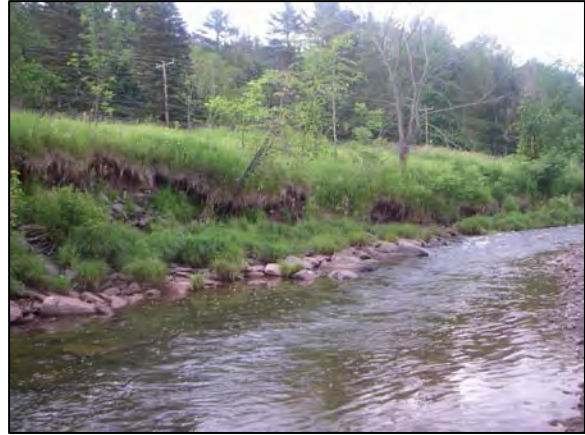
The right streambank on the side channel along the Route 23A embankment had suffered erosion along a 2,258ft<sup>2</sup> area. Revetment including 1,209ft of rip-rap and 641ft of T-wall had been installed along the right streambank downstream (Inset A, Station 68700). Although some vegetation had established along this revetment, additional plantings of native trees and shrubs along both the eroding and revetted bank would increase bank stability and improve the aquatic habitat by providing shade, resulting in cooler water temperatures.

*Bank erosion at Station 69050*

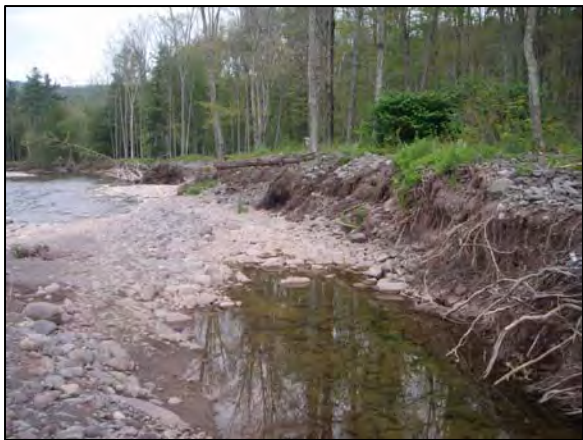
Bank erosion at Station 68900

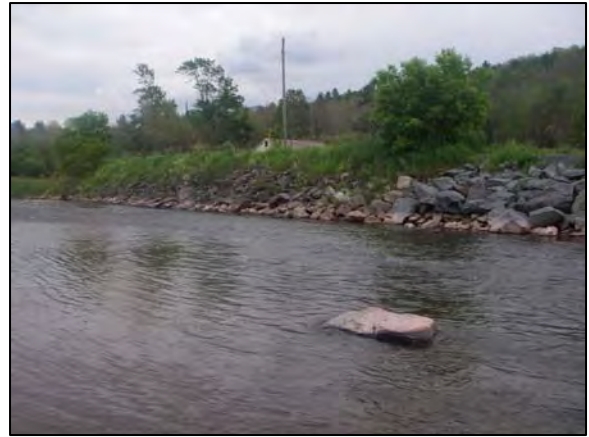
Although the upstream half of this chute was dry, the downstream end did contain base flow. At the downstream end of this chute rip-rap had been installed along 763ft of the left streambank protecting the Van Road embankment (Station 68300). While rip-rap and other hard controls may provide temporary relief from erosion, they

*Rip-rap at Station 68300*

are expensive to install, degrade habitat, and require ongoing maintenance or may transfer erosion problems to upstream or downstream areas. Alternate stabilization techniques should be explored for streambanks whenever possible. Native shrub and sedge species should be interplanted through the rip-rap and along the toe of this streambank to help strengthen the revetment and enhance aquatic habitat.

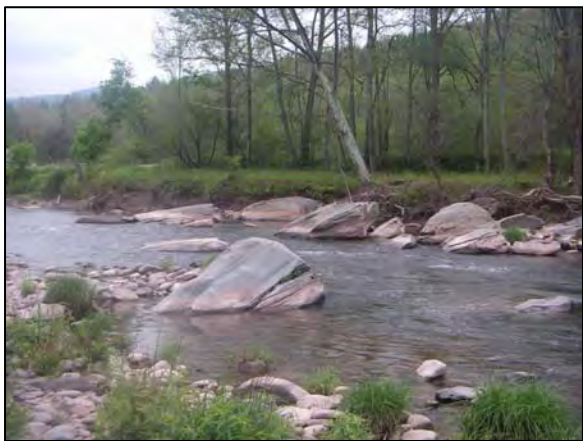
*Bank erosion at Station 67300 - looking upstream*

As the flood chute and mainstem stream channel converged, the left streambank had been scoured along the streambank toe. This type of erosion is common and part of natural stream process. In stable watersheds, the rate of erosion is slow and a natural healing process usually follows. Excessive sediment deposition was observed as the two stream channels reunited into one (Station 66800).

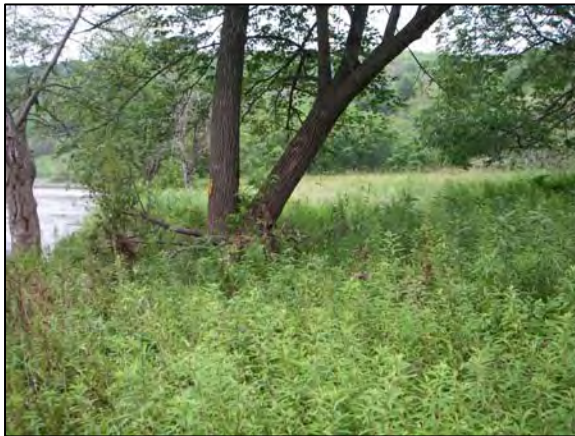
Downstream the riparian buffer beyond both the streambanks was comprised of a few mature trees with herbaceous fields to the edge of the bank (Station 66250). Buffer width

*Planting site at Station 66250 – right streambank*

should be increased along these banks by the greatest amount agreeable to the landowners, but increasing the forested buffer width by at least 100 feet would increase buffer functionality, such as filtering nutrients and pollutants, if any, from the adjacent fields.

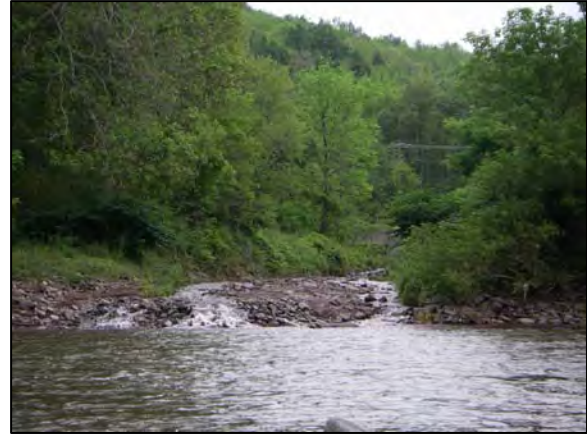
John Chase Brook entered from the right streambank (Station 65700). This tributary drained the slopes of Tower Mountain before it reached the flatter topography of the valley floor where it entered the Schoharie Creek. As a result of this change in stream slope, the tributary lost its ability to transport sediment gathered from the mountain slopes, and began to deposit sediment at its mouth and into the more gently sloped Schoharie Creek. This is a common feature of confluence areas, which often contain extensive sediment bars, function as important sediment storage areas, and are typically among the most dynamic and changeable areas in the stream system. This *tributary* was classified as C(t) by the NYS DEC, indicating that the best uses for this stream were the support of fisheries, including trout, and other non-contact activities (NYSDEC, 1994).

*John Chase Brook confluence at Station 65700*

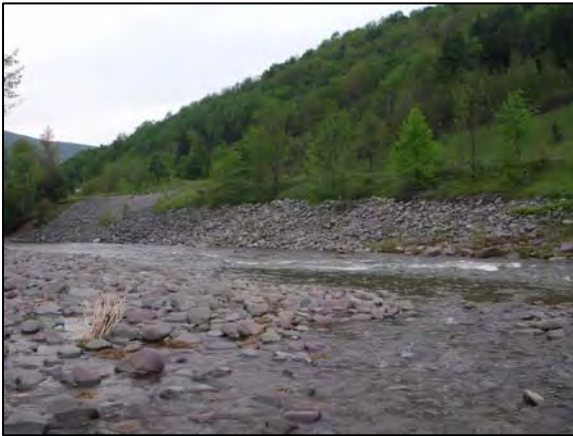
As the stream flowed directly towards the County Route 23A embankment, 500ft of

*Rip-rap at Station 65200*

rip-rap had been installed along the right streambank (Station 65200). Interplanting of the existing rip-rap, by inserting plantings into the soil between the rocks may help to strengthen and increase the longevity of this rip-rap. These plantings will also improve the aquatic habitat by providing shade, resulting in cooler water temperatures. Along this rip-rap an unnamed tributary entered the Schoharie Creek through a concrete culvert

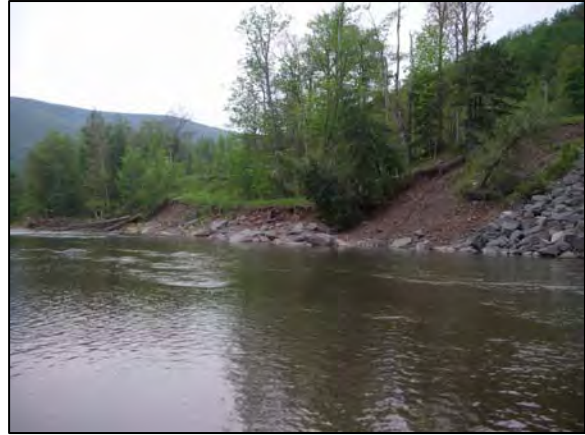
As this rip-rap ended, erosion began (Station 64580). The hillslope was being undermined by toe erosion, resulting in the mass wasting of a 3,479 ft<sup>2</sup> area of the right streambank. This erosion left the face of the stream bank unvegetated. The exposed lodgement till soil had a high silt and clay content, contributing a significant suspended sediment load during rainfall events. In addition to the water quality threat associated with the clay exposed at this erosion site, conditions here also present a future hazard to the County Route 23A embankment which could be threatened if this bank continues to erode.

*Bank erosion at Station 64580*

A bank erosion monitoring site (BEMS) was installed along this bank to study this erosion (Station 64315). If study of this streambank shows erosion rates accelerating significantly, full restoration to address property loss and water quality threats should be considered. This would likely involve establishment of a well-vegetated bench on the right bank with rock vanes to direct stream flows away from the bank, regrading and then revegetation of the bank face, and establishment of channel geometry throughout the unit to more effectively convey the *sediment load*.

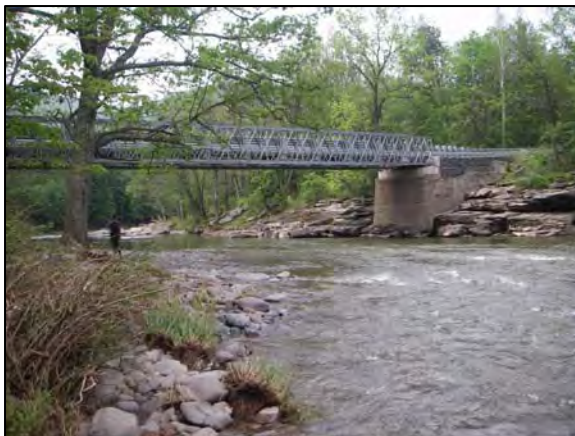
*Bridge at Bush Road Station 63446*

At the downstream end of this management unit the stream passed under the bridge at Bush Road (BIN 32012110). This bridge may constrict the floodplain at very high flows, as evidenced by aggradation at the left bridge abutment, but appeared to pass most flows effectively. Flood damage to

bridges is typically caused by inadequate hydraulic capacity of the bridge, misaligned piers and/or abutments, or accumulation of debris. As bridges are replaced over time, these issues should be evaluated and adjusted if necessary to lessen the probability of flood damage by providing a more effective conveyance channel that promotes water and sediment flow through the bridge opening.
