# Schoharie Creek Management Unit 12

Town of Lexington – County Route 42 Bridge (Station 55350) to Station 48154

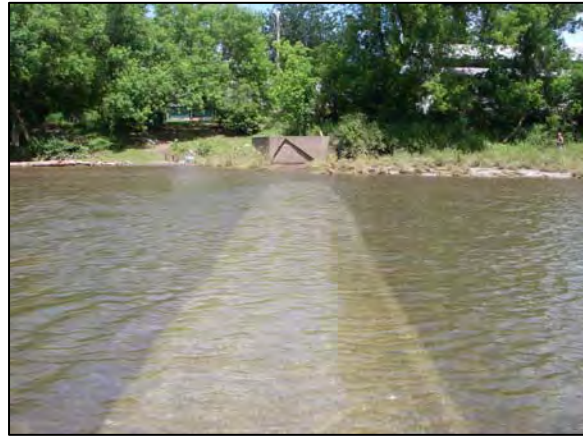
The stream channel downstream from the bridge was over-wide and aggrading (Inset D). This condition was exacerbated by a 6 ft wide concrete sill across the stream channel. In the past, wooden barriers were placed into this sill to pond water for a swimming area. Although this has not occurred in many years the concrete sill remains. Conducting a study of the effect of removing this sill or cutting a low flow channel into the sill is recommended. Creation of a low flow channel may reduce deposition and create aquatic habitat through the development of stream features, which are currently lacking. In-depth survey and design would be necessary to study the upstream and downstream effects of a restoration project.

*Concrete sill at Station 54480*

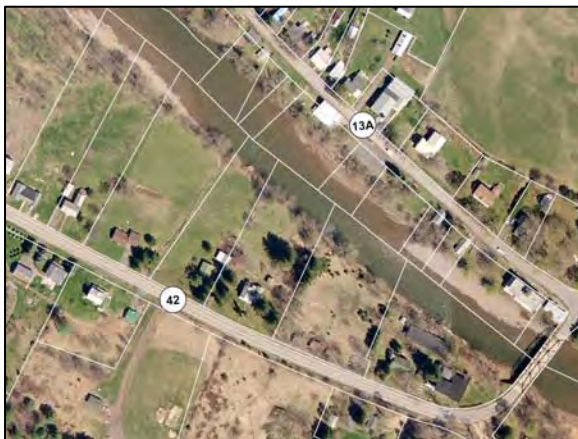
*Planting site at Station 54350 – left streambank*

Downstream, residential properties lined both streambanks. On the left streambank, several properties with homes along County Route 42 had large lawn areas within the 100-year floodplain mown to the stream edge (Station 54350). A buffer of native trees and shrubs should be planted along the streambank and corridor. Buffer width should be increased by the greatest amount agreeable to the landowner, but

increasing the buffer width by at least 100 feet will increase the buffer functionality, such as

slowing the flow of run-off from the floodplain and allowing sediment and its attached pollutants, if any, to settle out before reaching the stream. Along the right streambank the lawn was also mowed to the stream edges and the streambank toe showed signs of scour (Inset C, Station 54200). Native trees and shrubs should be planted on the face of stream bank. To provide protection against toe erosion, willow *fascines* and sedges should be planted along the toe of the stream bank. These planting can be spaced to retain views of the creek.

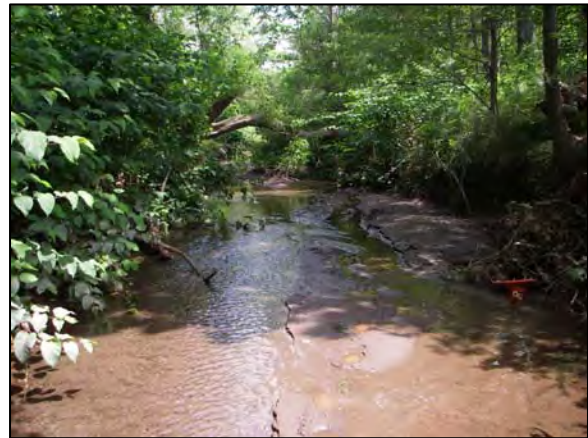
An unnamed tributary entered the Schoharie Creek from the right streambank (Station 53700). This tributary drained the steep slopes of Patterson Ridge, before it reached the flatter topography of the valley floor where it entered the Schoharie Creek. As a result of this stream slope change, the tributary lost its ability to transport sediment gathered from the mountain slopes, and began to deposit sediment at its mouth and into the more gently sloped Schoharie Creek. This is a common feature of confluence areas, which often contain extensive sediment bars, function as important sediment storage areas, and are typically among the most dynamic and changeable areas in the stream system. This tributary was classified C by the NYSDEC (NYSDEC, 1994).

*Tributary at Station 53700 – looking upstream*

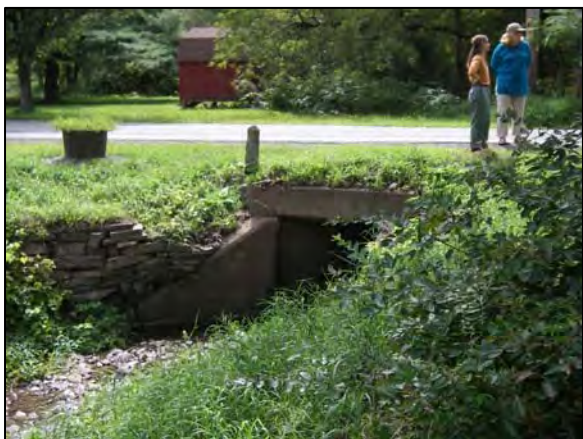
*Culvert in need of replacement on County Rt. 13A*

The tributary passed under County Route 13A through a culvert before entering the Schoharie Creek. During flood events this culvert is unable to pass flows and backwaters, leading to flooding of the roadway and adjacent residential properties. Repeated flooding in this area had resulted in expensive roadway repair work. To protect public and private infrastructure this culvert

should be replaced with a larger realigned culvert able to pass flood flows. The new culvert should also be ecologically friendly with an open bottom to provide passage for biota. Installation of flood plain drainage on the adjacent lawn could provide an outlet for any excess flood waters.

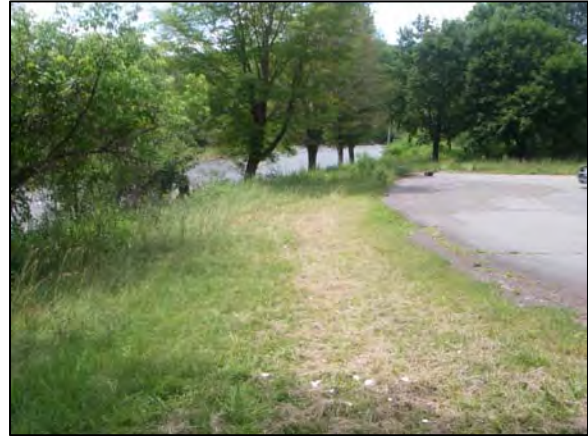
Downstream on the right streambank there was a NYSDEC public fishing access with a parking area at the top of the bank (Station 53500). These access points allow the public to wade and walk along the streambed and banks for the purpose of fishing. Rip-rap had been installed along 72 ft of this embankment.

*Planting site at DEC Parking Area – Station 53500*

To demonstrate creation of a high quality riparian buffer, native trees, shrubs, and sedges should be planted along this streambank and upland area. Buffer enhancement would not only increase bank stability but would also improve aquatic habitat by providing shade, resulting in cooler water temperatures. An educational kiosk at the DEC parking area could provide a description of the project and the importance of forested streamside buffers. Information explaining other restoration projects that may occur in the area, such as the proposed CR13A culvert replacement, could also be displayed.

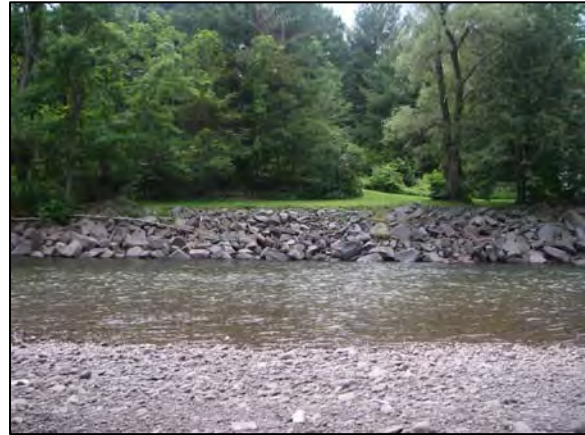
As the stream flowed directly toward County Route 42, rip-rap had been installed on approximately 729 ft of the left streambank (Station 52600-51700). While rip-rap and other hard controls may provide temporary relief from erosion, they are expensive to install,

degrade habitat, and require ongoing maintenance or may transfer erosion problems to upstream or downstream areas. Alternate stabilization techniques should be explored for streambanks whenever possible.

*Rip-rap at Station 52120*

Interplanting of this rip-rap, by inserting native shrub plantings into the soil between the rocks, would strengthen and increase its longevity. These plantings would also improve aquatic habitat by providing shade,

resulting in cooler water temperatures. To provide protection against toe erosion, sedges or willows could be planted along the toe of the streambank.

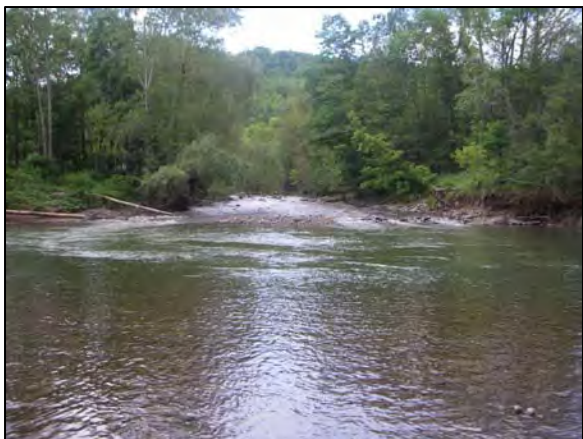
West Kill confluence at Station 51650  
looking upstream

confluence. The West Kill watershed drains approximately 31.2 mi<sup>2</sup> and is closely surrounded by the steep mountains of the Catskills. As evidenced by the large amount of deposition upstream and downstream of the confluence, the West Kill delivered a significant amount of sediment into the Schoharie Creek. The West Kill was classified as C(ts) by NYSDEC, indicating that the best uses for this stream were the support of fisheries, including trout spawning

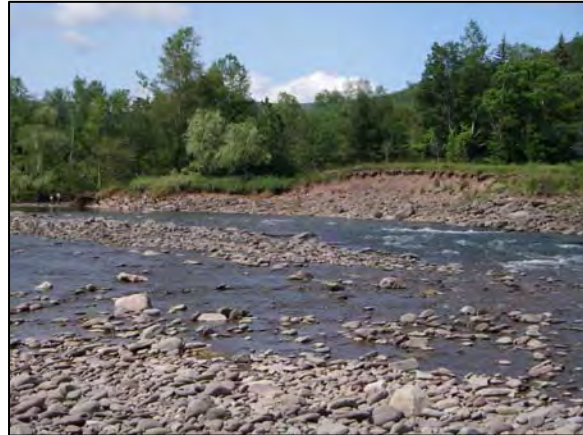
Immediately downstream of this confluence both streambanks had eroded, likely due to the increased drainage area and sediment load from the West Kill. Erosion was documented along 1,171 ft of the left streambank, exposing an estimated area of 6,191 ft<sup>2</sup>

*Bank erosion on left streambank at Station 51600*

(Station 51600). Restoration recommendations for this streambank include creation of a low bench at the toe of the eroding bank which may act to reduce flood water velocities near the bank and grading of the eroding bank to reduce its slope. The reshaped streambank should be planted with native trees, shrubs, and sedges. Installation of a 100 ft buffer along the adjacent stream corridor may also act to filter nutrients and pollutants, if any, from the adjacent fields.

A bank erosion monitoring site (BEMS) was installed along this bank to study this erosion (Station 51400). In 2006, a cross-section and long profile survey were conducted to collect baseline *morphology* data. In the future this cross-section can be resurveyed to calculate the bank's erosion rate.

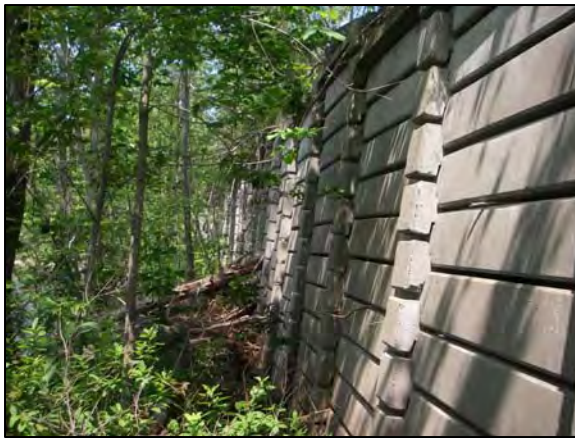
*T-wall at Station 49450*

As the stream flowed against the County Route 23A embankment revetment had been installed, including 1,308 ft of rip-rap (Station 50100) and 285 ft of concrete T-wall (Station 49450). A large amount of

native vegetation was growing throughout this revetment.
