Schoharie Creek Management Unit 15

Town of Lexington – Station 34336 to Station 31388

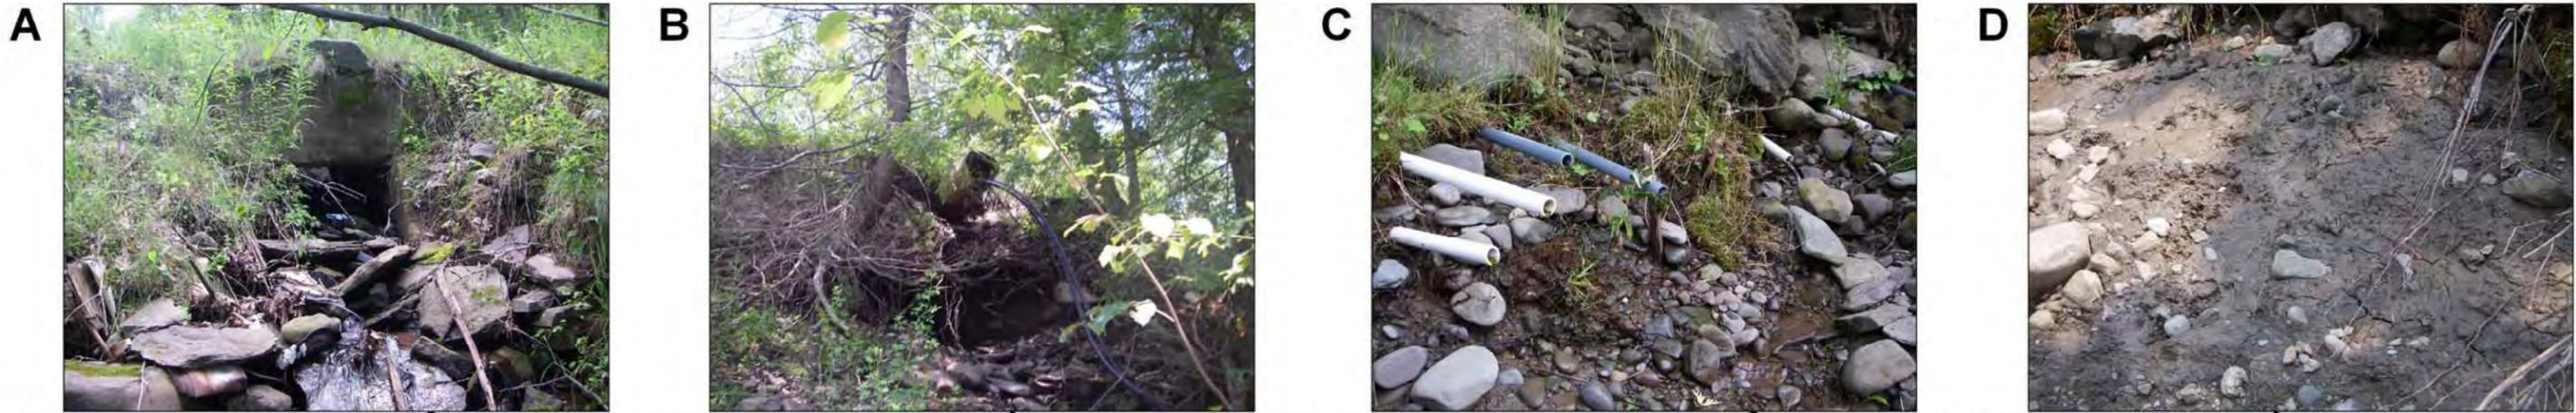
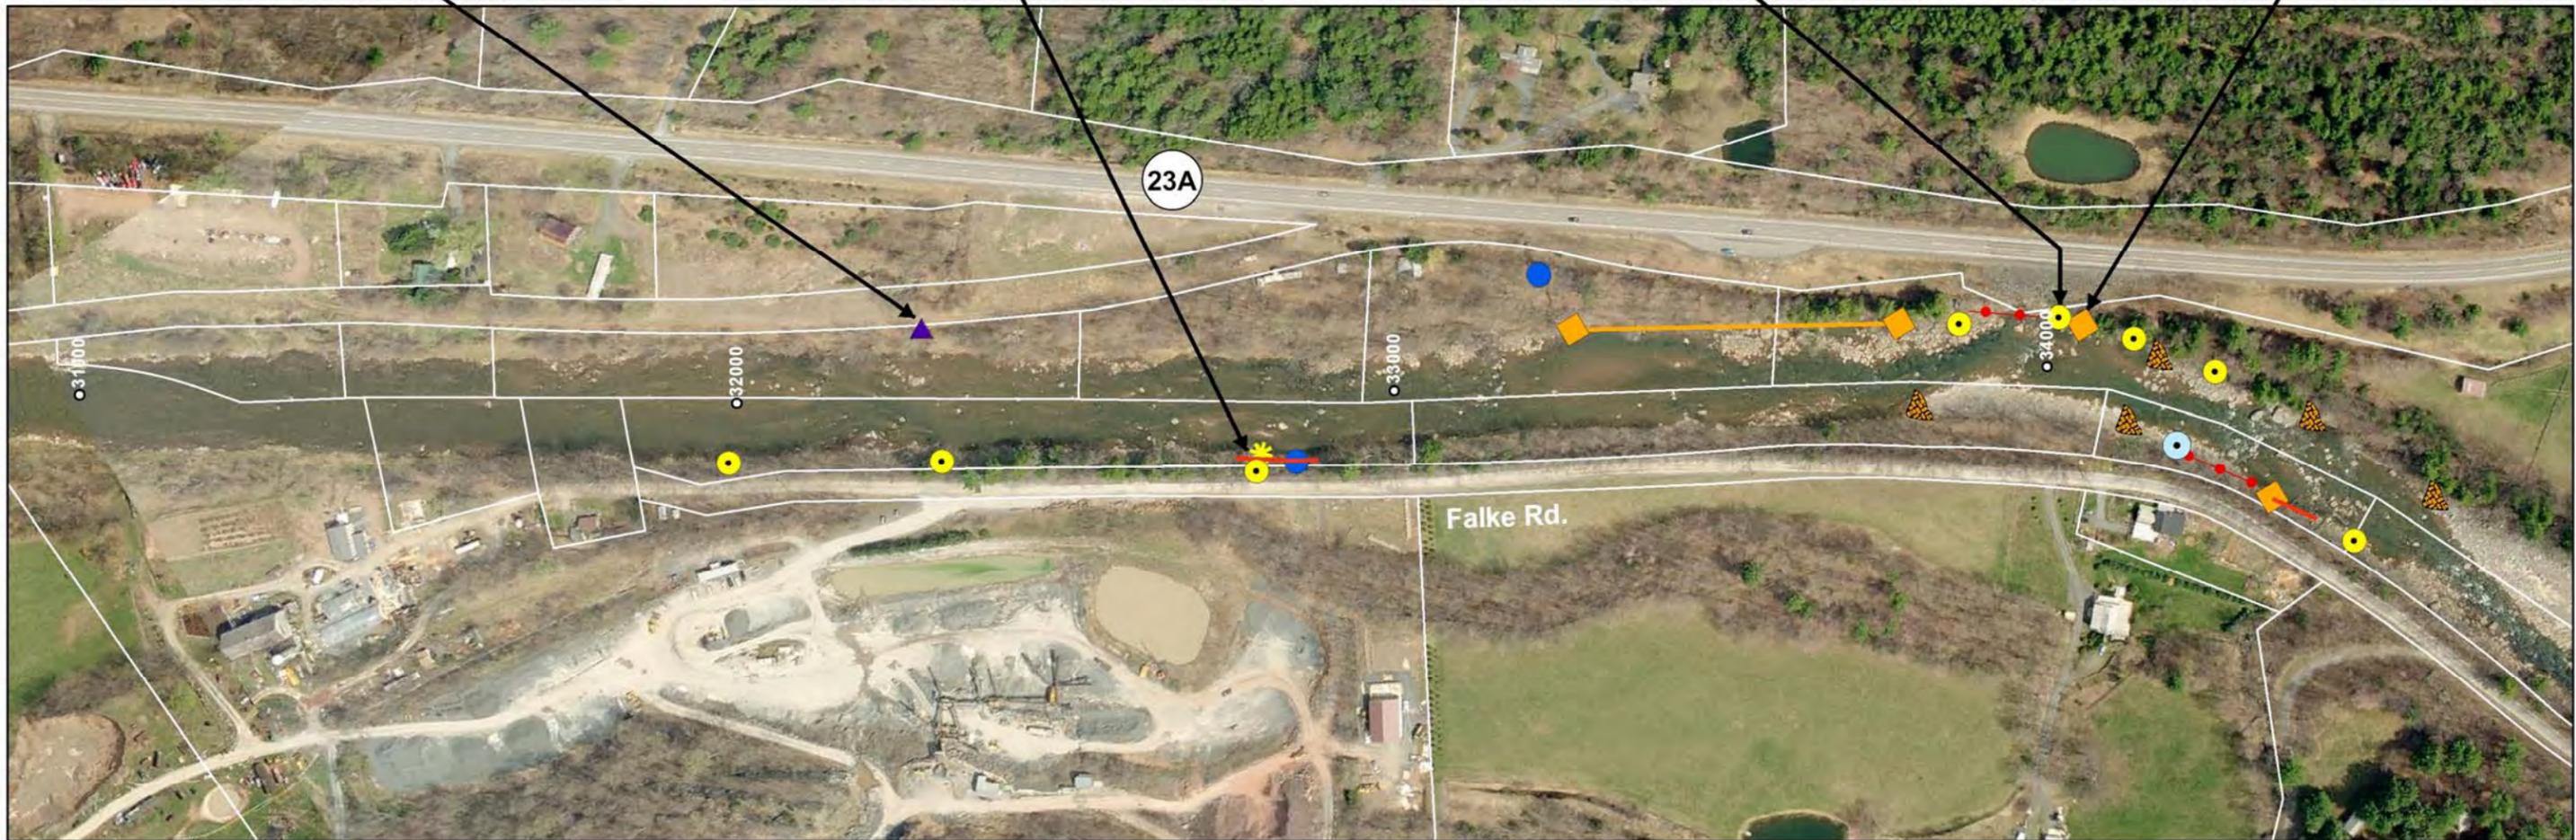
Figure 4.15.1 Management Unit 15 - 2006 aerial photography with stream feature inventory

The 2006 stream feature inventory revealed that 2.1% (126 ft) of the streambanks exhibited signs of active erosion along the 5,896 ft of total channel length in the unit (Figure 4.15.1). The total surface area of active erosion totaled approximately 3,283 ft². *Revetment* had been installed on 4.5% (265 ft) of the streambanks. No *berms* were identified in this management unit at the time of the stream feature inventory.

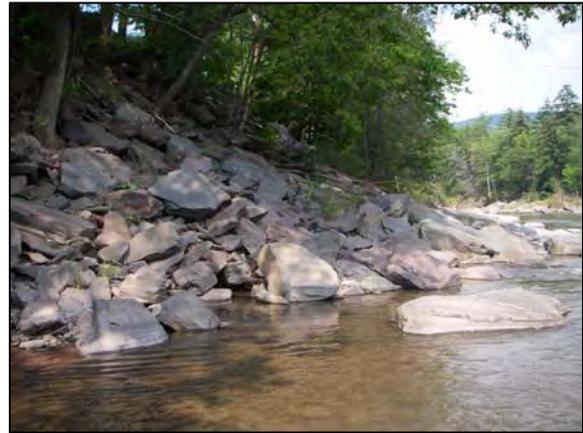
Rip-rap at Station 34360

At the upstream end of the management unit, rip-rap had been installed along 132 ft of the left stream embankment (Station 34360). While rip-rap and other hard controls may provide temporary relief from erosion, they are expensive to install, degrade habitat, and require ongoing maintenance or may transfer erosion problems to upstream or downstream areas. Alternate stabilization techniques should be explored for

streambanks whenever possible. Interplanting of this rip-rap, by inserting native tree and shrub plantings into the soil between the rocks, would increase bank protection and its long-term effectiveness. These plantings could also improve the aquatic habitat by providing shade, resulting in cooler water temperatures.

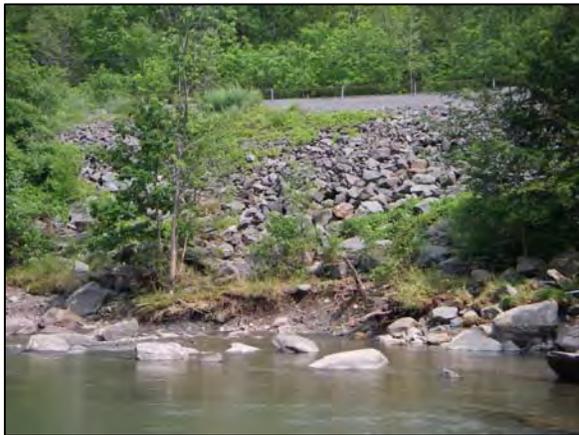
Rip-rap at Station 34050

On the opposite bank, the County Route 23A road embankment had scoured along 100 ft of the right streambank exposing the underlying *lacustrine* clay (Inset D, Station 34050). Fine sediment inputs into a stream increase *turbidity* and can act as a transport mechanism for other pollutants and pathogens. Sixteen small 1” drainage pipes outlet stormwater at the toe of the bank exacerbating this scour (Inset C). To provide

protection against further toe erosion, sedges and willows could be planted along the toe of the streambank. The rip-rap, which had been installed on the upper embankment, should be interplanted with native tree and shrubs to increase its longevity (Station 34000).

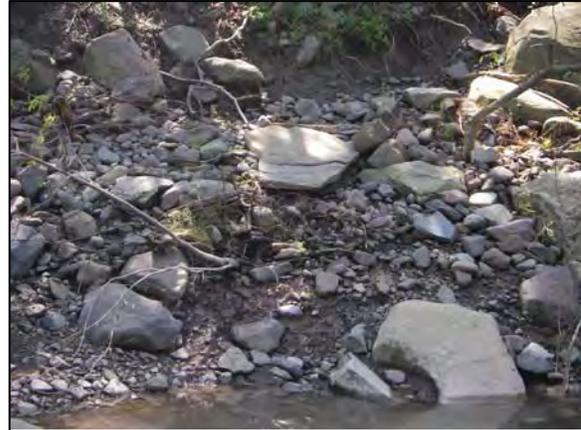
Clay exposure at Station 33800

Immediately downstream, the bank toe continued to scour exposing another 114 ft of clay and silt along both the streambank and bed (Station 33800). To increase bank stability and improve aquatic habitat, native shrubs and sedges should be planted along the streambank and toe. At the top of the streambank there was a NYSDEC public fishing access with a parking area. These access points allow the public to wade and walk along the streambed and banks for the purpose of fishing. Structured access should be provided from this parking area to avoid fishermen inadvertently increasing the erosion problem while accessing the stream.

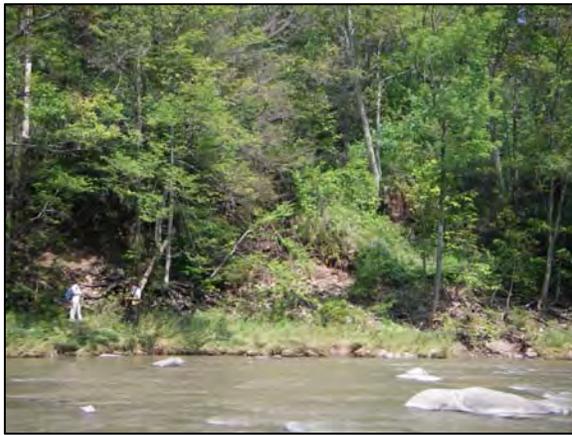
Bank erosion at Station 32900

Downstream, 126 ft of the hillslope on the left streambank was eroding resulting in the loss of mature vegetation from the face of the streambank (Station 32900). Stormwater from the outlet at the top of this bank appeared to be causing most of the erosion at this site (Inset B, Station 32800). Outlet protection, such as a rock lined channel, should be installed to dissipate flow and prevent erosion. To minimize erosion, stormwater outfalls

should be designed to outlet near the base of the streambank, set back from the active stream channel, and enter the stream at a low angle. The streambanks from here to the downstream end of the management unit appeared stable.
