# West Kill Management Unit 2

## Management Unit 2

Between Station 53971 and Station 51153

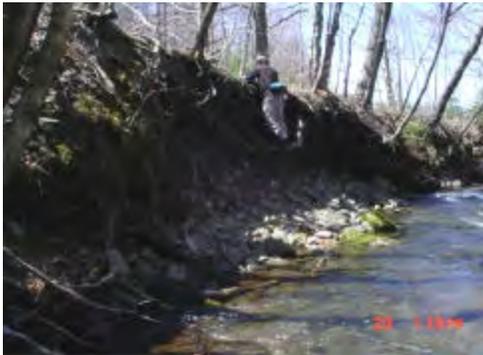
**Bank Erosion, with narrow, undercut buffer**

As the channel bends gently to the right, erosion is evident on the left bank, which has only a single line of trees providing buffer to the adjacent mowed pasture and unimproved road. The toe of the bank is being scoured at higher flows, and the site has been monumented as a Bank Erosion Monitoring Site (BEMS Station 02-53926) (Inset H, Fig. 4.2.2). In a prioritization of twenty-one BEMS sites throughout the West Kill watershed (see Section 3.3, Watershed Inventory and Assessment), this site ranked Low Priority.

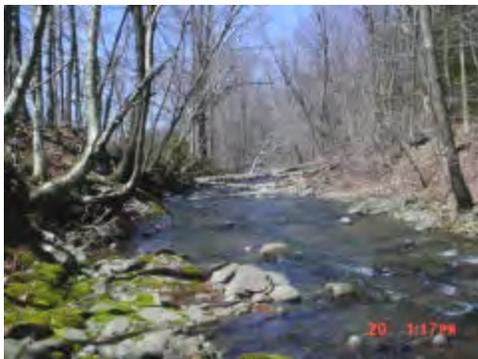
**Debris Blockage**

Continuing downstream, a large tree undercut by toe scour has fallen across the channel. The debris creates no obstruction at low flow, but likely more significant flow obstruction at higher flows.

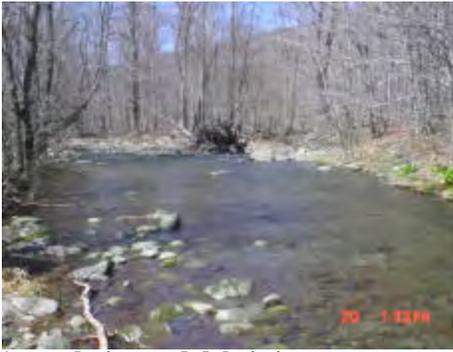
**Aggradation and debris jam at stream type transition**

As the channel straightens, the entrenchment decreases and the dominant bed material shifts from gravel to cobble, changing the stream type to C3, which continues for approximately 800 ft. The stream widens, and slope drops to 1.74%.

Aggradation is apparent here, likely the result in changing channel form and sediment load from Hunter Brook, which enters just downstream on the right. Flood flows have ample access to the mowed field on the left, and at higher flows, to a highly disturbed, forested floodplain on the right. Historic flows have left relic channels on both left and right floodplains throughout this reach.

A tree with large root fan at channel left appears to have triggered a headcut. As the headcut migrates through the reach, it may promote development of a more defined low flow channel, allowing revegetation of the relic channels on the floodplain.

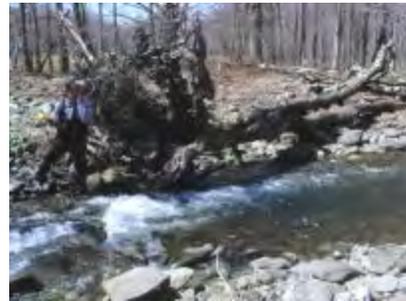
**Debris Jam - along head cut, low flow clear, left point bar obstruction**

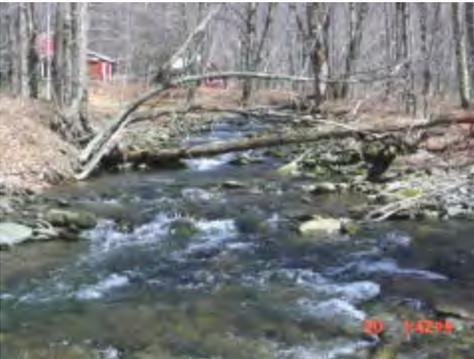
**Hunter Brook confluence**

Hunter Brook enters from right bank. The tributary is well-connected, with a healthy junction pool. Aggradation is evident downstream of the confluence (Inset D, Fig. 4.2.2), suggesting excess sediment loading from the tributary. Additional investigation of sediment sources in the Hunter Brook catchment is

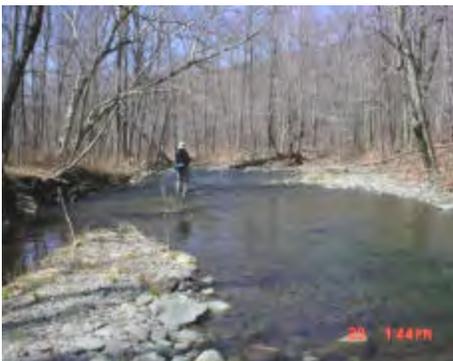
**Aggraded reach near confluence**

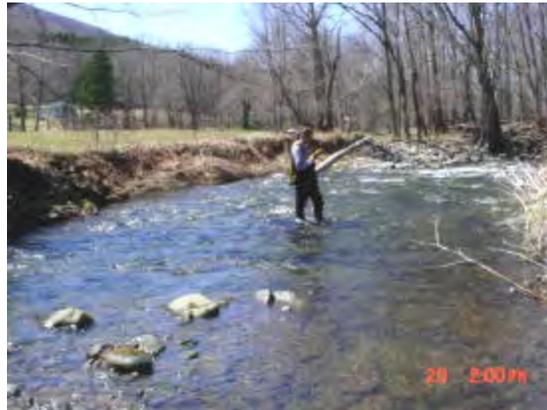
A monumented cross-section has been established at this aggradational setting (Station 53180), adjacent to an unbuffered horse pasture. The floodplain is excessively connected on both right and left, as what was a higher terrace upstream has become the bankfull floodplain. Planting trees and shrubs along the pasture is recommended to help stabilize the bank, and buffer the stream from the horse pasture.

**Aggradation**

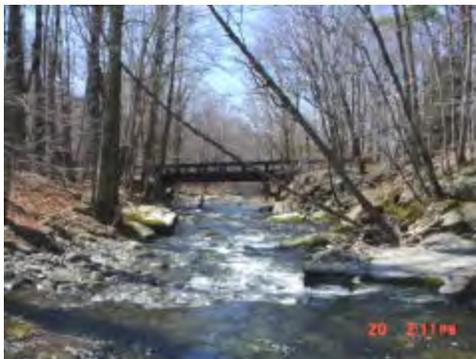
**Spruceton Road Bridge**

As the channel bends to the left on approach to the Spruceton Road bridge (Inset C, Fig. 4.2.2) and USGS gaging station (Gage #01349711), slope increases to 2.2%, and the channel recovers its capacity to transport its sediment load. Dominant bed material remains cobble. A monumented cross-section below the bridge documents a stream type change to B3 (Station 52706).

The mortared stone bridge abutments, with a poured scour wall and a short wing wall upstream on the right, measure approximately 25 ft. from footer to footer. Bankfull channel width at the monumented cross-sections up- and downstream ranges from 36 to 40 ft. The channel constriction at the bridge may be responsible for the aggradational conditions documented upstream. Road ditch drainage enters downstream of the bridge, on the right.

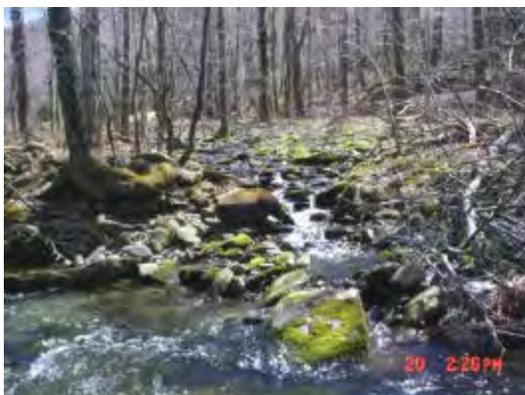
**Tributary**

Downstream of the monumented cross-section, a small, well-connected unnamed tributary drains the pastured field, left. There was evidence of nutrient enrichment (algal growth) at the confluence.

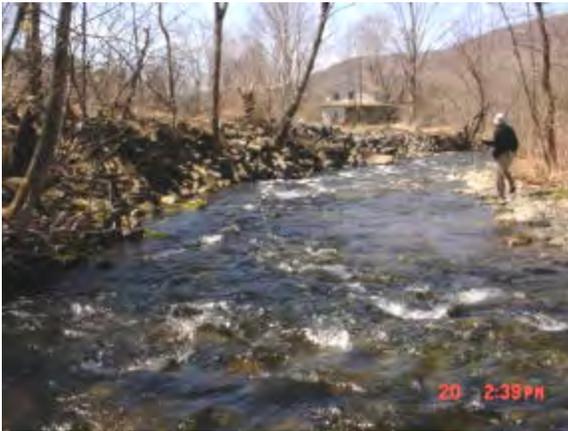
**Revetment**

F, Fig. 4.2.2). A single line of trees buffers a mowed field on the right. There is some evidence of channelization, widening and aggradation through the straight reach downstream.

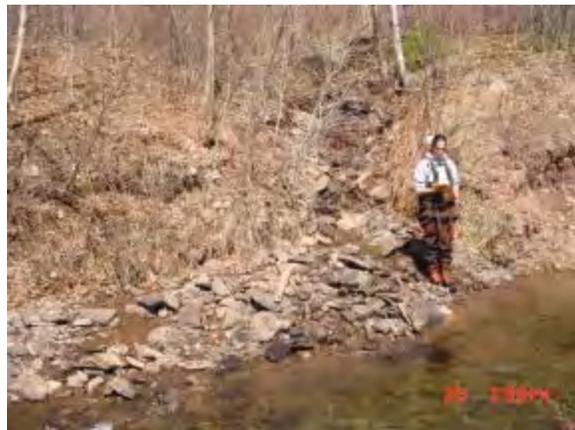
At the downstream end of the aggradational setting, the channel bends to the left, and is divided by a well-vegetated center bar. A small, unnamed tributary enters from the right near the head of this island. This tributary is perched, with a small delta formation at the confluence. Lake clay underlies the bed of the tributary.

**Unnamed tributary confluence, right**

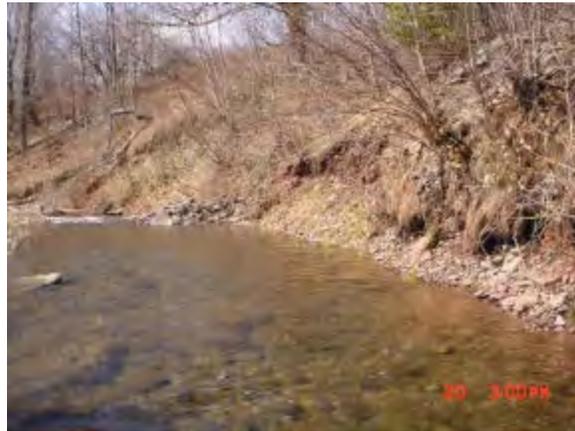
Erosion of the right bank, adjacent to the center bar, has been monumented as a Bank Erosion Monitoring Site (BEMS Station 02-51510) (Inset B, Fig. 4.2.2). In a prioritization of twenty-one BEMS sites throughout the West Kill watershed (see Section 3.3, Watershed Inventory and Assessment), this site ranked Medium Priority. The *thalweg*, or deepest part of the stream channel flows up against the terrace here. The hillslope is being undermined by toe erosion, leaving sections of the stream bank unvegetated. The *exposed ice contact deposits* and *lacustrine* soils have a high silt and clay content, contributing sediment through both *wet and dry ravel* and yielding a significant suspended sediment load during high flows. Clay inputs into a stream are a serious water quality concern because they increase *turbidity*, degrade fish habitat, and can act as a carrier for other pollutants and pathogens.

**Bank Erosion, with clay exposure, right bank**

Recommendations for this site would be for Assisted Self-Recovery, including promotion of a single thread channel by closing the right channel thread with large rock or woody debris, to direct flows away from the terrace wall. This would likely involve establishment of a well-vegetated bench on the right with rock vanes to direct stream flows away from the right bank, and revegetation of the bank face. In-depth survey and design would be required to plan a stream restoration project at this site.

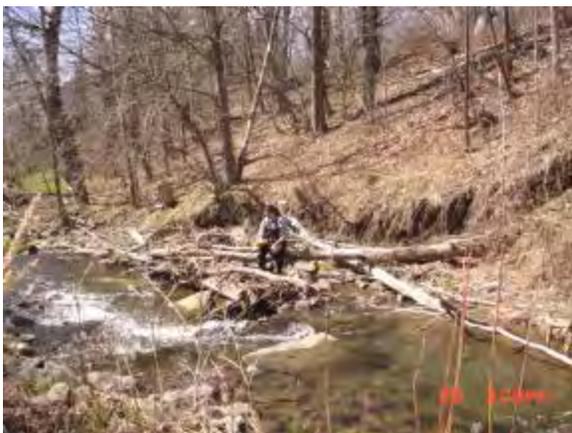
**Large woody debris blockage**

At the downstream end of the eroding bank, large woody debris has collected along the right bank, creating some low-flow obstruction. This debris jam is likely to exacerbate the upstream erosion problem.

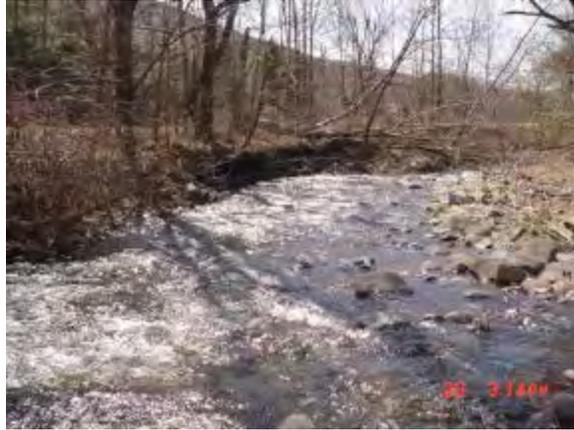
There is also minor bank erosion on the left bank of the left channel thread, adjacent to the downstream end of the central bar. This bank is buffered from Spruceton Road by a narrow line of trees along a low terrace. This erosion was not monumented. Erosion at the left and right of the center bar, however, as well as the mature vegetation on the island, suggests that the aggradational condition is unlikely to recover without intervention.

**Bank Erosion, left bank**

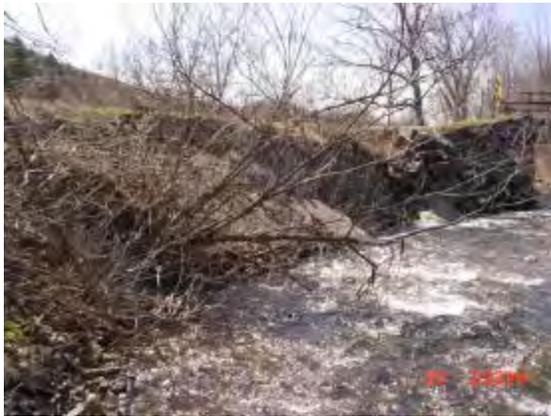
**Rip-rap revetment on approach to bridge, left bank**

The channel bends as it converges with Spruceton Road just upstream of the Bridge #3201250. The stream type changes again as the slope increases upstream of the bridge constriction, to enter a 147 ft. reach of F4b as slope increases to 2.33%. The left bank on the bridge approach has been revetted with stacked rock, portions of which have been undermined (Inset E, Fig. 4.2.2). F4 stream types exhibit extreme sensitivity to disturbance, poor recovery potential, very high streambank erosion potential and typically produce a very high sediment supply.

The continued failure of the rip rap on the left stream bank on the upstream approach to Spruceton Road Bridge #3201250 poses a threat to the crossing. Modifications to this revetment should include stabilization of the toe of the bank, to a depth greater than anticipated stream bed scour depths. Vegetative applications on the face of the revetment and upper bank would increase the strength and longevity of these measures while enhancing the habitat function and aesthetic value of the treatment.

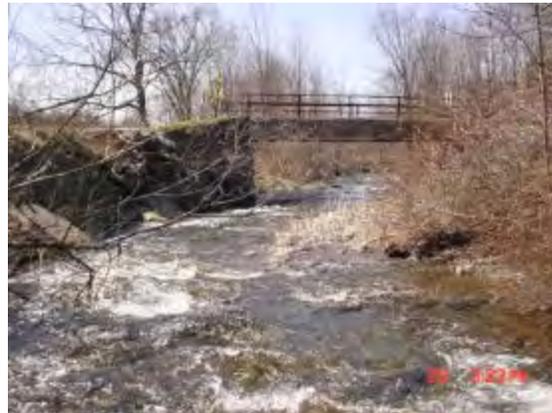
**Spruceton Road Bridge, #3201250.  
Note loss of floodplain connectivity  
due to entrenchment at bridge**

The poured concrete bridge abutments measure approximately 35 ft. from footer to footer. Bankfull channel width at the monumented cross-sections both up- and downstream is approximately 34 ft. While bankfull flows would appear to pass without

constriction at the bridge, backwatering of higher flows due to the disconnection of the floodplain may be contributing to the aggradational conditions documented upstream. The abutments and deck of this bridge have severely deteriorated. When bridge replacement is scheduled, consideration should be given to installing a geomorphically appropriate bridge span to improve sediment transport continuity. Additional *floodplain drainage*, using culverts set at the floodplain elevation under the south bridge approach, may also help mitigate this problem.
