# West Kill Management Unit 7

## Management Unit 7

Between 39851 and 36944

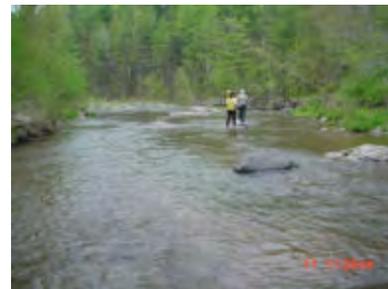
Aggradation, as documented here at the time of the stream feature inventory, is a typical response to marked reductions in channel slope. Over widening, accelerated bar development and historic channel migration in the reaches below the bridge suggest that this process is on going, and has been for some time.

**Aggradation downstream of bridge**

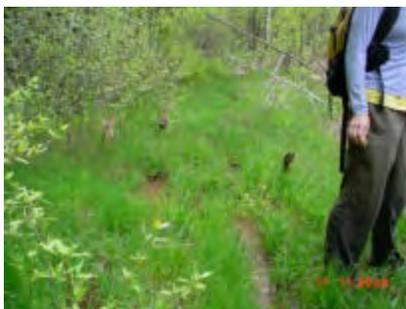
**Tributary, right**

As the channel bends to the left, a small unnamed tributary enters from the right. The tributary flows across a well vegetated low floodplain, before spilling over a small shelf at the confluence. Knotweed was noted on the right bank near the tributary confluence. During the 2004 inventory, one stand of Japanese knotweed (*Fallopia japonica*), an invasive, exotic shrub species that can grow rapidly to

crowd out more beneficial streamside vegetation, was observed here on the right bank. In the 2005 inventory, the number of stands throughout the management unit had increased to four. A program of eradication of Japanese knotweed throughout the West Kill valley is recommended.

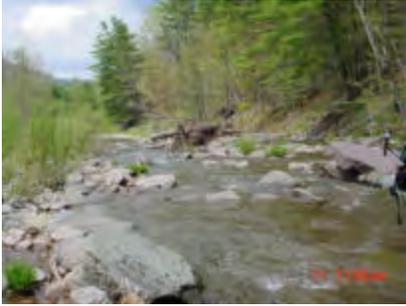
**Debris jam**

A center bar begins near station 39300. A large debris jam is accumulating at the head of the center bar, promoting continued development of the center bar. The debris causes an obstruction only at high flow, while the low flow channels, at both the left and right, remain clear.

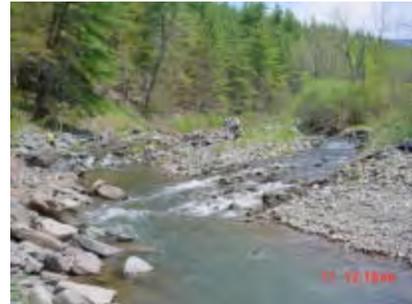
**Headcut at convergence, looking upstream**

The left and right channel threads converge at the tail of the center bar near station 39000 (Inset H, Fig. 4.7.2). A headcut is evident near the convergence of the two channel threads, with several exposures of clay in the reaches immediately downstream of the headcut.

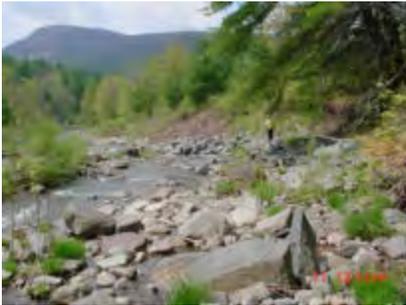
**Rip rap**

Rip-rap toe protection has been installed in the lower third of the bend to the left. The rip-rap protects the toe of a previously eroded bank. The condition of the rip-rap is poor and continues to decline toward the downstream end of the installation.

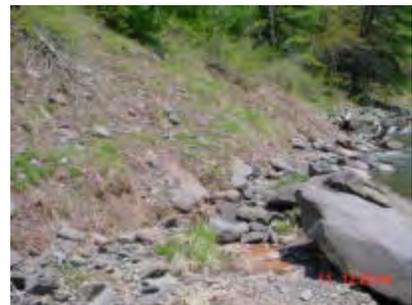
Toe scour prevails at the downstream end of the rip-rap, resulting in significant bank erosion (Inset D, Fig. 4.7.2). This site is documented as a Bank Erosion Monitoring Site (BEMS 07-38945). In a prioritization of twenty-one BEMS sites throughout the West Kill watershed (see Section 3.3, Watershed Inventory and Assessment), this site ranked Medium

**Bank Erosion, looking upstream**

Priority. The *thalweg*, or deepest part of the stream channel flows up against portions of the hillslope here. The *glacial till* soils have a high silt and clay content, yielding a significant suspended sediment load during high flows. Clay inputs into a stream are a serious water quality concern because they increase *turbidity*, degrade fish habitat, and can act as a carrier for other pollutants and pathogens.

Full restoration is recommended for this site. This would likely involve establishment of a well-vegetated bench on the right with rock vanes to direct stream flows away from the right bank, and revegetation of the bank face. In-depth survey and design would be required to plan a stream restoration project at this site.

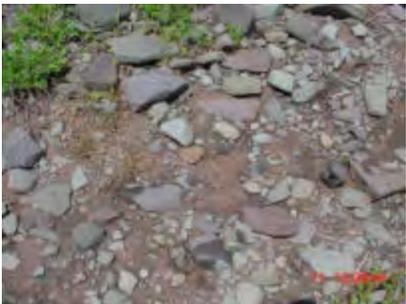
**Clay Exposure**

The photo above depicts the nature of the glacial till found in the eroded bank, and several other nearby clay exposures in both the bed and banks of this reach.

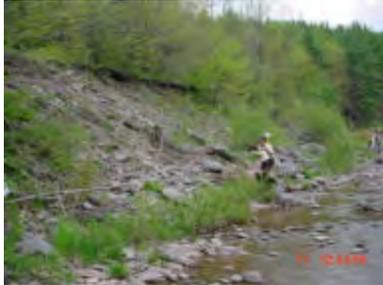
**Bank erosion, looking upstream**

As Greene County Rte. 6 again begins to encroach on the stream corridor, and channel confinement increases, bank erosion is evident on the right bank (Inset C, Fig. 4.7.2). A small lateral bar at the toe of the erosion has begun to vegetate, improving the recovery potential of this bank exposure. This site was not documented as a Bank Erosion Monitoring Site.

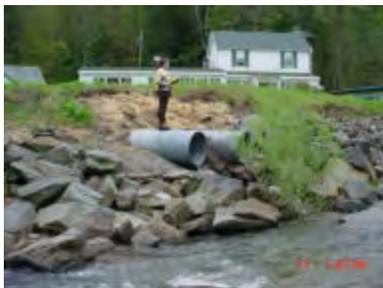
**Double culvert**

older and appear to be made of material drawn from the stream channel. A gravel bar colonized by willows has formed at the toe of the older portion of the rip-rap. The newer section of the installation at the downstream end is made of angular quarry stone, and has no vegetation at its toe. Interplanting of this rip-rap installation is recommended to improve the longevity of the treatment while also enhancing the riparian buffer. Near the mid-point of the rip-rap, two 36 inch culvert pipes emerge from the left bank, conveying an unnamed tributary and road drainage under County Route 6 (Inset G, Fig. 4.7.2). The culverts are somewhat perched, but have adequate outfall protection.

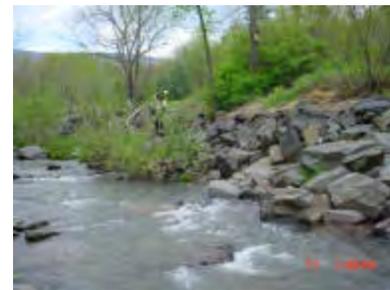
**Rip Rap, looking upstream**

Interplanting of this rip-rap installation is recommended to improve the longevity of the treatment while also enhancing the riparian buffer. Near the mid-point of the rip-rap, two 36 inch culvert pipes emerge from the left bank, conveying an unnamed tributary and road drainage under County Route 6 (Inset G, Fig. 4.7.2). The culverts are somewhat perched, but have adequate outfall protection.

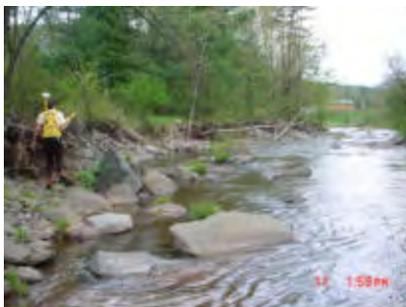
**Bank Erosion**

As the channel begins to depart from County Route 6, at the downstream end of the rip-rap, 234 ft. of bank erosion is documented. Aggradation in this reach has formed a transverse bar, resulting in erosive cross currents, exacerbating the erosion problem at this low terrace. This site is documented as

a Bank Erosion Monitoring Site (BEMS 07-38013). In a prioritization of twenty-one BEMS sites throughout the West Kill watershed (see Section 3.3, Watershed

Inventory and Assessment), this site ranked Low Priority. Continued monitoring of this site is recommended.

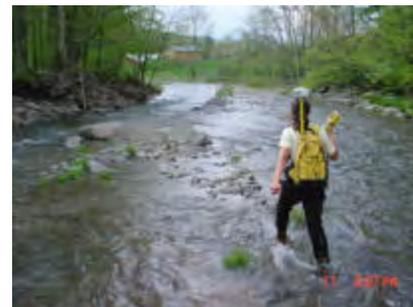
**Aggradation**

Increased bed elevations have been the result of aggradation in this reach, and the channel is now more connected to its floodplain than it was in the reach immediately upstream. Evaluation of LIDAR data, made available through a NYSDEC flood study, reveals a 700 ft. reach of C3 stream type.

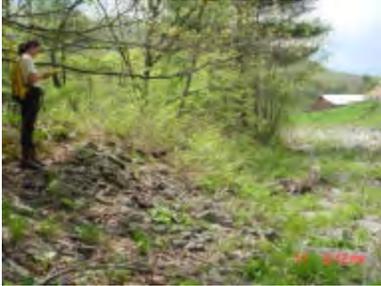
**Berm**

A fairly old berm, made of side cast stream material, begins just down stream of the erosion, on the left. It confines the channel for approximately 444 ft., preventing flood water from accessing the terrace floodplain beyond the berm.

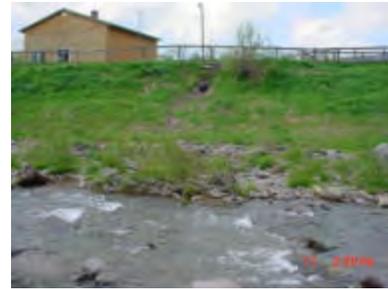
documented on the right bank. The culvert outfall is perched on the hillslope, and flows down onto a bankfull bench. Though the outfall of this culvert is not badly eroded, rock outfall protection is recommended in order to preserve the stability of the bank.

**Culvert**

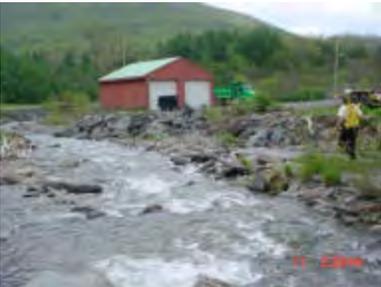
Approximately 100 ft. downstream of the culvert, rip-rap has been installed on the right bank (Inset B, Fig. 4.7.2). The rip-rap protects a garage located immediately at the top of the bank. The garage and its contents are threatened by both erosion and inundation in the event of a large flood event.

**Rip Rap, right**

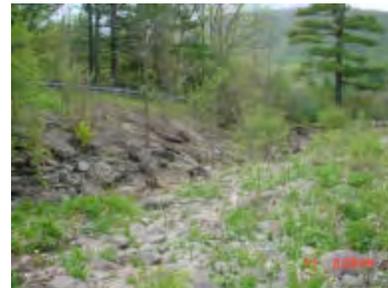
As the berm on the left ends, and County Route 6 draws close to the channel near Aufarth Road, rip-rap is found on the left bank at the back of a large cobble bar. This old rip-rap once protected County Route 6 when the West Kill was located in a now relic channel at the toe of the rip-rap.

**Rip Rap, left**

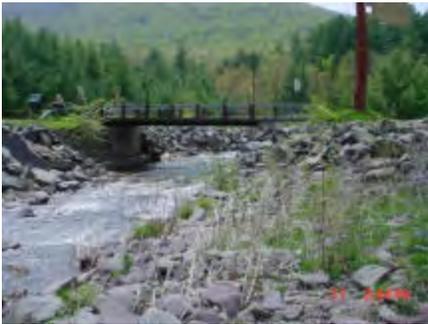
The Greene County Route 6 embankment, on the left of this confined approach, is protected by large angular rip-rap. The rip-rap continues downstream of the bridge, extending into Management Unit 8, and is in good condition. Gravel deposits upstream of bridges are commonly caused by inadequate sizing of the bridge opening. An undersized bridge opening causes water to back up upstream of the bridge, reducing stream velocity, which results in sediment deposition. In high stage, the floodwater may seek conveyance through alternative paths, forming new channels around the bridge constriction, as appears to have happened at this site. Additional *floodplain drainage*, using culverts set at the floodplain elevation under the north bridge approach, may help mitigate this problem. Even bankfull flows appear to be constricted by this bridge, and higher flows likely backwater, resulting in the upstream aggradation.

**Aufarth Road Bridge**

Recommendations in this area include interplanting of the rip-rap, enhancement of the riparian buffer on both the left and right floodplains, and hydraulic analysis of the bridge at Aufarth Road to determine its capacity to convey flood flows.
