West Kill Management Unit 11

Stream Feature Statistics

Management Unit 11
Between Station 30263 and Station 26957

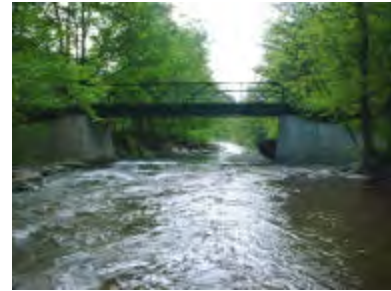
The bridge at RCH Stables marks the upstream limit of Management Unit #11. The channel invert through the bridge is controlled by bedrock spanning the entire bed from abutment to abutment.

Bridge at RCH Stable

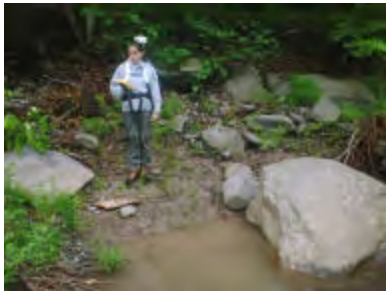
Clay exposure, right

Six significant clay exposures (Inset G, Fig. 4.11.2) were identified during the 2004 walkover in the reach between Station 30250 and Station 29900. The exposed lacustrine clay deposits

were discovered on both the left and right banks and in the bed throughout the reach. The *exposed lacustrine* deposits have a high silt and clay content, contributing sediment through both *wet and dry ravel* and yielding a significant suspended sediment load during high flows. Clay inputs into a stream are a serious water quality concern because they increase *turbidity*, degrade fish habitat, and can act as a carrier for other pollutants and pathogens.

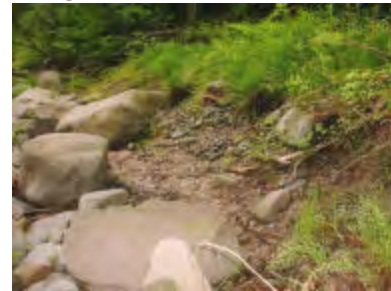
Clay exposure, right

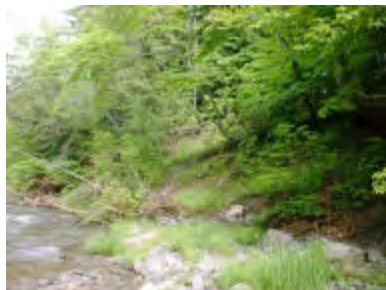
Bank Failure, right

A deep rotational failure is active on the right bank immediately downstream of the bridge. Lacustrine clay deposits are exposed at the toe along the entire 260 ft. length of the failure. Although Greene County Route 6 lies approximately 150 ft. from the toe of the failure, stress cracks are evident in the pavement, the result of mass wasting of the hillside. This failure poses an imminent threat

to the stability of the sole egress from the upper valley. Failure of the bank and roadway would prevent emergency services from accessing a significant number

of homes in the upper valley. This erosion has been monumented as a Bank Erosion Monitoring Site (BEMS Station 11-30028). In a prioritization of twenty-one BEMS sites throughout the West Kill watershed (see Section 3.3, Watershed Inventory and Assessment), this site ranked Medium Priority. Geotechnical evaluation of this failure is recommended before any treatments are attempted in this area.

There is one Bank Erosion Monitoring sites in MU11 (BEMS 11-30028). A geotechnical assessment of this site is recommended to evaluate the extent and magnitude of the failure.

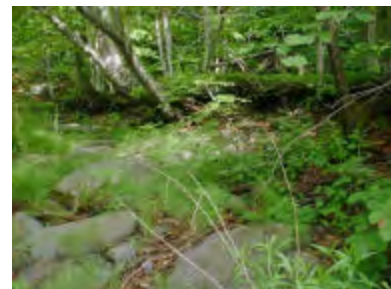
Bank Failure, right

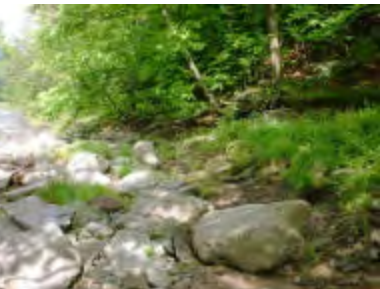
Bank Failure, right

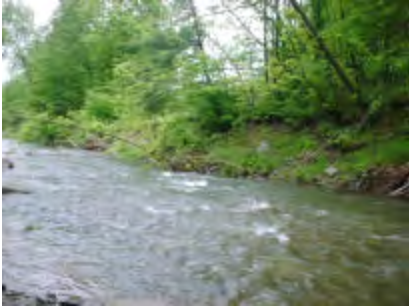
Bank erosion, right

Bank erosion continues on the right for another 164 ft. However, the erosion becomes far less rotational and more surficial.

Debris introduction is a problem along both of these eroded banks. Mature trees are slumping from the

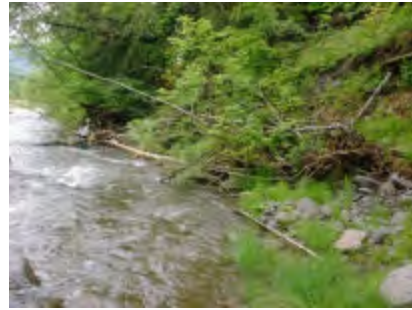
bank, and several have become entangled in debris jams (Inset F, Fig. 4.11.2) located on the right bank, at the downstream end of the both the first and second erosion locations. The debris is aligned parallel to the bank, providing some measure of toe protection and creating only a minimal flow obstruction.

Debris jam, right

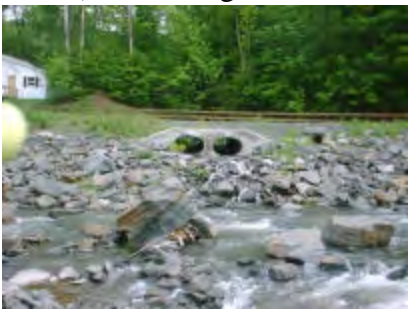
Schoolhouse Brook, right

The brook flows under Greene County Route 6 through a concrete twin-elliptical culvert structure before outfalling onto the heavily armored road embankment. A smaller culvert (Inset B, Fig. 4.11.2) just upstream of the concrete culvert conveys roadside drainage to the West Kill under Greene County Route 6.

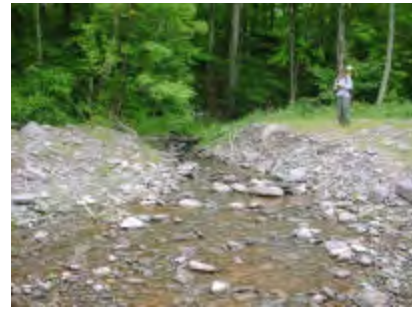
Tributary, right

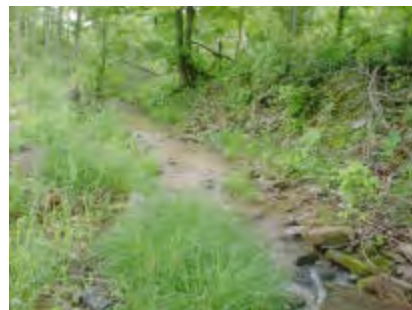
A third tributary (Station 27860) joins the West Kill, in the project reach, from the left. The mouth of the tributary is perched but well vegetated. Flow from the tributary is notably turbid even at low flow. Investigation of the source of turbidity is recommended here.

Tributary, left

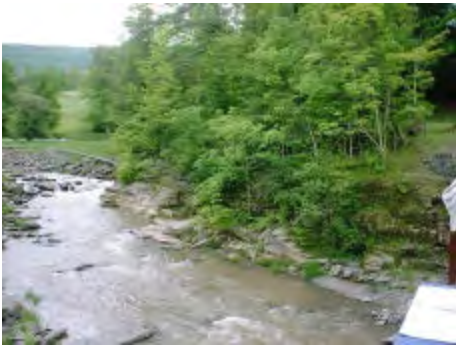
Bedrock, left

Bedrock controls 55 ft. of the left bank and portions of the bed near Station 27100. The left abutment of the Shoemaker Road Bridge is poured on this bedrock.

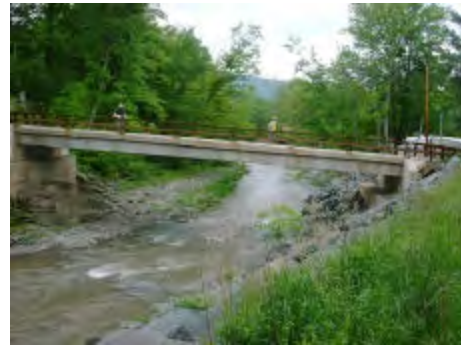
**Shoemaker Road bridge,
looking downstream**

Shoemaker Road bridge (Insets A and E, Fig. 4.11.2), replaced following the 1996 flood, marks the downstream limit of Management Unit #11 (MU11). The left abutment is poured on bedrock, and the right is armored with heavy rip-rap. No scour is evident at either of the abutments.

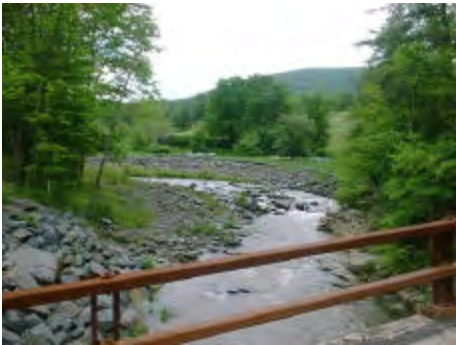
**Shoemaker Road bridge,
looking upstream**
