West Kill Management Unit 15

Stream Feature Statistics

Management Unit 15
Between Station 18646 and Station 16010

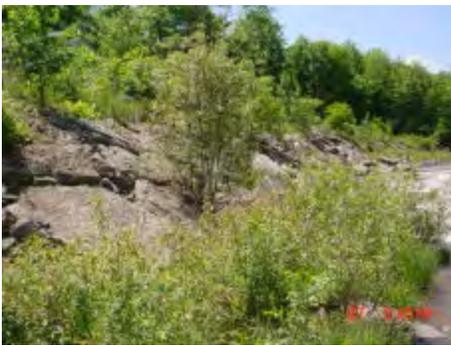
Riprap, left

As Management Unit 15 begins, 214 ft. rip-rap is found on the left bank behind residential structures. The rip-rap continues from Management Unit 14. The riparian buffer beyond the rip rap installation is in poor condition, with mown grass to the edge of the bank. The risk to bank stability can be minimized by maintaining mature trees along the stream margin, including a critical buffer zone extending approximately 75 ft. from the centerline of the stream (Fig. 4.15.4). The risks and benefits associated with management of streamside

vegetation will depend partly on the current channel conditions, and local channel surveys are recommended at each site. Recommendations for this area include interplanting of the rip rap, and enhancement of the riparian buffer with planting of ecologically appropriate tree and shrub species in the adjacent mown lawn.

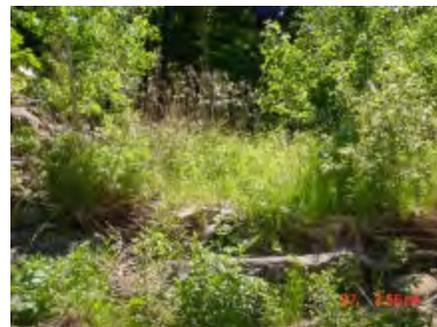
Tributary, left

A tributary channel is evident on the left bank immediately downstream of the rip-rap. The channel is quite large, but conveyed no flow on the day it was observed. The channel appears oversized for its catchment, and may convey West Kill flood water known to flank the Greene County Route 6 bridge at the head of Management unit 14 during extreme flows. The mouth of the tributary is perched and scour at the outfall is evident.

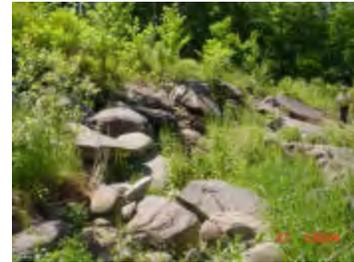
Rip-rap, left

Fifty-one feet of rip-rap are found on the left bank behind the West Kill Community Center. The installation has ample young vegetation growing through it and on the terrace beyond the rip-rap. A bench in front of the rip-rap is composed of glacial till, indicating that it is a glacial deposit exposed by bed degradation rather than an alluvial deposit formed by the stream. Recommendations for this site are to allow the existing vegetation to continue growing to maturity.

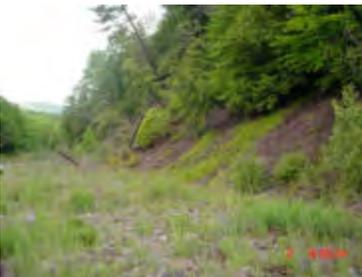
Bank erosion, right

A large bank failure (see Inset D, Fig. 4.15.2) at the right has a large bar formed at its toe. The 482 ft. long failure appears active, with large debris sliding down its face, forming two debris jams at the toe. The first jam is set back on a bar, clear of low flow, but the second spans the low flow channel and causes a significant obstruction at higher flows. The bank is composed of clay rich till, posing a threat to water quality. The recovery potential of this failure is high due to the bar formation at the toe, reducing toe scour and

enhancing the overall stability of the bank. This failure was not monumented as a Bank Erosion Monitoring Site, but monitoring of this failure is recommended.

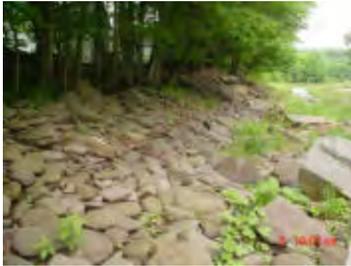
Side castings, left

Evidence of side casting (see Inset G, Fig. 4.15.2) is observed along 338 ft. of the left bank. This is a likely relic of gravel removal in this aggradational setting.

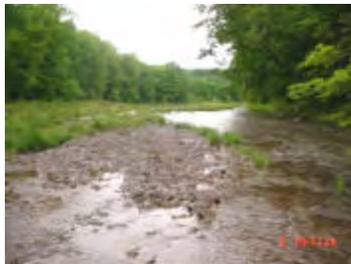
Aggradation becomes apparent near Station 17900, and is the prevailing stream process through the remainder of Management Unit 15. The channel becomes increasingly connected with the flood plain to the left of the channel as the stream flows behind the hamlet.

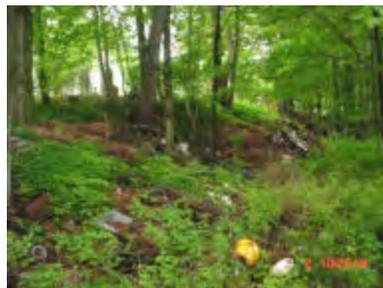
Dump Site

A dumpsite is discovered on the terrace behind the flash boards. The dump site appears to still be active, with old

and new metal, garbage and appliances. The dump site lies in one of the six wetlands within this management unit mapped in the National Wetland Inventory. Appliances, trash and other refuse often contain metals, lubricants and various chemicals that can be detrimental to water quality. The dumpsite also degrades the aesthetic quality of this reach. Removal of the trash and appliances is recommended in order to protect water quality and limit further soil contamination.

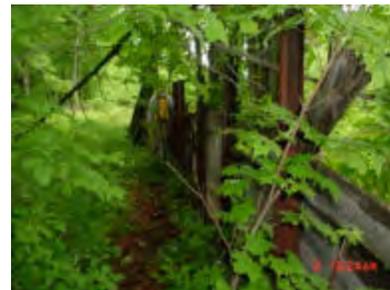
Flash Boards, left

Remnants of a flash board installation are found on the left terrace. The flash boards, intended to reduce flooding in the hamlet, are rotted or missing. The flood reduction measures are in poor condition, and are no longer effective.

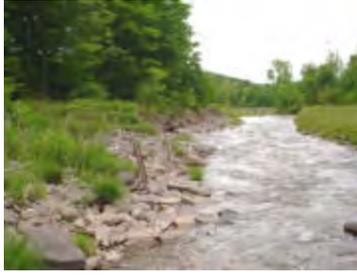
Flash boards, left

More remnants of flash boards are found along 70 ft. of the left bank near Station 17350. Only the steel railroad track uprights remain bent over to the bed of the stream.

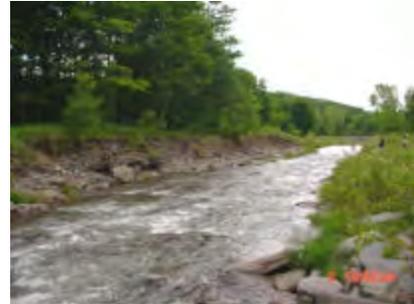
Bank erosion, left

has natural rocky toe protection, but is inadequate to prevent the aggradation-triggered erosion.

Bank erosion (Inset C, Fig. 4.15.2) is active along 231 ft. of the left bank, beginning near Station 17250. The bank

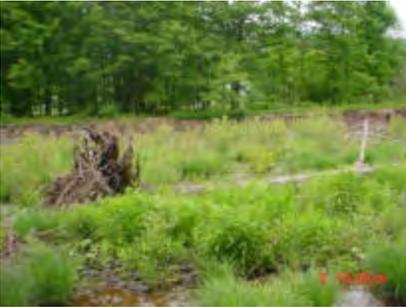
Debris Jam, right

The bar opposite the erosion has accumulated several separate pieces of large woody debris.

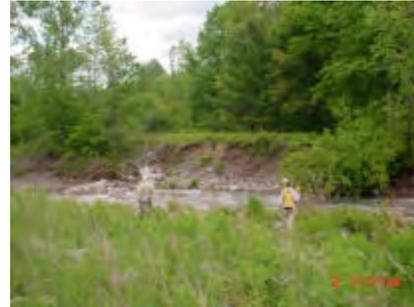
Bank Erosion, right

Erosion is evident along 98 ft. of the right bank near Station 16750. The erosion has undermined trees that may become entrained in future flow events.

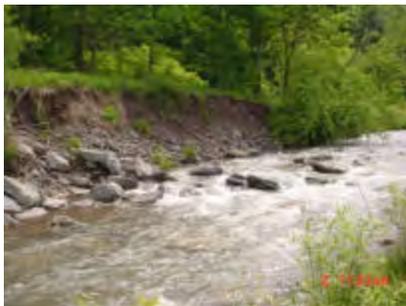
Grade control

The bank appears to have formerly been rip-rapped, as large angular rock lies in the stream bed along the erosion. The rock seems to have been pulled from the bank that it once armored. The rock does provide some measure of grade control (Inset B, Fig. 4.15.2) to the channel.

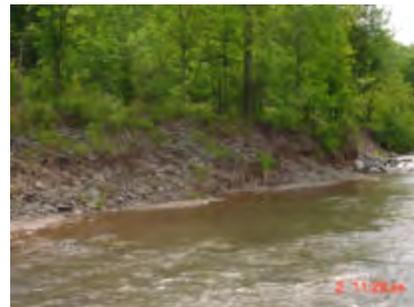
Bank Erosion, looking upstream

On the right, bank erosion continues for another 76 ft. downstream of the rock grade control. This erosion is less severe than the erosion upstream of the grade control, and has fair recovery potential. Neither of these two erosion sites were monumented as Bank Erosion Monitoring Sites.

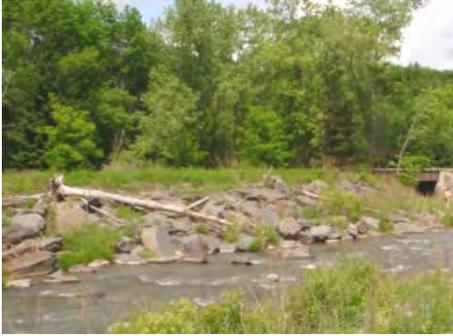
Rip-rap, debris jam, left

A large debris jam is found at the upstream end of a 146 ft. long rip-rap installation on the left bank approaching the NYS Route 42 bridge. The debris forms a modest obstruction at high flows. The rip-rap appears new, and is in good condition.

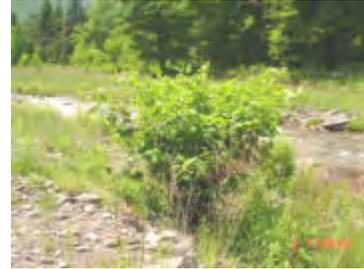
Three small, isolated Knotweed stands are noted along rip-rap on the right bank between Stations 16400 and 16250.

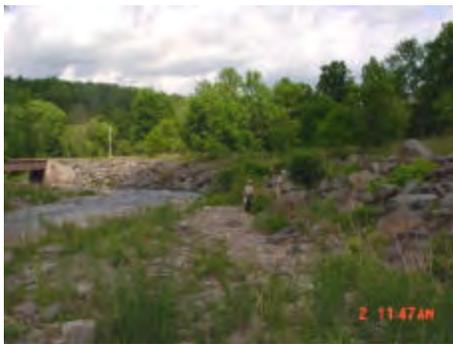
Rip Rap, right

Rip-rap begins on the right bank near Station 16400, and extends 484 ft. The rip-rap armors the approach to the NYS Route 42 bridge, and continues into Management Unit 16. The rip-rap is fairly new and in good condition. The riparian buffer beyond the rip rap installation is in poor condition, with grass to the edge of the bank. Recommendations for this area include interplanting of the rip rap, and enhancement of the riparian buffer with planting of ecologically appropriate tree and shrub species in the adjacent grassed area.

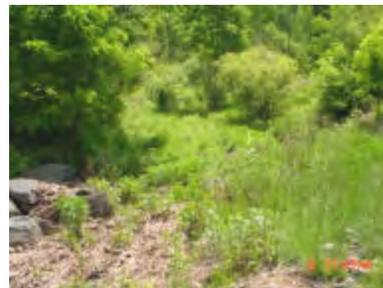
Tributary, right

An unnamed tributary joins the West Kill near the upstream end of the rip-rap. The tributary drains a 0.5 mi² catchment, and is well vegetated and connected at its mouth.

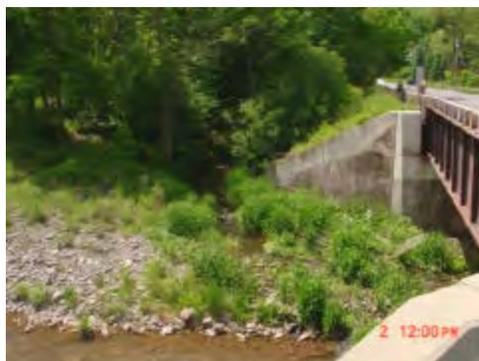
Tributary, left

Another significant, but unnamed tributary, draining 1.6 mi², joins the West Kill from the left just upstream of the NYS Route 42 bridge. The tributary confluence is well connected with abundant vegetation. The reaches of this tributary between its mouth and its conveyance under Greene County Route 6 have recently been dredged to improve road drainage.

Recommendations for this tributary include investigation of the feasibility of conveying stormwater runoff from NYS Route 42 and Greene County Route 6 in a dedicated drainage swale, to mitigate water quality impacts to the tributary.

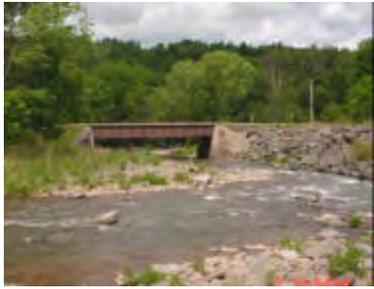
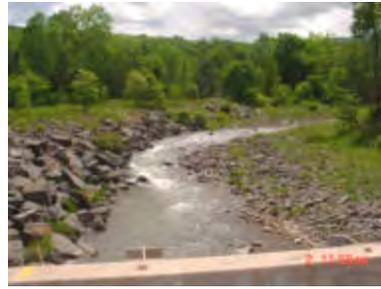
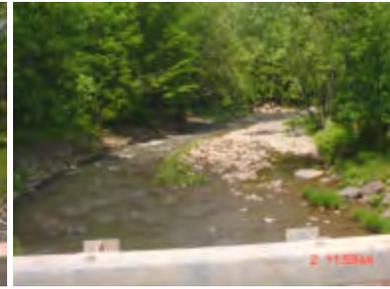
NYS Route 42 bridge marks the downstream limit of Management Unit 15. The alignment of this bridge is poor, creating a sharp bend to the left as the channel approaches the bridge opening. The sharp bend in combination with poor floodplain drainage through the NYS route 42 road fill results in backwater and aggradation upstream. Recommendations at this site include modification of the stream approach to the bridge, and installation of flood plain drains under NYS Route 42.
