West Kill Management Unit 17

Stream Feature Statistics

Management Unit 17
Between Station 14742 and Station 9304

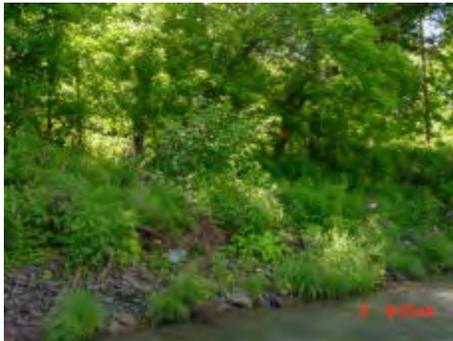
Knotweed, right, looking upstream

A small isolated stand of Japanese knotweed was observed on the right bank. A few similar stands are located elsewhere in the area. During the 2004 inventory, 12 stands of Japanese knotweed (*Fallopia japonica*), an invasive, exotic shrub species that can grow rapidly to crowd out more appropriate streamside vegetation, were observed throughout management unit 17. In the 2005 inventory, the number had increased to 31. A program for eradication of Japanese knotweed throughout the West Kill valley is recommended.

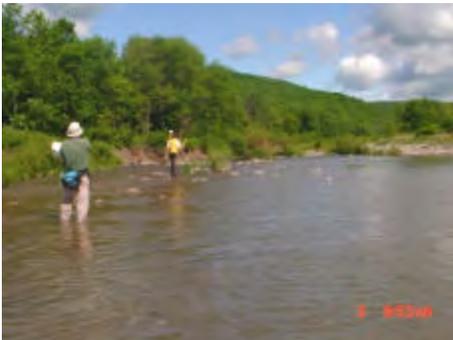
Aggradation

Continuing downstream, alternating reaches of aggradation and headcutting are observed, often promoting bank scour where the channel approaches the alluvial terrace on either side.

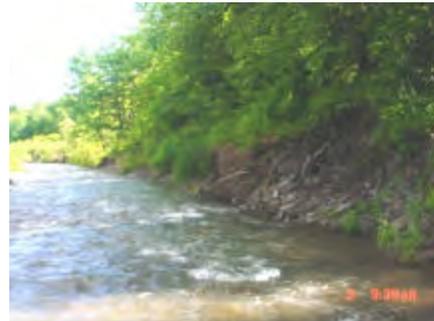
Bank Erosion

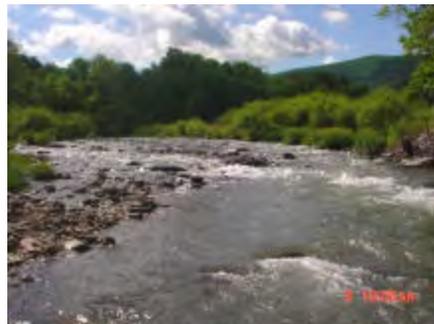
Headcut

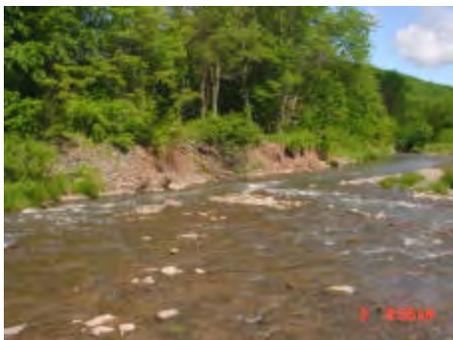
Bank erosion, left

Transverse flow across the headcut results in toe scour and 124 ft. of bank erosion on the left bank. Aggradation is again noted immediately downstream of the exposed bank (Inset H, Fig. 4.17.2).

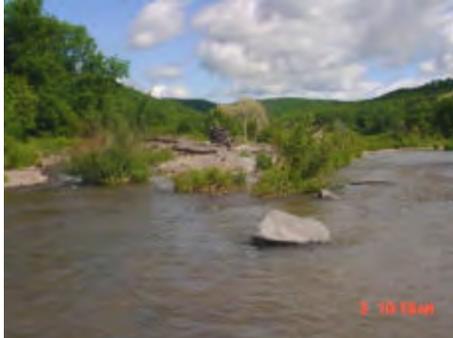
A debris jam has accumulated on a center bar at the channel divergence, presenting no obstruction at low flow, but a major obstruction at high flow. The jam is comprised of large woody material, not easily floatable.

Debris Jam

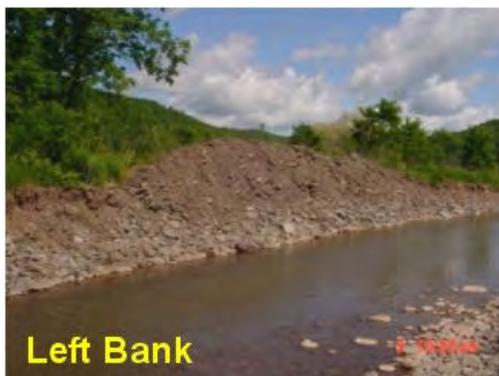
Downstream of the confluence, the low terrace banks on both sides of the channel are experiencing erosion (Inset G , Fig. 4.17.2). Erosion at the left is scouring the toe of a recently deposited spoil pile. Erosion at the right leaves vegetation from a more mature riparian buffer over-hanging the channel.

Left Bank
Bank erosion

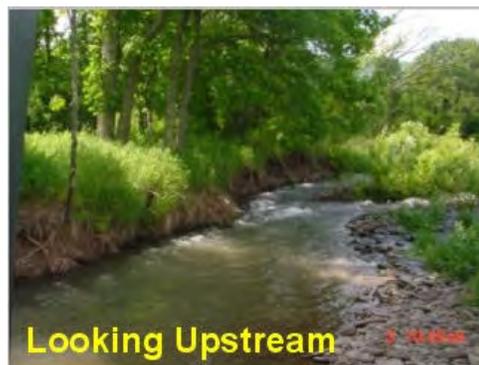
Looking Upstream
Bank erosion, right

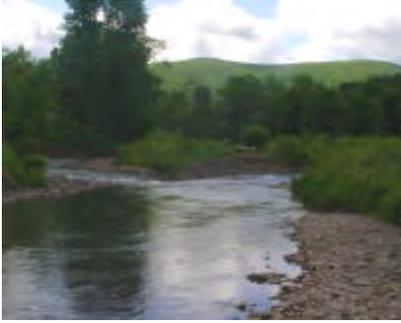
Knotweed on meander scroll

Knotweed occurrences are noted throughout this management unit.

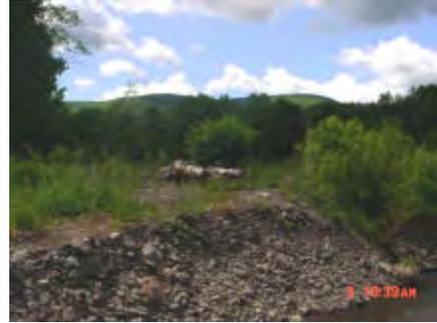
Knotweed on center bar

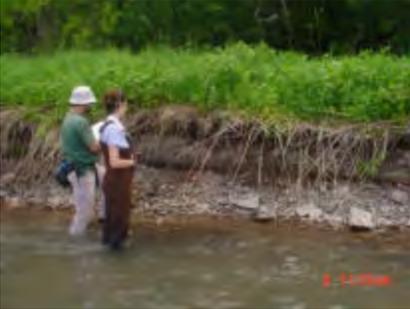
Bank erosion, right

Bank erosion is evident on the right bank downstream of a pool formed at the convergence of two channel threads (Inset C, Fig.4.17.2).

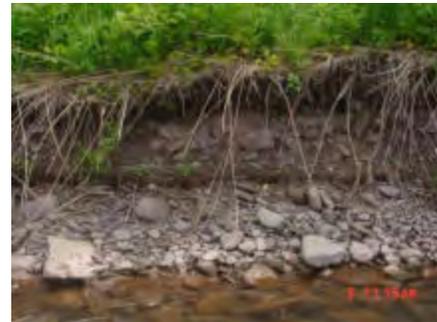
Cutting of the low terrace on the right reveals soil strata deposited under varying flow conditions. This bank has a relatively low sediment yield.

Soil stratification

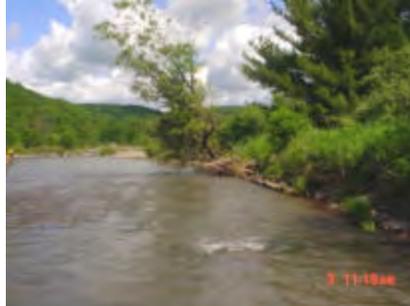
Debris jam

Downstream of the bank erosion, two debris jams are identified. The first is found at the downstream end of the erosion at the right bank, and provides some measure of bank protection, while creating only a minimal flow obstruction.

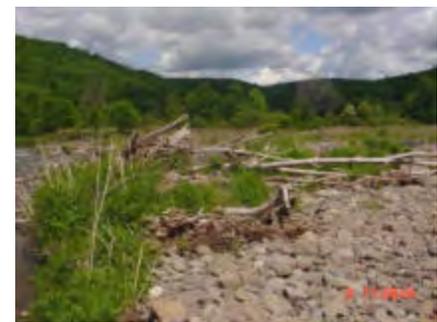
A second jam lies at the head of a center bar. Much of the debris is well anchored by deposited gravel.

Debris jam

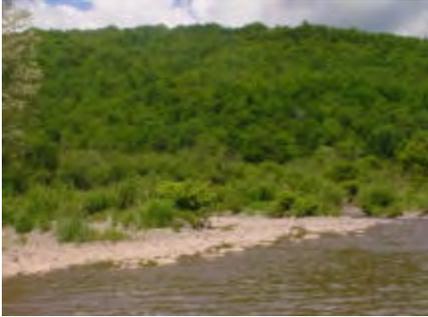
Knotweed

Several small stands of Knotweed are observed on the bars throughout this area.

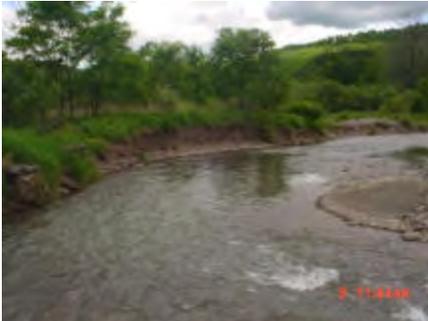
Bank erosion, left

As the channels converge at the tail of the center bar (Inset F, Fig. 4.17.2), 133 ft. of erosion is evident on the low terrace at the left.

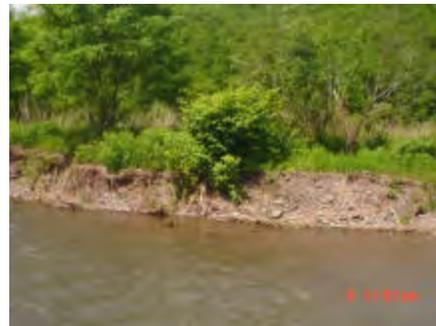
Knotweed

Knotweed was observed atop the eroded terrace. Channel shifting prevents colonization by anything other than herbaceous vegetation on the banks and floodplains of this unit. Knotweed is likely to out-compete more appropriate riparian species in these continuously disturbed conditions.

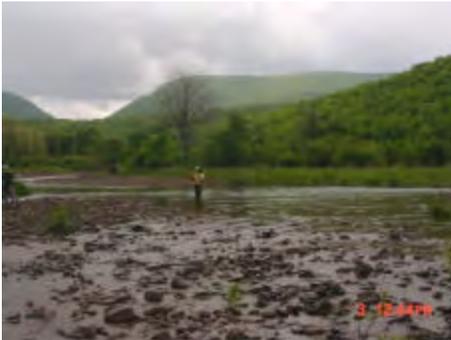
Severe aggradation

Throughout the unit, severe aggradation exacerbates bank erosion as seen here at the toe of a large rip-rap installation on the NYS Route 42 embankment (Inset B, Fig. 4.17.2).

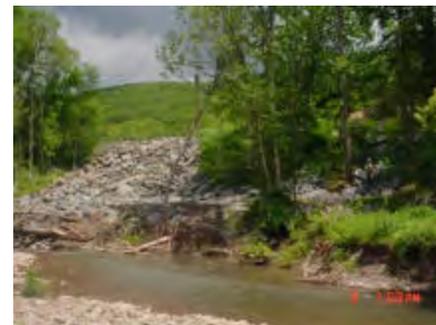
Bank erosion at toe of rip-rap

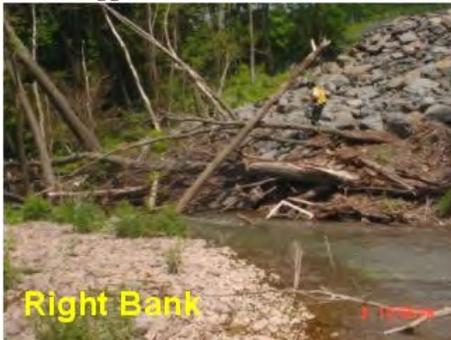
Debris jam

The erosion has further destabilized the mature riparian forest between the channel and the rip-rap, creating a large debris jam at the downstream end of the revetment. Erosion similar to that seen here threatens the embankment at various locations through the next 600 ft. downstream.

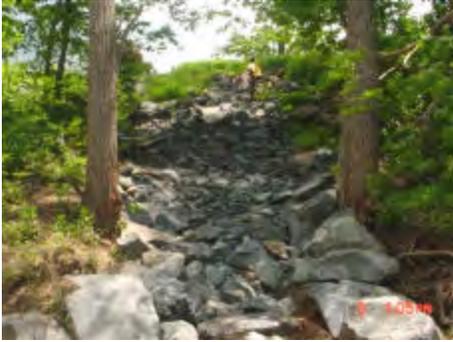
Culvert

A culvert carrying drainage away from NYS Route 42 outfalls from the right onto this steep embankment. Stormwater conveyed by this culvert is likely to saturate this slope, potentially destabilizing it further.

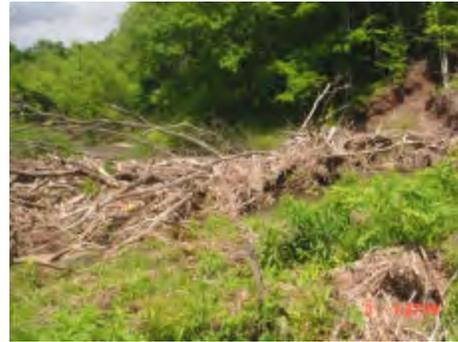
Debris jam

At some locations these accumulations of woody material exacerbate aggradation, resulting in headcuts and bank scour.

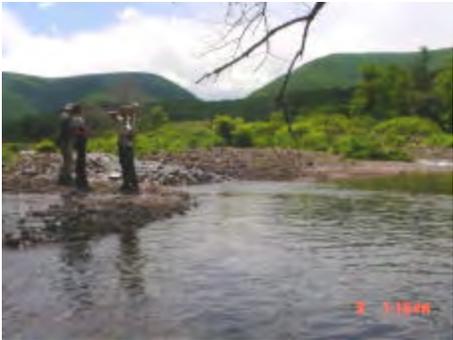
Headcut

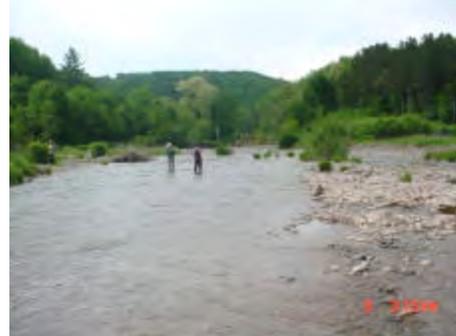
Aggradation

In the final reach of the unit, the valley pinch-point at Lady’s Bridge results in aggradation from backwatering upstream of the bridge. An undersized bridge opening can cause water to back up upstream of the bridge, reducing stream velocity, which results in sediment deposition. In high stage, the floodwater may seek conveyance through alternative paths, forming new channels around the bridge constriction.

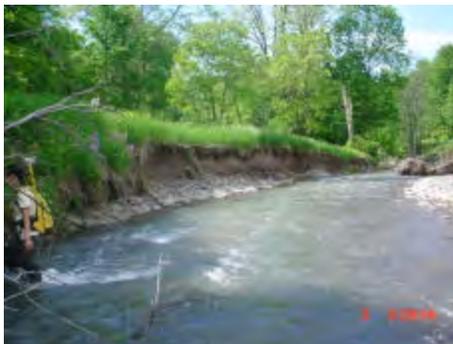
Bank erosion, left

The erosion observed here on the left bank is the start of a flanking process that may eventually threaten the stability of Lady’s Bridge. This site has been monumented as a Bank Erosion Monitoring Site (BEMS 17-09386). In a prioritization of twenty-one BEMS sites throughout the West Kill watershed (see Section 3.3, Watershed Inventory and Assessment), this site was ranked Low Priority. The *thalweg*, or deepest part of the stream channel flows up against the alluvial terrace here. The terrace is being undermined by toe erosion, leaving

vegetation overhanging the channel. Increasing valley confinement and healthy riparian buffer suggest a potential for self-recovery here. Continued monitoring is recommended at this site to determine the rate of bank retreat and degree of hazard posed to the bridge.
