PROJECT REPORT
Westkill Stream Restoration Demonstration Project

Greene County & Water Conservation District
December 2005

2005 Damage Repairs Post Construction Report

**Prepared By: Joel DuBois, CPESC
For: Greene County Soil & Water
Conservation District
October, 2005**

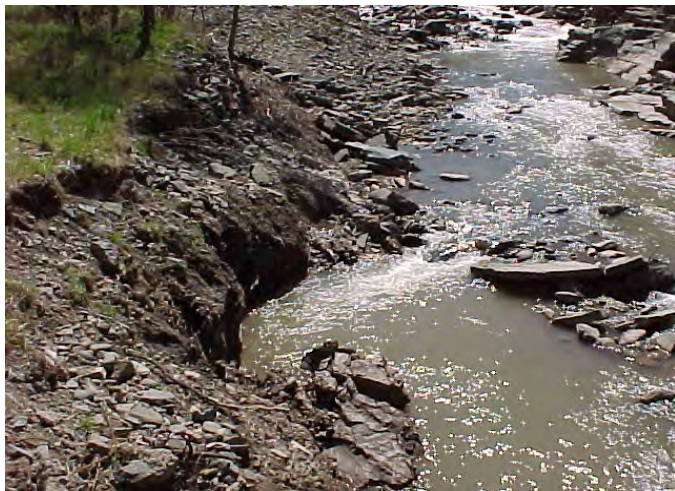
Figure 1: Extensive clay exposures due to channel down cutting presented a significant water quality impact, as well as extensive infrastructure damage.

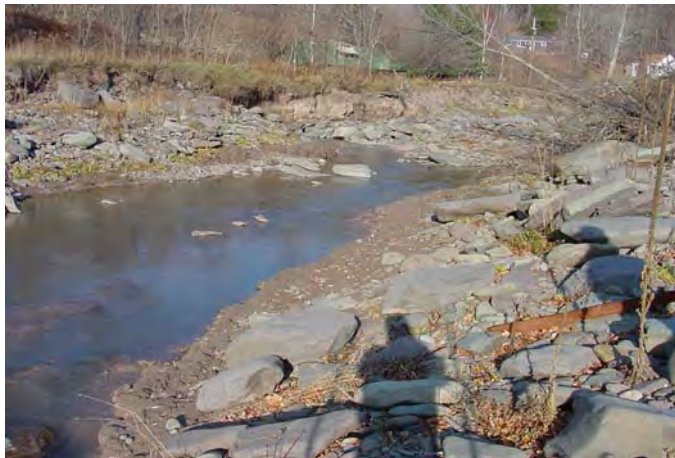
Figure 2: Coarse gravel/cobble materials seen on the right and left banks represent the channel invert elevation prior to downcutting. Note the clay present in the current channel bottom

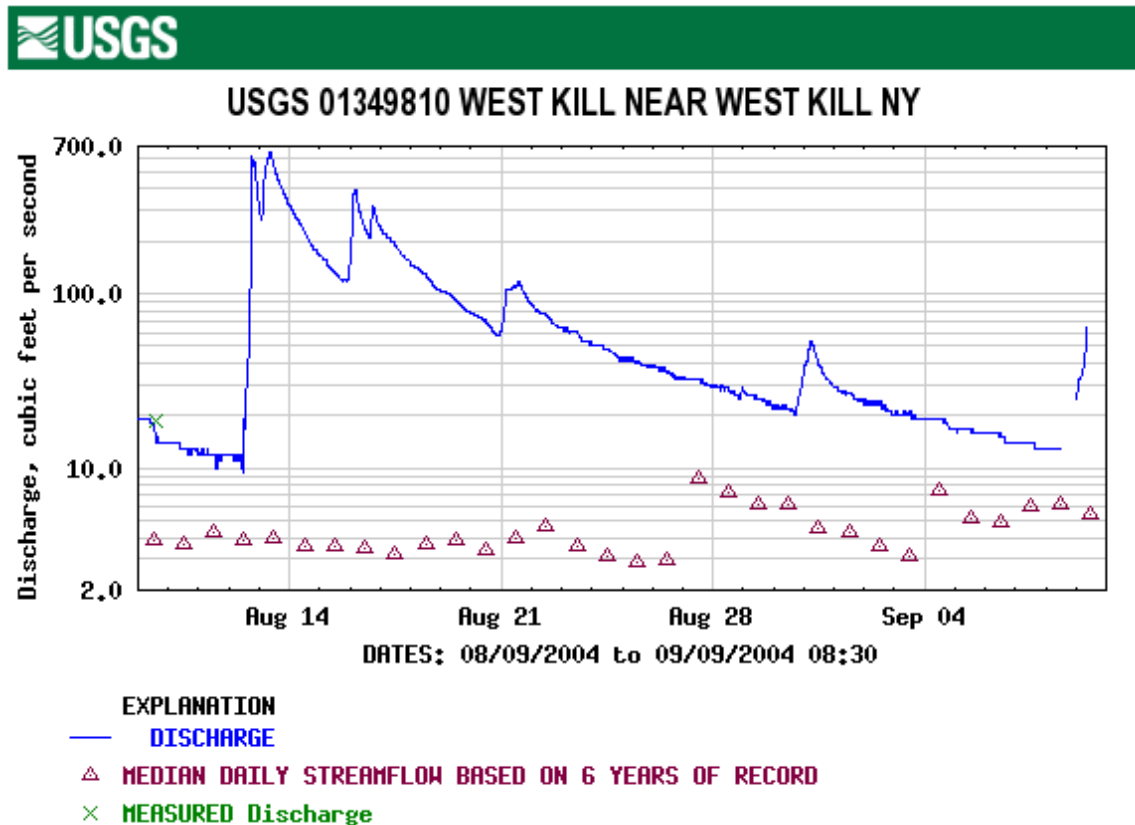
Similar problems were experienced during the summer of 2004, however approximately 75% of the project was completed. Figure 3 below shows a hydrograph for the West Kill that was typical of the 2003 and 2004 construction seasons. Please see Appendix D for a sample of the available documentation for the above average stream flow during the 2004 construction season. A late spring storm in 2005 caused excessive runoff and damaged a portion of the work completed during the 2004 construction season which added repair work on to the 2005 construction season's schedule. Please see Appendix E for a description of the repair work.

Figure 3: Hydrograph from lower West Kill stream shows the impact of repeated storm events in the watershed.

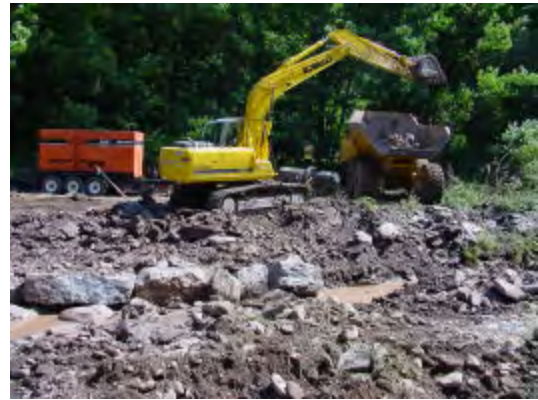
Figure 10: Excavating excess clay from the channel bottom

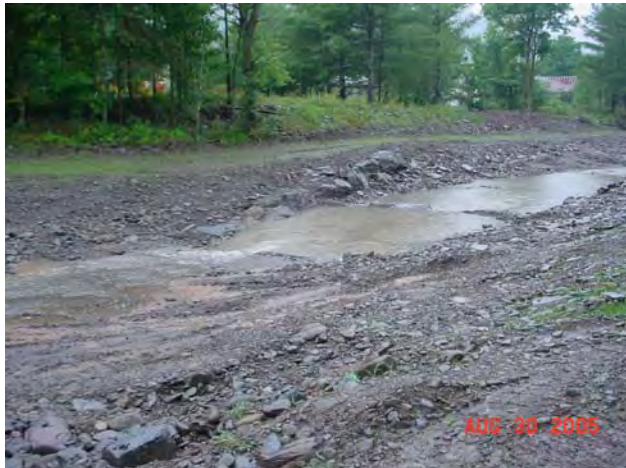
10+50 – 12+00

Aggradation in this reach resulted in lateral channel migration. Following reestablishment of the design channel grades in phase 1 of the repair work, an additional rock cross vane was installed at station 11+00. The structure is intended to promote stable sediment transport through the reach. The cross vane will also provide structural control of the channel plan, dimension and profile. Keyways were installed, as components of the vane installation, which reduce the risk of structure flanking on both the left bankfull bench and the right flood plain. The keyway at the right extended across the entire floodplain and tied into the toe of the low terrace. 2 additional rock sills were added to the structure at

approximately 1/3 and 3/4 of the way along the vane arms. The sill elevations were set in such a way that each sill was slightly lower in elevation than the sill immediately upstream of it. This resulted in a cascading step pool feature. The additional sills were intended to improve grade control while facilitating fish passage through the structure. The effectiveness of the

structure modification will be evaluated over time for its applicability on future projects.
