# Neversink River East Branch

## MANAGEMENT UNIT 10

### Summary of Post-Flood Recommendations

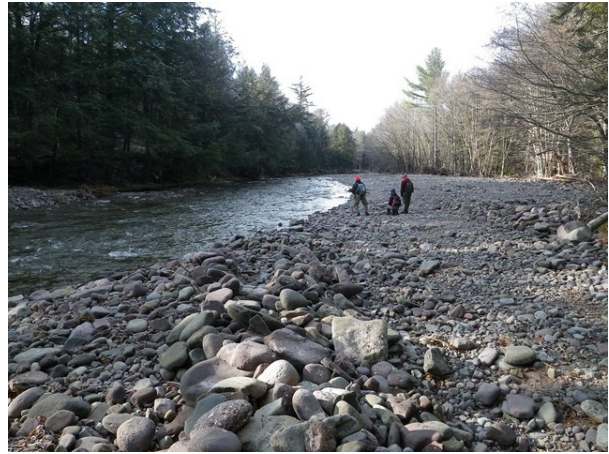
A berm begins along the right bank at Station 38800, ending nearly 400-feet downstream at Station 38440. At the time of the summer 2010 survey it was noted that the side cast stream materials in this berm, along with a shallow and overwidened channel in this reach suggest that the stream may have been cleared with a bulldozer at some point in the past. Consistent with past activities, this stream reach appears to have been excavated following the flooding associated with TS Irene. The resulting side bar and main channel are not

sized to transport sediment effectively, and the bar appears to block former floodplain channels, effectively disconnecting the stream from the floodplain in this stream reach. A *full restoration* effort in this stream reach to shape and align it to improve effectiveness of sediment transport described is described below.

*Stream channel reach that is overwidened and shallow due to post-flood restoration efforts. (IMG1572)*

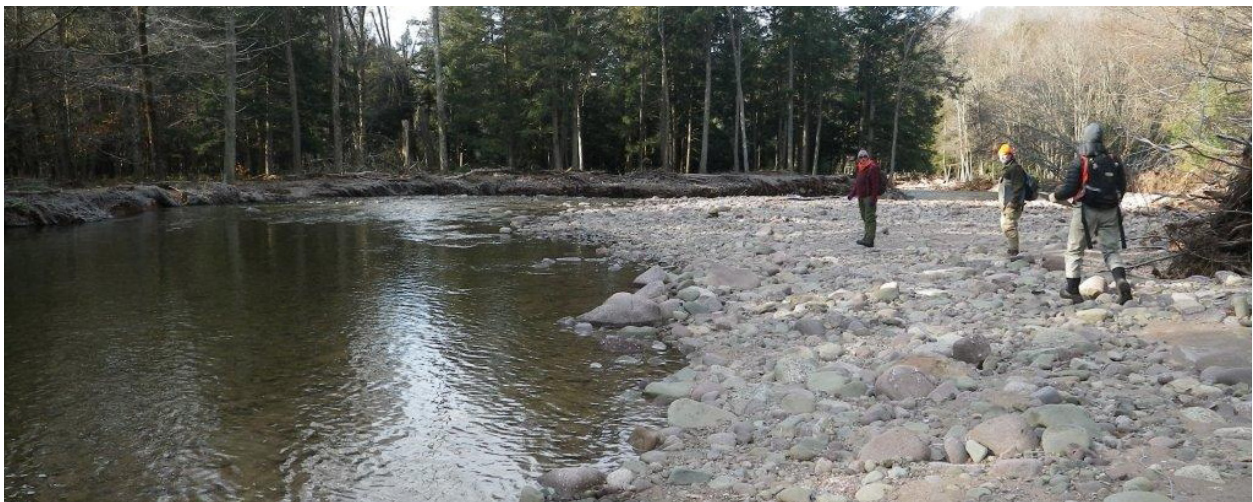
Continuing downstream, the stream begins to meander to the right exposing a long bank erosion section on the left bank beginning at Station 38380 and continuing approximately 450-feet to Station 37930 (BEMS NEB10\_37900). Since 2010 this bank has experienced continued hydraulic erosion which led to significant bank retreat. Most of the several large trees along this bank that were experiencing root scour in 2010 were carried downstream during recent high flow events.

A point bar consisting of cobble sized materials on the inside of the meander bend directly across from the bank erosion site documented in 2010 has since aggraded due to sediment deposition. It appears that in an effort to protect Denning Road from future flooding, large woody debris and root wads were collected from this stream reach and placed along the tree line behind this point bar.

*Point bar continues to form across from erosion area. (IMG1574)*

*Full restoration* is recommended for this site, including stabilization of the left bank using bioengineering techniques, establishment of a riparian buffer to slow near-bank velocities and reduce shear stresses on the bank during future high flow events, and re-alignment of the channel to establish a more sustainable radius of curvature for this stream reach.

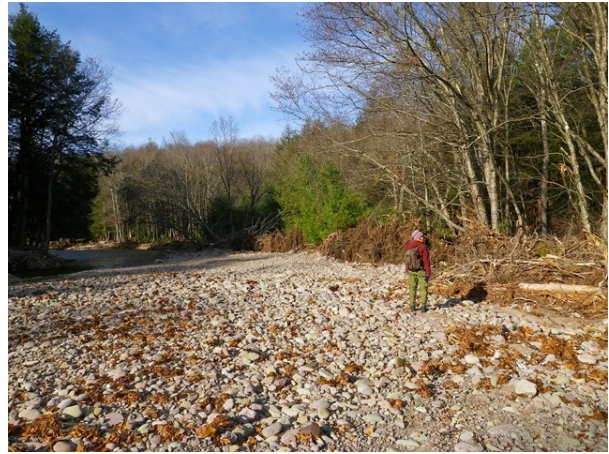
*Root wads and large woody debris placed along the tree line behind the cobble point bar. (IMGP1578)*

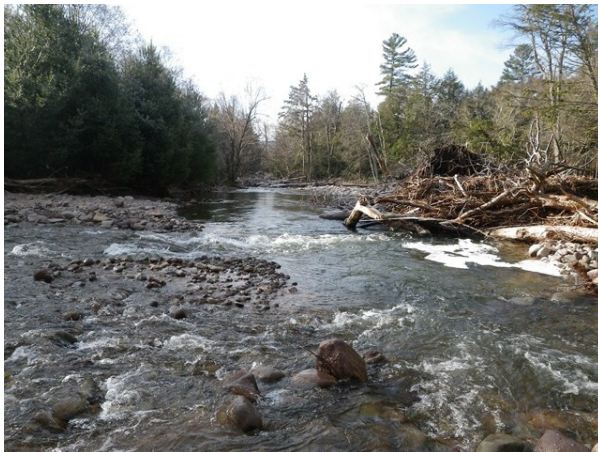
Approximately 100 feet downstream from the point bar, the stream takes a hard left turn and enters into a straight reach highlighted by excessive accumulation of large woody debris and channel instability. While the exact location of the woody debris jams and obstructions have shifted slightly, the river processes impacting this stream reach have remained the same since the summer of 2010. Debris accumulation has resulted in channel braiding along the well connected right and left floodplains. Continued channel instability is also evident in the formation of *headcuts* below obstructions. Scour is occurring directly downstream of the obstructions because the water faces an abrupt vertical drop as it flows over the debris. This continuous scour is resulting in headcuts which are actively migrating upstream, and will continue to do so until they meet a substrate that is not erodible.

*Headcut in stream reach characterized by woody obstructions. (IMGP1581)*

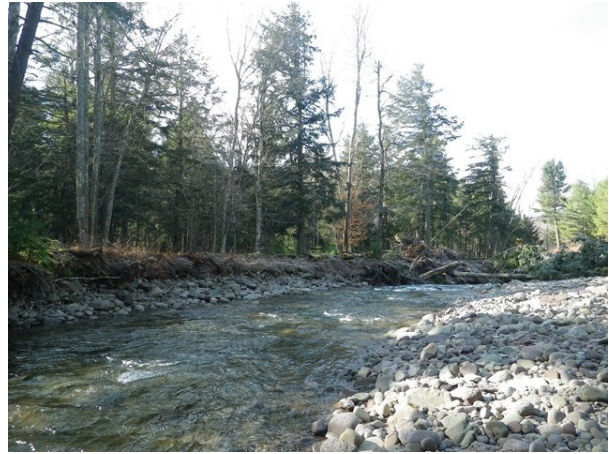
Erosion on the left bank begins at Station 36720 and continues until Station 36450 (BEMS NEB10\_36400). Hydraulic erosion has exposed cobble sized alluvial material at the toe of this bank. A large hemlock located at the downstream end

of a depositional point bar at Station 36500 is causing an obstruction to high flows, further contributing to deposition and exacerbating erosion of the left bank.

Large rocks are beginning to deposit at the toe of this eroding bank. However, due to the near vertical slope of the bank and the increased scour caused by the obstruction immediately downstream, this bank is still at risk for further erosion during high flow events. Therefore, *assisted restoration* is recommended for this site, including removal of the woody obstruction downstream and possibly bioengineering techniques to stabilize the bank.

*Eroding bank segment and woody debris obstruction. (IMGP1858)*

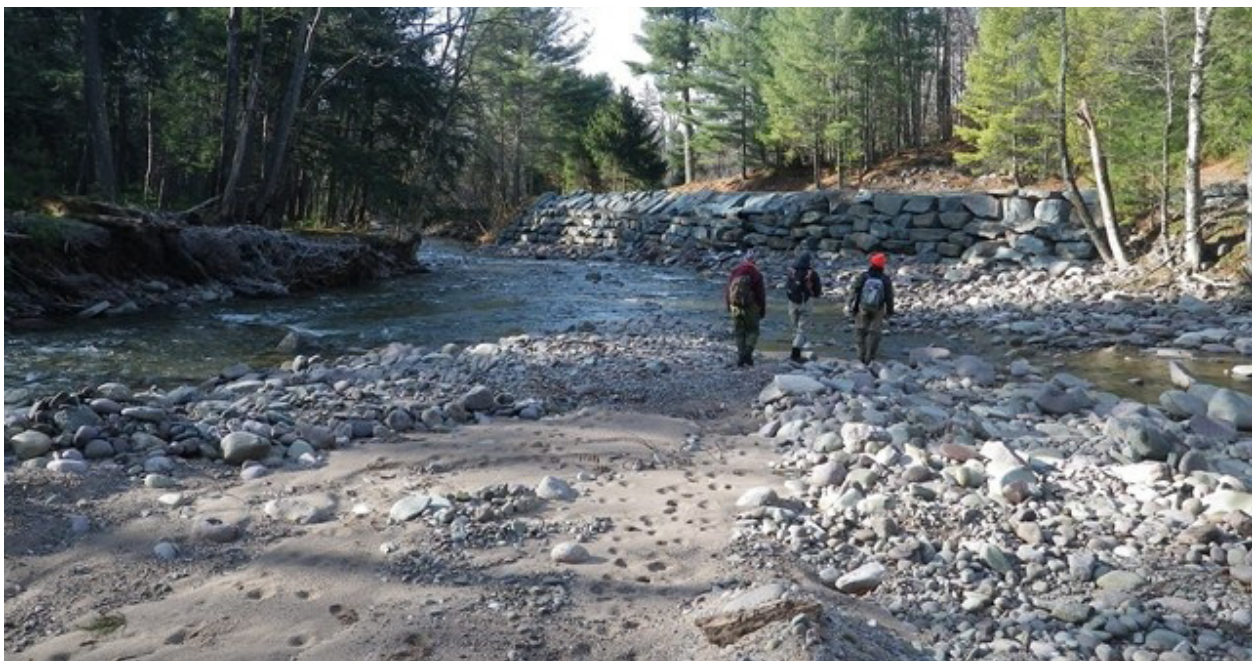
During the 2010 survey a stacked rock wall was documented between Station 36380 and Station 36300. The revetment was designed to provide bank stabilization and protection for this section of Denning Road. This revetment was repaired due to damage to Denning Road during the flooding associated with TS Irene. It was extended to 190 feet long with an average height of 12 feet. The top two courses of the revetment adjacent to Denning Road are now a sloped stone wall. The revetment was documented in good structural and functional condition. The culvert protruding through the revetment is still present, remaining a potential source for contaminants from road runoff.

*Stacked rock wall on right bank protecting Denning Road. (IMGP1586)*

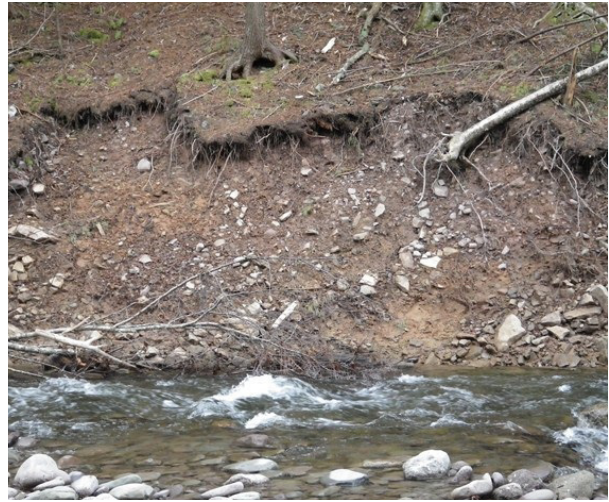
From Station 35600 through Station 35525 (BEMS NEB10\_35500) an eroding bank segment has resulted in exposure of the root structure of the mature vegetation across from a depositional bar. In December 2011 this eroding bank segment was also documented as a potential source of fine sediment from glacial till. It is still possible for this bank to stabilize without treatment (*passive restoration*). However, it is recommended that this site be monitored for changes in condition.

*Bank erosion site in need of continued monitoring.  
(IMG1598)*
