Neversink River East Branch

MANAGEMENT UNIT 12

E A S T B R A N C H M A N A G E M E N T U N I T 1 2
B E T W E E N S T A T I O N 4 3 6 5 0 A N D S T A T I O N 4 2 2 0 0

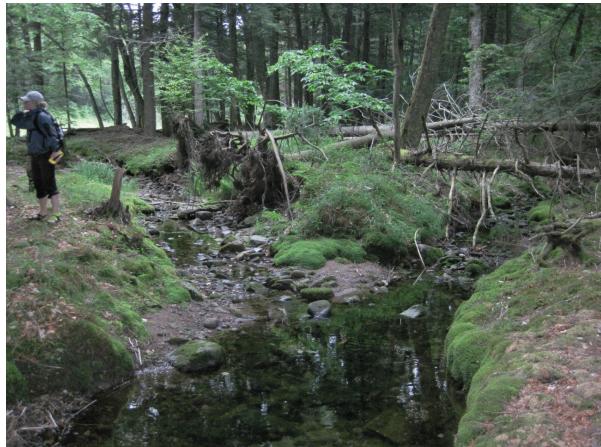
At Station 43310, a portion of the flow diverges into a small side channel on the left floodplain, continuing for about 550-feet before converging back with the main channel at Station 42840. This side channel was receiving a small flow at the time of the walkover, indicating that it stays inundated even under relatively dry conditions. (*A130*)

Divergence with small side channel (A130)

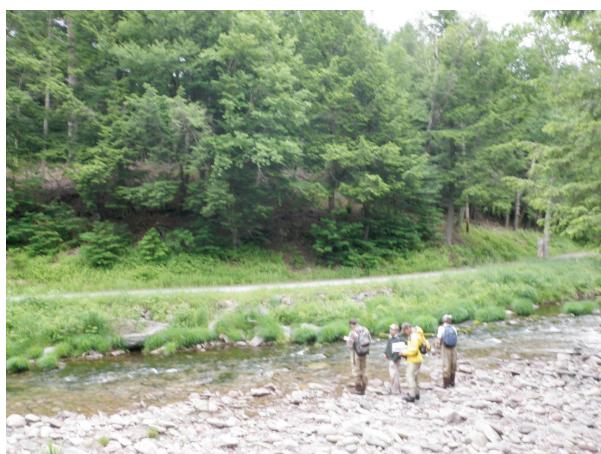
A cobble berm begins on the right bank at Station 42290, continuing 195-feet until Station 43095. (*B61*) This berm was installed with the goal of preventing the stream from flowing onto Denning Road during flood events. The right stream bank is less than 50-feet from the road in this location and does not have a vegetated riparian buffer. A vegetated riparian buffer can naturally slow the flow velocity along stream banks during flood events, and can help prevent water from easily reaching the road. A riparian buffer including woody vegetation can also strengthen the stream bank and slow erosive forces of higher flows during flood events.

Cobble berm on right bank protecting Denning Road (B61)

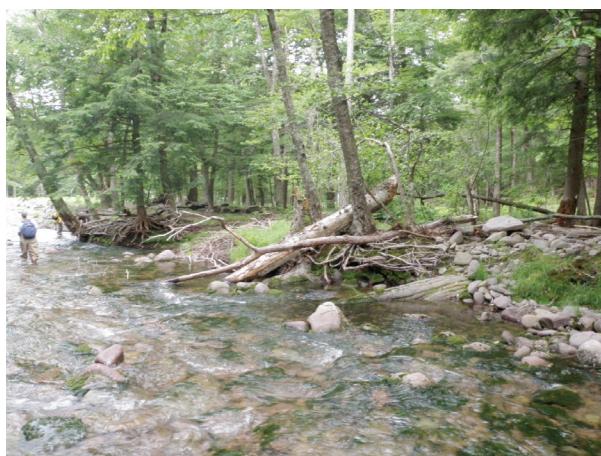
Continuing past the downstream end of the berm there is an accumulation of large woody debris on the right bank at Station 43070. (*B65*) A bedrock protrusion located directly underneath the debris obstruction is preventing the bank from any significant erosion. The bank continues to remain relatively stable for approximately 90-feet until Station 42980, where a stacked boulder revetment

Large woody debris on right bank (B65)

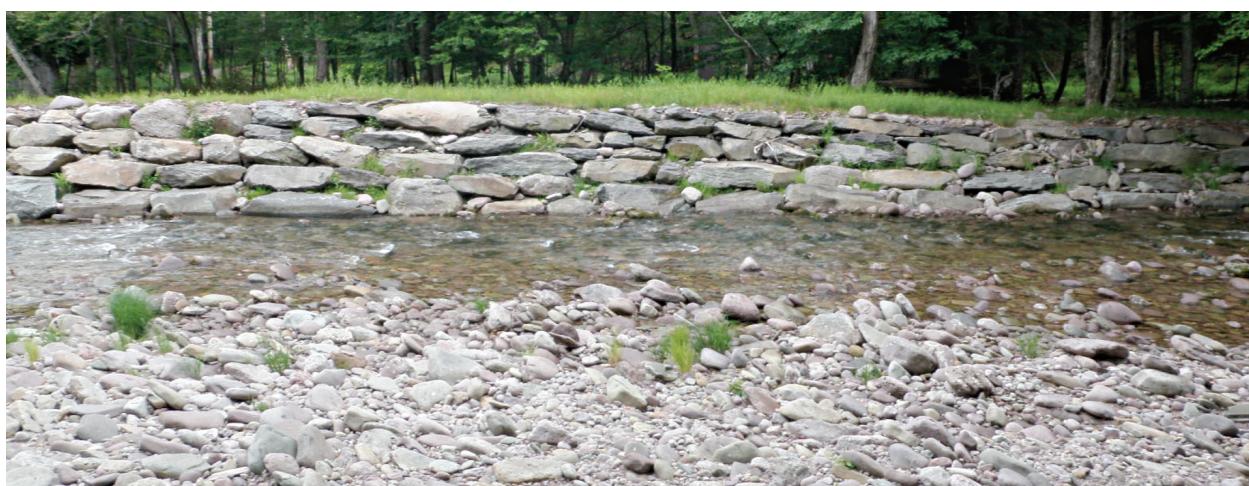
begins on the right bank. The boulders are deeply embedded in the bank with the intention of stabilizing the severely eroding bank in this section of stream. This revetment continues for 248-feet to Station 42720 and is in good structural and functional condition. (B68) The riparian zone behind this revetment is primarily mowed grasses and other herbaceous vegetation which offer little stabilization to the bank. Improvements can be made to this riparian buffer through planting techniques (B71)

Stacked boulder revetment on right bank (B68)

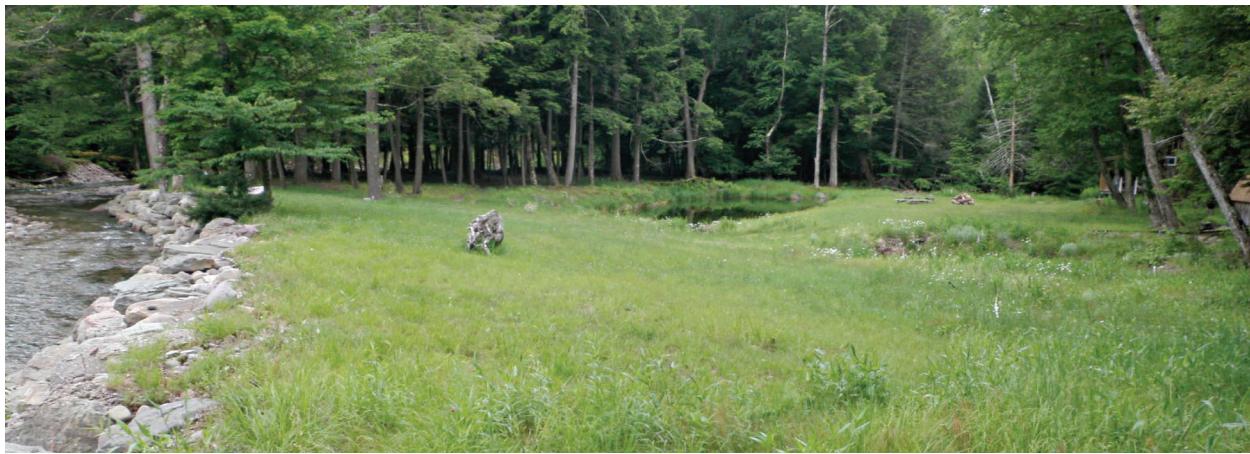
Mowed field offering little stabilization to right bank (A71)

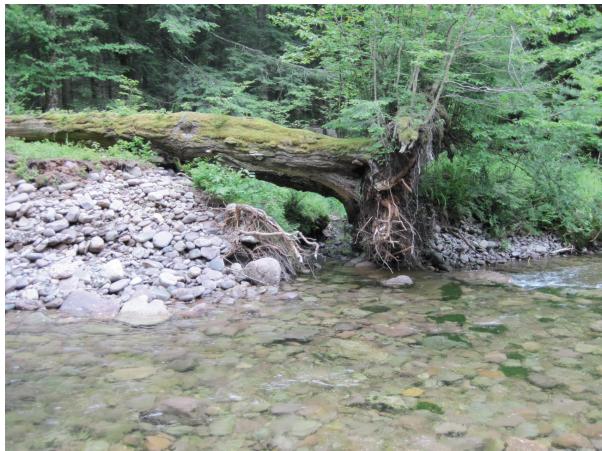
The stream begins a sharp meander to the right at Station 42700, forming a 180-foot long point bar on the inside of the bend along the right bank. A small unnamed tributary enters the main channel from the left bank at Station 42570. (A138) A large tree has deposited at the mouth of this tributary, diverting higher flows into the left bank and causing hydraulic erosion (BEMS NEB13_44500). This bank erosion averages 5-feet in height and continues to expose alluvial cobble sized materials for approximately 20-feet in stream length. (A139) The larger cobbles that are accumulating on this bank are offering some armoring against further erosion, indicating that it is possible for this bank to stabilize without treatment (passive restoration). However, it is recommended that this site be monitored for changes in condition.

Large tree at small tributary entrance on left bank (A138)

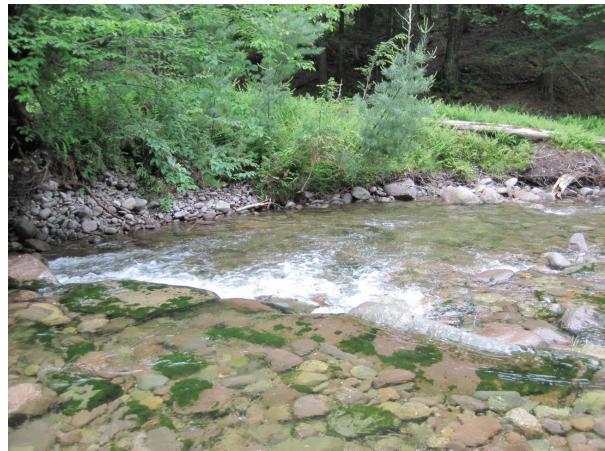
Erosion on left bank (A139)

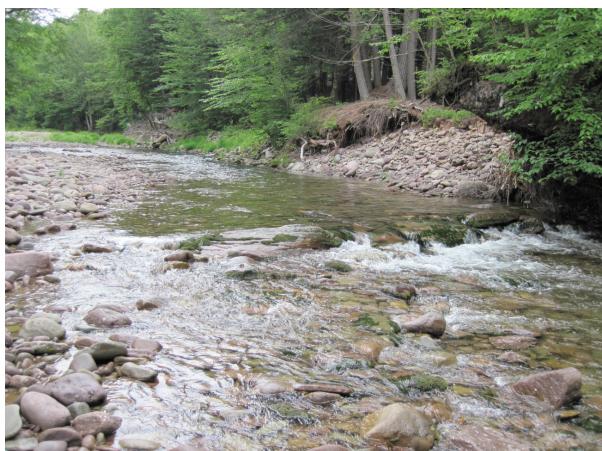
At Station 42560, several boulders embedded in the right side of the stream channel are acting as a grade control. (A136) Scour is occurring directly downstream of the grade control because the water faces an abrupt vertical drop as it flows over the boulders. A headcut is occurring at Station 42530, most likely resulting from the presence of the grade control directly upstream. (B73) The headcut is actively migrating upstream, and will continue to do so until it meets the boulder control point.

Boulders embedded in right side of stream channel (A136)

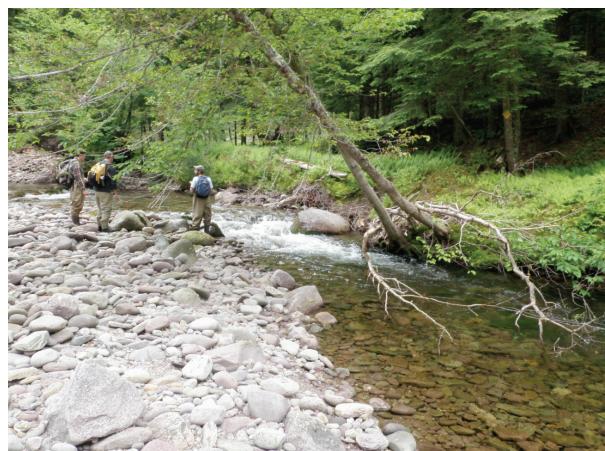
Looking upstream at headcut (B73)

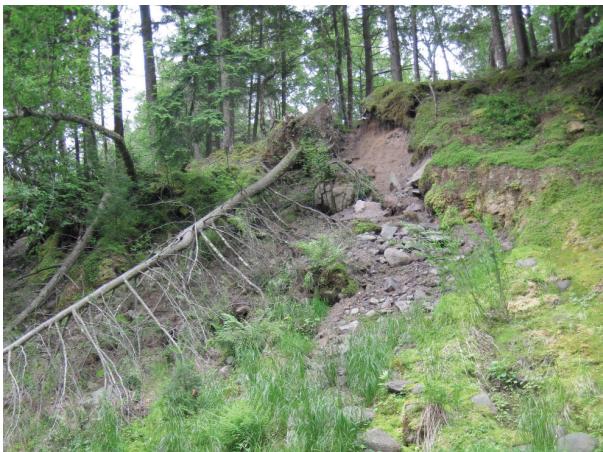
A mass failure of the left stream bank begins at Station 42440, continuing downstream until Station 42360 (BEMS NEB12_42300). This bank is 40-feet in height and consists of alluvial material, much of which is larger cobbles (I'm not sure that this isn't glacial till, rocks appear jagged edged mixed with silts). (A145) The exposed silts near the top of this slope are a potential source of fine sediment that could be entrained during high flows.

Mass failure on left bank (A145)

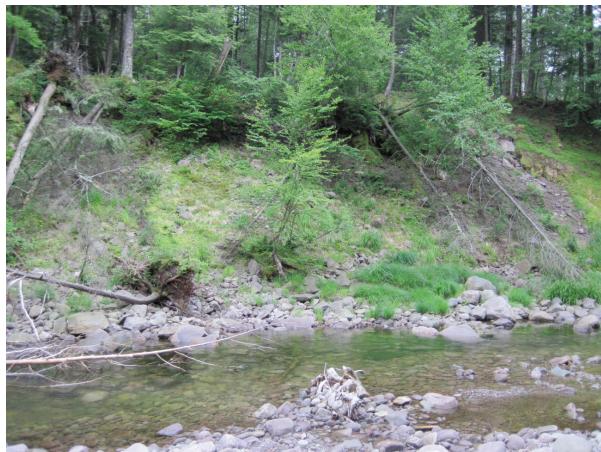
Large cobble and sedge beginning to stabilize toe (A140)

Large cobble deposition and sedge colonization have begun to stabilize the toe of this bank. It appears that larger mature trees have slid down the slope and established near the toe of the bank, suggesting that this slope failure may have reached an angle of repose and will continue to stabilize. (A140) It is possible for this bank to stabilize without treatment (passive restoration). However, it is recommended that this site be monitored for changes in condition.
