# Neversink River East Branch

## MANAGEMENT UNIT 14

EAST BRANCH MANAGEMENT UNIT 14  
BETWEEN STATION 46900 AND STATION 50100

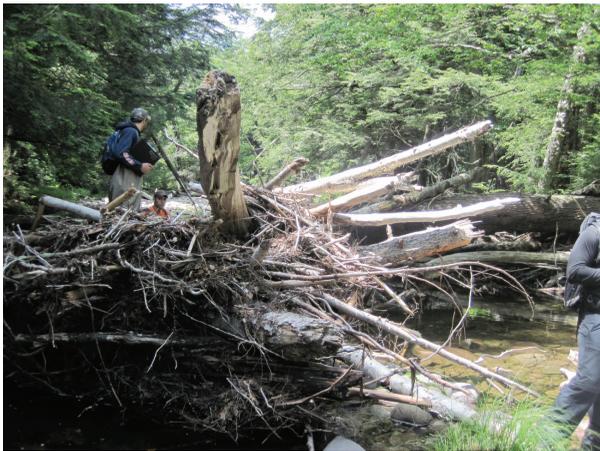
of mature woody tree material. Accumulation of woody debris in this management unit is first evident at Station 50100, where a log jam obstruction across the main channel has caused a portion of the flow to divert into a secondary side channel. (A13).

*Log jam in main channel (A13)*

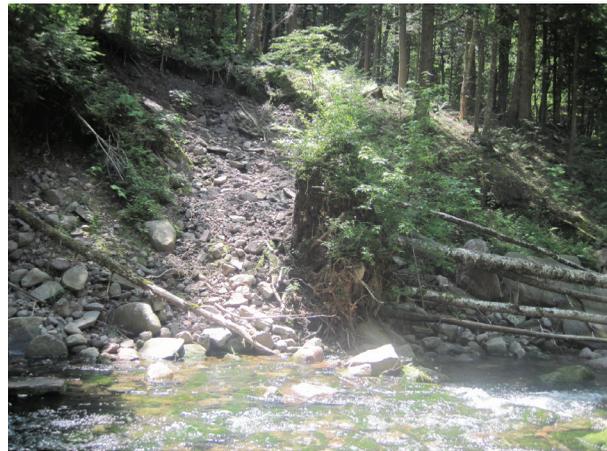
*Fallen tree in diverted side channel (A20)*

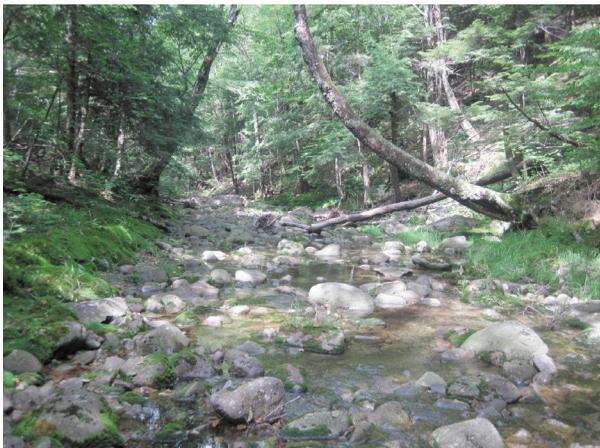
*Destabilization of trees along right bank due to toe scour (A2)*

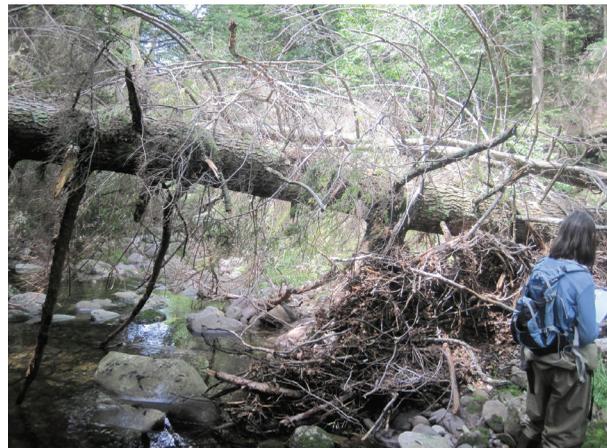
*Obstruction in channel due to scour (A6)*

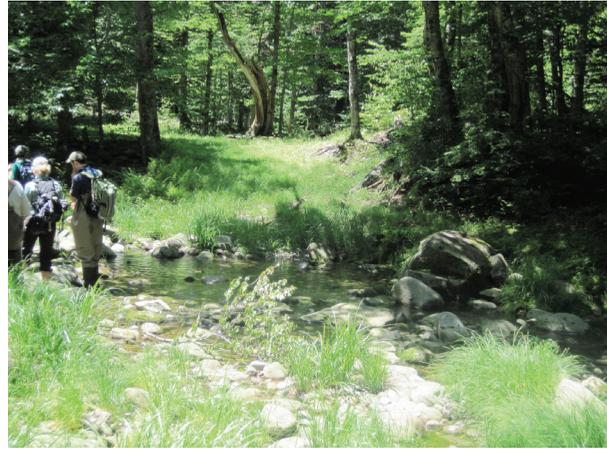
*Recreational road and stream ford (A21)*

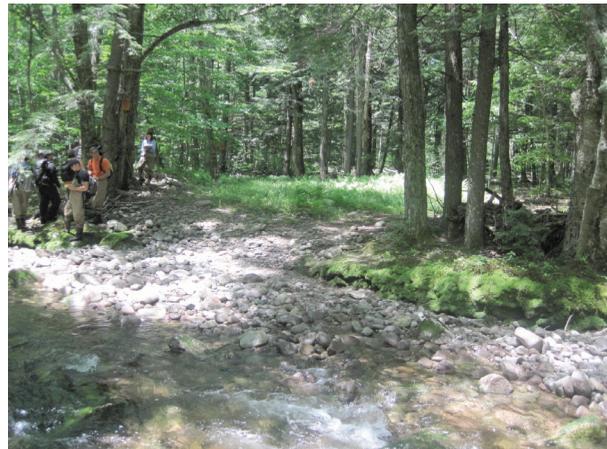
*Recreational road crossing side channel (A18)*

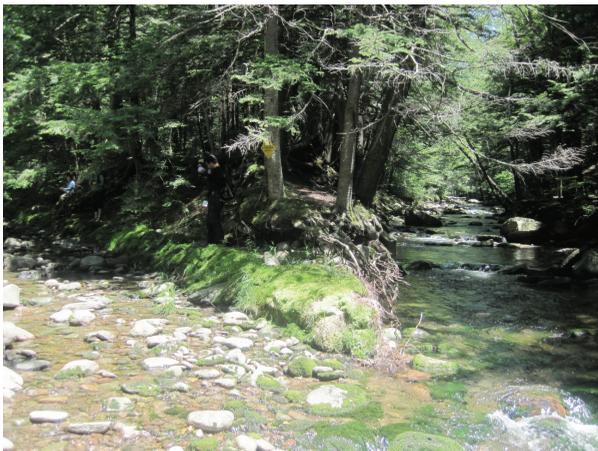
direction until it eventually crosses the side channel further upstream. (A18). The main channel and side channel come to a convergence at Station 48650, where the stream continues in a single channel for the rest of the management unit. (A24)

*Looking upstream at main and side channel convergence (A24)*

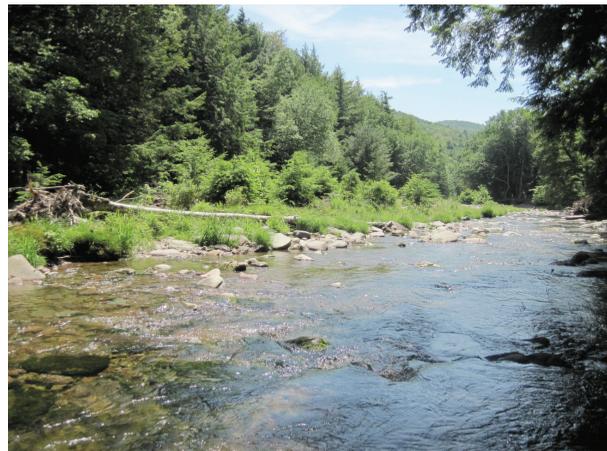
A depositional area begins at Station 48300, where a side bar consisting of cobbles has formed on the left bank. The bar is vegetated with grass and sedges on the upstream end, but transitions to woody vegetations and shrubs at Station 48200, indicating that this bar has been established for a long period of time. (A28) At Station 47920 the stream begins to meander to the left near the downstream end of the side bar, causing a 120-foot long segment of erosion on the right bank, and ending at Station 47800 (BEMS NEB14\_47700). The inserted photo shows the unconsolidated alluvial sediments exposed by fluvial erosion at this location. (A43) Though actively eroding under high flows, the toe of this eroding bank is currently being protected from scour by large cobbles that have been deposited. The rooting depth of the mature trees present on this bank helps to provide stability to the exposed soils. A riparian buffer including woody vegetation can strengthen the stream bank and slow erosive forces of higher flows during flood

*Left bank cobble side bar with woody vegetation (A28)*

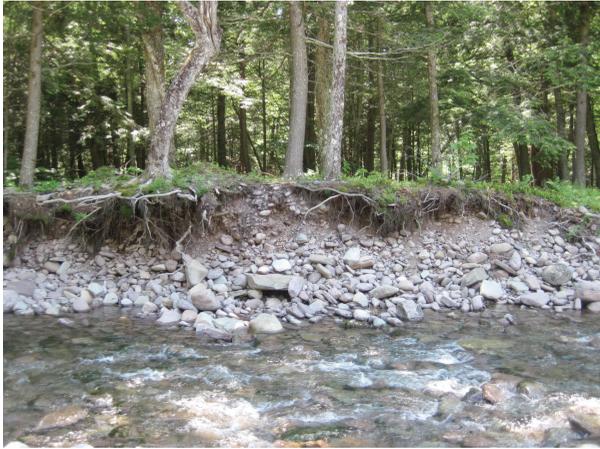
*Right bank erosion showing unconsolidated alluvial sediments (A43)*

events. Recommendations for this bank erosion site minimally include monitoring for significant changes in condition and possible assisted restoration with techniques to stabilize the bank.

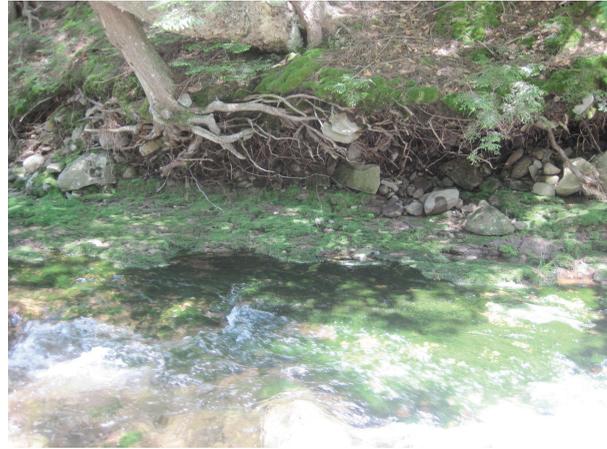
*Left bank mudstone control (A48)*

Continuing directly downstream of the side bar the stream is controlled on the left bank by a 173-foot section of mud stone beginning at Station 47800. (A48) This mud stone is only exposed on the lower portion of the bank, controlling the stream during low flows, but still allowing access to the floodplain during large flows. A spring enters from the left bank at Station 47700, contributing a perennial flow.

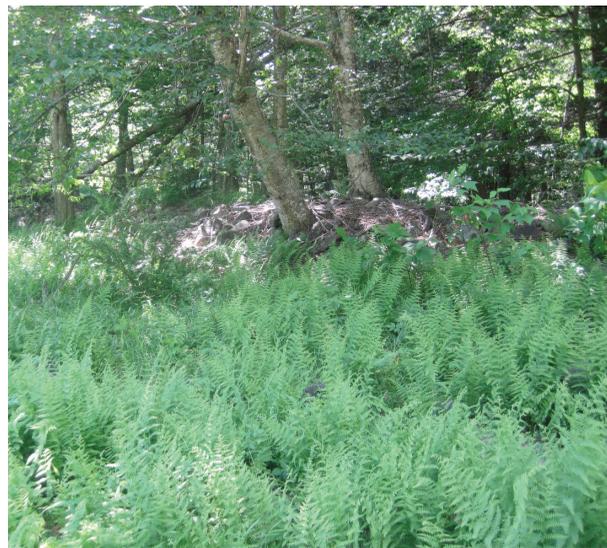
*Stone berm on right terrace (A49)*

The channel begins to approach the first occurrence of development on the East Branch near the downstream end of this management unit. At Station 47500 there is an old stone berm spanning 446-feet along the right terrace, located between the active channel and an abandoned relict channel. (A49) This berm is overgrown by mature woody vegetation and does not appear to be maintained. A newly placed gabion basket exists on the right bank at station 47200, intended to deflect flows away from a barn in the floodplain. (A51) Gabion baskets are very susceptible to failure during high flows, as larger rocks moved by the stream can continuously hit the cage and cause structural weaknesses. The combination of stresses caused by stream flow and sediment movement can cause tearing of the basket and release of the rock inside, resulting in the structure no longer functioning for its intended purpose.

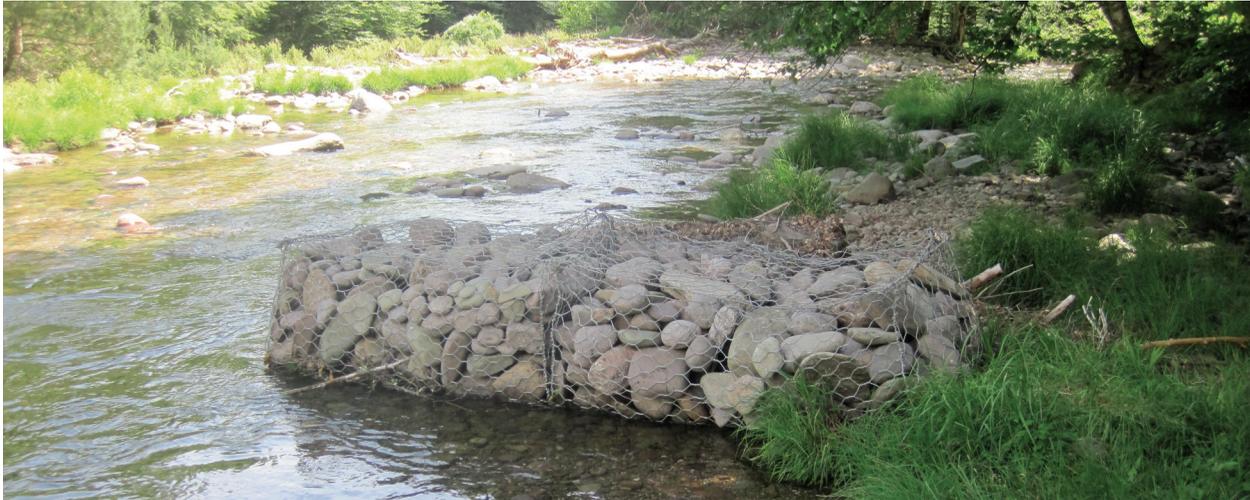
*Gabion basket on right bank (A51)*

**INFRASTRUCTURE** 0.25% (16 ft.) of the stream bank length in this management unit has been treated with some form of stabilization. The only revetment existing in EBMU14 is a gabion basket at Station 47200 on the right bank which looked to be newly placed and in good structural and functional condition. One berm was documented in this management unit between Station 47500 and Station 45150, totaling 6.92% (447.5 ft.) of the total length of stream bank. This old stone berm appeared to be unmaintained and overgrown with mature woody vegetation.

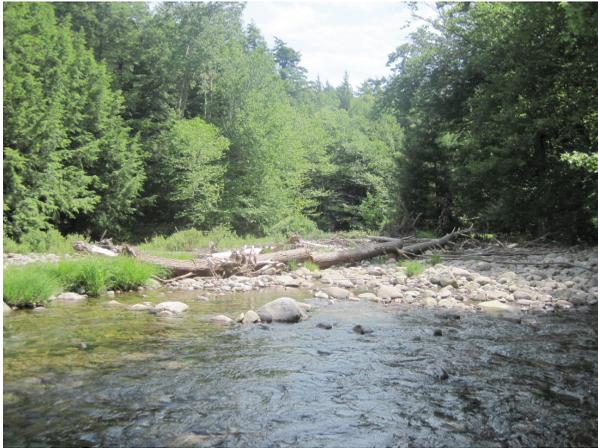
*Large log causing channel divergence (A55)*

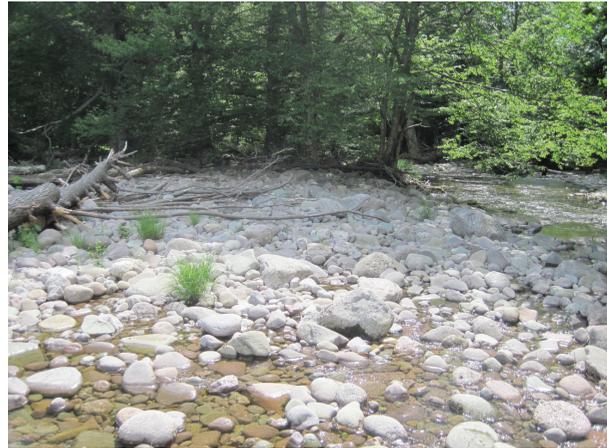
*Side channel without leaf litter (A56)*

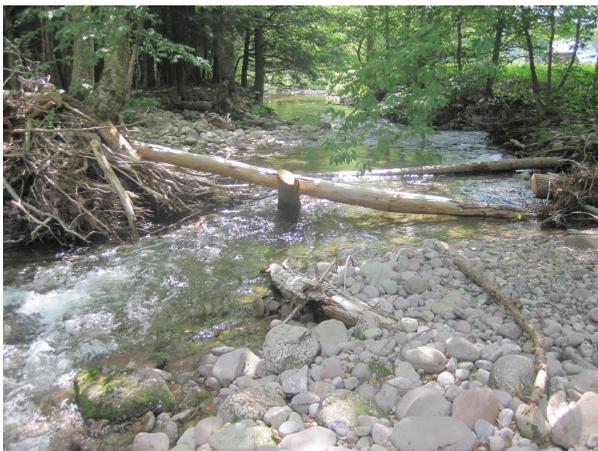
*Large woody debris causing partial reroute of main channel (A60)*

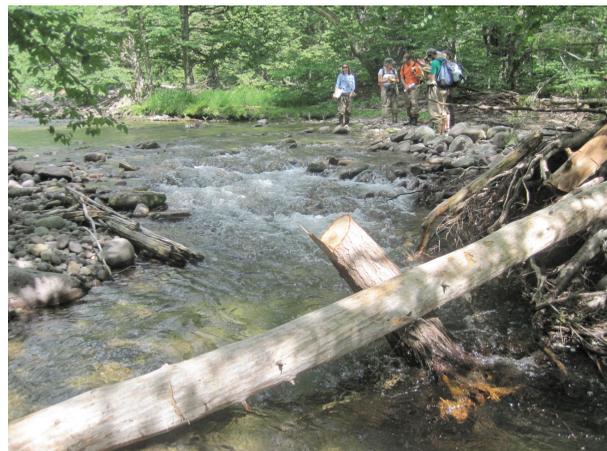
*Headcut migrating upstream (A61)*

The downstream end of this management unit is another area characterized by channel divergences and braiding caused by the accumulation of large woody debris. Directly downstream of the gabion basket a large log has deposited on the left bank, and is most likely the cause of a channel divergence at the same location. (A55) The flow in this side channel was sub-surface at the point of divergence, but re-surfaces further downstream and maintains a significant flow into the next management unit. However, the lack of leaf litter accumulation on the substrate suggests that this side channel is active under higher flows and has received significant flow at some point this year. (A56) Another large woody debris obstruction at Station 47025 causes the main channel to reroute a portion of its flow to a side channel on the left bank. (A60) Scour is occurring directly downstream of the obstruction because the water faces an abrupt vertical drop as it flows over the debris. This continuous scour is resulting in a headcut which is actively migrating upstream, and will continue to do so until it meets a substrate that is not erodible. (A61)
