# Neversink River East Branch

## MANAGEMENT UNIT 2

EAST BRANCH MANAGEMENT UNIT 2  
BETWEEN STATION 5270 AND STATION 1450

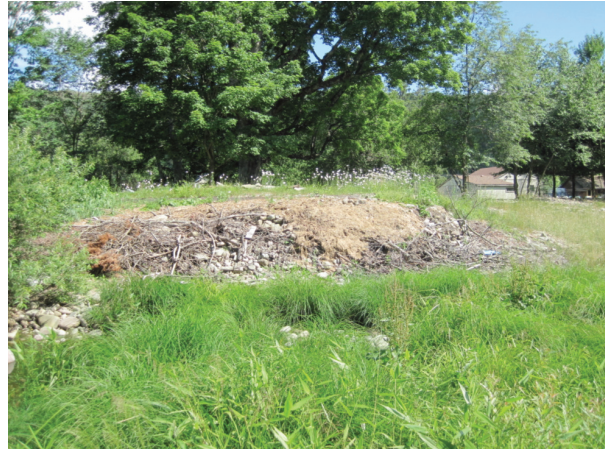
*Flow deflecting structure on left bank (A426)*

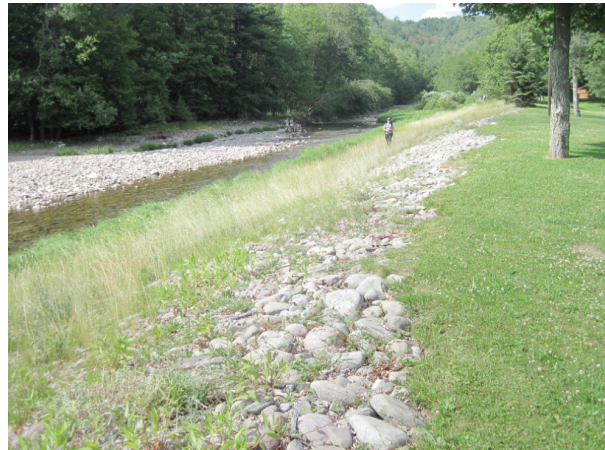
*Dumped stone revetment providing temporary stabilization (A430)*

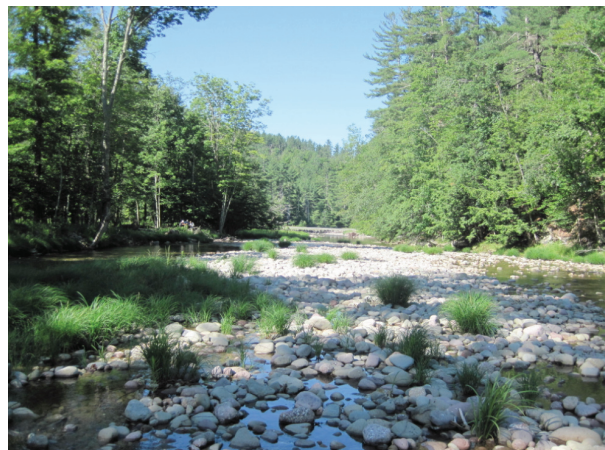
Due to the frequent accumulation of sediment in this management unit, EBMU2 could be primarily classified as a sediment storage reach. Evidence of this sediment aggradation begins at Station 4950, where a cobble side bar has formed along the right side of the stream. This bar continues for approximately 400-feet before ending at Station 4550. A depositional center bar also consisting of cobbles begins at Station 4600 and continues downstream until Station 4400. (A451)

*Depositional center bar (A451)*

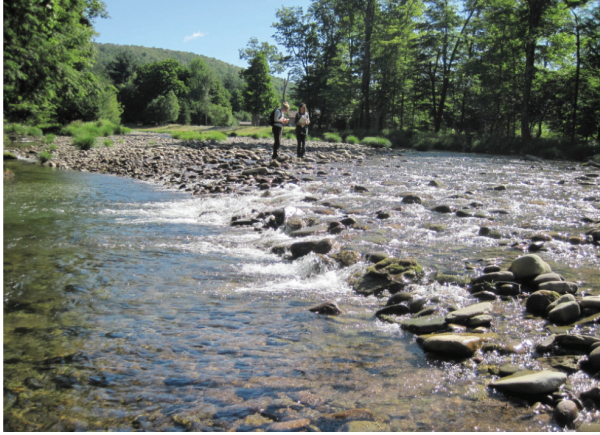
Scour is occurring directly downstream of the bar because the water faces an abrupt vertical drop as it flows over the depositional area. (A455) This continuous scour is resulting in a headcut which is actively migrating upstream, and will continue to do so until it meets a substrate that is not erodible.

*Scour downstream of center bar (A455)*

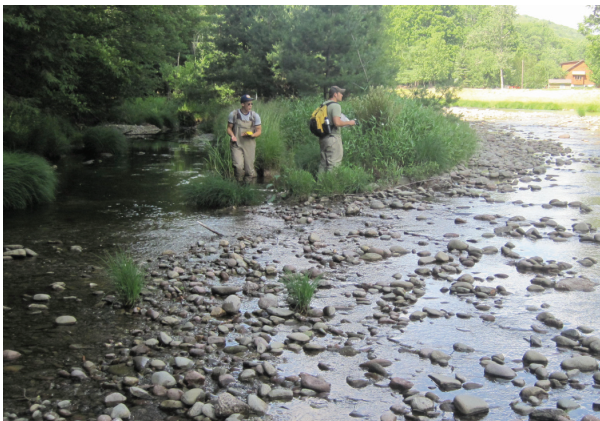
*Convergence of main and side channel (B335)*

The side channel that previously diverted a portion of the flow into the right floodplain upstream in EBMU3 converges back with the main channel at Station 4500. (B335) In this same general location exposed bedrock begins within the stream bed as well as along the right side, effectively preventing the channel from migrating vertically or laterally to the right. This bedrock control continues downstream for approximately 155-feet before ending at Station 4345. (B345) Along the left side of the stream, a fallen tree with its root wad still intact has caused an obstruction at Station 4350. (B42) During higher flows this debris reduces velocities and sediment transport capacity along the left side of the stream, resulting in the deposition of sediment. A side bar begins just downstream of the obstruction at Station 4250, and continues downstream until Station 3970. (A459) This depositional area is densely populated with sedges and other herbaceous vegetation.

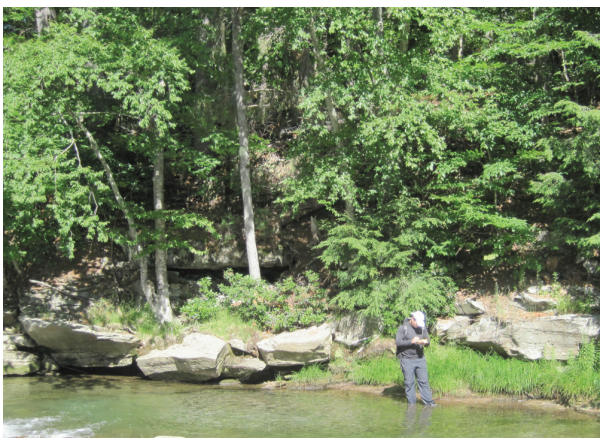
*Bedrock control along right bank and stream bed (B345)*

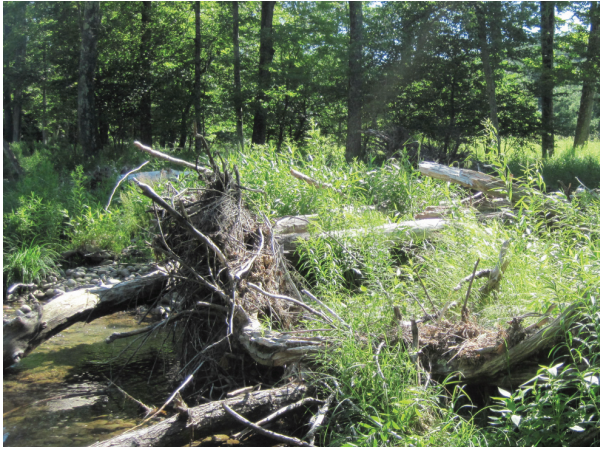
*Fallen tree obstructing flow (B342)*

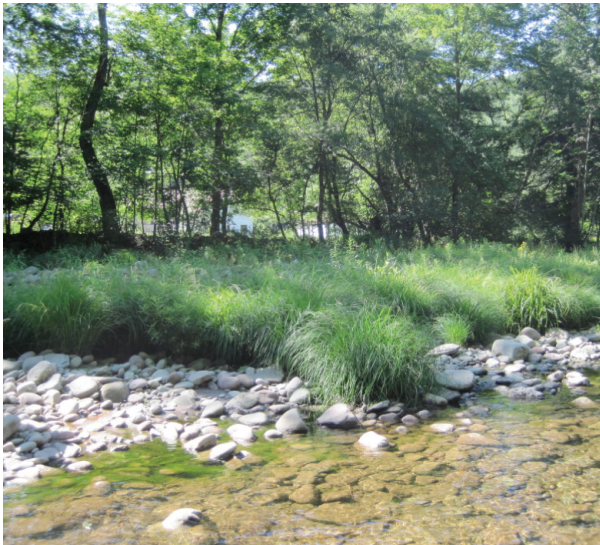
*Well vegetated side bar (A459)*

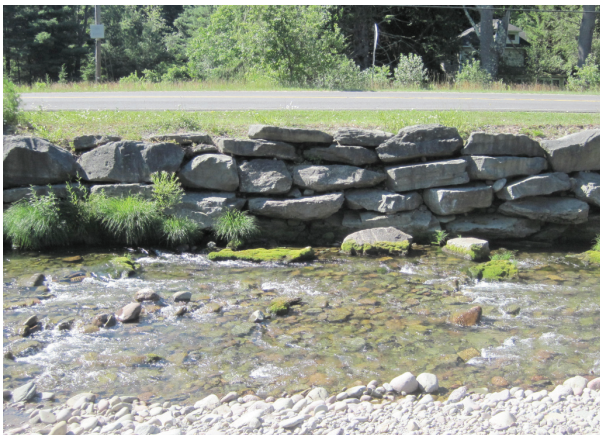
*Stacked boulder revetment along left bank protecting road (B349)*

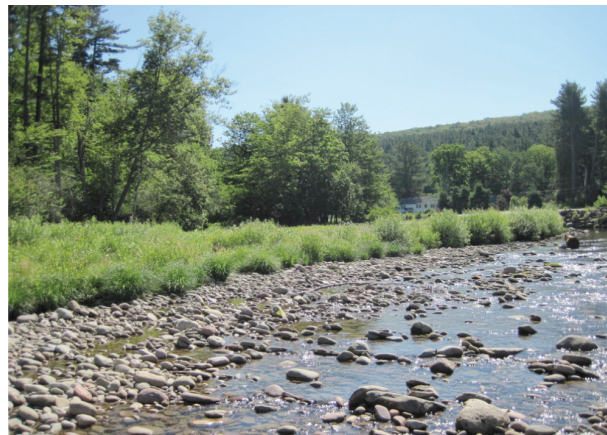
*Large vegetated point bar (A474)*

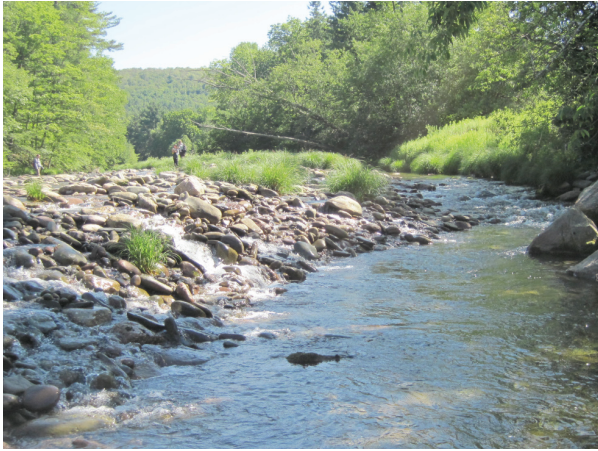
Excessive sediment deposition is occurring along the inside of this meander bend in the form of a large point bar. This bar begins just downstream of a large woody debris obstruction at Station 4020. It begins as a narrow extension of the right bank, but increases in width to nearly 160-feet before tapering off at Station 3200. (A474) A side channel is carrying a small amount of flow along the right side of the point bar. The elevation of this bar is significantly higher than the main channel which is resulting in the formation of a head cut at Station 4850 as water flows over the depositional area and makes the abrupt drop into the main channel. (B356)

*Side channel entering main channel over side bar (B356)*

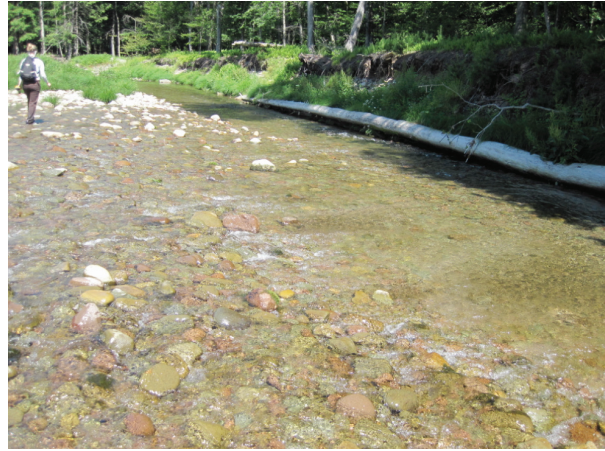
*Transverse bar along right half of channel (A480)*

right half of the channel. (A480) A center bar that is densely vegetated with sedges begins at Station 3080 and continues until Station 2900. (A481) Also at this station, a large woody debris obstruction is causing a significant enough drop in stream bed elevation to result in a head cut. (A483) Dense sedge colonization is present on the point bar that has formed along the left bank between Station 3100 and Station 2700.

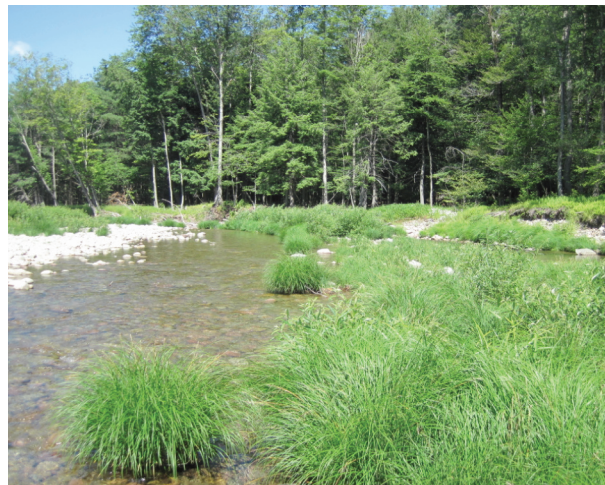
*Center bar with densely vegetated sedges (A481)*

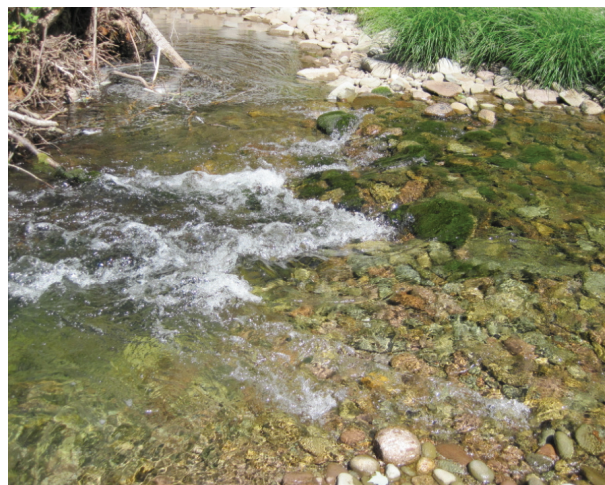
*Headcut forming due to obstruction (A483)*

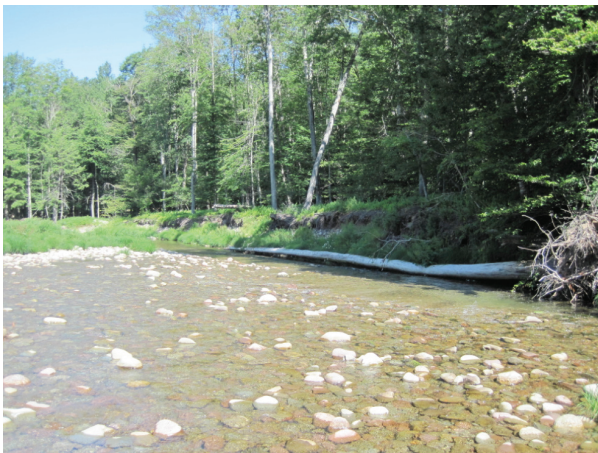
A large woody debris obstruction that has deposited along the right bank at Station 3150 is aggravating bank erosion around the outside of the meander bend. This erosion begins in the same location as the obstruction and continues for approximately 430-feet to Station 2720 (BEMS ID # NEB2\_2700). (A476) As flow passes through this meander bend, hydraulic pressure is causing erosion at the toe of the bank and exposing cobble sized alluvial material. This toe scour left a large portion of sod at the top of the bank without anything to support its weight, causing it to slump down to the water level. In its current position, the sod is covering a large portion of the bank erosion and offering protection from future scour. If the sod cover remains intact, it is possible for this bank to stabilize without treatment (passive restoration).

*Large woody debris and bank erosion (A476)*

However, it should be monitored for future changes in condition.

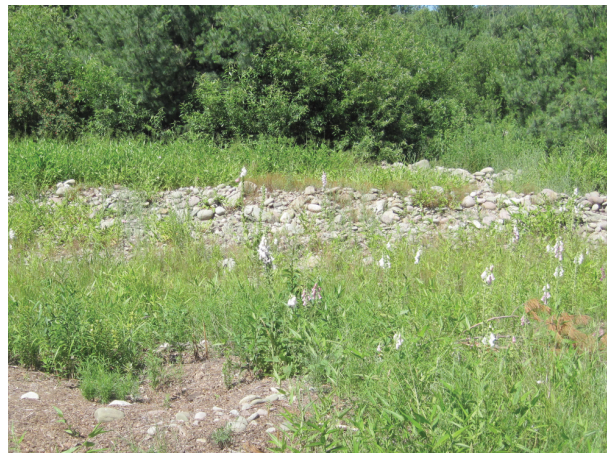
*Relict berm in left floodplain (B368)*

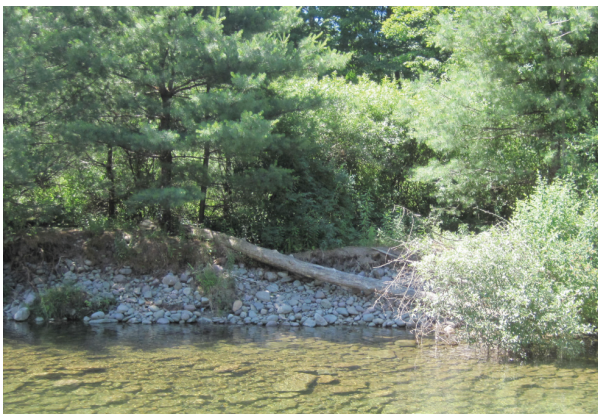
Continuing downstream, the channel again meanders slightly to the right and the resulting hydraulic pressure put on the left bank has caused erosion. This erosion site begins at Station 2600, continuing approximately 90-feet to Station 2510 (BEMS ID # NEB2\_2500). (B378) Cobble sized alluvial materials are exposed throughout this 5-foot high bank, and the resulting instability is causing trees on the bank to uproot and fall into the stream. Recommendations for this bank erosion site minimally include monitoring for significant changes in condition and possible assisted restoration with techniques to stabilize the bank.

*Erosion along left bank (B378)*

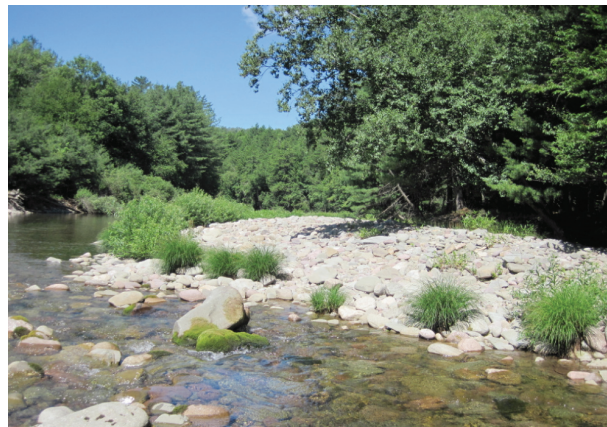
*Cobble point bar along right side of stream (A488)*

Across the stream from this erosion site, a cobble point bar has formed along the right side of the stream between Station 2700 and Station 2440. (A488) This bar reaches a maximum width of 51-feet at its midpoint and is moderately vegetated with sedges and various shrub species. A side bar begins along the left side of the stream at Station 2400 and continues downstream before ending in front of a private residence at Station 1820. (B386) Sedges have established over a significant portion of this depositional area.

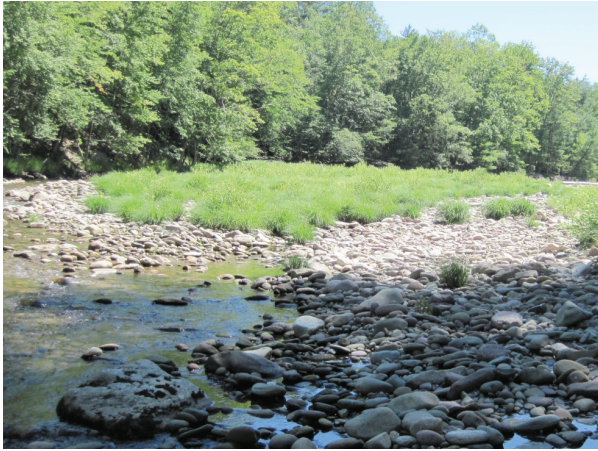
*Side bar vegetated with sedge (B386)*

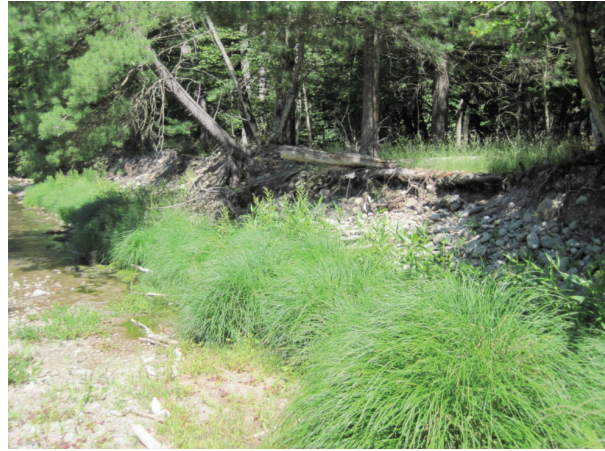
*Hydraulic erosion along right bank (A490)*

Erosion begins along the right bank at Station 2450, continuing for approximately 300-feet until Station 2150 (BEMS ID # NEB2\_2100). (A490) Hydraulic erosion has exposed significant amounts of cobble sized alluvial materials and is causing several trees to lean toward the stream. A transverse bar located in the channel is cause for concern because it is directing a portion of the flow perpendicular in the direction of the eroding bank. Despite these seemingly negative conditions, additional stability is being offered to the bank in the form of large sedge clumps which have established along the toe. Because of the additional stability offered by this vegetation, it is expected that this bank could stabilize without further treatment (passive restoration). However, the leaning trees could cause future problems and therefore should be monitored for any changes in condition.

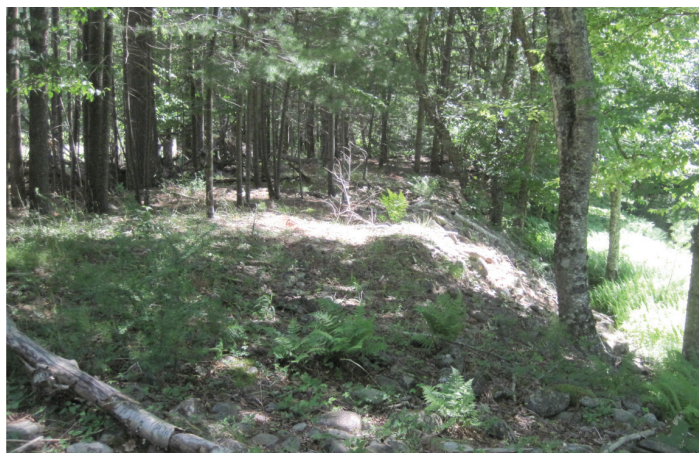
*Berm on left floodplain consisting of sidecast material (B383)*

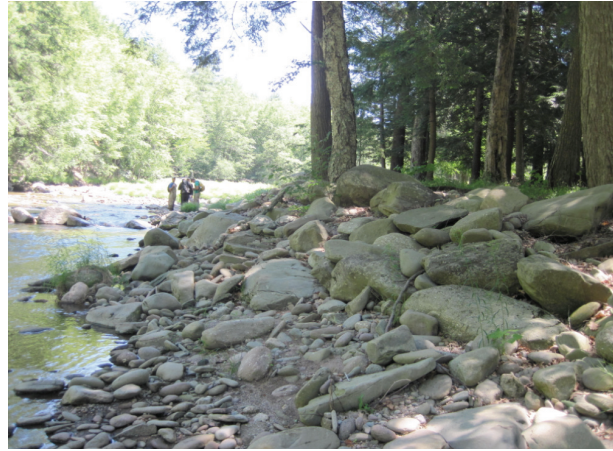
*Stacked boulder revetment on left bank (A500)*

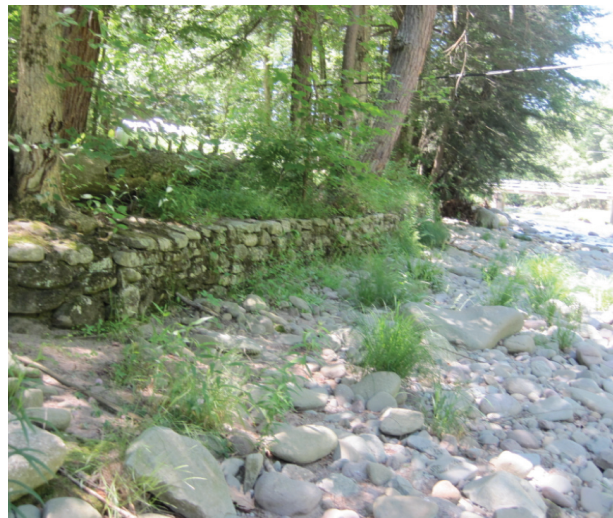
*Revetment transitioning to mortared stone wall (A502)*

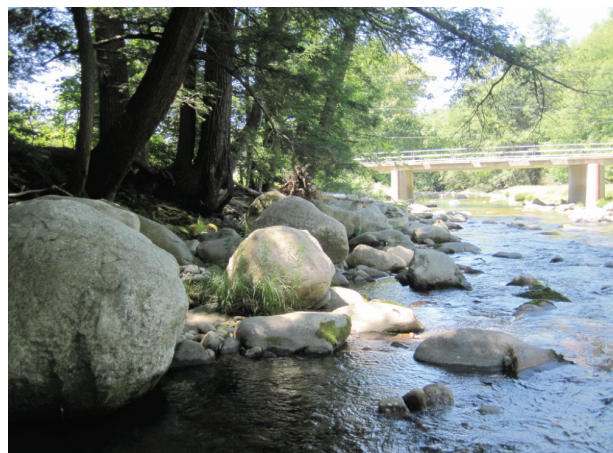
*Large boulders placed downstream of stone wall (A504)*

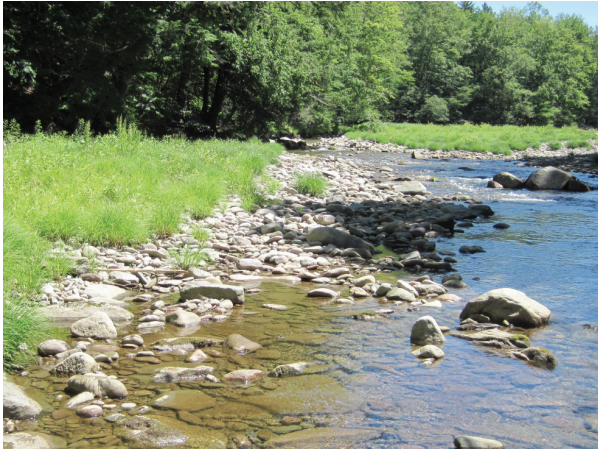
A depositional bar is forming across from the revetment along the right bank, beginning at Station 1850 and continuing downstream until Station 1750. (B392) This bar consists of cobble sized materials and is covered with various species of sedge and herbaceous vegetation. A power line crosses the downstream end of this bar on its way to the house on the left bank, representing a potential hazard in the event that it fell into the stream.

*Depositional bar forming across from revetment (B392)*

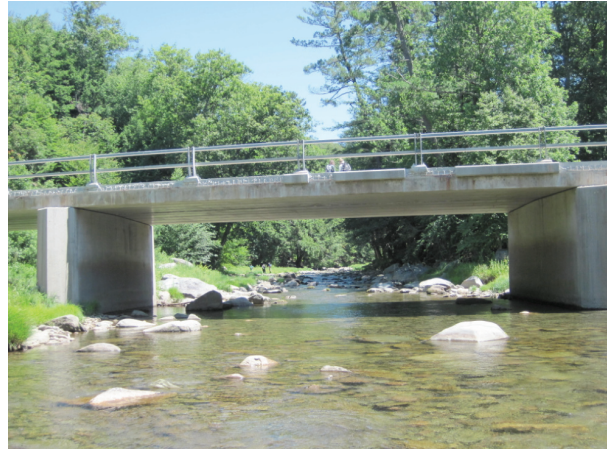
*West Branch Road bridge (A507)*

EBMU3 ends at Station 1450 as the stream channel is crossed via bridge by West Branch Road. (A507) This bridge has been constructed relatively recently and is in good structural condition. However, it was not designed to effectively convey the large flows that are relatively common to the East Branch of the Neversink River. Two abutments encroach severely on the bankfull channel, and as a result are causing aggradation of the stream channel in the vicinity of the bridge. This aggradation and subsequent raise in stream bed elevation can increase the likelihood of flood damage to surrounding infrastructure during significant events. Boulder and cobble sized rip-rap have been dumped along both the right and left banks at the upstream and downstream sides of the bridge abutments. (B400) Quarry stone can be seen scattered throughout the channel and is likely an indicator that this rip rap is unstable and becomes dislodged during large flood events. The right and left banks between Station 1550 and Station 1450 have insignificant riparian vegetation and should be assessed for potential restoration using planting techniques, including inter-planting of the existing rip rap. Recommendations for this bridge include further assessment to determine its ability to effectively convey large flows and sediment loads.

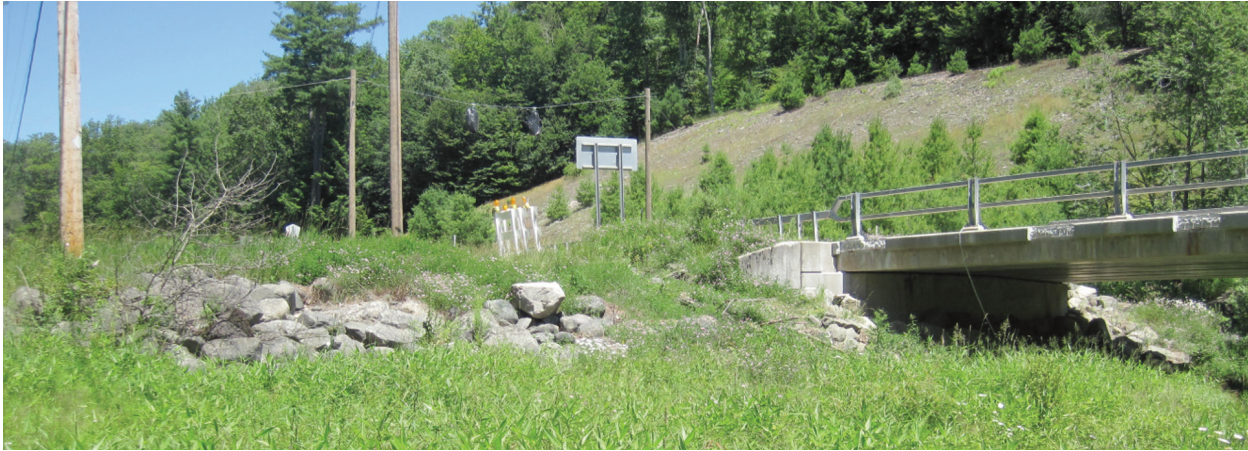
*Boulder and cobble sized rip rap on both sides of bridge abutments (B400)*
