Neversink River East Branch

MANAGEMENT UNIT 3

EAST BRANCH MANAGEMENT UNIT 3
BETWEEN STATION 9200 AND STATION 5270

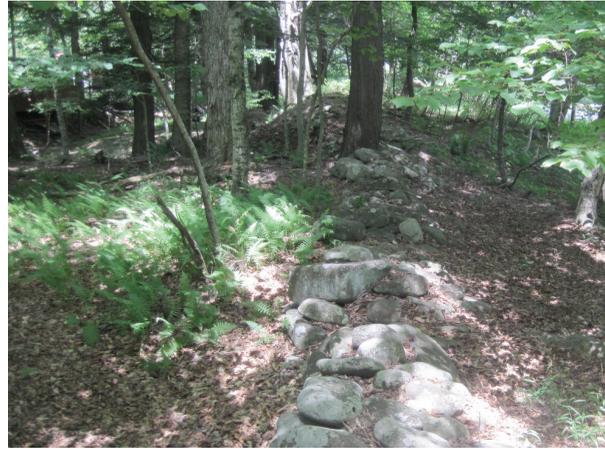
An old cobble berm that began in EBMU4 continues into the first 60-feet of EBMU3, offering an attempt at flood mitigation for the infrastructure in the left floodplain. (B265) This berm is overgrown with vegetation and does not appear to have been maintained in recent years. Continuing downstream past the two bridges, the impact that these structures have on stream morphology becomes increasingly evident. It is likely that the bridge abutments are not spaced wide enough to accommodate large events, creating a bottle neck as flows are conveyed through. As a result, severe scour was documented around the abutments of the active bridge near Station 9100. This scour has created slow moving pools which continue for a short reach downstream of the structure. (A326) The slower velocities do not effectively transport sediment through the reach, resulting in a significant amount of aggradation under the bridge. The left bank is revetted with placed rip-rap beginning at the bridge abutment near Station 9060, continuing for approximately 50-feet until Station 9010. (B276)

Old cobble berm in left floodplain (B265)

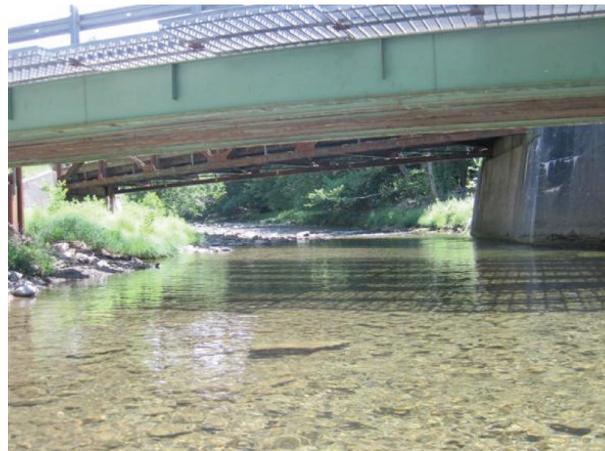
Aggradation under bridge (A326)

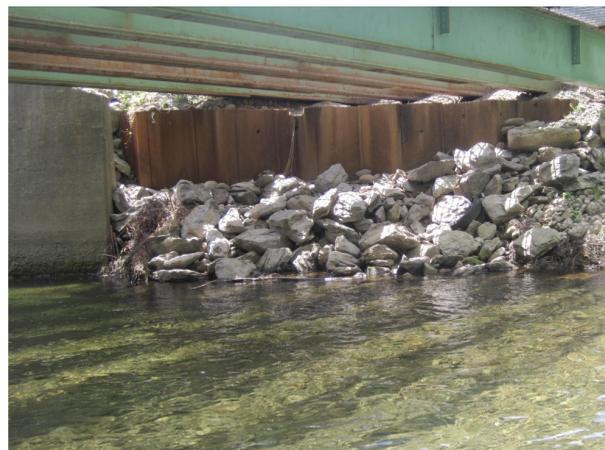
Left bank revetted with rip rap at bridge abutment (B276)

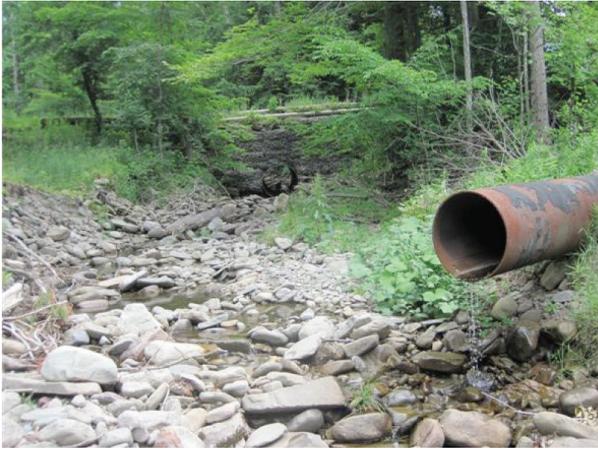
Drainage pipe from Wildcat Road (A313)

Neversink. (A313) This culvert is constructed from smooth steel which has rusted over time. There is no outfall or headwall protection present other than the stream cobbles which have deposited in the vicinity of the culvert.

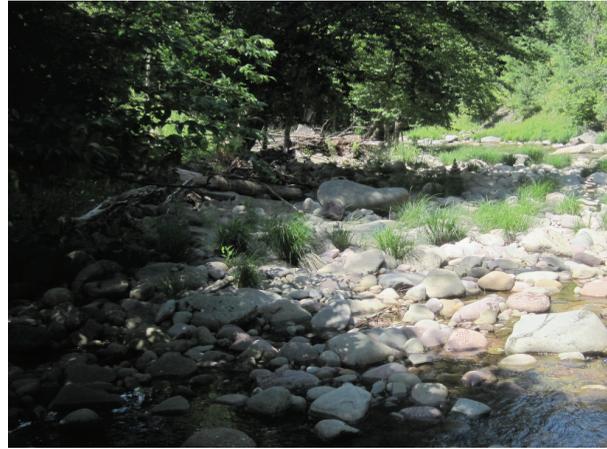
Cobble side bar along left bank (B278)

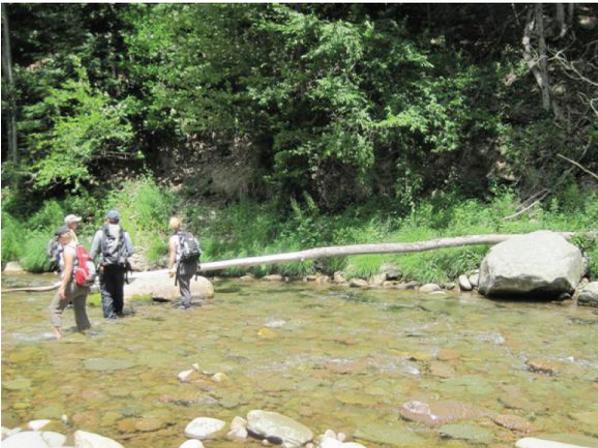
Fallen tree causing obstruction to flow on right bank (A329)

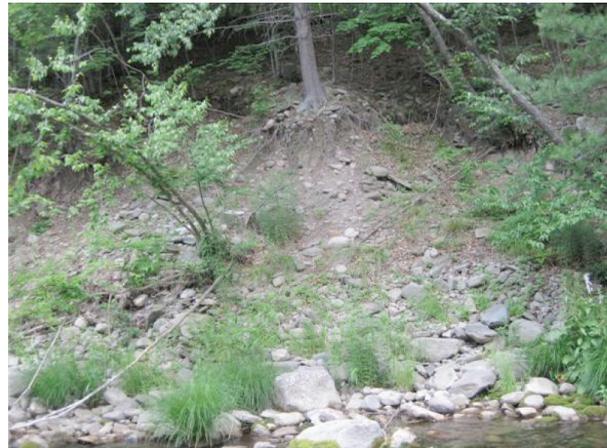
Stabilizing slope failure on right bank (A334)

stabilization to the eroding bank. With adequate toe stabilization it is possible that this site can continue to stabilize without treatment (passive restoration). However, it is recommended that it be monitored for future changes in condition. (A334)

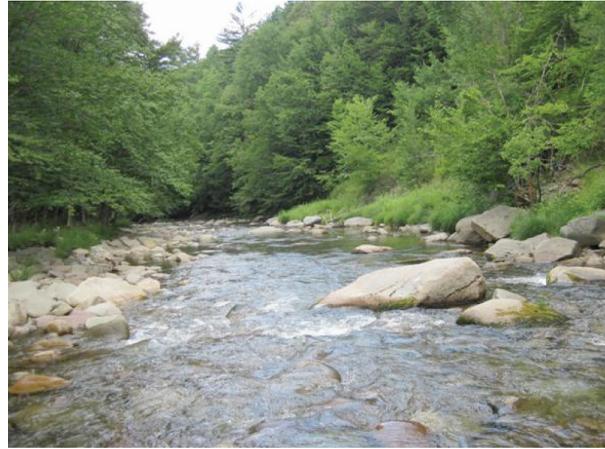
Large boulders contributing to bank stabilization (A337)

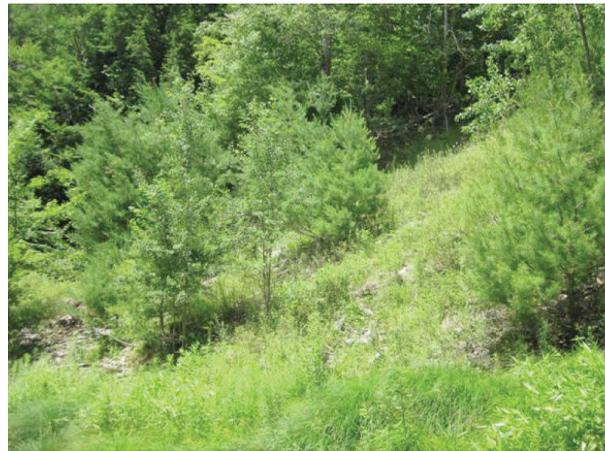
A larger re-vegetated slope failure begins at Station 8680 and continues for approximately 100-feet until Station 8580 (BEMS ID# NEB3_8500). (A344) Although exposed cobbles on this slope indicate a previous landslide, this bank has been naturally re-stabilized by the deposition of large boulders at the toe. A large percentage of the slope is now covered with mature vegetation, and all signs indicate that this bank will continue to stabilize without treatment (passive restoration).

Re-vegetated slope failure (A344)

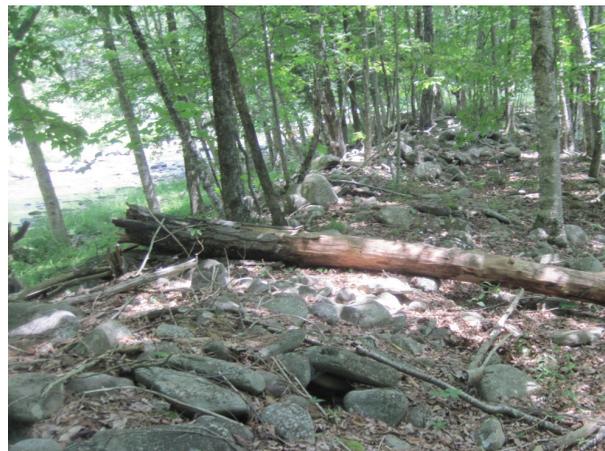
Berm along left bank (B288)

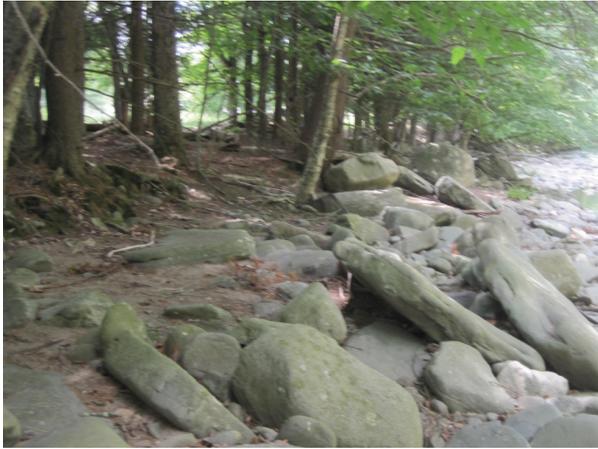
Boulder revetment along left bank (B293)

recently placed boulder revetment which continues downstream until Station 8210. (B293) This revetment has been washed out in some spots, but overall is in fair condition.

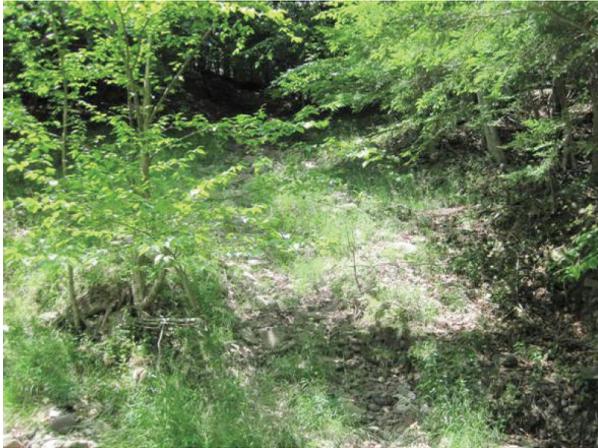
Slope failure due to upland drainage (A358)

At Station 8220, water that is draining from upland sources through the bank is eroding and washing out finer soil particles (BEMS ID # NEB3_8200). The removal of these finer particles destabilized the bank, resulting in a failure of the hill slope which continues downstream for approximately 25-feet until Station 8195. (A358) Some silts and sands are exposed along this slope and could potentially be a source of fine sediment; however, they are not expected to be contributing to turbidity problems in the Neversink. A large percentage of the slope has re-vegetated naturally, suggesting that this bank has reached an angle of repose and will continue to stabilize without treatment (passive restoration). It is recommended that this site be monitored for future changes in condition.

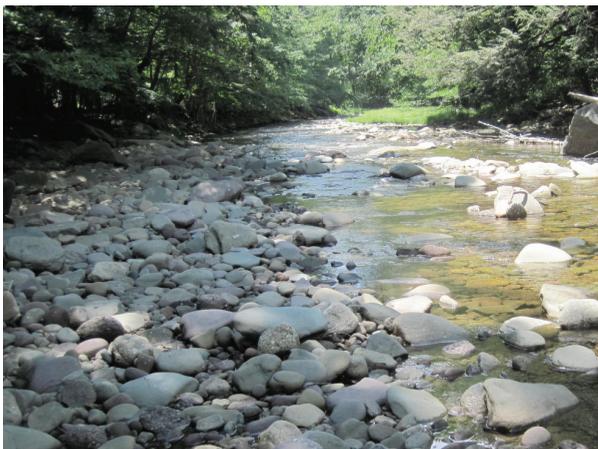
Cobble sidebar on left side of channel (B297)

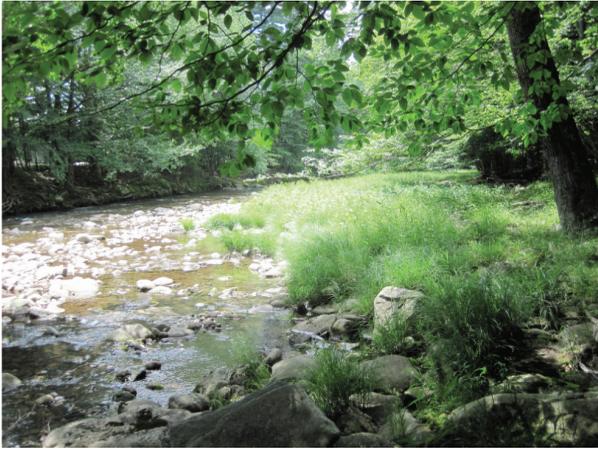
Vegetated side bar on right side of channel (A366)

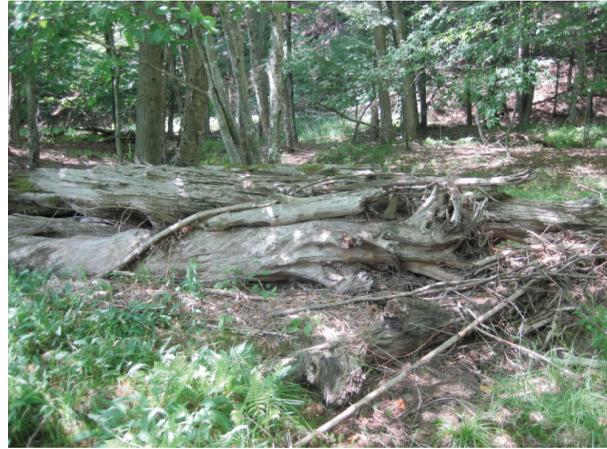
Large woody debris deposited on right floodplain (A371)

piles of tree trunks were documented significantly above the wetted channel width. (A371) Along the left bank, an access path has been mowed from the floodplain all the way down to the stream, removing all woody riparian vegetation at Station 7500. (B301) Removing significant amounts of vegetation from the riparian zone can reduce bank stability and lead to erosion. An intact riparian buffer including woody vegetation can strengthen the stream bank and slow erosive forces of higher flows during flood events, reducing the need for the installation of revetments and berms.

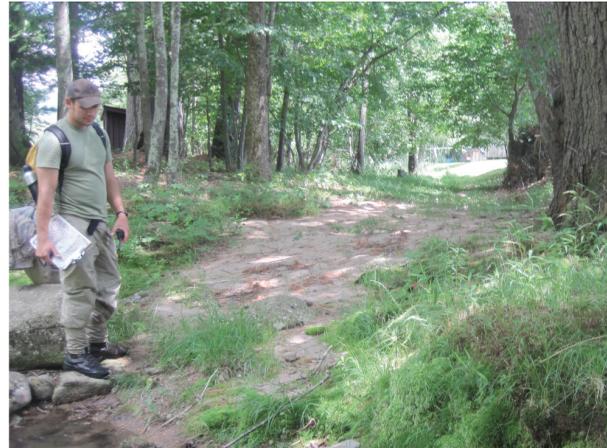
Access path along left bank (B301)

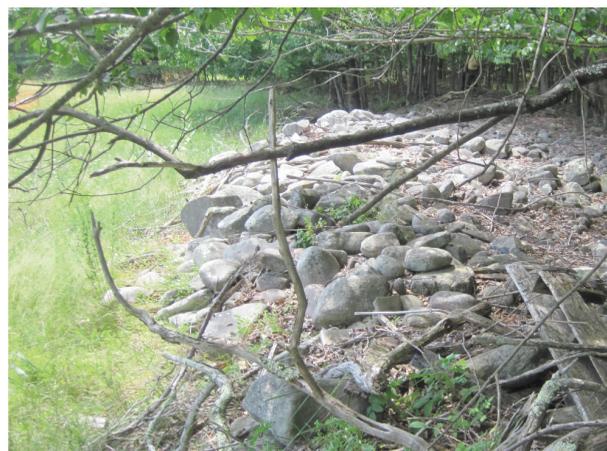
A berm begins along the left bank at Station 7400, continuing downstream for approximately 165-feet to Station 7235. (B304) This berm consists of large cobbles and is located where the narrowly forested portion of the riparian buffer transitions to open field. A construction site for a building structure was located in this field at the time that the inventory was conducted. This new development exists just outside of the delineated 100-year floodplain boundary, but is still at a very high risk of inundation and subsequent damage during flood events. A cobble bar begins along the left side of the stream in front of this berm

Berm along left bank (B304)

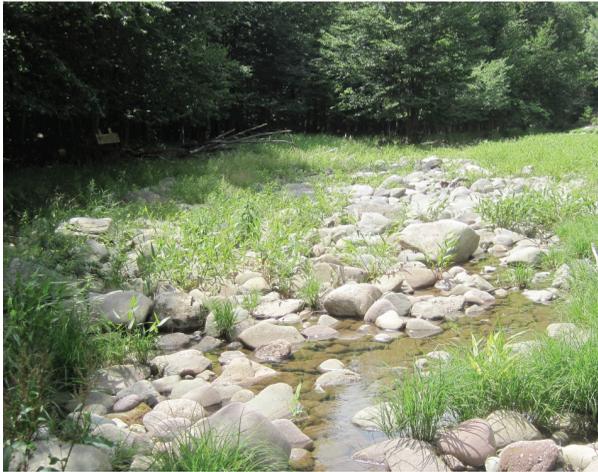
Cobble bar forming along left side of stream (B302)

at Station 7300, continuing around the sharp bend for approximately 950-feet before ending at Station 6350. (B302)

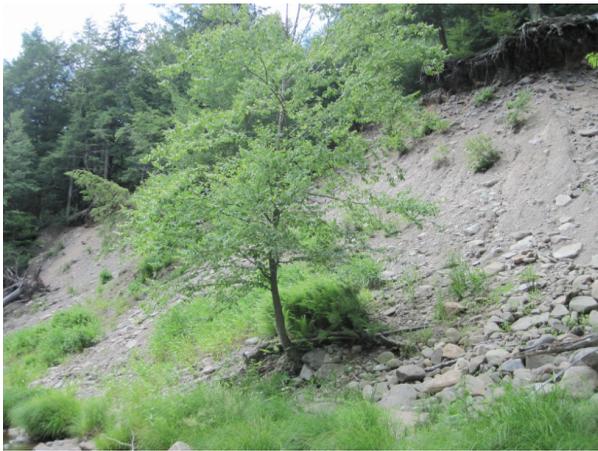
Severe slope failure on right bank (A384)

As the channel approaches a hard left turn, there is a relatively severe slope failure that begins at Station 6950 and continues for approximately 160-feet until Station 6790 (BEMS ID # NEB3_6800). (A384) The glacial till that makes up this 70-foot high bank is exposed in most locations, indicating a source of fine sediment that can be entrained during high flows. The slope failure was most likely caused by a spring seepage that drains down through the bank, which continuously erodes the sediment particles that keep the slope intact. As the sediment particles become unstable, the bank fails under its own weight and large portions begin to slide down the slope. At the time of this inventory, several trees had either fallen to the base of the bank or were leaning with their root structures exposed. Due to the severe angle of this bank and the lack of scour protection at the toe, it is unlikely that this slope will stabilize without treatment. Remediation of this erosion site would likely have to be part of a full restoration of the channel in order to redirect the flow away from the bank.

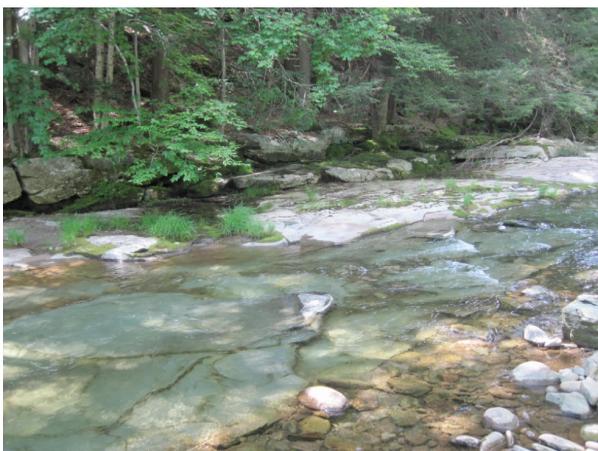
Bedrock grade control (A408)

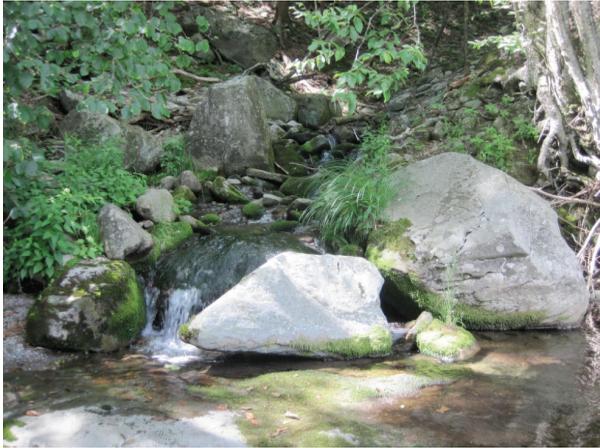
6600. (A401) Small feeder streams such as this often play an integral role in ecosystem integrity, as they are a source of the cold and well oxygenated water that is necessary to support a diversity of aquatic life. Sediment is depositing on a center bar which begins at Station 6580 and continues downstream until Station 6500. At time of this inventory, flow was diverted to the left and right around this bar, allowing sedges to establish amongst the cobbles. (A402)

Small perennial tributary entering on left (A401)

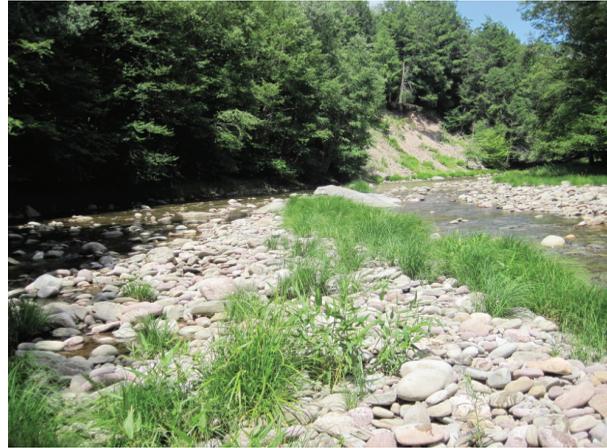
Sedges establishing on center bar (A402)

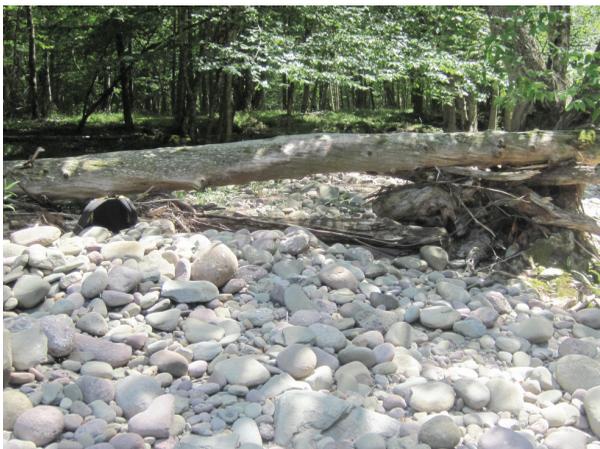
Obstructions along left bank (B313)

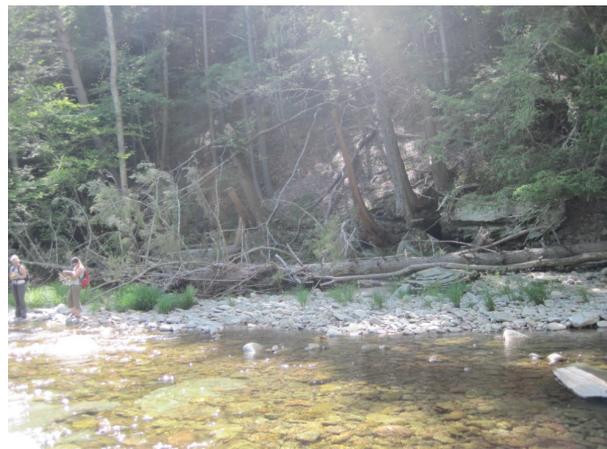
Series of woody debris along right bank (A413)

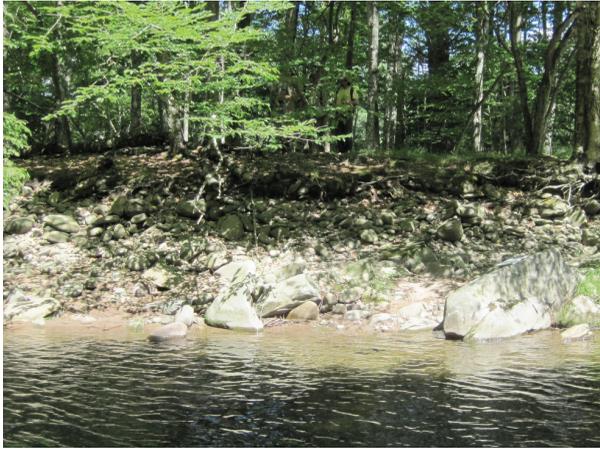
Erosion on left bank (B319)

The left bank begins to erode at Station 6200 and continues downstream for approximately 160-feet until Station 6040 (BEMS ID# NEB3_6000). (B319) This erosion site may be aggravated by the presence of large woody debris obstructions along the right side of the channel, which divert hydraulic pressure into the bank during high flows. The bank angle is not severe enough that it would indicate future failure, and large cobbles that have been exposed through the erosion process are now helping to armor the bank down to the toe. It appears that it is possible for this bank to stabilize without treatment (passive restoration). However, it is recommended that this site be monitored for changes in condition.

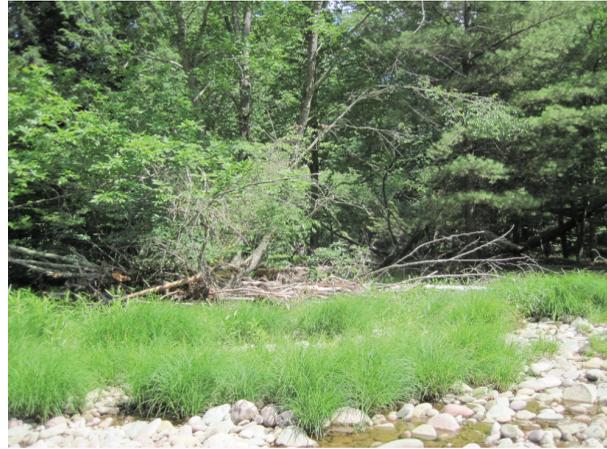
Obstructions along left bank (A416)

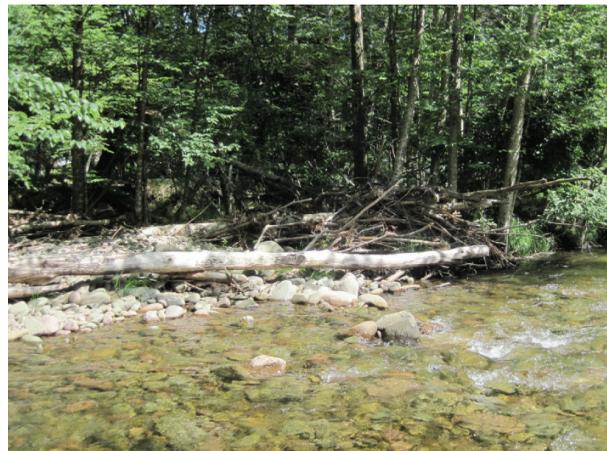
Obstructions along left bank (A418)

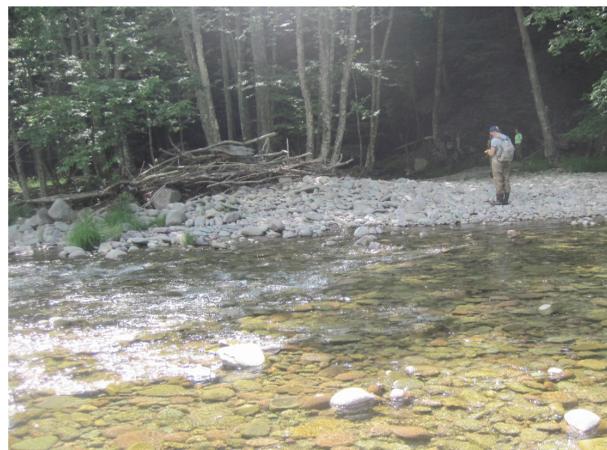
Divergence of flow into side channel (B327)

An obstruction along the right bank at Station 5700 has caused a divergence of flow into a side channel, significant during high flows. (B327) The side was mostly dry at the time of this inventory, but had received flow at some point this year as was evidenced by the lack of leaf debris on the channel substrate. This channel flows up against the right valley wall and continues to follow the course of this exposed

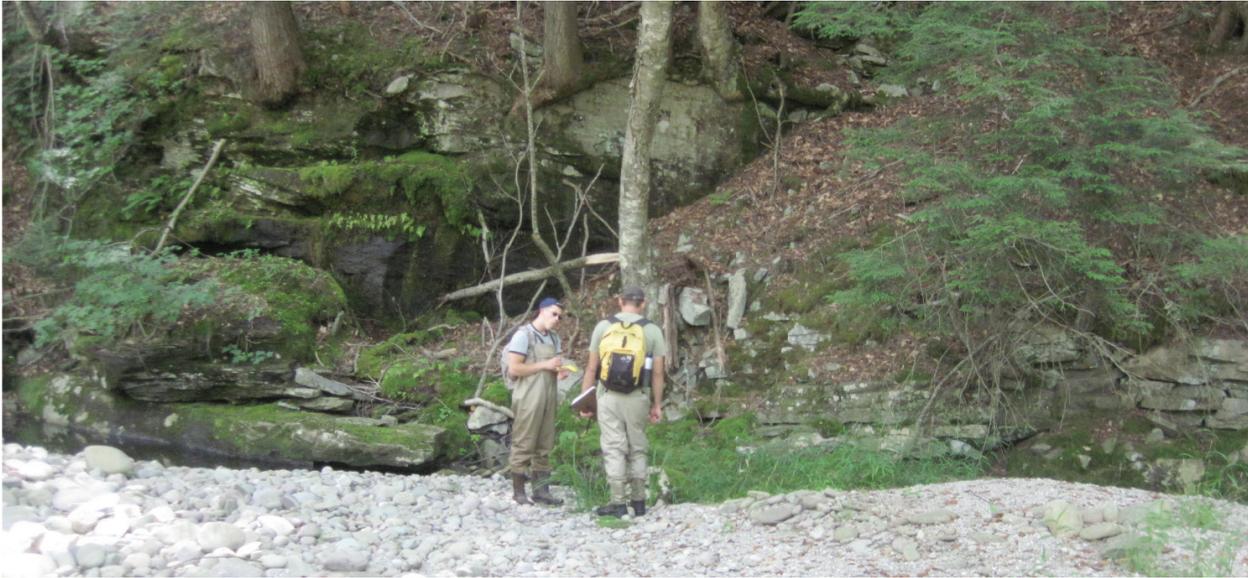
Bedrock along right valley wall (B328)

bedrock before converging back with the main channel further downstream in EBMU2. (B328) Fallen trees are causing a large obstruction in the side channel at Station 5350. (B332)

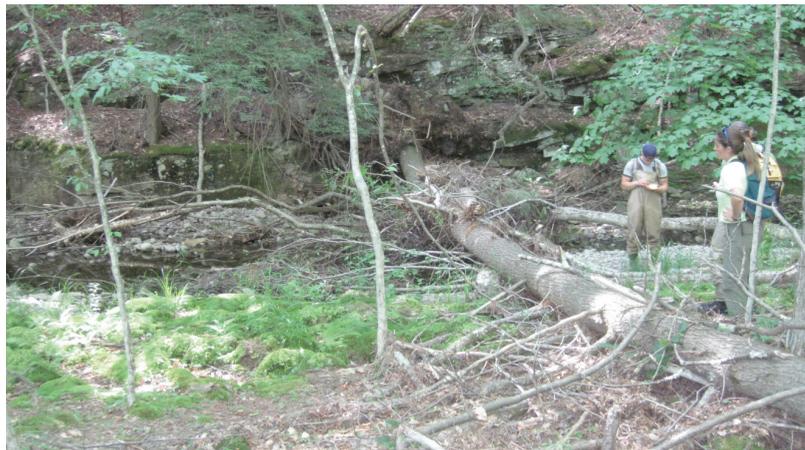
Large obstructions in side channel (B332)
