# Neversink River East Branch

## MANAGEMENT UNIT 4

EAST BRANCH MANAGEMENT UNIT 4  
BETWEEN STATION 13450 AND STATION 9200

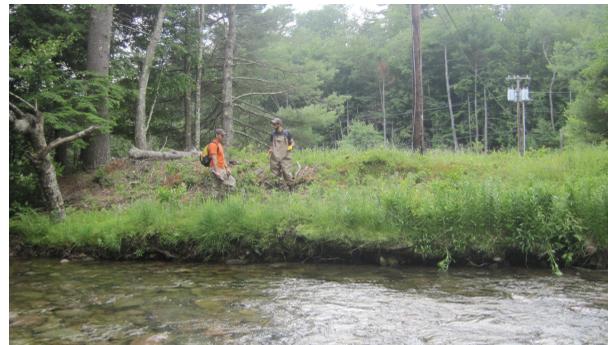
*Berm on right bank (B209)*

An old berm begins along the right bank at Station 12900, continuing approximately 400-feet to Station 12500. (B209) This berm consists of old sidecast stream and earthen materials, including cobble sized stones. It appears to be unmaintained and overgrown, and was most likely installed to prevent high flows from reaching Denning Road. Power lines cross the channel just upstream of the

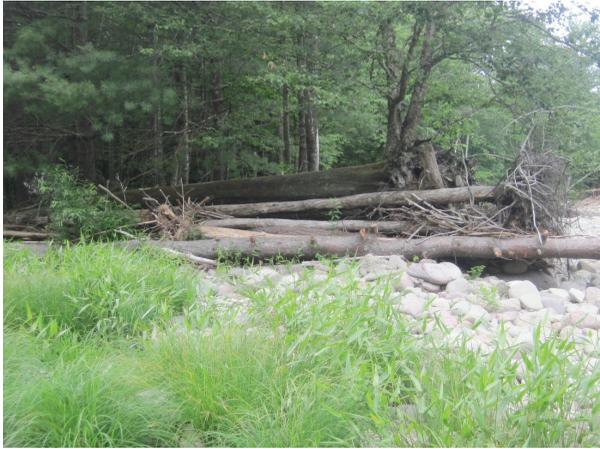
at Station 12100. A woody debris obstruction causes flow to split into two separate channels at Station 11900. This division of flow has effectively reduced the power of the stream in this reach, as is evidenced by the excessive sediment deposition present here. (B216) The channel that diverges to the right flows very close to Denning Road and various building structures with little to no riparian vegetation present. These

*Woody debris causing diversion (B216)*

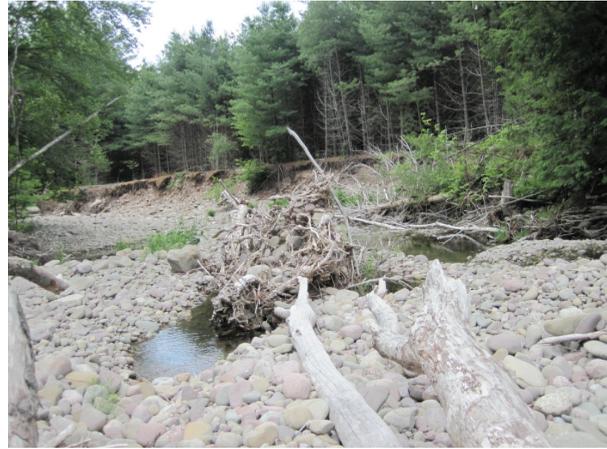
*Obstructions and aggradated channel (A222)*

structures are very high risk of inundation and subsequent property damage during large events. This right channel is heavily aggraded, forcing the flow to braid through and around depositional areas. Large woody debris has deposited at Station 11800 and Station 11600, most likely obstructing any significant flows. (A222) Hydraulic erosion is evident along the right bank in two locations in the right channel.

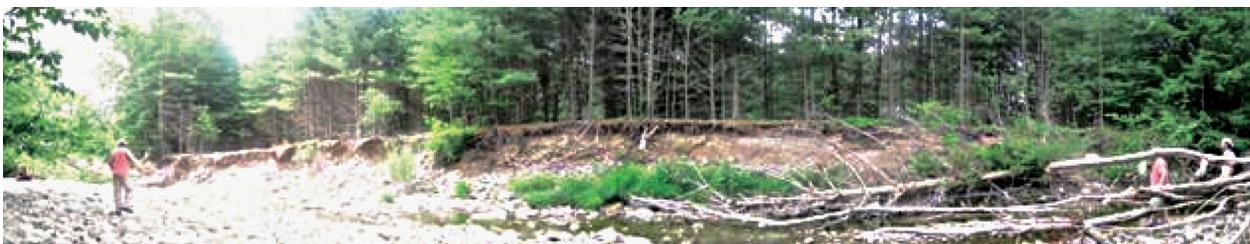
The first begins at Station 11600, continuing approximately 125-feet until Station 11475 (BEMS ID # NEB4\_11500). (Stitched A224-229) The glacial till that makes up this bank is exposed and entrained during high flows. Historical aerial imagery indicates that during the time period that the stream was stable it stayed in the left channel and did not flow past this eroding bank. Remediation of this bank may be part of a potential full channel restoration which would move all of the flow back into the historic channel (full restoration) and prevent any flows from reaching this unstable bank. Large woody debris obstructions are evident at the upstream and downstream ends of this site and are contributing to the erosion problems. (A232)

*Hydraulic erosion along right bank (A224-229)*

A riparian buffer including woody vegetation can strengthen the stream bank and slow erosive forces of higher flows during flood events. Therefore, recommendations for this site include assisted restoration with planting and possibly bioengineering techniques to stabilize the bank.

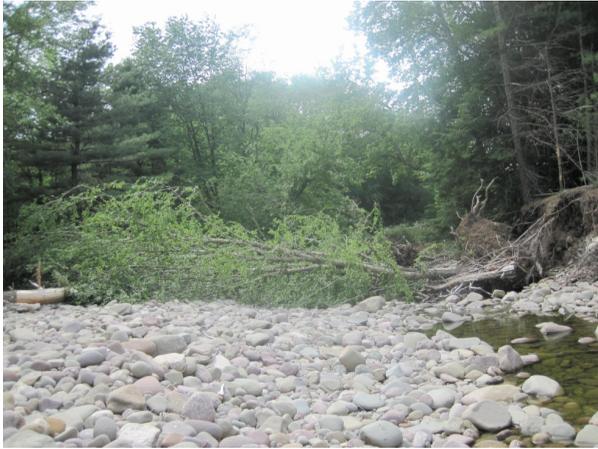
*(A232) Obstructions contributing to erosion*

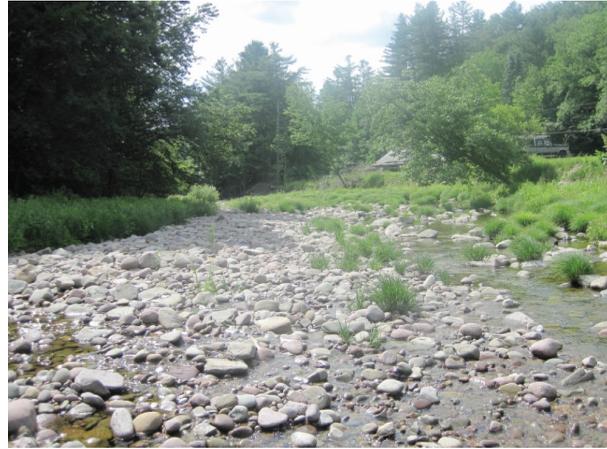
The second erosion site in the right channel begins at Station 11040 and continues downstream for 340-feet until Station 10700 (BEMS ID # NEB4\_10700). (A234) Sedges have established at the toe of this bank which have aided in stabilization, allowing the site to re-vegetate without assistance. However, because there is no mature woody vegetation present, this bank is still at risk for further erosion during large events. Flood damage to the building structures along this bank is very likely.

*(A234) Looking downstream of right channel*

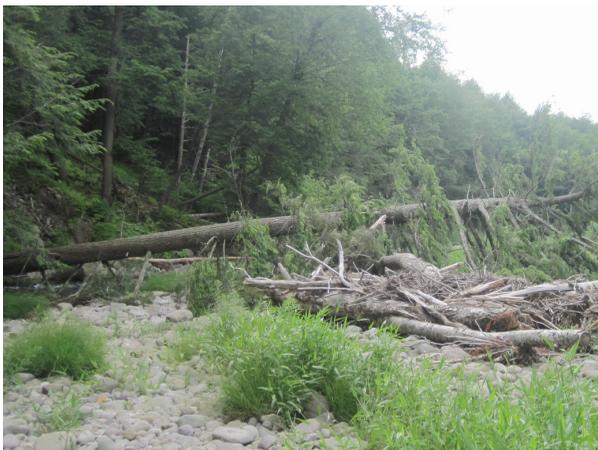
*(B221) Fallen trees obstructing flow*

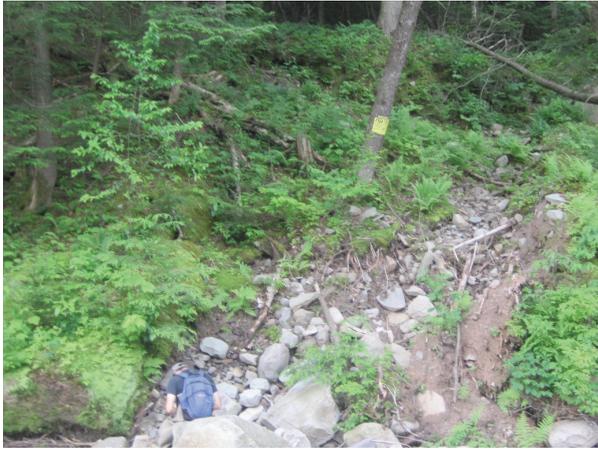
*(B224) Hydraulic erosion on left bank*

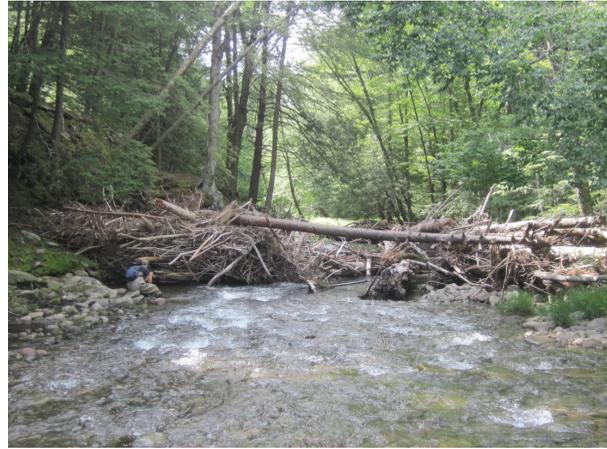
*(B230) Significant obstructions across channel*

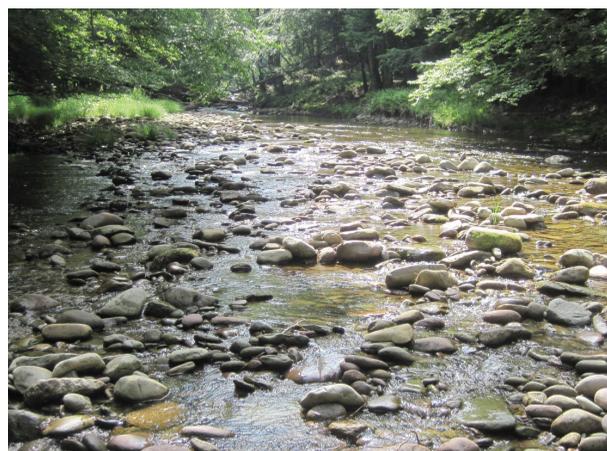
*(B243) Full channel aggradation*

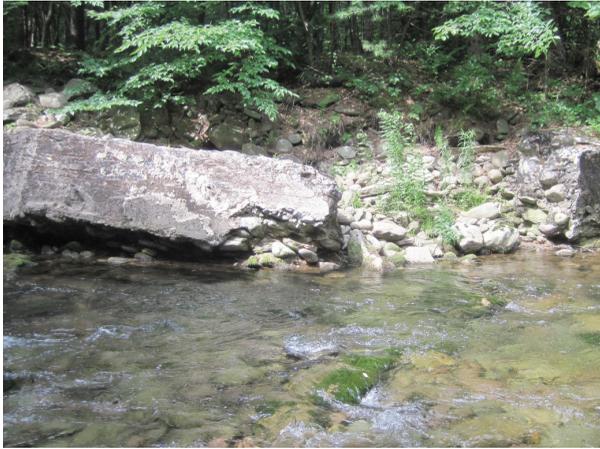
*(B244) Crumbled bridge abutment serving as revetment*

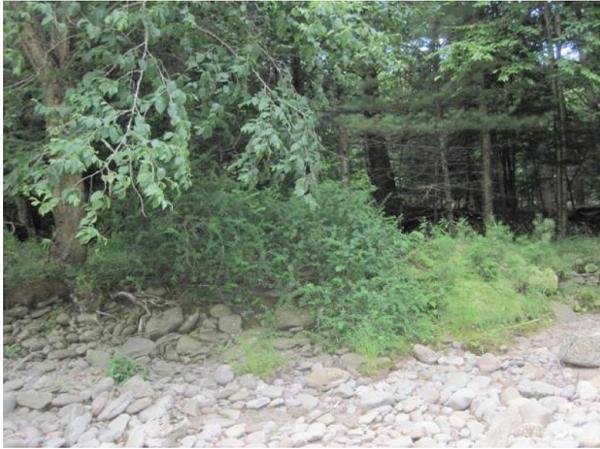
(A260) *Japanese Barberry, Invasive Species*

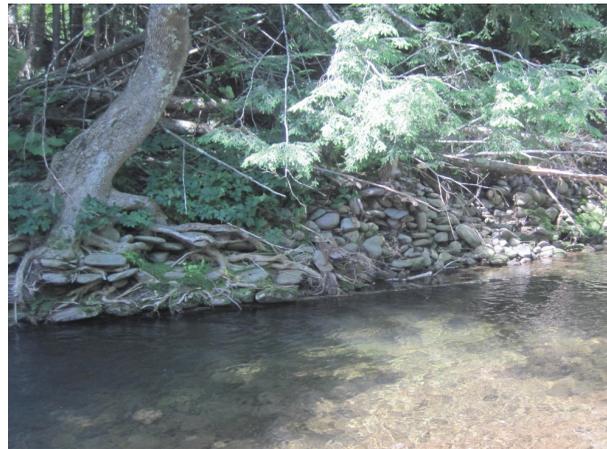
is approximately 60-feet in length, ending near Station 9930. (B248) Directly downstream of this structure, the left bank shows signs of hydraulic erosion beginning at Station 10020, continuing downstream for 45-feet until Station 9975 (BEMS ID # NEB4\_9900). (B249) Although this erosion was not severe at the time of this inventory, it does not appear that it will be able to stabilize without treatment. Therefore, recommendations for this bank erosion site minimally include monitoring for significant changes in condition and possible assisted restoration.

(B249) *Hydraulic erosion downstream of revetment*

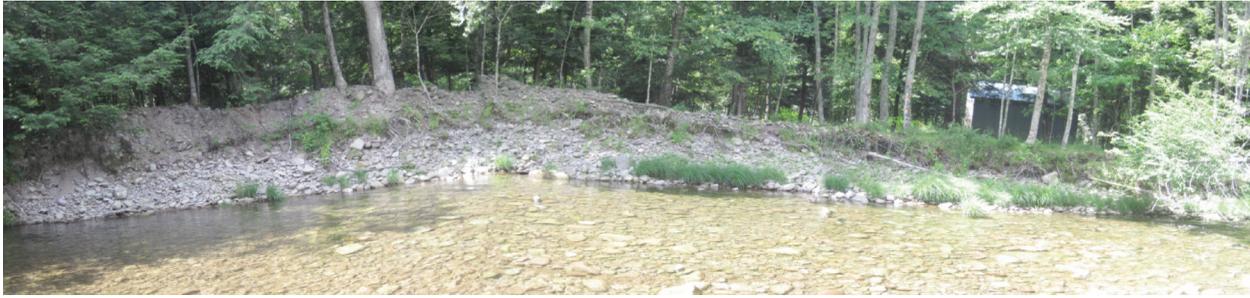
A more severe erosion site begins along the left bank at Station 9940, continuing approximately 85-feet to Station 9855 (BEMS ID # NEB4\_9800). (Stitched B251–253) Hydraulic pressure put on this 10-foot high bank has exposed cobble sized materials which are entrained during high flows. The erosion of this bank puts nearby building structures at a high risk of damage during flood events. Although some sedges have established at the toe of the bank, it does not appear that it will stabilize without treatment. *Assisted restoration* for banks stabilization is recommended for this site.

*(B251-253) Severe hydraulic erosion on left bank*

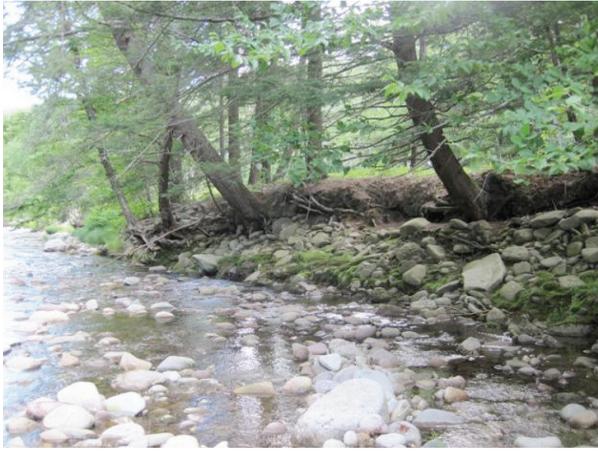
*(A284) Erosion on right bank*

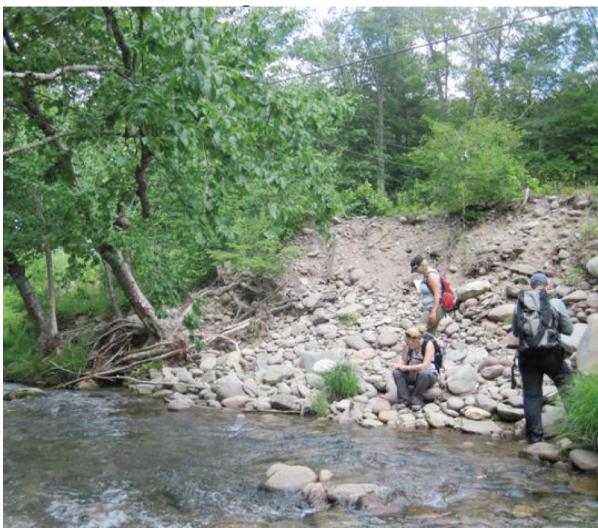
Along the right bank, erosion begins at Station 9340, continuing for approximately 60-feet to Station 9280 (BEMS ID# NEB4\_9300). (A298) Hydraulic pressure has destabilized this bank exposing alluvial cobbles and silt particles that can be entrained during high flows. The finer silts near the top of the bank are a potential source of fine sediment and turbidity issues. This erosion is located only 20-feet from the road with little to no riparian vegetation, and therefore is not likely to stabilize naturally. Recommendations for this bank erosion site minimally include monitoring for significant changes in condition and possible assisted restoration to stabilize the bank.

*(A298) Erosion along right bank*

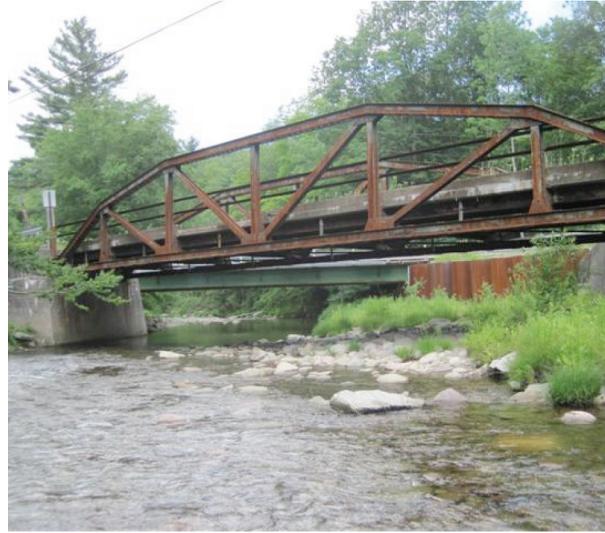
*(A304) Denning Road Bridge*

EBMU4 ends near Station 9200 where Denning Road crosses the stream channel. *(A304)* Due to the poor structural and functional condition of the original bridge, it was not in use at the time of this inventory. A more recently installed bridge just downstream is currently being used to allow traffic to pass over the stream channel. Abutments for both of these bridges are encroaching on the wetted channel and are affecting the stream's ability to transport sediment through this reach. A significant amount of sediment aggradation was documented upstream and underneath these structures, typical of bridges with which the abutments are not spaced wide enough to accommodate large flows. Further assessment is recommended to determine potential hazards associated with flood conveyance and sediment transport at these bridges.
