# Neversink River East Branch

## MANAGEMENT UNIT 5

**EAST BRANCH MANAGEMENT UNIT 5**  
**BETWEEN STATION 18600 AND STATION 13450**

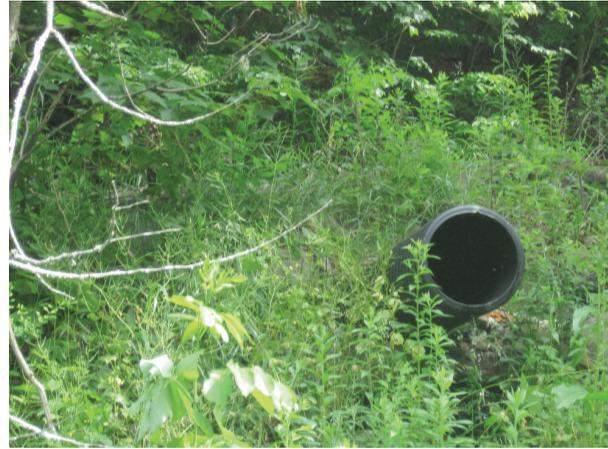
EBMU5 begins just downstream of where a bridge crosses Denning Road over the stream channel at Station 18700. As described in EBMU6, this bridge is in good condition but may not be constructed wide enough to effectively convey large flows. A plastic culvert conveys road drainage from the right side of the stream, making it a potential source for contaminants from road runoff. It is likely that this drainage contributes

chlorides (salt) and petroleum by-products from road runoff to the Neversink. (B130)

*Plastic culvert conveying road drainage on right bank (B130)*

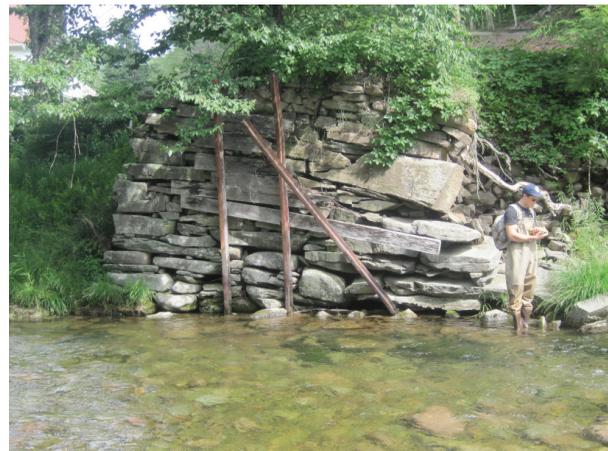
At Station 18400 relict bridge abutments now serve as control points to high flows on both sides of the stream. (B132) There is a house on the right bank that is less than 100-feet from the stream and at risk during flood events. There is very little mature riparian vegetation on this bank, which does little to mitigate flood risk or stabilize the bank. The left bank in this area also has insufficient riparian vegetation buffering the stream from the road. A stone berm begins at Station 18400 and continues downstream until Station 18230. (B135) This berm was most likely installed to prevent flood waters from reaching the nearby road. A riparian buffer including woody vegetation can restore the forest connectivity and help mitigate flood threats to surrounding infrastructure. It is highly recommended that both the left and right banks from Station 18600 and Station 18000 be assessed for restoration using riparian planting techniques.

*Relict bridge abutment controlling high flows (B132)*

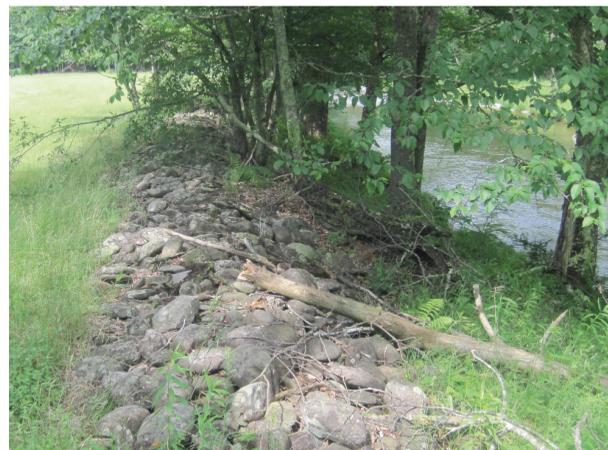
*Stone berm on left bank (B135)*

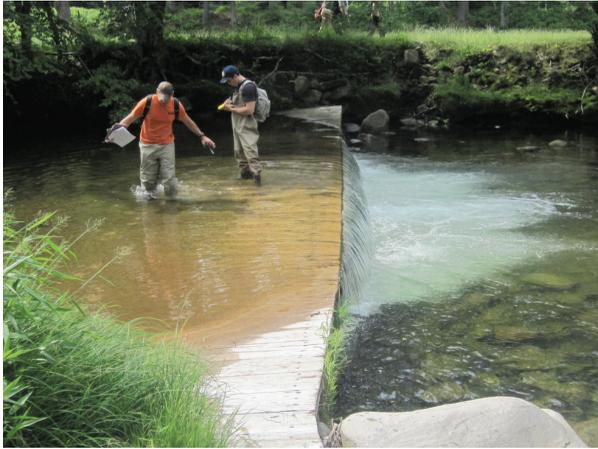
At Station 18100 there is an old wooden dam that spans the entire width of the stream and is supported by large boulders on both sides. (B137) This structure appears to have been placed to provide habitat for trout. The water faces an abrupt vertical drop as it flows over the dam, resulting in a deep scour pool below. The structure appears to be relatively new and continues to function for the creation of habitat. Structures such as this were observed frequently in the East Branch of the Neversink River.

*Wooden dam spanning length of stream (B137)*

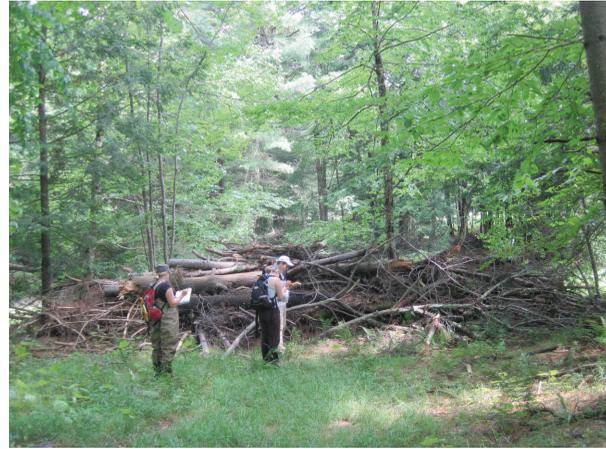
Continuing downstream, the riparian zone becomes well forested on both sides of the stream after Station 18000. A large pile of woody debris has accumulated in the left floodplain at Station 17900. (A120) Deposition this far from the active

*Woody debris accumulation on left floodplain (A120)*

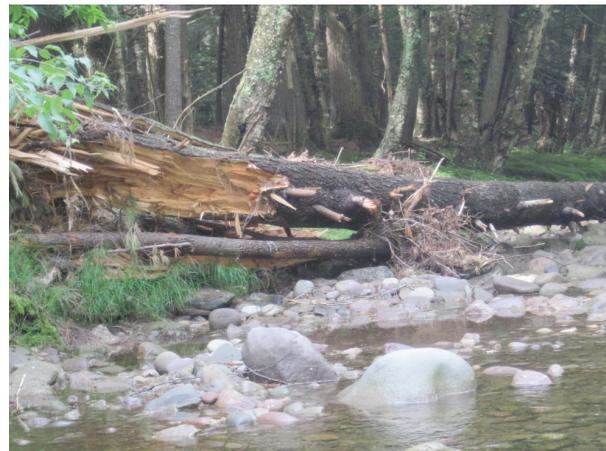
*Large woody debris contributing to sediment accumulation (B141)*

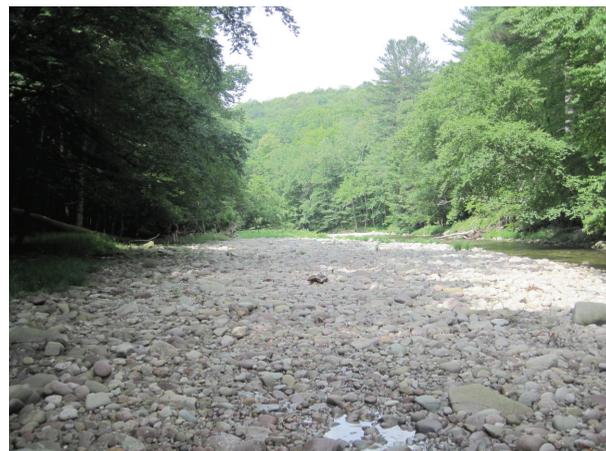
*Cobble side bar along left side of stream (A125)*

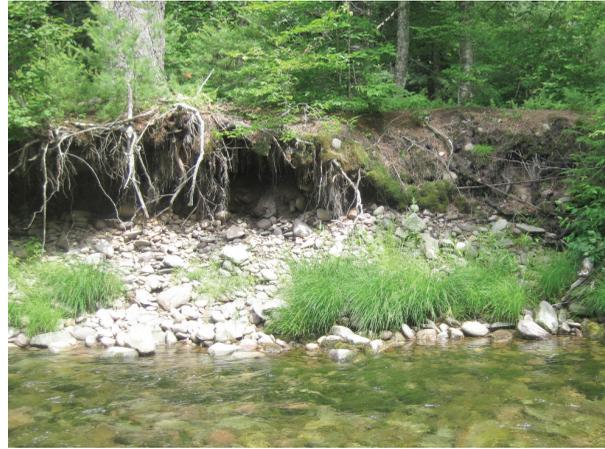
*Hydraulic erosion on right bank (B155)*

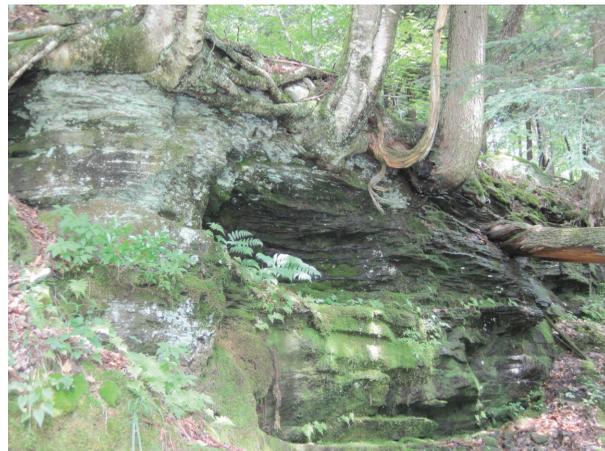
The stream flows into contact with the right valley wall at Station 17200 and is forced into a relatively sharp left turn. (A146) This exposed bedrock control continues downstream for approximately 90-feet to Station 17110. The right valley wall effectively cuts off floodplain connectivity on the right side for the remainder of EBMU5. A small tributary enters from the right bank at the upstream end of the bedrock wall. (A143) On the left side opposite of the bedrock wall, large boulders are preventing the stream from moving laterally into the left floodplain at Station 17000. Sediment is being stored in the form of a lateral bar beginning at Station 16900 and continuing approximately 100-feet downstream. (B161)

*Bedrock control along right valley wall (A146)*

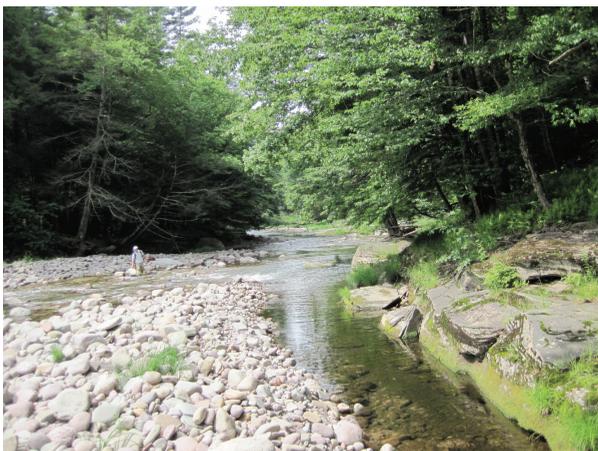
*Small tributary entering on right (A143)*

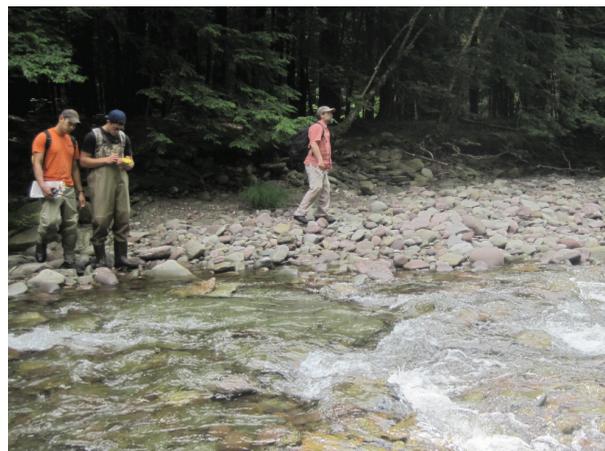
*Lateral bar (B161)*

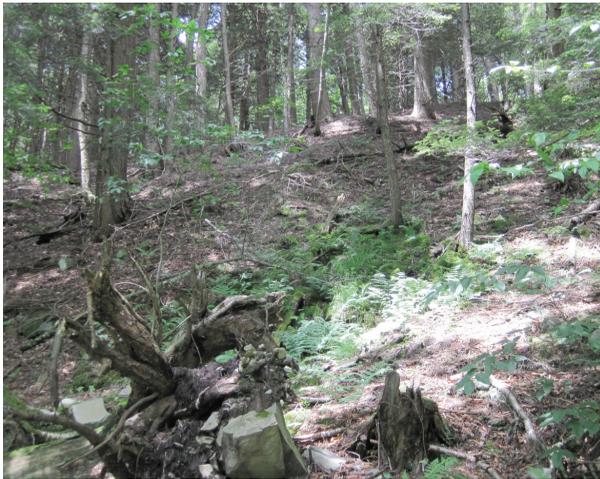
A series of re-vegetated hill slope failures begins along the right bank at Station 16760, continuing approximately 580-feet until Station 16180 (BEMS # NEB5\_16100). (A165) At one point this steep length of bank was destabilized, most likely through hydraulic erosion of the toe. However, at the time of that this stream feature inventory was conducted, the slope appears to

*Re-vegetated hill slope failure (A165)*

have reached an angle of repose and maintains established mature vegetation. It is likely that this site will remain stable without treatment (passive restoration); however, it is recommended that it be monitored for future changes in condition.

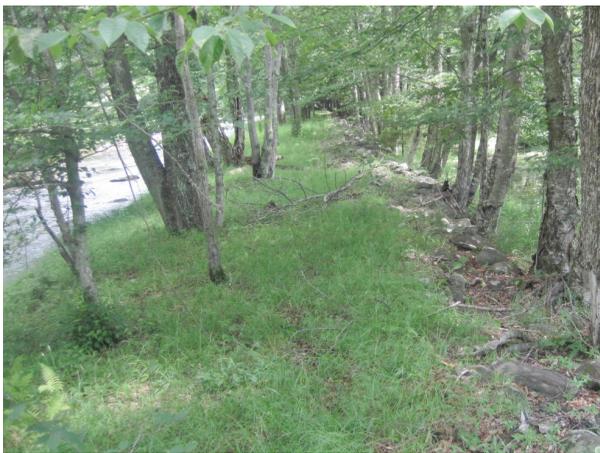
*Berm along left bank (B165)*

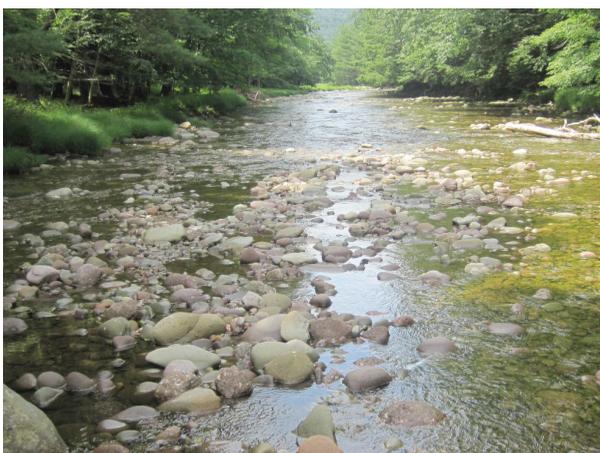
*Significant channel aggradation (B169)*

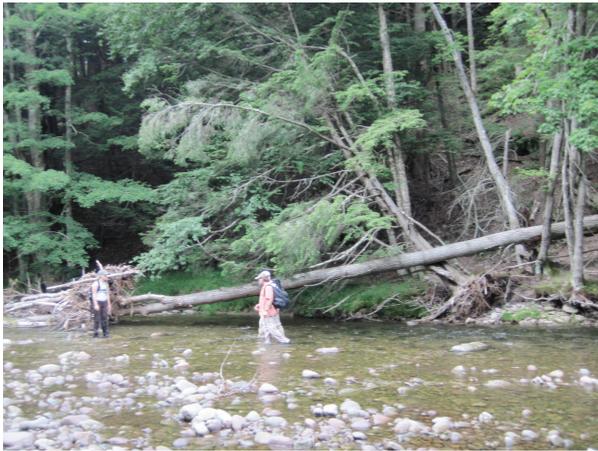
*Woody debris deposition (A168)*

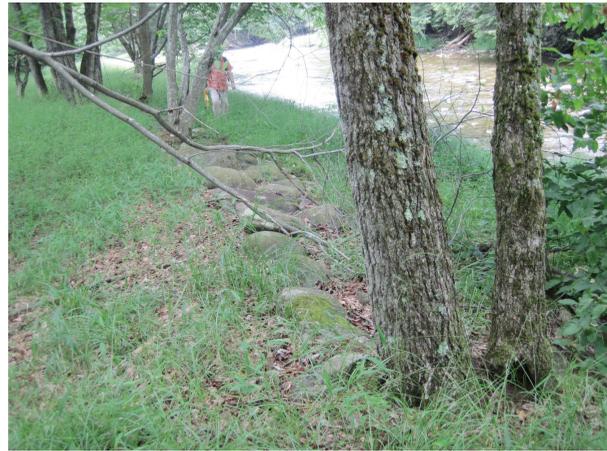
nearly 200-feet to Station 15400. The second begins at Station 15400 and continues downstream for approximately 120-feet. Both of these revetments appear washed out and ineffective. (A174)

*Washed out stacked rock revetment on left bank (A174)*

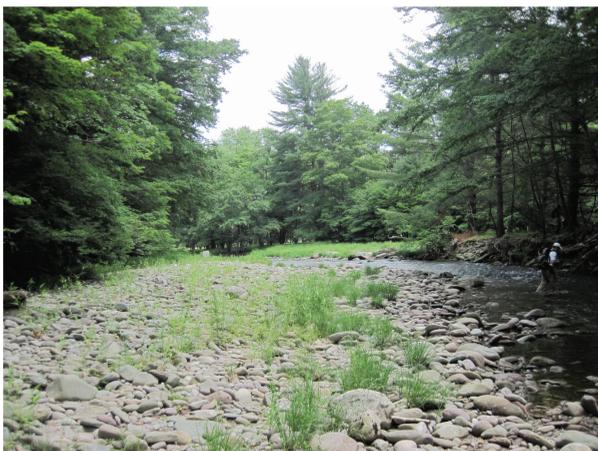
A side bar begins on the right side across from the downstream end of the revetment at Station 15320, continuing approximately 200-feet to Station 15120. (A189) The width of this depositional bar varies between 50 and 70 feet. Large woody debris has deposited on the bar at Station 15300, causing an obstruction to flow and contributing to the accumulation of sediment. (A187) Another woody obstruction was documented on the left side of the stream across from the berm at Station 15250. This obstruction is causing a diversion of flow into a small side channel in the left floodplain.

*Side bar on right (A189)*

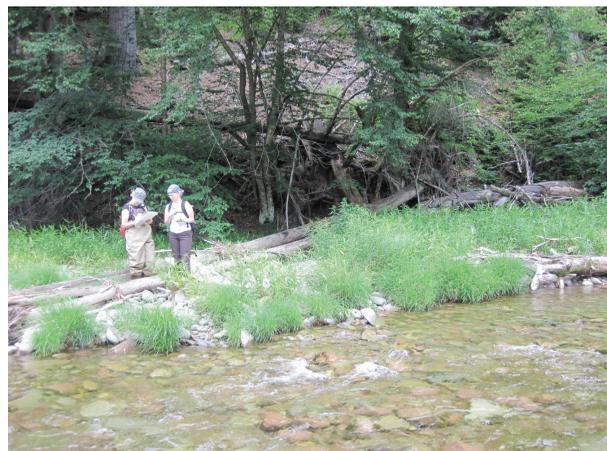
*Large woody debris deposited on side bar (A187)*

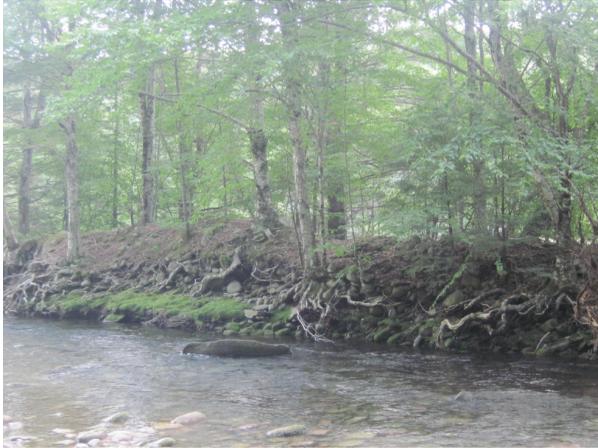
Just downstream of the channel divergence, a 130-foot long berm starts along the left bank at Station 15200. (B180) This structure was likely intended to prevent flows from reaching the side channel, but appears to be relatively old as it has mature trees growing through it. A significant amount of cobble sized

*Berm on left bank (B180)*

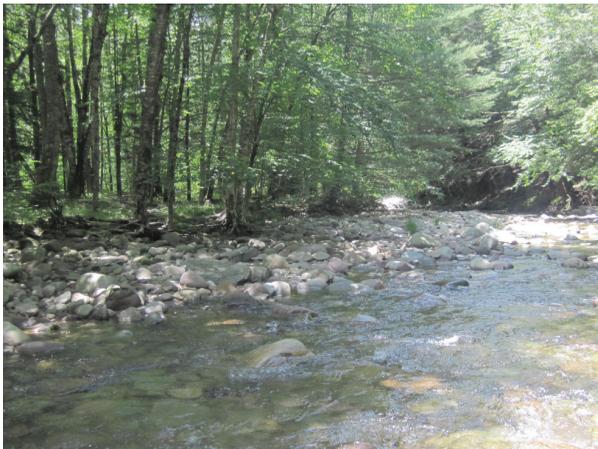
*Cobble side bar (B181)*

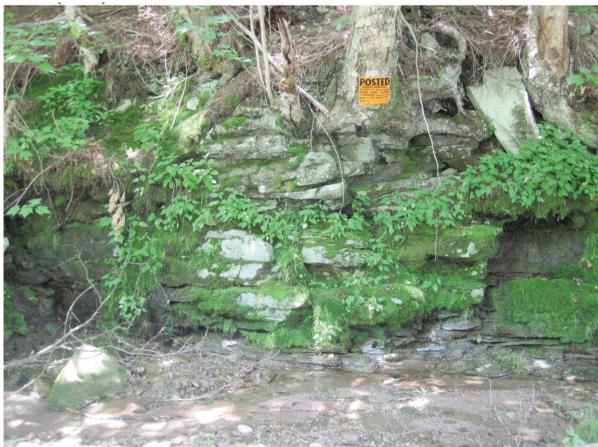
*Small drainage entering through right bedrock wall (A193)*

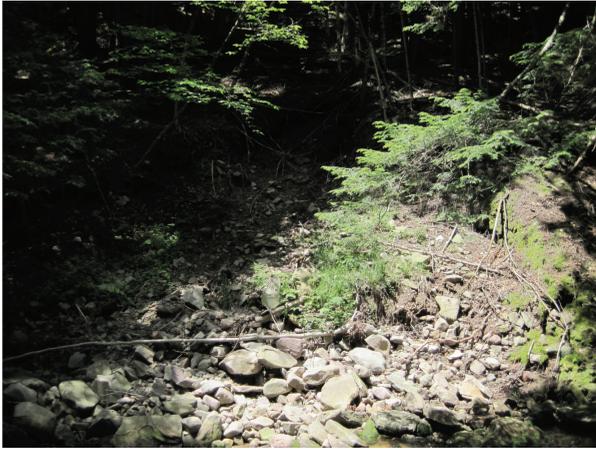
The right bank is experiencing hydraulic erosion for approximately 75-feet, beginning at Station 14910 and continuing until Station 14835. (A194) At one point scour of the toe caused the bank materials to slide down at this location. However, at the time of this stream feature inventory it appeared that this bank had reached an angle of repose and should be able to recover without assistance (passive restoration). Large rocks accumulating at the toe of the bank will further assist in natural re-stabilization of this bank. However, it is recommended that this site be evaluated for future changes in condition.

*Erosion along right bank (A194)*

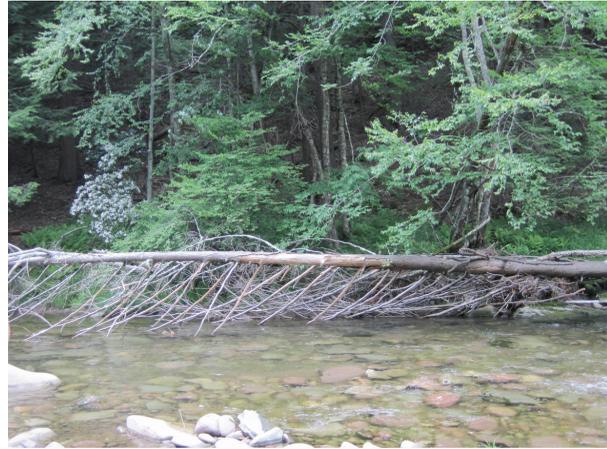
*Obstruction causing deposition upstream (A197)*

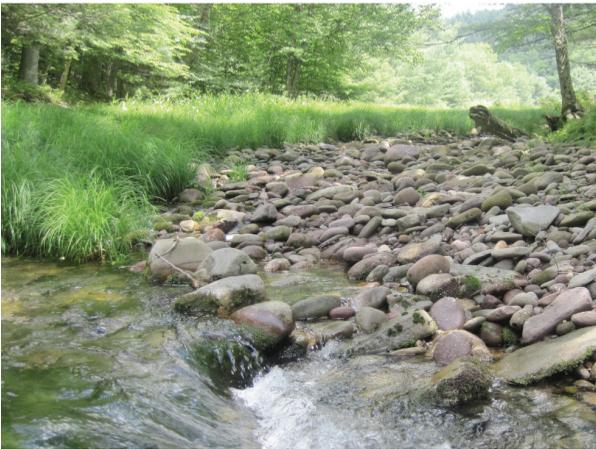
*Convergence with side channel (B185)*

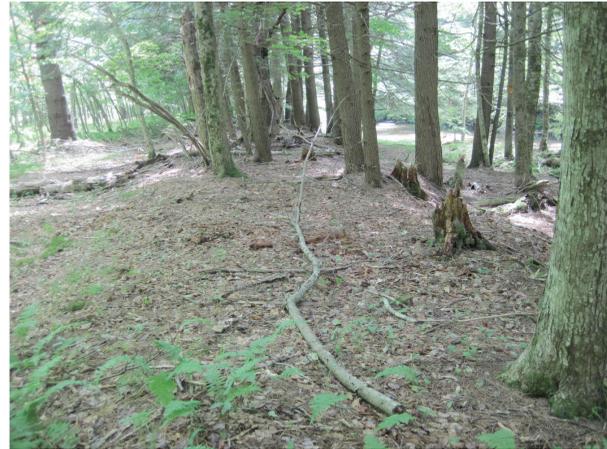
*Well vegetated berm on left bank (A201)*

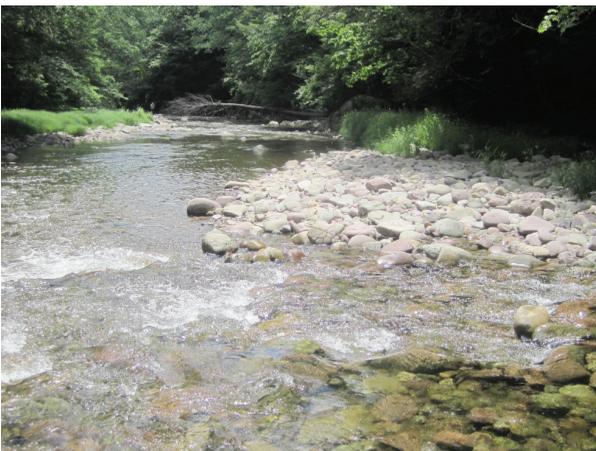
*Lateral bar consisting of cobble sized material (B187)*

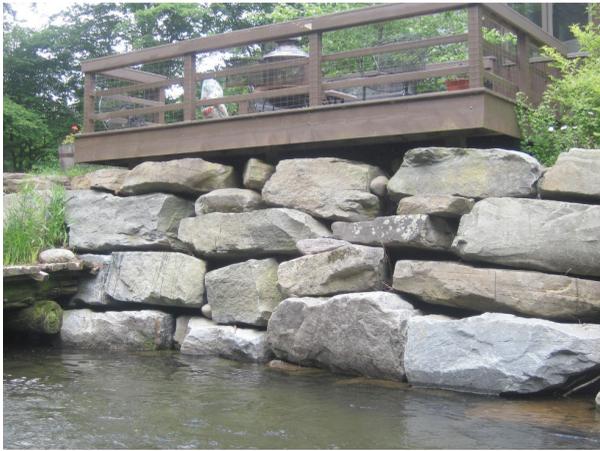
*Stacked boulder wall along left bank (B196)*

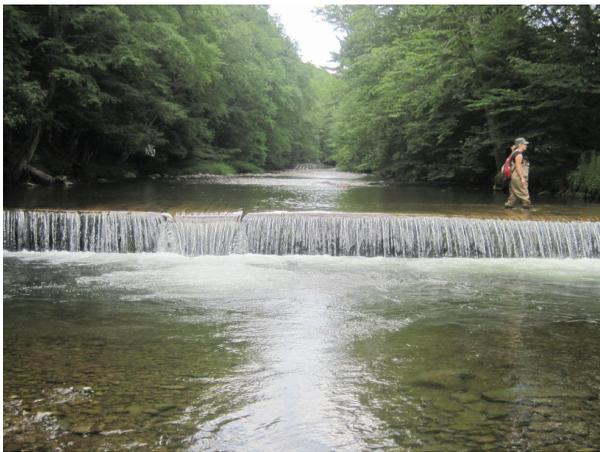
*Looking upstream at wooden dam (B195)*

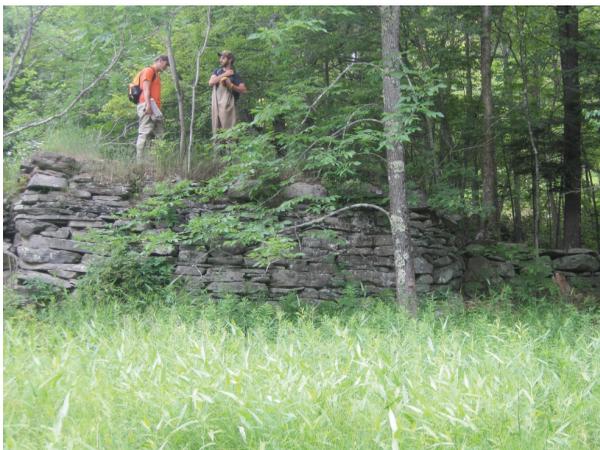
*Stacked rock wall revetment along right bank (B199)*

A stacked rock wall leading up to an old bridge abutment is now serving as a revetment along the right bank between Station 13650 and Station 13550. (B199) The stacked revetment was likely intended to protect the private driveway that runs behind it, but has since fallen into disrepair. The relict bridge abutment represents the location where the road used to cross this section of the East Branch years before the current bridge was constructed.

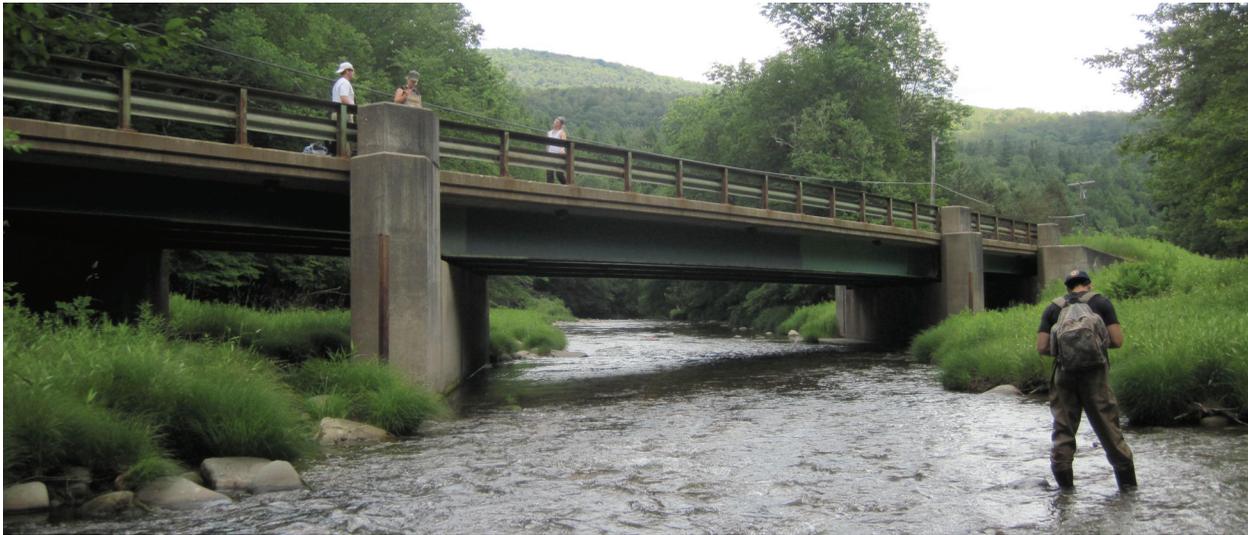
EBMU5 ends at Station 13450 where the stream is again crossed by a bridge on Denning Road. (A204) This bridge appears to be in good structural condition, but does encroach on the bankfull channel by several feet on both sides of the stream. Improper spacing of bridge abutments does not allow the bridge to effectively convey large

*Denning Road bridge (A204)*

flows and can cause a backwatering effect which can lead to excessive sediment deposition and flooding of nearby infrastructure. This bridge is most likely a contributor to the numerous points of channel aggradation documented in this management unit, and should be assessed for associated flood risks.
