Neversink River East Branch

MANAGEMENT UNIT 6

EAST BRANCH MANAGEMENT UNIT 6
BETWEEN STATION 25030 AND STATION 18700

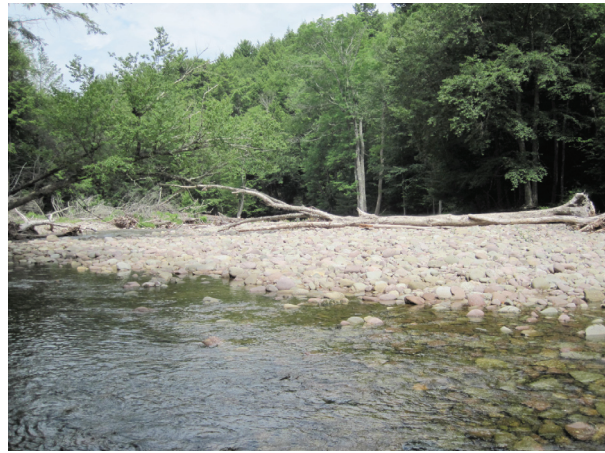
The East Branch of the Neversink River continues to move away from the left valley wall as it enters EBMU6, maintaining a densely forested left floodplain at the top of this management unit. The trend of sediment deposition and aggradation that was evident in previous management units upstream continues here, beginning with the formation of a point bar on the right side at Station 25000. (B36) This bar

is approximately 200-feet in length, ending at Station 24800. The accumulation of large woody debris on the point bar is contributing to the diversion of a portion of stream flow into a side channel to the right.

Point bar on right side of stream (B36)

Historical aerial imagery of this reach indicates that the channel has migrated significantly since 1980, most likely due to the deposition of large woody debris and resulting obstruction to flow. A large amount of woody debris has accumulated across the channel at Station 24700 and is diverting flow out of the historical channel and towards the right bank. (A31) As the water is forced in this direction, the hydraulic pressure put on the right bank during high flows has resulted in approximately 120-feet of erosion from Station 24730 to Station 24610 (BEMS # NEB6_24600). (A30) If the woody obstructions were removed from the channel, it is possible that flow would return to the historic channel and alleviate the pressure on this bank. The rooting depth of the mature trees already present on this bank will help to provide stability to any exposed soils. Therefore, assisted restoration is recommended at this site for the removal of large woody debris obstructions.

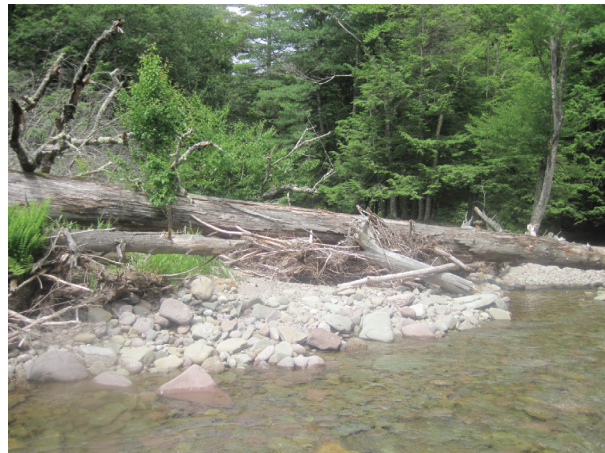
Large woody debris diverting flow (A31)

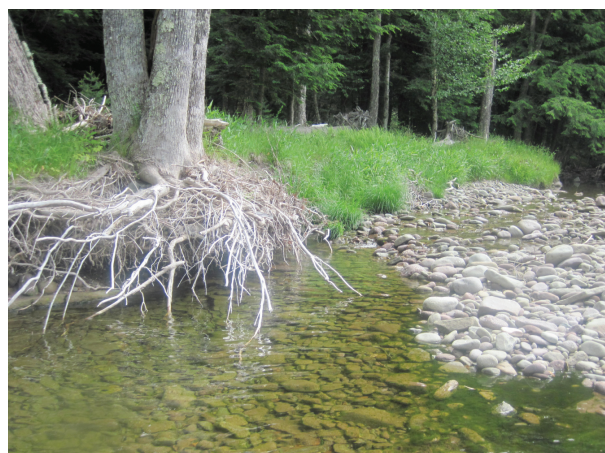
Erosion on right bank (A30)

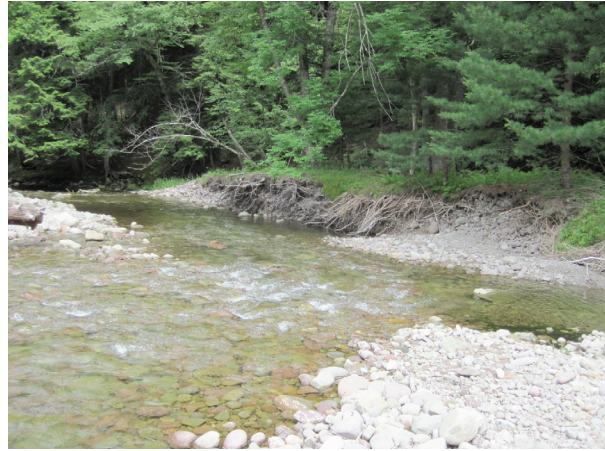
The side channel which previously diverted to the right converges with the main channel at Station 24730. The elevation of the stream bed in the main channel is significantly higher than that of the side channel. As flow from the main channel enters the convergence, it experiences enough of a vertical drop to cause scour. This continuous scour is resulting in a headcut which is actively migrating up the main channel, and will continue to do so until it meets a substrate that is not erodible. (B38)

Headcut migrating upstream (B38)

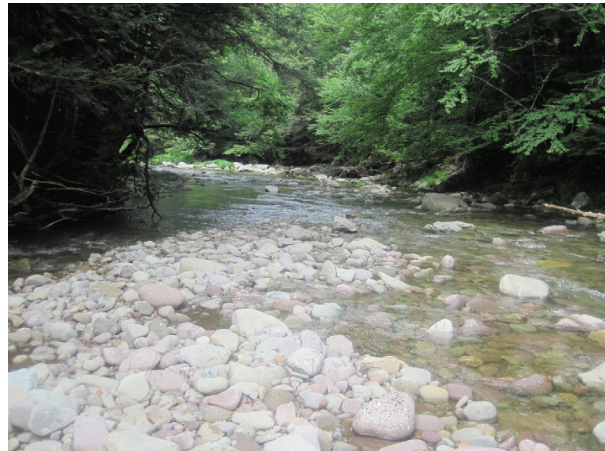
(A33) Large woody debris has deposited and caused obstructions to flow at several locations around this meander bend. Large trees have become lodged along the right bank at Stations 24500, 24300, 24030, and 23970. (A37) A dry relict side channel enters from the left floodplain at Station 23950.

Convergence with historic channel (A33)

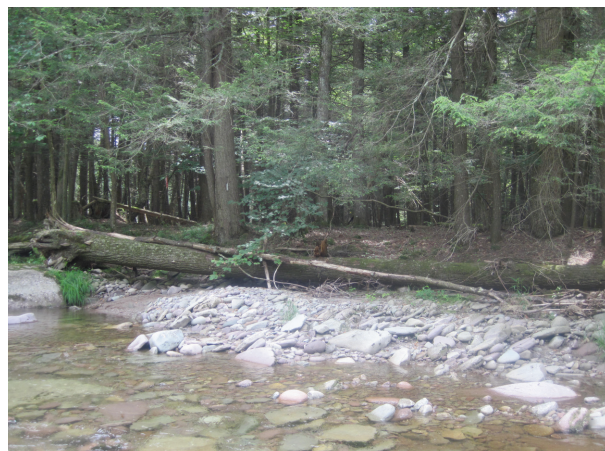
Large trees lodged on right bank (A37)

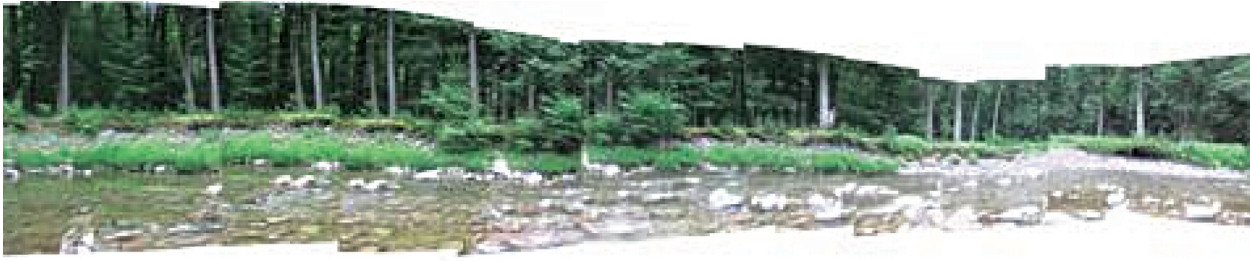
The left bank begins to erode and expose cobble sized materials as the channel approaches the point of the meander bend at Station 23820. This bank erosion is caused by hydraulic pressure as flow begins to make the turn around the bend, continuing approximately 190-feet before ending at Station 23630 (BEMS # NEB6_23600). (A43-60 *Stitched*) Large rocks are beginning to deposit at the toe of this eroding bank along with a healthy establishment of sedges, indicating that it is possible for this bank to stabilize without treatment (passive restoration). However, it is recommended that this site be monitored for changes in condition.

Left bank erosion (A43-60)

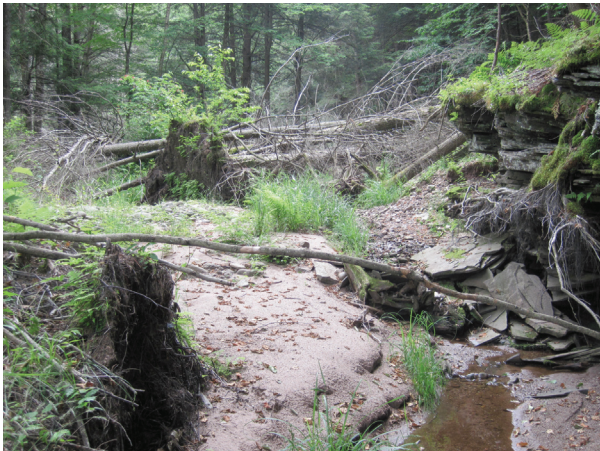
At the downstream end of the eroding bank a small perennial tributary enters from the left bank at Station 23630. (B45) The flow of this tributary was partially blocked by woody debris at the time that this inventory was conducted. A headcut exists in the same location as the stream flows over a series of boulders. (B44) On the opposite side of the stream, a point bar has formed on the inside of the meander bend. This depositional area is approximately 50-feet in length, ending at Station 23580. (A61)

Small perennial stream entering on left bank (B45)

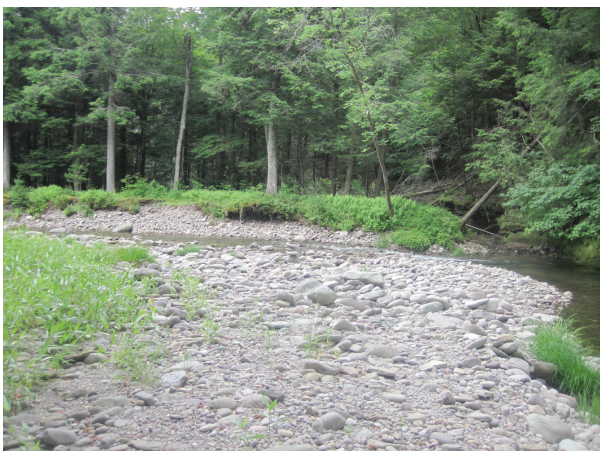
Looking upstream at point bar on right bank (A61)

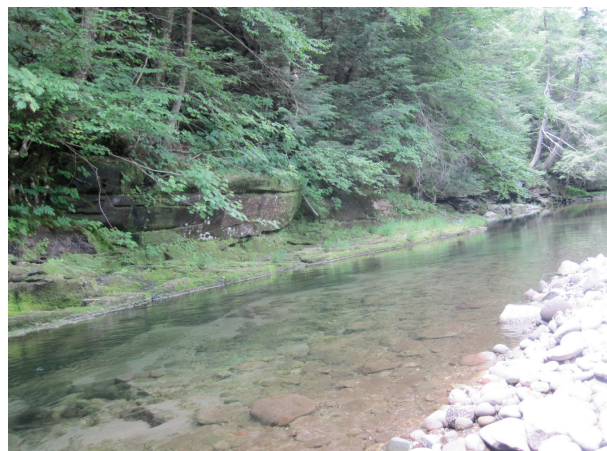
The channel hits the exposed bedrock of the left valley wall at Station 23600, which continues to control flow for approximately 300-feet until Station 23300. (B41) A spring enters through the upstream end of the bedrock wall, contributing a perennial source of cold water to the stream. As this exposed bedrock wall ends, the valley floor begins to open up on both sides allowing the

Exposed bedrock on left valley wall (B41)

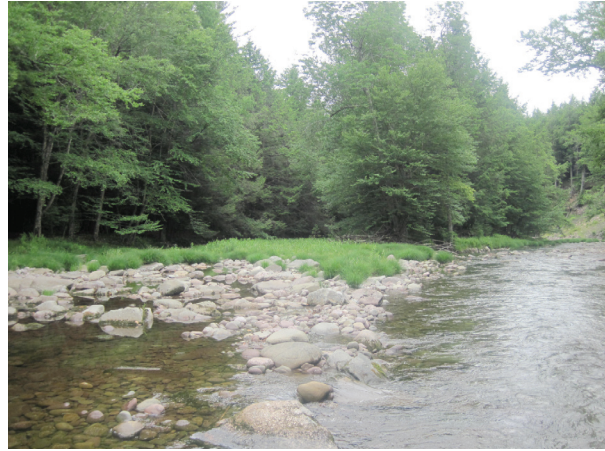
stream access to its floodplain during high flows. At Station 23390 a side channel diverges into the left floodplain. (A64) This side channel continues for approximately 560-feet before converging back with the main channel at Station 22760.

Channel diversion into left floodplain (A64)

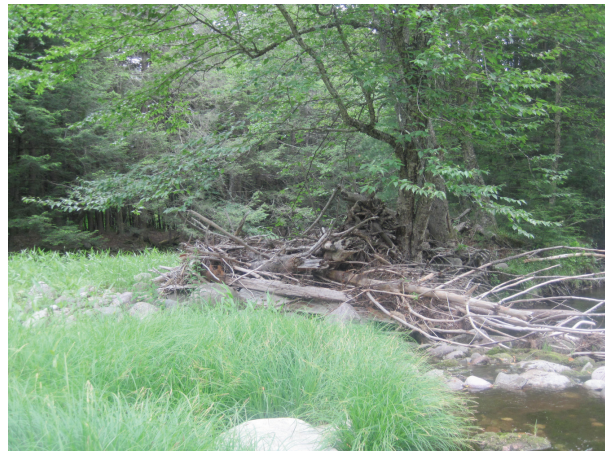
Continuing downstream, the stream begins to hug the right valley wall and large woody obstructions were documented along the left bank at Stations 23280 and 23120. (A69) Both of these obstructions were located above the water level at the time that this inventory was conducted, but could be of significant impact to higher flows. A massive bank failure begins at Station 23040, continuing approximately 220-feet until Station 22820 (BEMS # NEB6_22800). (A73–75) At some point hydraulic erosion at the toe of this bank destabilized the steep slope, causing mature trees to slide down with their roots intact and re-establish at a lower elevation on the bank. The establishment of these trees along with various shrubs and sedges near the toe indicate that this bank may have reached an angle of repose where it will begin to stabilize without treatment (passive restoration) (please double check, it is difficult to determine from the photos). Because glacial till is exposed at various points on the eroding bank and is a potential significant source of fine sediment, it is recommended that this site be monitored for future changes in condition.

Large woody obstructions (A69)

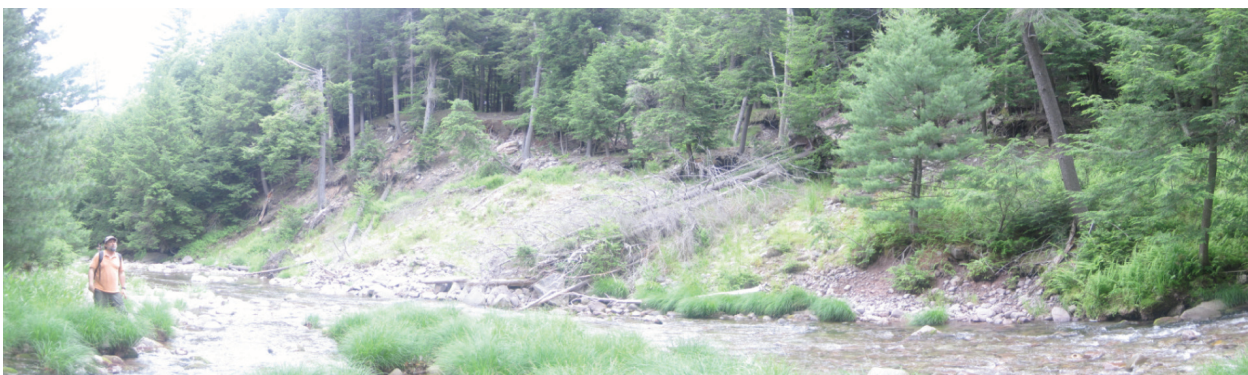
Massive bank failure (A73–75)

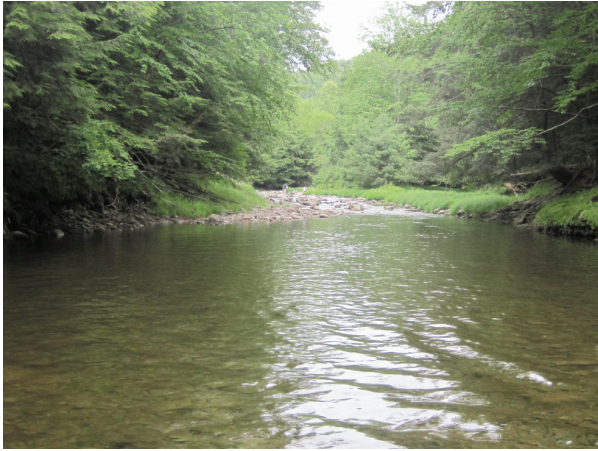
Straight aggraded main channel (B64)

At Station 22580, the channel becomes very straight and aggraded before entering a meander to the left. (B64) A hill slope failure exists on the right bank beginning at Station 22530, continuing approximately 110-feet to Station 22420 (BEMS # NEB6_22400). (B65–67) This failure appears to be able to recover without treatment (passive restoration), as evidenced by the establishment of a significant amount of herbaceous vegetation on the bank. There is a drainage that enters near the upstream end of the failure which carries storm water runoff from the road. (B71) Although the bank has recovered, water carried through this drainage always has the potential to saturate the bank and contribute to more failure. Therefore, it is recommended that this bank be monitored for future changes in condition.

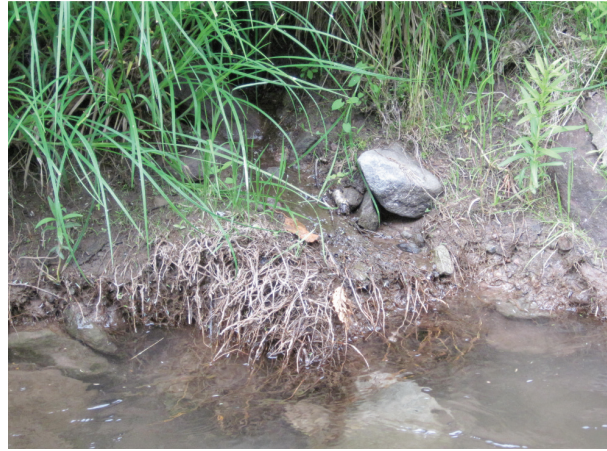
Road drainage entering stream (B71)

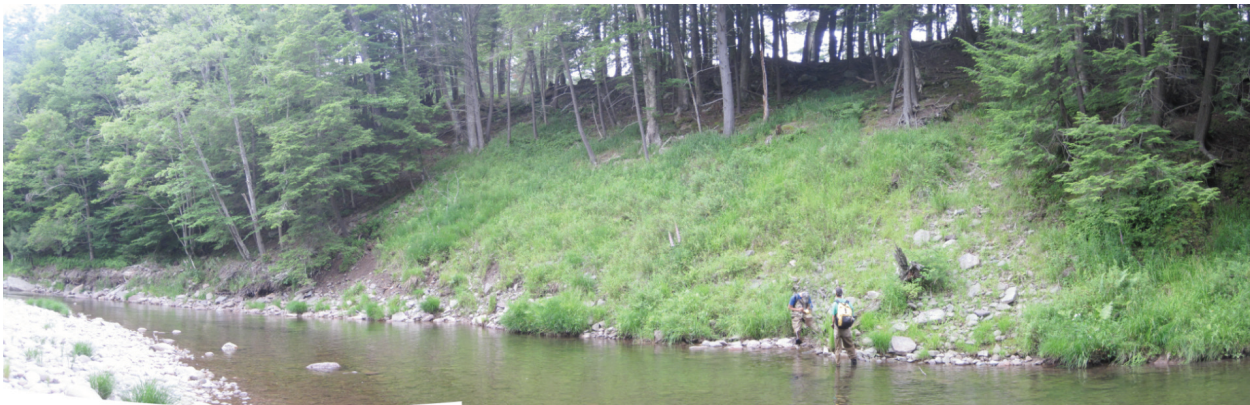
Hill slope failure on right bank (B65–67)

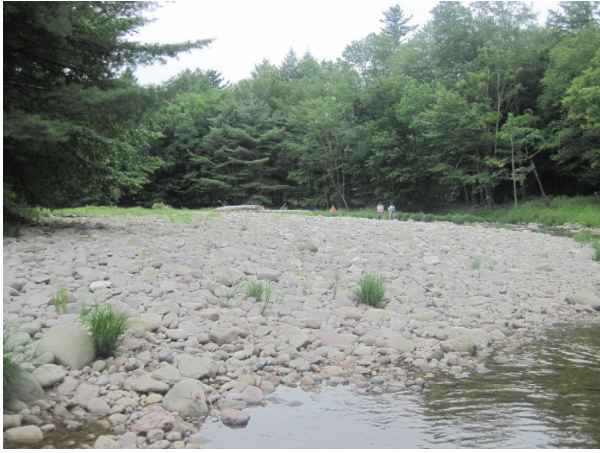
Point bar on left side of stream (A79)

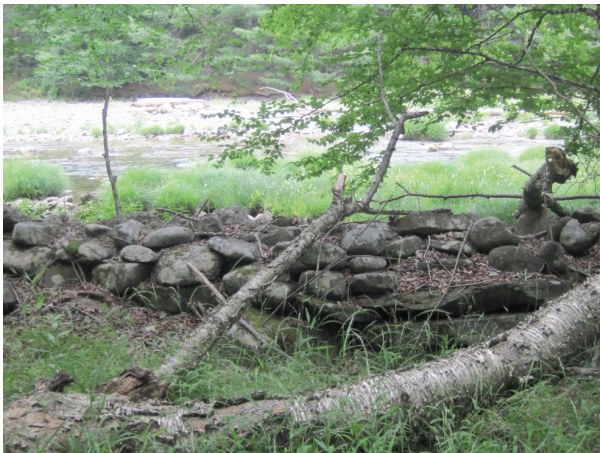
Stacked cobble berm on right bank (B77)

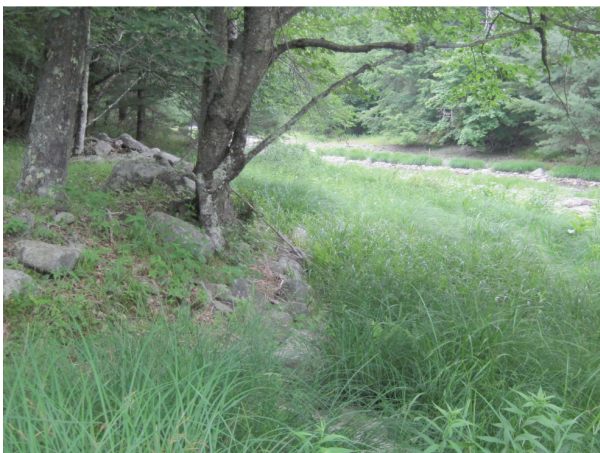
Stacked cobble berm on right bank (B81)

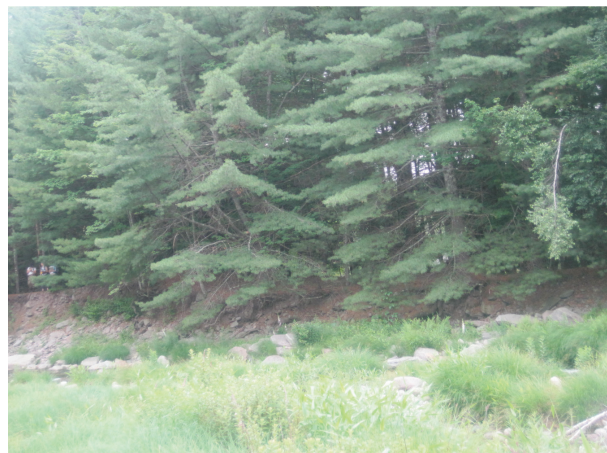
Older berm situated closer to the stream (A84)

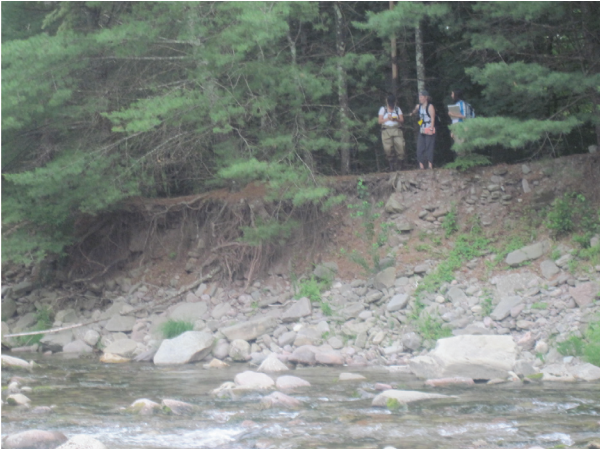
pressure on the steep section of bank (BEMS # NEB6_21900). (A85) Large rocks have deposited at the toe and are protecting it from further scour, indicating that this bank may stabilize without treatment (passive restoration). However, it is recommended that this site be monitored for future changes in condition.

Erosion of right bank (A85)

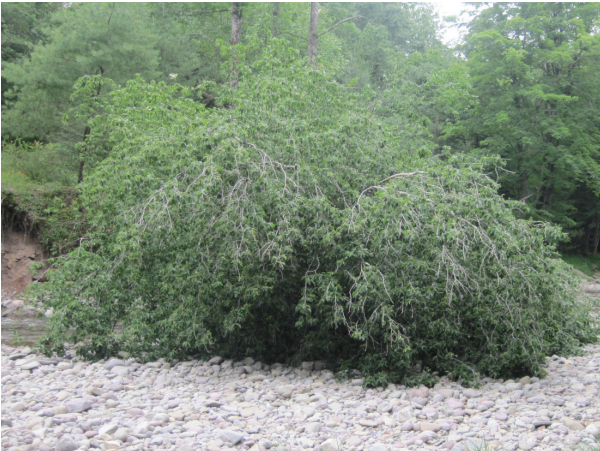
A large woody debris obstruction has deposited at Station 21650 (B92). This debris consists of a full mature tree that still had green leaves at the time of this inventory, indicating that it was deposited relatively recently. The obstruction is forcing flows into the left bank, and the resulting hydraulic pressure on the bank is causing erosion beginning at Station 21860, continuing approximately 180-feet to Station 21680 (BEMS # NEB6_21600). (B89) The materials in this bank consist of cobbles and coarse silts, which can be entrained into the stream flow during large events. Recommendations for this bank erosion site minimally include monitoring for significant changes in condition and possible assisted restoration with techniques to stabilize the bank.

Large woody obstruction (B92)

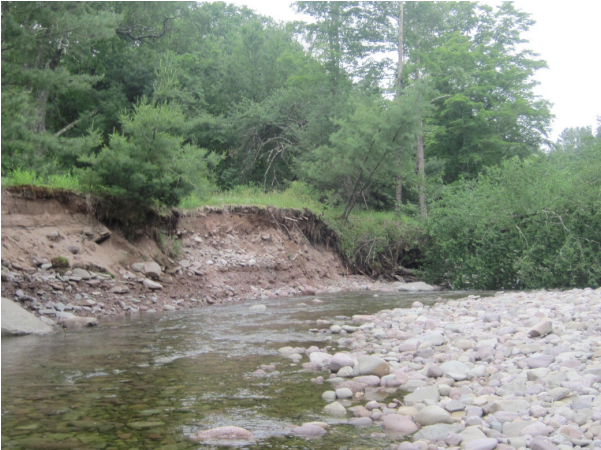
Left bank erosion due to obstruction (B89)

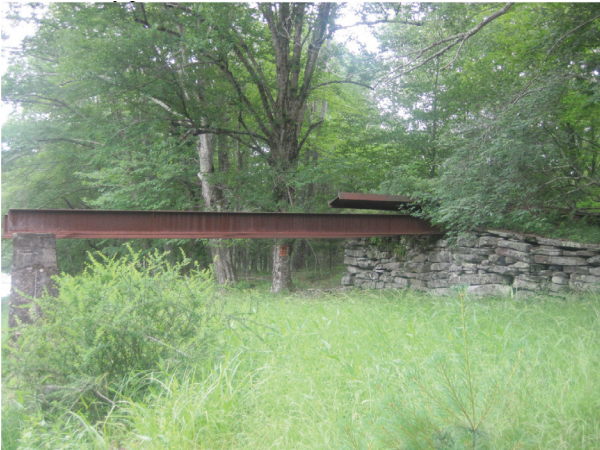
Relict bridge abutment on right bank (A89)

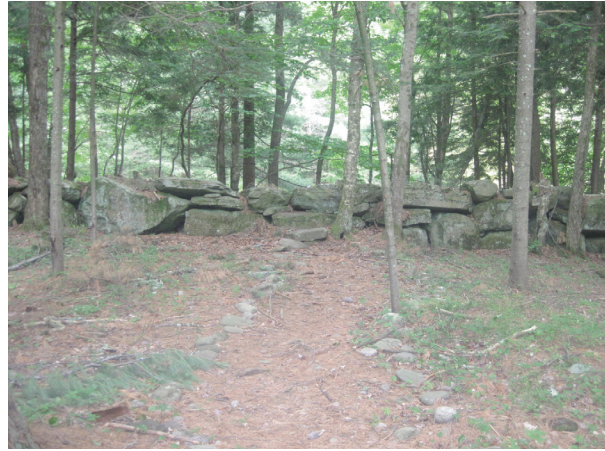
Berm located on right floodplain (A93)

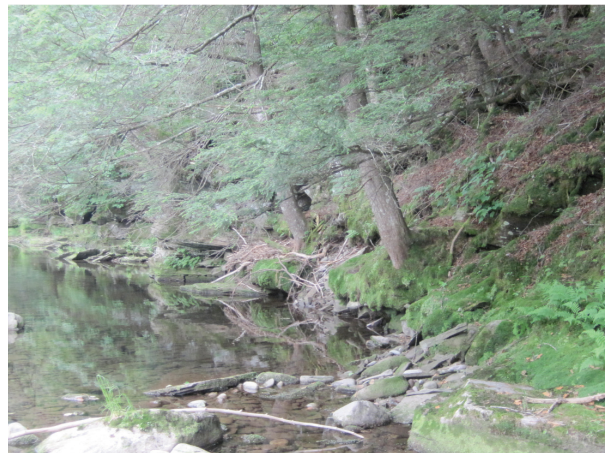
Bedrock on left valley wall (B55)

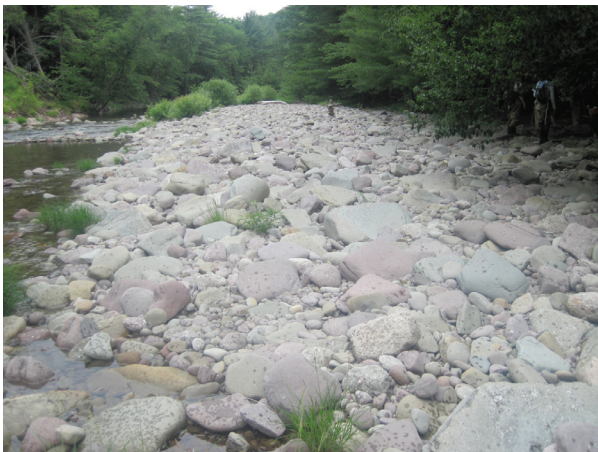
The channel flows close to the left valley wall at Station 21100, coming in contact with exposed bedrock. Flow continues to be controlled on the left side until Station 21000. (B55) After this control point the channel begins to meander slightly to the right, forming a point bar at the inside of the meander from Station 20900 and Station 20620. (A92) The majority of this bar

Point bar forming on right side of channel (A92)

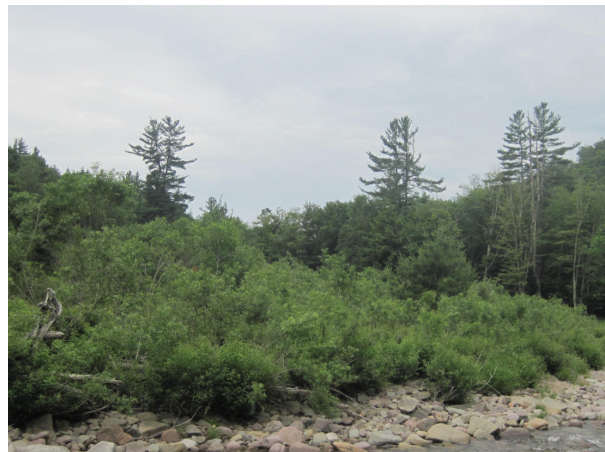
Willow harvest site at Station 20200 (B115)

is vegetated with grasses and sedges. Near the downstream end of the bar there is a relatively large establishment of willows that could potentially be harvested for use in restoration projects. A similar willow harvest site was also documented at Station 20200. (B115)

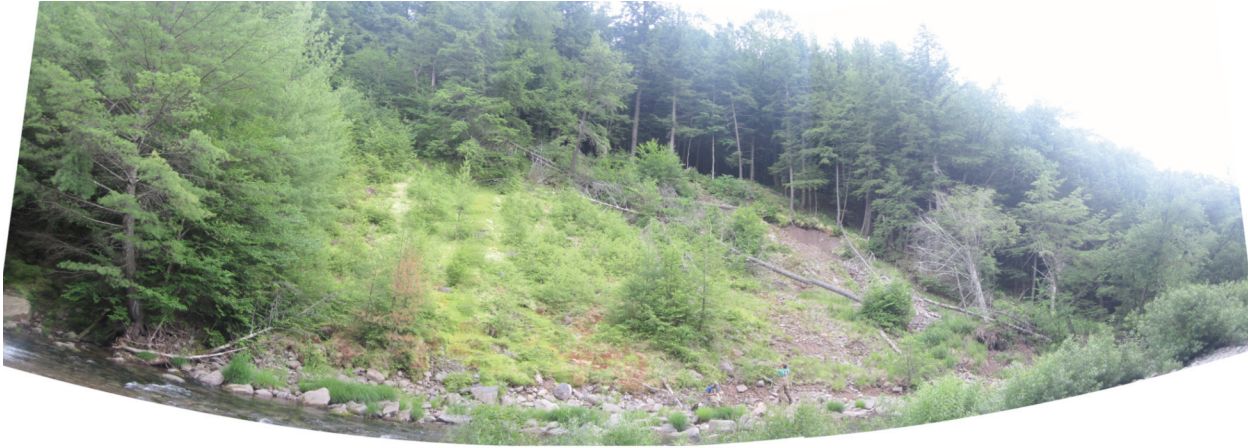
Left bank failure (B101–104)

A bank failure was documented on the left bank beginning at Station 20850, continuing approximately 150-feet to Station 20700 (BEMS # NEB6_20700). (B101–104) This steep bank is 120 feet high and consists of silts which are a potential source of fine sediment. Large cobbles have deposited at the toe of this bank along with the establishment of sedges, both of which aid in re-stabilization. A large percentage of the slope appears to have re-vegetated since the last slide, suggesting that this bank may be able to stabilize without treatment (passive restoration). However, due to the presence of fine sediment it is recommended that this site be monitored for any future changes in condition

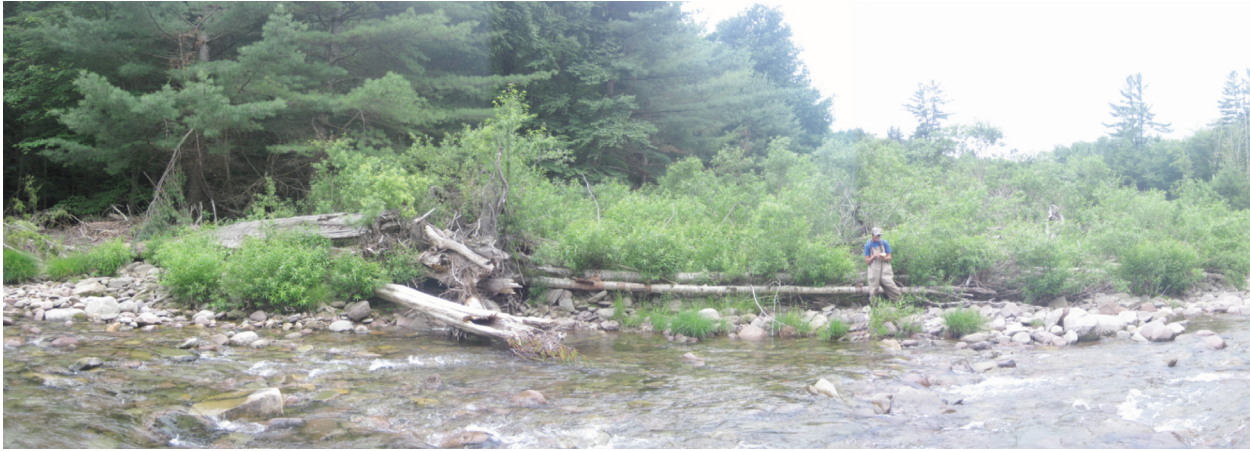
Large woody debris deposited on point bar (B112–114)

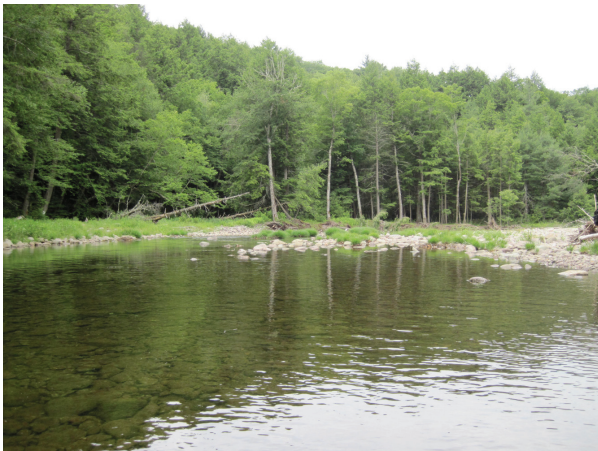
Downed trees accumulating on left bank (B105)

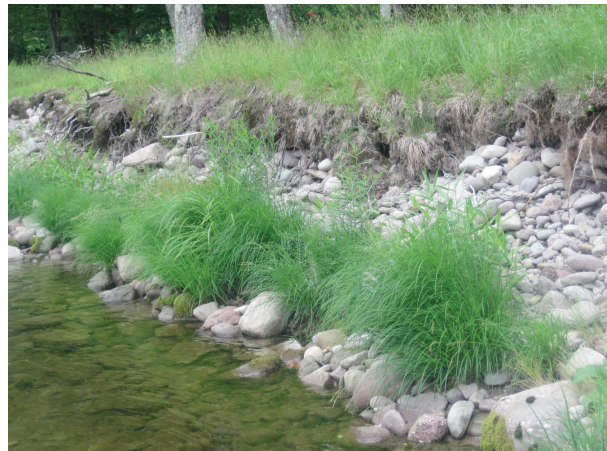
Right bank erosion (A99)

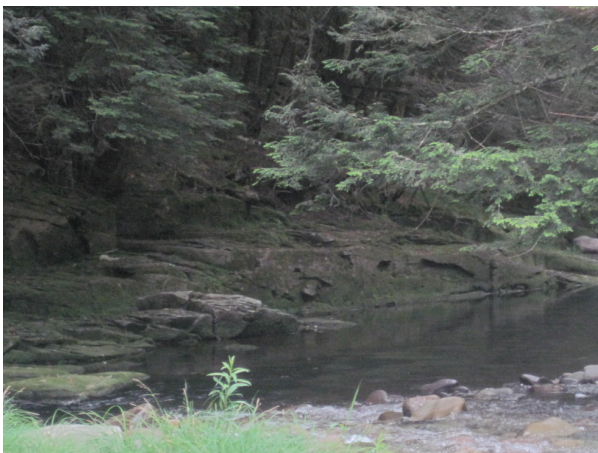
Exposed bedrock on left valley wall (B122)

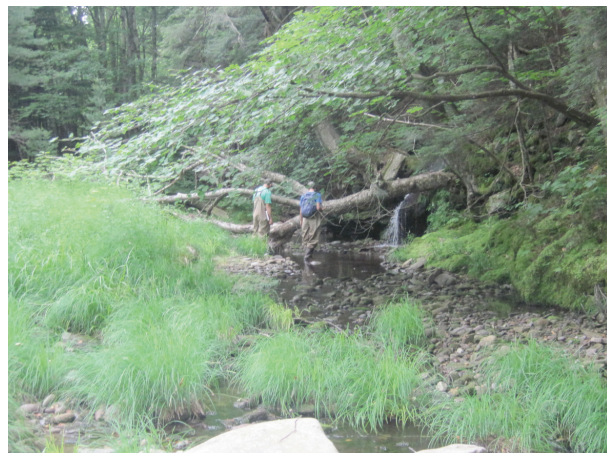
Tributary entering through left bedrock wall (B118)

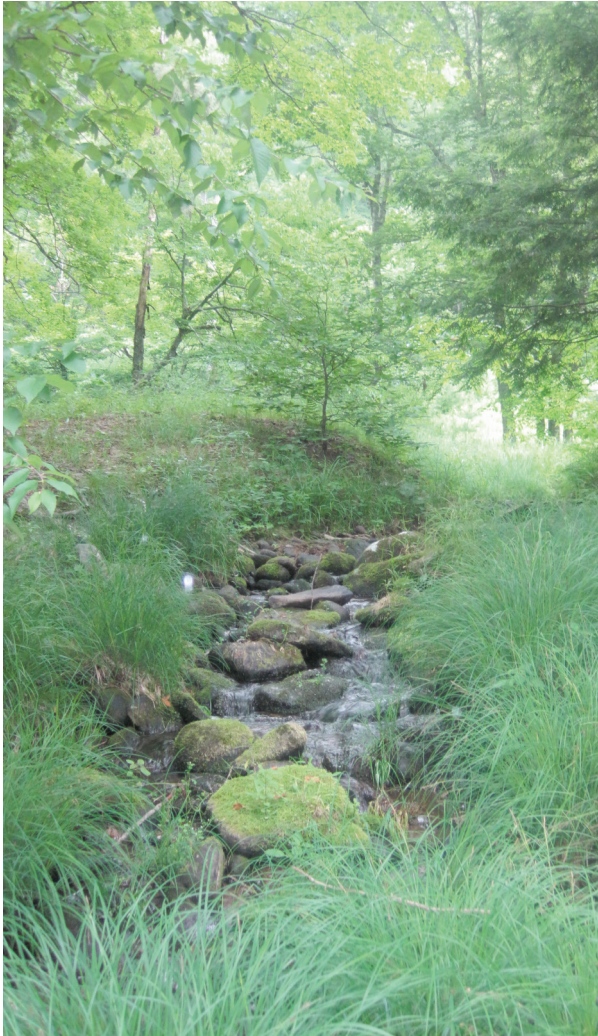
Tributary entering on left floodplain adjacent to Denning Road (A111)

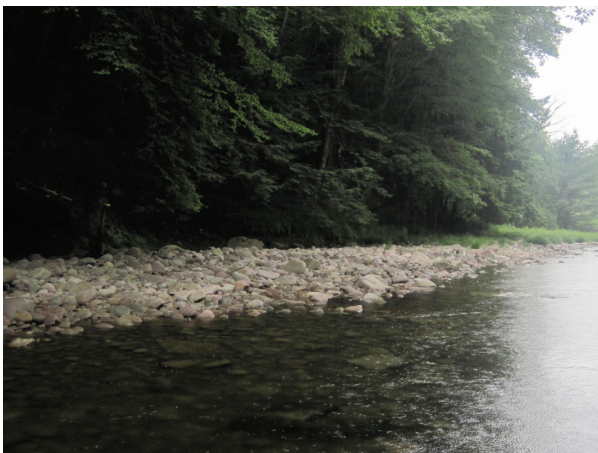
Cobble side bar on left side of channel (B125)

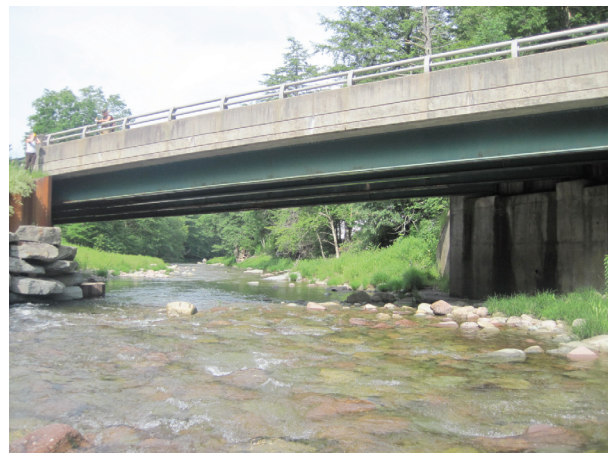
EBMU6 ends at Station 18700 where a bridge allows Denning Road to cross over the stream channel. This bridge appears to be well maintained and was documented in good structural and functional condition. (A112)

Denning Road bridge (A112)

It does however constrict flow during large events, as its abutments are not spaced wide enough and cause backwatering during significant flows. This is evident in the formation of a side bar just upstream of the bridge at Station 18730. The left bridge abutment has been revetted with stacked rocks to prevent scour. This revetment appears to be relatively new and actively maintained, indicating that it has been a source of concern for road maintenance officials. (A116)

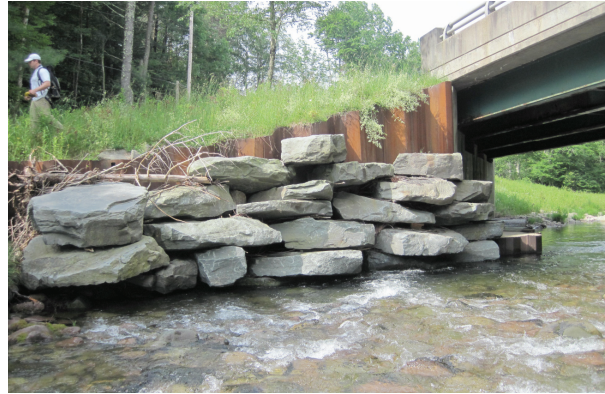
Left bridge abutment with revetment (A116)
