# Neversink River East Branch

## MANAGEMENT UNIT 6

### Summary of Post-Flood Recommendations

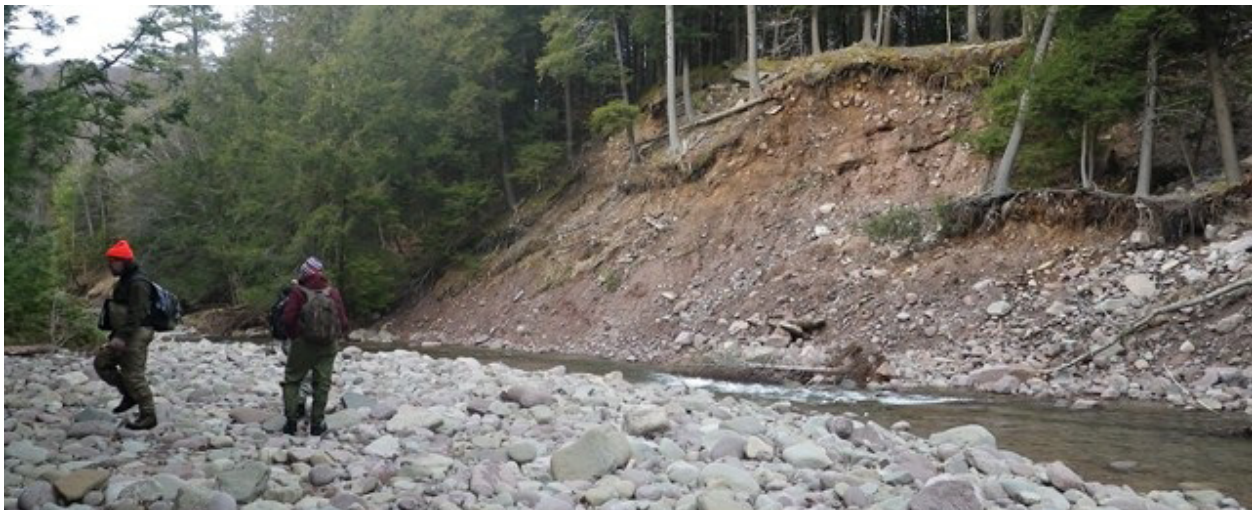
A massive bank failure begins at Station 23040, continuing approximately 220 feet until Station 22820 (BEMS # NEB6\_22800) (See stitched photos A73-75 on page 8 for pre-flood condition). Since the survey conducted in 2010, additional mature trees have slid down the slope with their roots intact and re-establish at a lower elevation on the bank. The root mass of an additional row of trees was documented as undercut and threatening to slide during the 2011 post-flood stream survey. There are no longer various shrubs and sedges established near the toe, which indicate that this bank is now unlikely to stabilize without treatment. Furthermore, glacial till is exposed for the entire length of the eroding bank and is a significant source of fine sediment.

*Slope failure and fine sediment source on the right bank. (IMGP1642)*

*Full restoration* is recommended for this site. This restoration could include installation of a bankfull stage bench at the toe of the slope, an increased radius of curvature, and establishing a riparian buffer including woody vegetation to strengthen the stream bank and slow erosive forces of higher flows during future flood events. A monitoring program could be implemented at this site to monitor the rate of bank retreat and sediment entrainment.

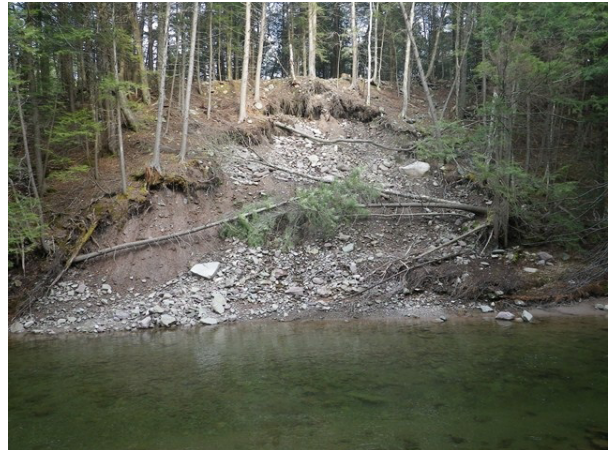
An eroding bank segment begins at Station 21860, continuing approximately 180-feet to Station 21680 (BEMS # NEB6\_21600). The materials in this bank consist of glacial till, a significant source of fine sediment and risk to water quality. Recommendations for this bank erosion site minimally include monitoring for significant changes in condition and possible *assisted restoration* with techniques to stabilize the bank (see photo B89 on page 11 for pre flood condition).

*Eroding bank segment on the right bank. (IMGP1646)*

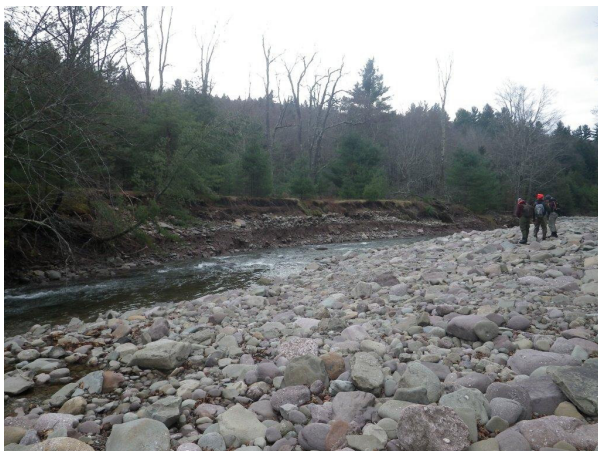
A bank failure was documented on the left bank beginning at Station 20850, continuing approximately 300-feet to Station 20520 (BEMS # NEB6\_20700). This steep bank is ranges from 15 feet to 48 feet

high and consists of glacial till, a significant source of fine sediment and risk to water quality. Most of the revegetation of the slope previously documented appears to have been scoured away in recent flood events, suggesting that this bank will require assistance to stabilize. Recommendations for the site are *assisted restoration*, which could include use of trees falling from the top of the slope to build a rootwad revetment at the toe, establishment of a *bankfull* stage bench, and use of bioengineering techniques to further stabilize the slope.

*Eroding bank segment on the left bank. (IMGP1654)*

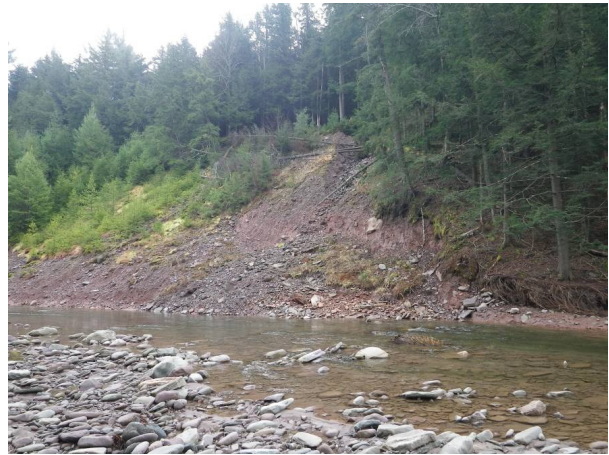
During the 2010 survey an eroding bank segment was documented on the outside of a meander bend beginning at Station 20300, continuing approximately 465-feet until Station 19835 (BEMS # NEB6\_19800). At the time, woody obstructions at Station 19800 and Station 19650 were contributing to this erosion by deflecting flows into the bank and the proximity of Denning Road to this erosion site raised concern for risk of infrastructure damage (see photo A99 on page 14 for pre-flood condition). This stream reach was realigned with engineering guidance in a post-flood emergency restoration effort, and the created banks were planted with willows in an effort to establish a riparian buffer to protect the bank during future high flow events. This site should be monitored for future changes in condition and to assess the stability of the realignment and planting effort.

*Left bank failure. (IMG1665)*

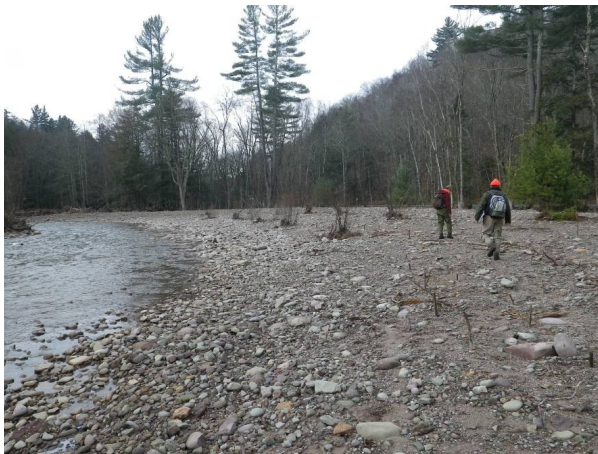
*Post-flood restoration effort including realignment and planting. (IMG1668)*

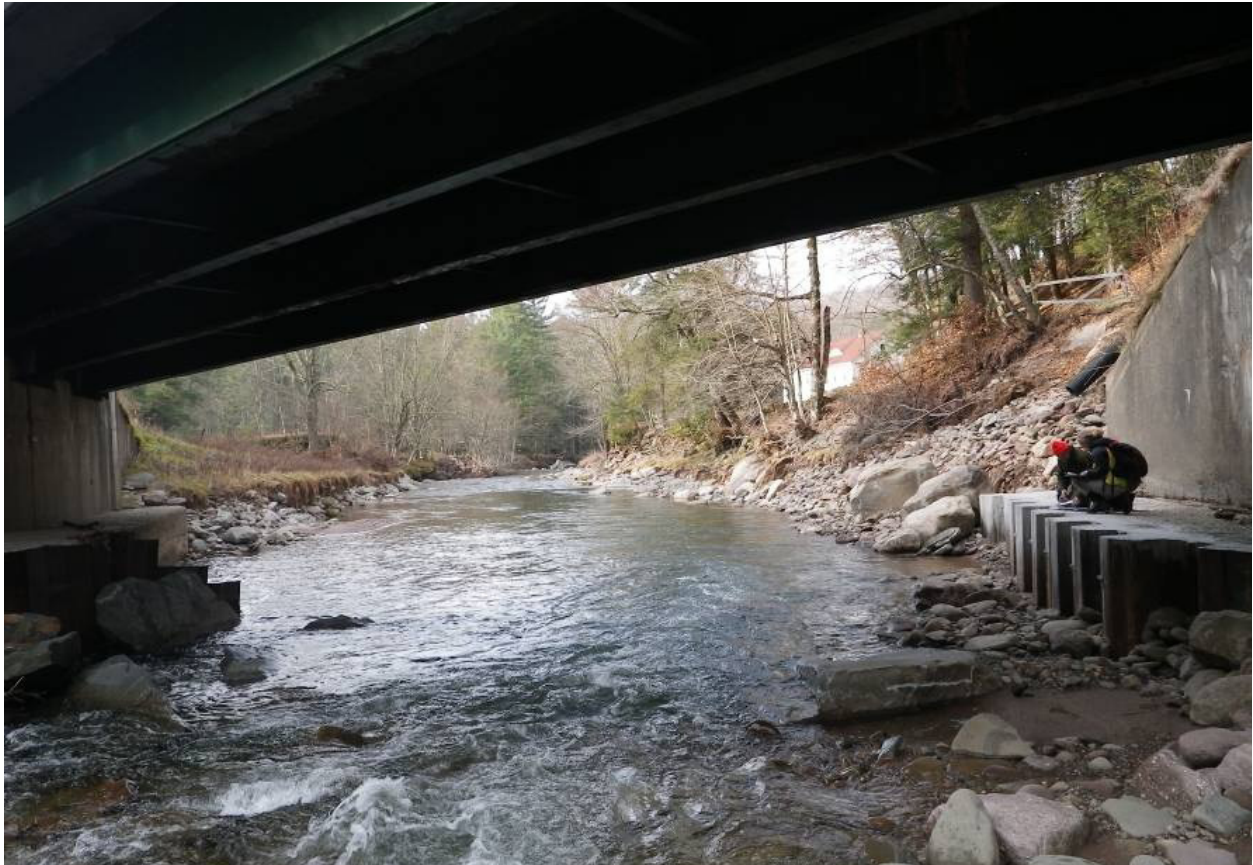
EBMU6 ends at Station 18700 where Denning Road crosses the stream channel. This bridge appears to be well maintained and was documented in good structural and functional condition in 2010. As evidenced by significant scour on both abutments after the flooding associated with TS Irene, this bridge constricts flow during large events, as its abutments are not spaced wide enough and cause backwatering during significant flows. The abutment scour on the right bank was reported after the flooding was large boulder were placed to reduce future scour in this location. In addition, possible flanking on the sheet piling at the base of the left abutment

*Denning Road bridge—note repair at downstream end of right abutment. Stacked rock revetment has since been installed. (IMG1681)*

was documented in the 2011 stream survey. This abutment has since been protected with a stacked rock revetment; scour should be monitored during future high flow events.
