# Neversink River East Branch

## MANAGEMENT UNIT 7

EAST BRANCH MANAGEMENT UNIT 7  
BETWEEN STATION 28000 AND STATION 25030

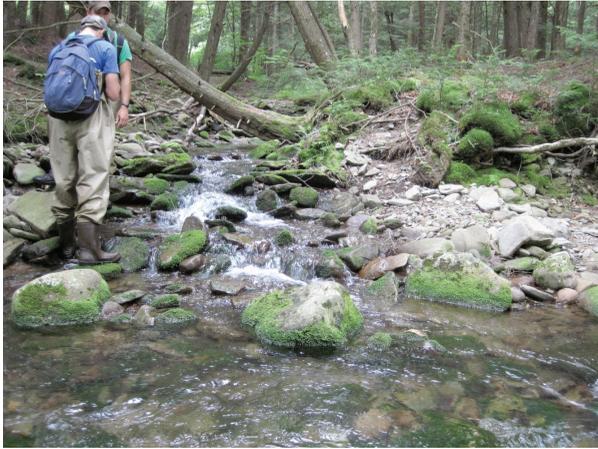
*Tributary entering on left bank (B2)*

An unnamed tributary enters from the left at Station 27400, contributing a perennial flow that is significant even under low flow conditions. (B2) This tributary drains through a densely forested section of the valley and is likely well filtered through natural processes. Small feeder streams such as this often play an integral role in ecosystem integrity, as they are a source of the cold and well oxygenated water that is necessary to support a diversity of aquatic life.

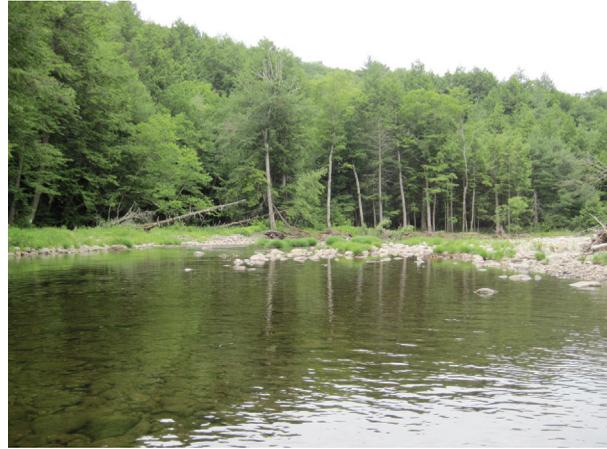
*Overwidening of channel due to aggradation (B5)*

Continuing downstream, the deposition of large woody debris and sediment becomes evident at Station 27000 and continues until approximately Station 26060. Excessive amounts of sediment storage mark this reach in the form of depositional bars and full channel aggradation. At Station 27000, the entire width of the channel has become aggraded with cobble sized materials, causing overwidening of the channel as well as increased elevation of the stream bed. (B5) Along the right side of the stream in the same location a large tree has deposited, obstructing high flows and contributing to the development of a point bar along the right bank. (B11) This bar continues for approximately 480-feet until Station 26520. (B6) Aside from some sedges along the left side, this bar does not have established mature vegetation on it.

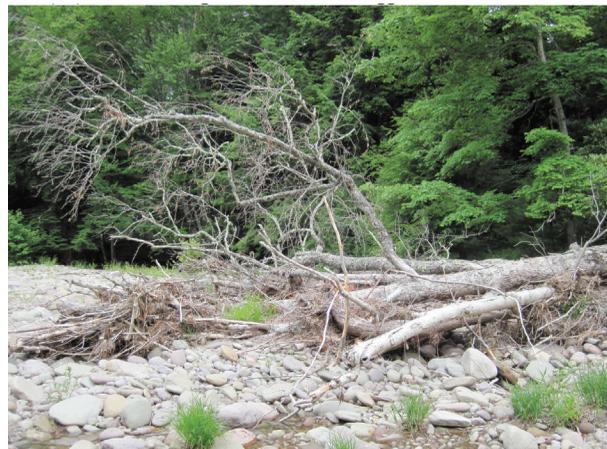
*Obstruction on right bank contributing to development of point bar (B11)*

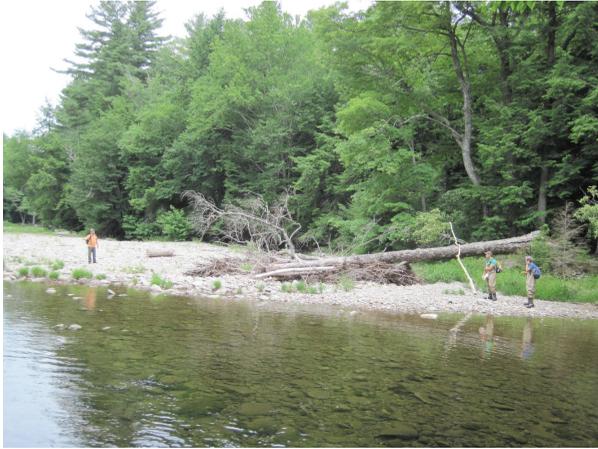
*Point bar along right bank (B6)*

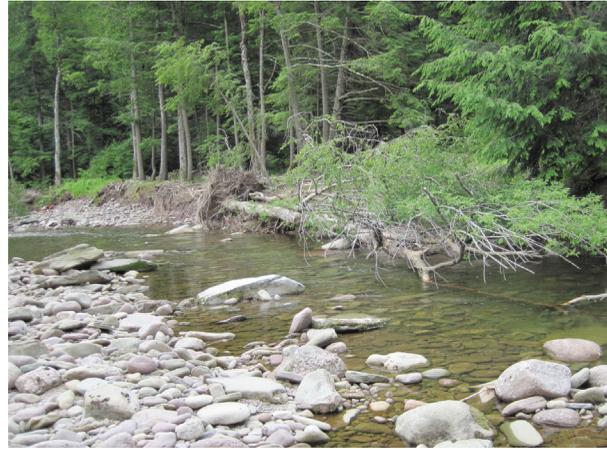
The stream meanders slightly to the left as it flows past the point bar but stays over 200-feet from contact with the left valley wall. A fallen tree is causing a flow obstruction at Station 26650. (B17) This tree spans 70-feet with its root ball still attached, which is facing upstream and directly into direct flow. During high

*Fallen tree causing flow obstruction (B17)*

flows, this tree is forcing the water into the left bank, resulting in minor erosion just upstream of the obstruction. At Station 26500, a cobble side bar has formed on the left side of the stream which continues approximately 250-feet to Station 26250. (B20) This bar appears to be actively forming and has no established vegetation on it. Large woody debris has deposited as an obstruction at the downstream end of the bar, contributing to the backwater effect that has resulted in the development of this bar. (A5)

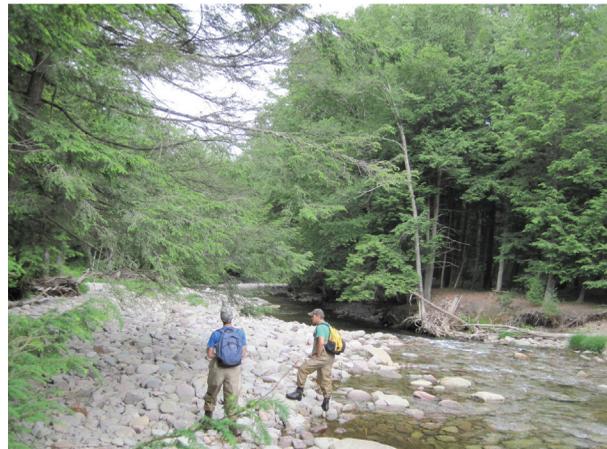
*Cobble sidebar on left side of stream (B20)*

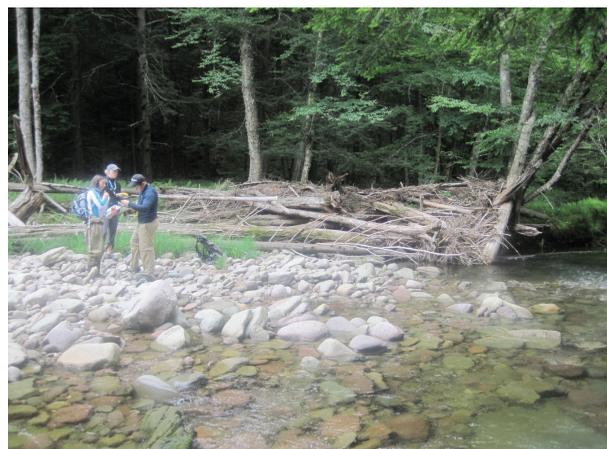
*Obstruction contributing to side bar development (A5)*

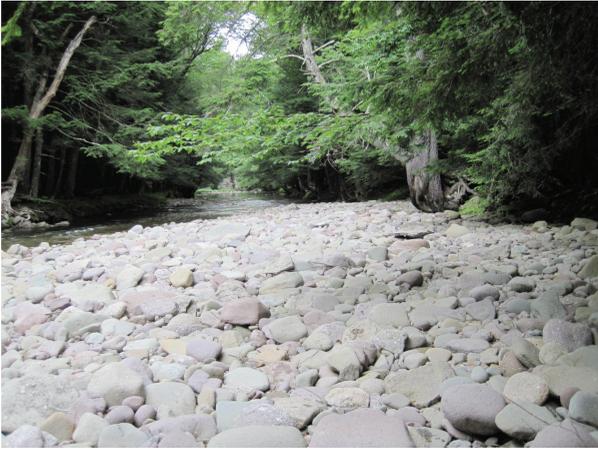
On the right side of the stream, another cobble side bar has formed at Station 26200. This bar is approximately 140-feet in length, ending at Station 26060. (B28)

*Cobble sidebar on right side of stream (B28)*

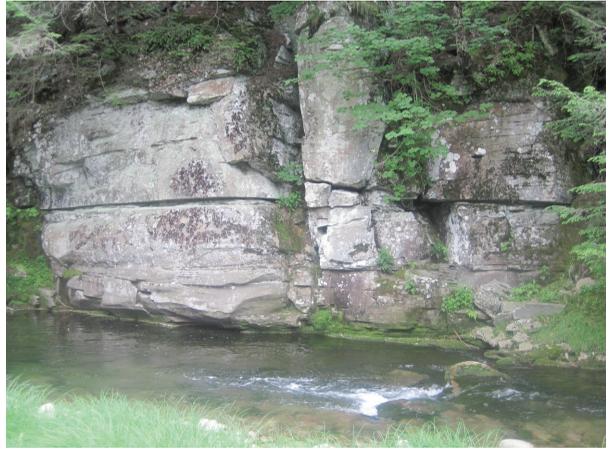
The channel flows up against the right valley wall at Station 25600 before taking a sharp left turn and entering into a relatively straight reach for the remainder of EBMU7. Flow is laterally controlled on the right side by exposed bedrock from Station 25600 to Station 25100. (A12) A small unnamed tributary enters from the right bank at the start of the expose bedrock. (A9) This channel most likely carries storm drainage from the nearby portion of Denning Road.

*Exposed bedrock controlling flow (A12)*

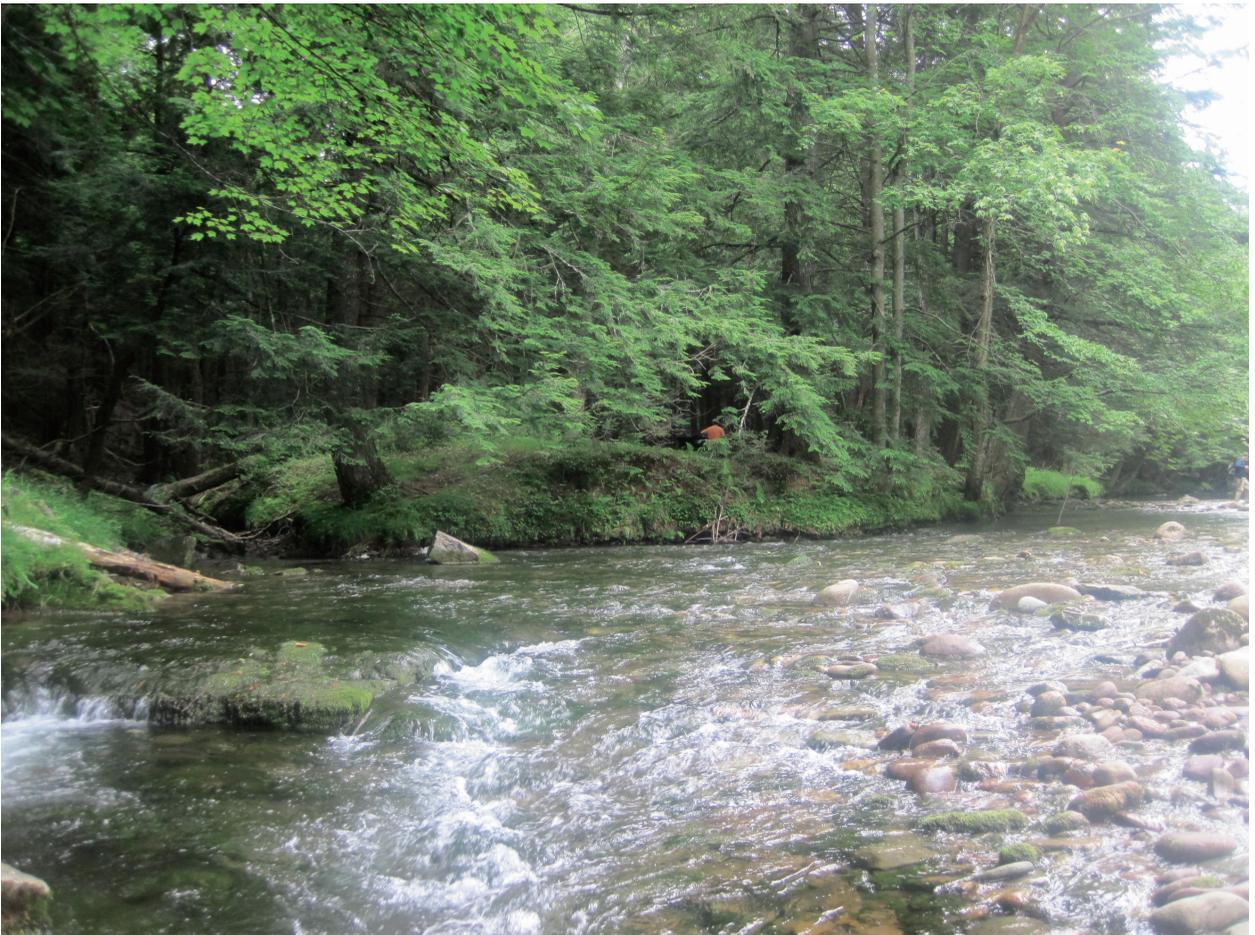
*Small tributary entering on right bank (A9)*

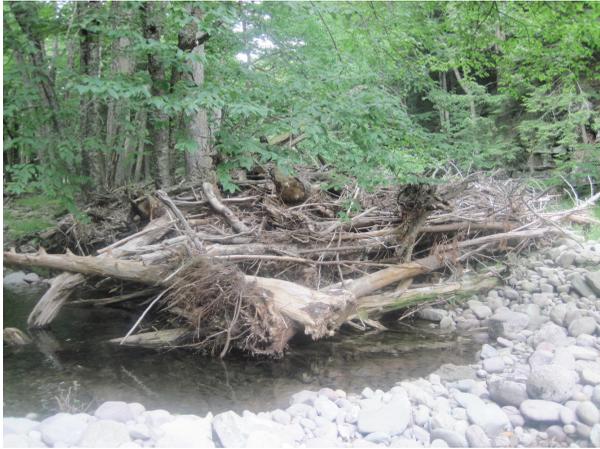
*Large woody debris jam causing divergence (A17)*

At Station 25390, large woody debris has deposited and is causing a divergence of a small portion of the flow into a side channel to the right. (A17) Although this side channel flows in the direction of Denning Road, the steep bedrock wall keeps it confined on the right side and prevents any potential flood threats. A small tributary drains in from the right through the bedrock wall near this same location. (A19)

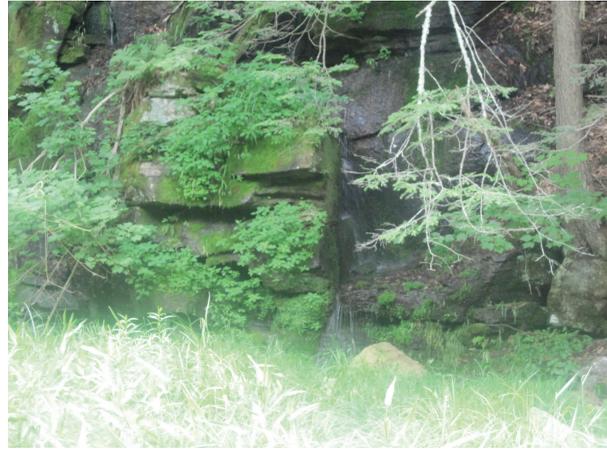
*Small tributary entering on right through bedrock (A19)*

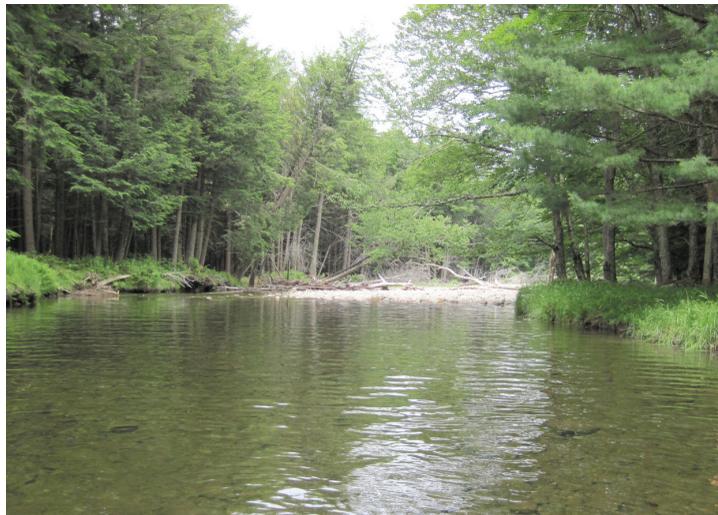
EBMU7 ends at Station 25030 where the stream begins to move away from the valley walls and the floor opens up, representing a change in valley type and associated channel morphology. Like most of EBMU7, the downstream end of this management unit does not transport sediment effectively. Aggradation of the full channel with cobble sized materials was documented at Station 25100. (B34)

*Full channel aggradation (B34)*
