Neversink River East Branch

MANAGEMENT UNIT 9

EAST BRANCH MANAGEMENT UNIT 9
BETWEEN STATION 34900 AND STATION 30800

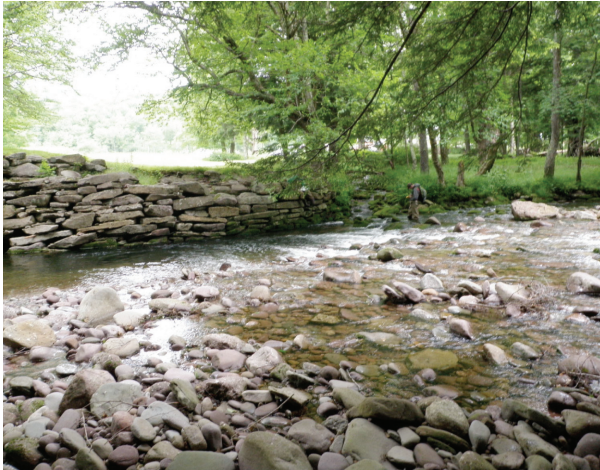
The East Branch enters EBMU9 just downstream of where Erts Brook flows into the main channel. The backwater effect created by this tributary confluence is causing significant aggradation just upstream. (*B173*). The exposed bedrock first documented in EBMU10 continues along the channel bottom and left valley wall in this management unit until Station 34080, restricting both vertical and lateral channel

Aggradation upstream of Erts Brook (B173)

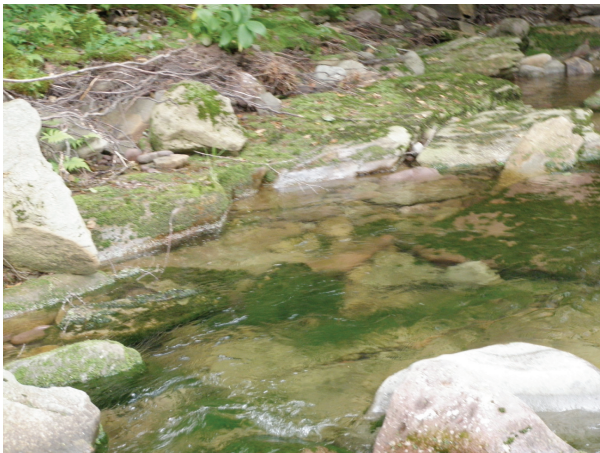
migration. (B163) The stream is controlled by the left valley throughout most of this management unit, however, it maintains good floodplain connectivity on the right side.

Bedrock control along stream bed and left valley wall (B163)

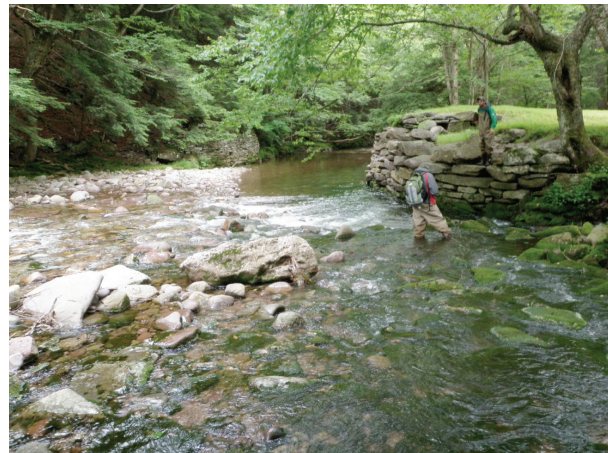
Relict bridge abutments are now serving as revetments on both sides of the stream at Station 34860. (B171) The abutments consist of stacked rock and are approximately 12-feet in length. The good structural condition of the abutment on the right bank suggests that it has been maintained over the years to provide bank stabilization.

Relict bridge abutments serving as revetment on right and left banks (B171)

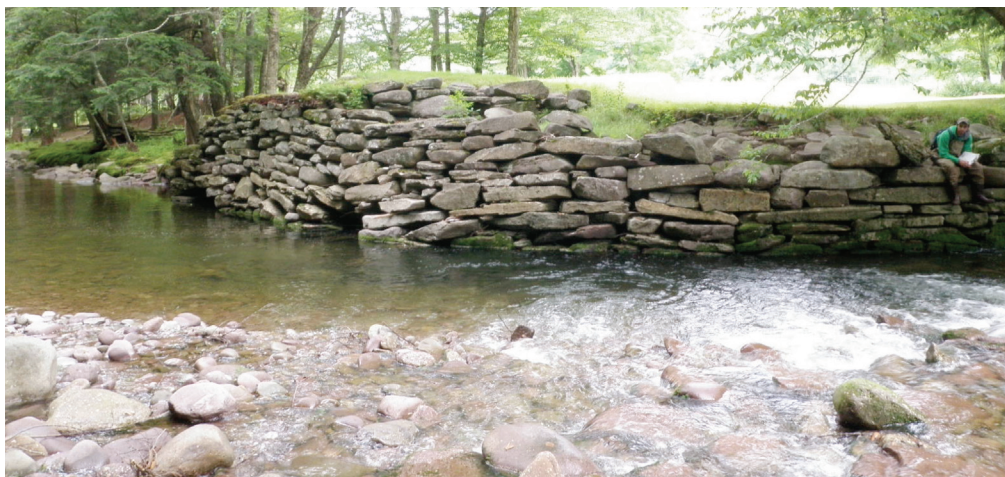
Mowed grass above abutment (B174)

The riparian area above this abutment consists of mowed grass, which does not adequately provide stability to the stream bank under high flows. (B174) It is recommended that this area be planted with native woody vegetation, which can strengthen the stream bank and slow erosive forces of higher flows during flood events.

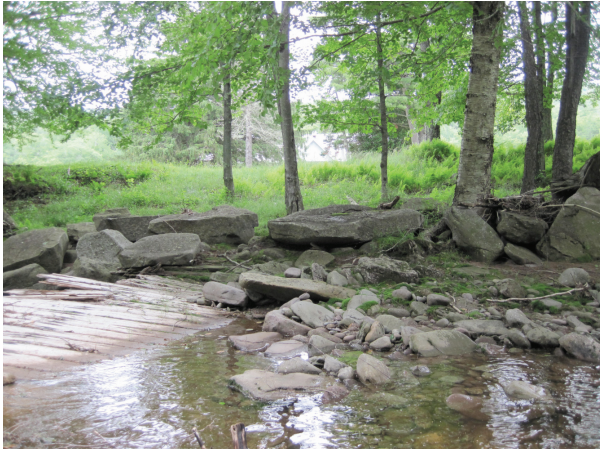
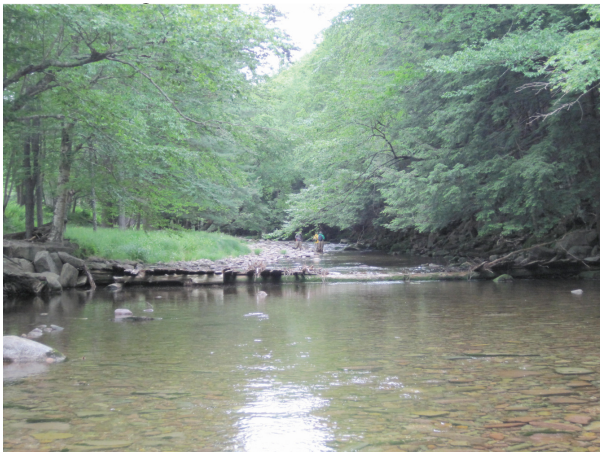
Large boulders and wooden dam (A266)

Looking upstream at wooden dam spanning channel (A269)

At Station 34460 there is an old wooden dam that spans the entire width of the stream and is supported by large boulders on both sides. (A266 & 269) This structure appears to have been placed to provide habitat for trout. The water faces an abrupt 3-foot vertical drop as it flows over the dam, resulting in a deep scour pool below. The structure continues to function for the creation of habitat, but appears unmaintained and is beginning to wash out towards the center. Structures such as this were observed frequently in the East Branch of the Neversink River.

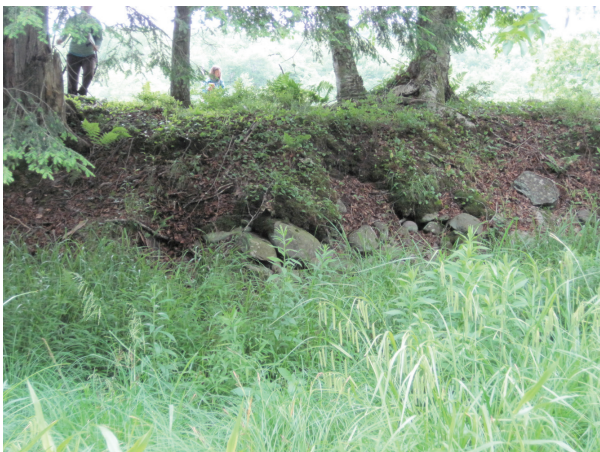
Cobble size stone berm (A272)

A stone berm consisting of cobble sized materials begins along the right bank at Station 34360, continuing approximately 225-feet until Station 34135. (A272). This berm was most likely intended to prevent flooding along the adjacent Denning Road. The portion of the riparian corridor directly adjacent to the stream consists of only a 5-10-foot wide buffer of woody vegetation before transitioning to mowed grass until it is intersected with Denning Road. A wider vegetated riparian buffer in this corridor would assist in mitigating flood risks to Denning Road, and it is recommended that the mowed grass be replaced with mature woody vegetation.

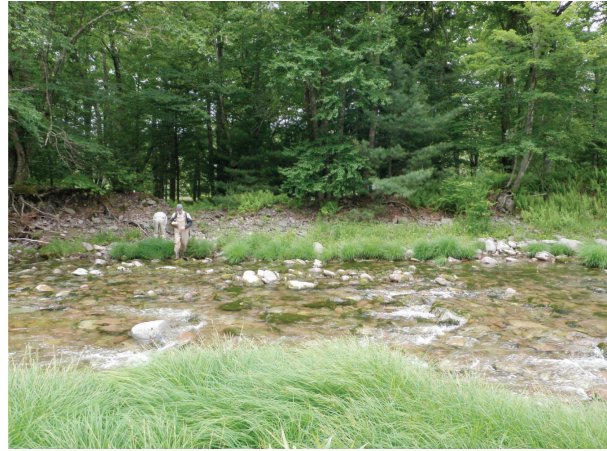
A second berm begins along the right bank at Station 33830 and continues approximately 895-feet until Station 32935. (B190) The berm consists of cobbles and other earthen materials, and has

Cobble and earthen berm on right bank (B190)

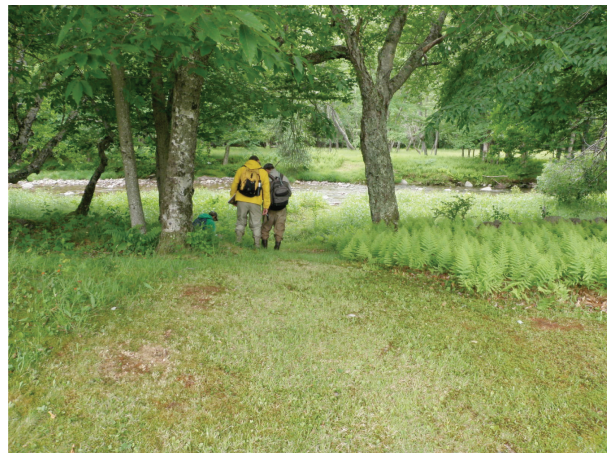
become overgrown with mature vegetation. At Station 33600 there is a break in the berm where a mowed access path runs from the road to the stream. (B187)

Mowed path across stream channel (B187)

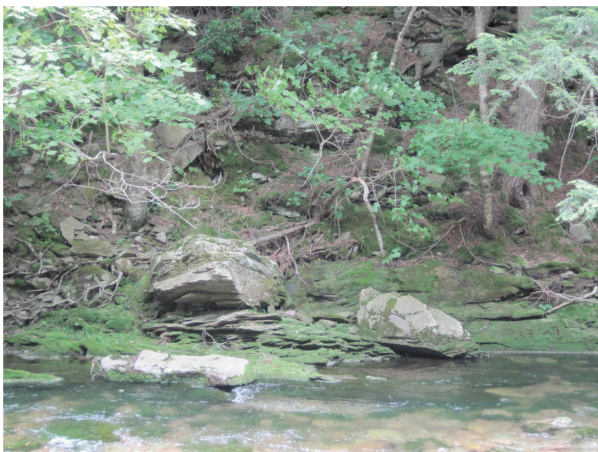
Continuing downstream, the channel again flows up against the left valley wall at Station 32900. (A280) The stream remains semi-confined on the left side for approximately 790-feet until Station 32110. A tree and root ball have fallen out of the bank at Station 32710 and deposited at the toe of the slope, causing an obstruction to higher flows. (B193) It does not appear that the removal of this tree will cause significant bank failure in the future; however, it should be monitored for future changes in condition.

Stream flowing against left valley wall (A280)

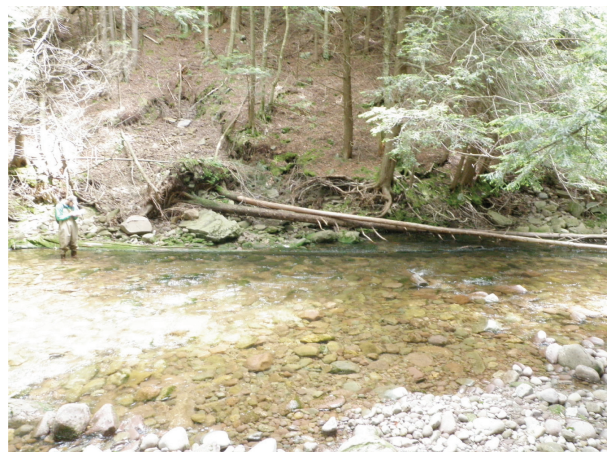
Tree and root ball fallen on left bank (B193)

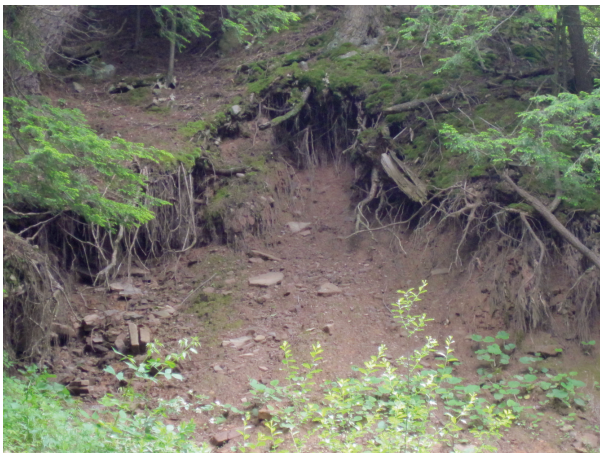
The right bank begins to erode at Station 32380 (BEMS NEB9_32100), continuing approximately 210-feet to Station 32170. (A282) This erosion is caused by hydraulic pressure on the bank during high flows, which entrains the alluvial sediments (listed as alluvial, this looks like till to me double check) and exposes the root structure of the vegetation present. Large rocks have deposited at the toe of this bank, which along with the present establishment of sedges and various other

Erosion of right bank (A282)

vegetation, indicate that it is possible for this bank to stabilize without treatment (passive restoration). (A284) However, it is recommended that this site be monitored for changes in condition.

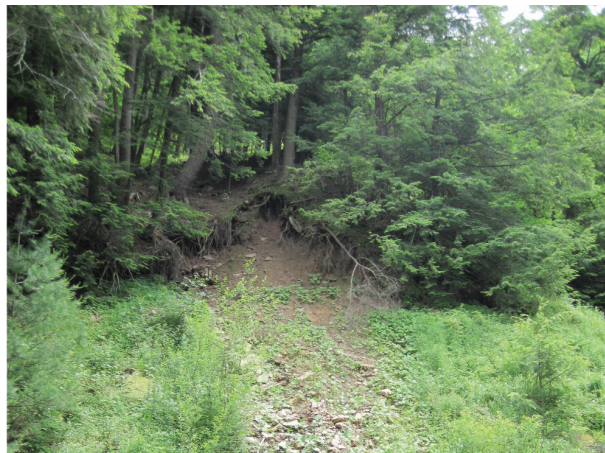
Large rocks deposited at toe of right bank (A284)

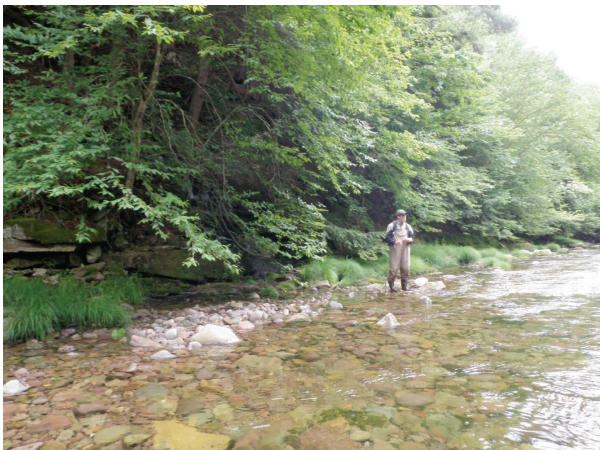
A small unnamed tributary enters through the bedrock valley wall on the left bank at Station 32270. (B195) This tributary contributes a perennial flow of cool water to the East Branch which helps to maintain good water quality and aquatic life. At Station 32100 the channel begins to pull slightly away from the left valley wall and has established just under 100-feet of forested floodplain. This reach appears very aggradational, characterized by frequent shallow riffles. (B202)

Small tributary entering on left bank (B195)

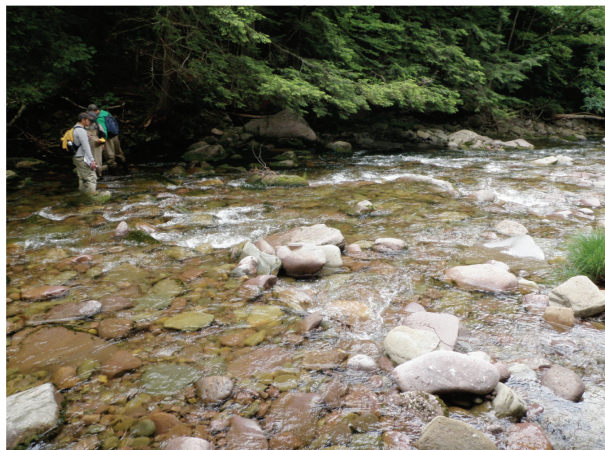
Aggradated stream channel (B202)

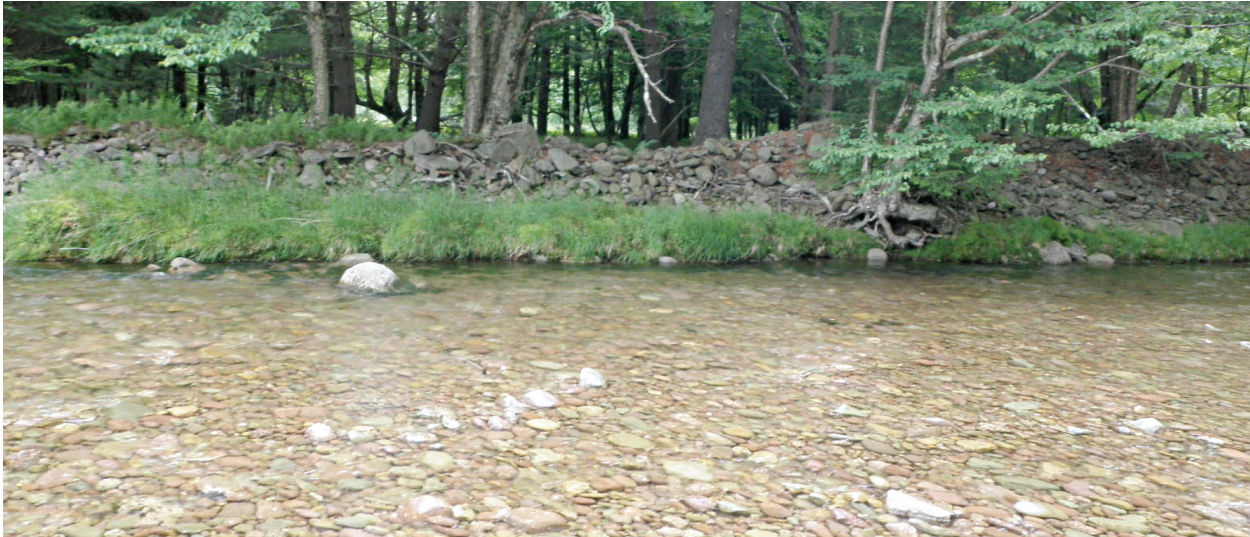
At Station 31800 a stone berm begins on the right bank and continues for approximately 150-feet until Station 31650. The intention of this berm was most likely to prevent high flows from reaching the nearby section of Denning Road. (B208) Across from the downstream end of the berm a depositional side bar has formed on the left side of the stream bed at Station 31650. (A289) This bar is well vegetated with sedges and grasses, and does not appear to be causing any management issues.

Stone berm on right bank protecting (B208)

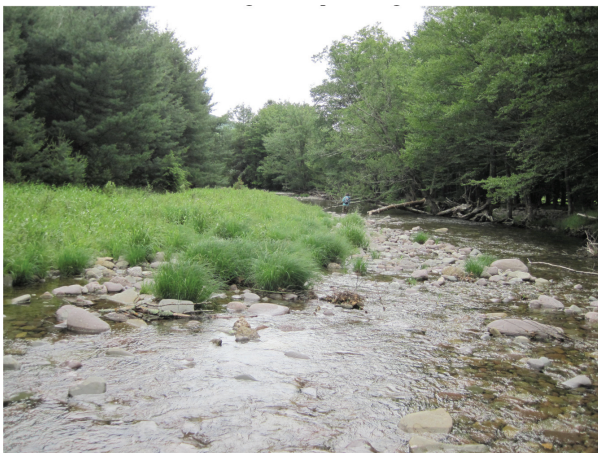
Depositional side bar on left bed (A289)

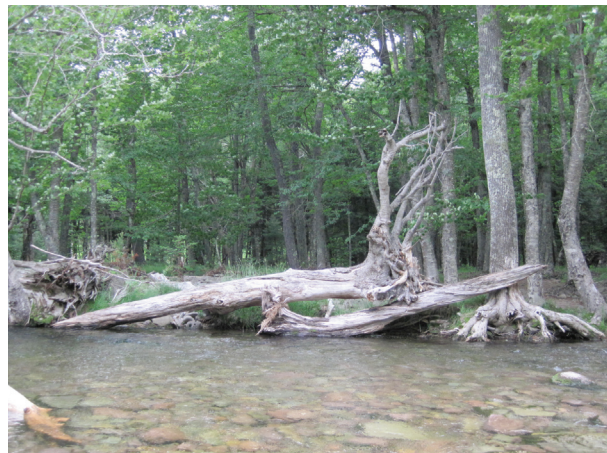
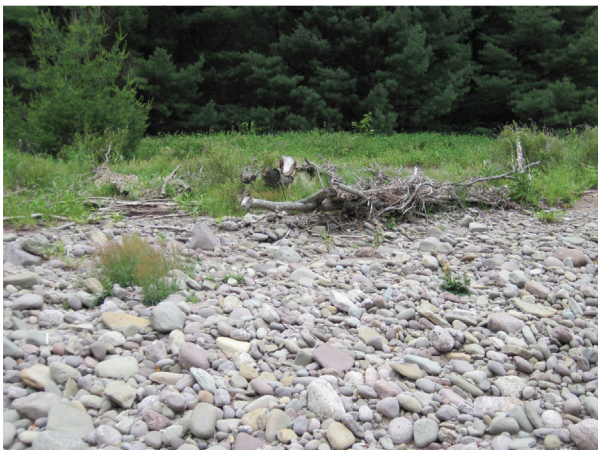
Large woody obstructions (A293)

Channel braiding caused by obstructions (A306)

A series of large woody debris obstructions begins at Station 31500, and is evident again at Station 30950, causing channel braiding and instability throughout the remainder of EBMU9. (A293, 306) A side channel diverges to the right at Station 31450 and continues to braid through the right floodplain in a series of several small side channels. (B211 & 216) These side channels are oriented in the direction of Denning Road and pose a flood risk to the road under high flows. Woody debris and sediment deposition are evident throughout these side channels. The presence of large woody debris obstructions is also causing sediment deposition in the main channel in the form of side bars and full channel aggradation. (A299)

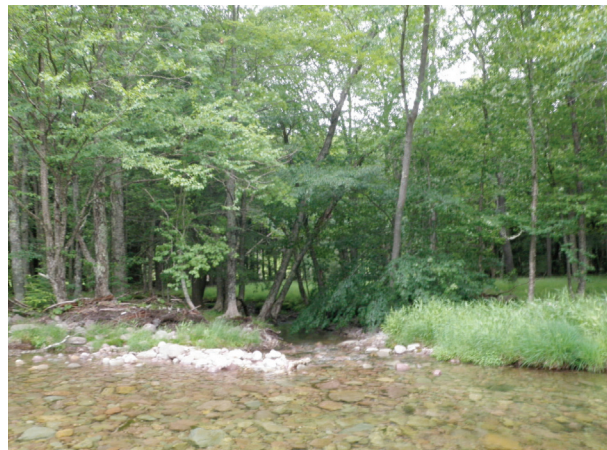
Side channel divergence (B211)

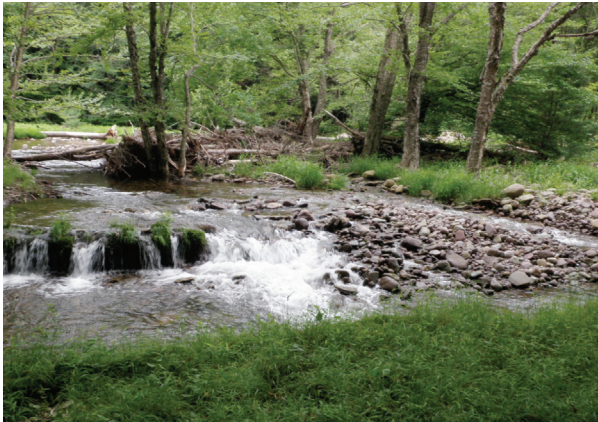
Braided side channels on right floodplain (B216)

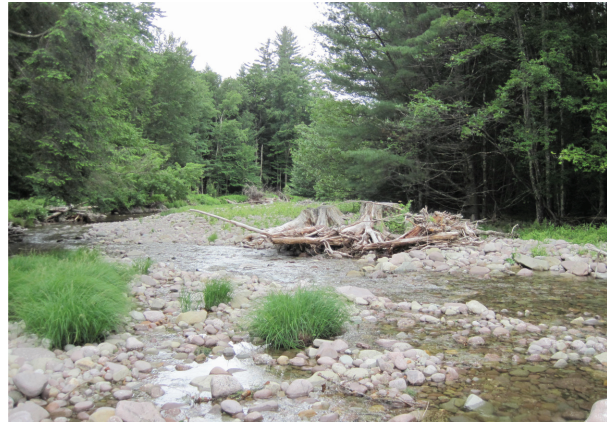
Full channel aggradation (A299)

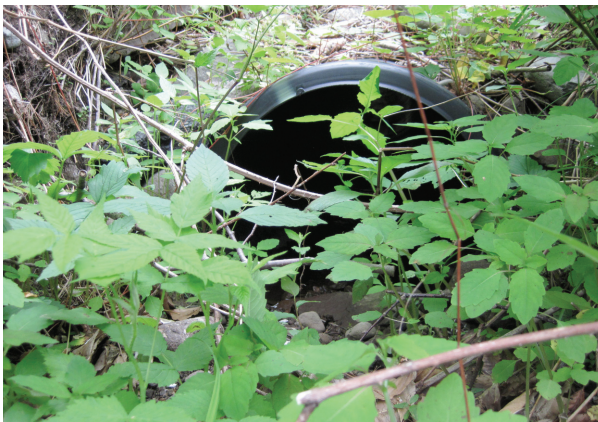
At Station 30830, a 18-inch diameter plastic drainage culvert conveys storm water runoff from Denning Road into the stream. This pipe was halfway covered with silt at the time of that this inventory was conducted, indicating that it may not be fully effective during storms. (A315)

Denning Road culvert pipe (A315)

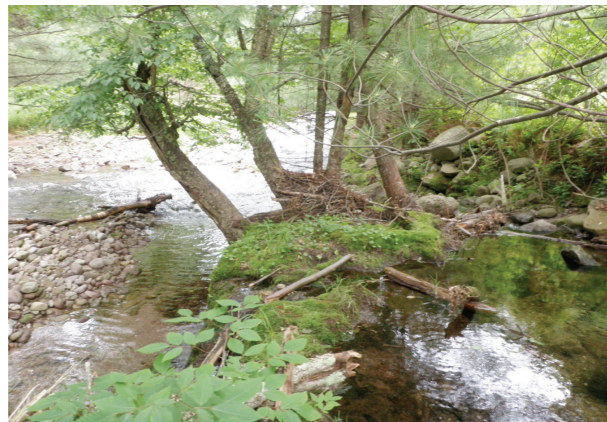
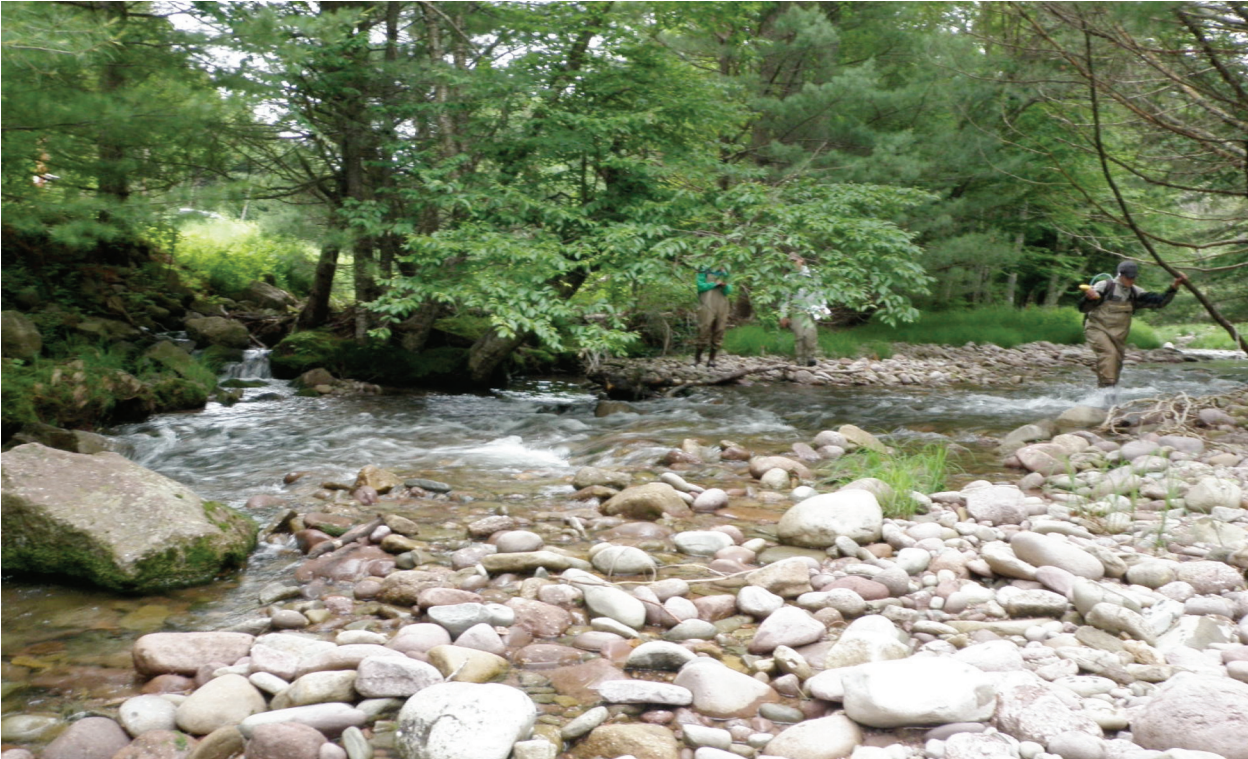
EBMU9 ends at Station 30800, where a drainage channel enters the stream on the right side. (B218 & 219) The drainage channel flows from two relatively large retention ponds located on a farm in the right floodplain. This drainage flows adjacent to Denning Road for approximately 2,500-feet before entering the stream, making it a potential source of contaminants including chlorides (salt) and petroleum by-products from road runoff to the East Branch of the Neversink River.

Drainage channel entering stream on right side (B218)

Looking upstream at convergence with drainage channel (B219)
