Neversink River Main Branch

MANAGEMENT UNIT 3

MAIN BRANCH MANAGEMENT UNIT 3
BETWEEN STATION 9300 AND STATION 6300

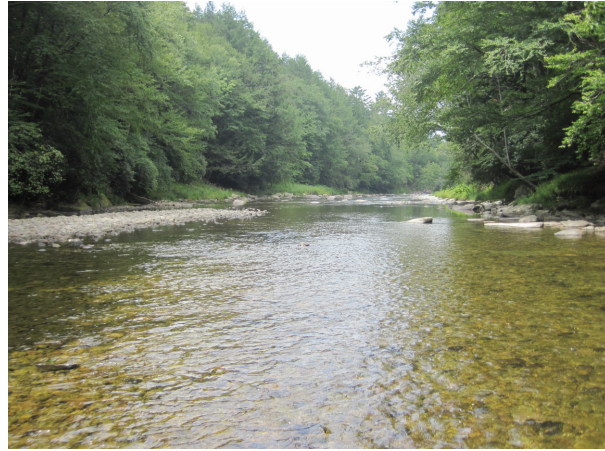
MBMU3 begins at Station 9300 with exposed bedrock constraining the stream bed and left bank (continued from MBMU4) and a large bolder obstruction forming a small gravel bar and scour pool on the right bank. The exposed bedrock ends at Station 8950, where the main channel widens slightly, leading to some aggradation in the reach downstream. (A249)

Widening and aggradation of channel (A249)

To better understand sediment transport dynamics of this section of the Neversink, a baseline survey of channel form and function is recommended for this management unit.

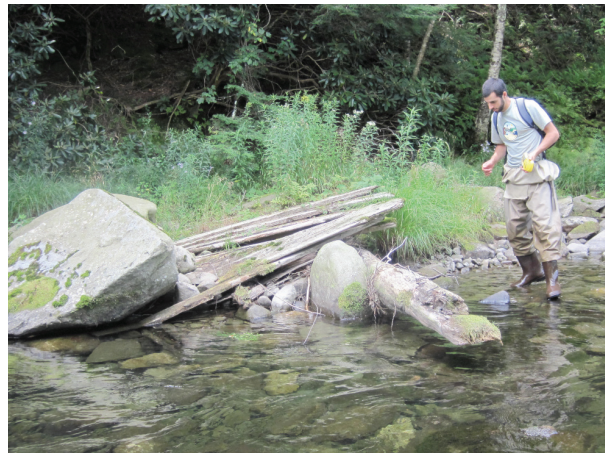
At Station 8080 there is a relict habitat structure which begins a reach that appears to have been managed historically for fish habitat. (B527) Approximately 300 feet downstream, at Station 7800 and Station 7650

Relict habitat structure (B527)

Features like these barbs were observed frequently on the main branch of the Neversink River. It is difficult to decipher the original design objectives; they may have been designed to improve or enhance aquatic habitat or to protect banks. It is recommended that the history and original objectives of these features be investigated to better understand their current function and ongoing hydraulic effects. Long term monitoring of the structures is also recommended.

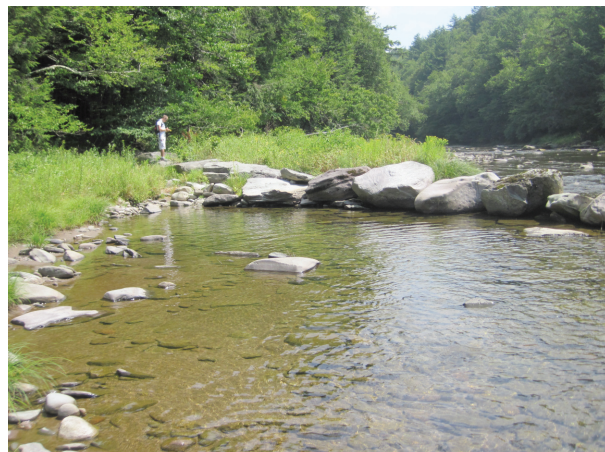
there are two placed stone bars projecting approximately 55 feet from the bank into the main channel angled 45 degrees downstream. (A256) Both structures were documented in good structural condition; because the purpose and past use of the structures remain unclear the functional condition cannot be assessed. Overall, the reach-scale affect of the barbs appears to be formation of a depositional side bar on the right bank extending downstream approximately 400 feet. There is a house located on the right bank up slope of the depositional bar within the FEMA mapped 100-year floodplain near Station 8120.

Stone barb (A256)

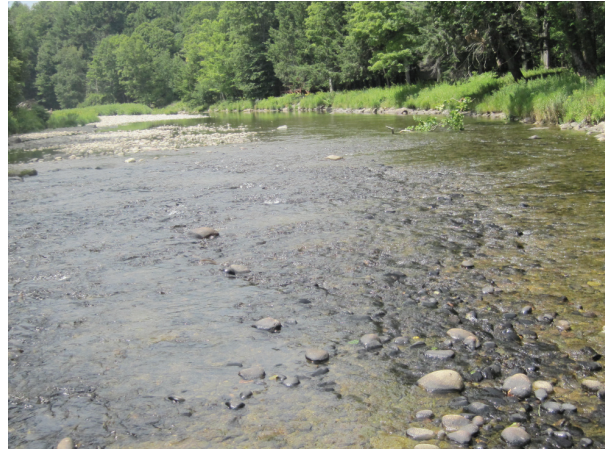
The aggradation continues downstream with the side bar extending from Station 7300 to Station 7000, and a transverse bar centered at Station 6970 which directs flow at the forested terrace on the right bank. (B530) A flood chute was detected in aerial photography diverging from the main channel into the left floodplain near Station 7150. This chute re-joins the main channel near Station 5000 in MBMU2. It is likely that this chute conveys flow through a forested floodplain that is inundated during high flow events. (insert Bing image looking southeast centered to view entire S-curve. consider calling out flood chute location)

Aggradation and transverse bar (B530)

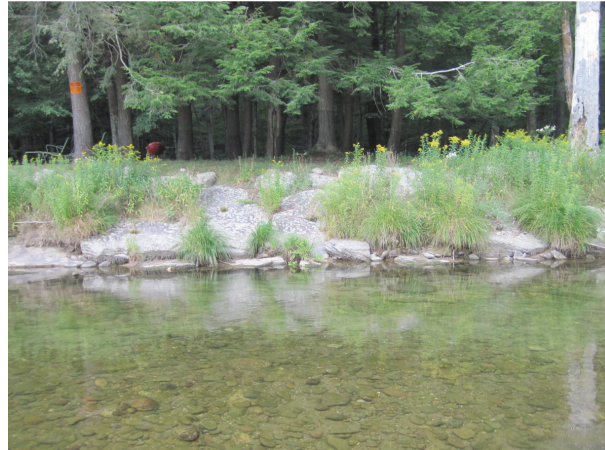
At Station 6600 the main channel enters an S-curve with a relatively large amplitude, known locally as the Big Bend, that begins with a wide meander to the left. A 330-foot long sloped stone revetment was observed on the right bank from Station 6600 to Station 6270, which appears to protect the bank at a residential property with two cabins and a private access road (including a bridge over Dry Brook) within the 100-year floodplain. This revetment was documented in good structural and functional condition. (A263) The revetment ends at the confluence of a tributary with the main channel in MBMU2.

Sloped stone revetment on right bank (A263)

INFRASTRUCTURE 5.45% of the stream bank length in this management unit has been treated with revetment. A 330-foot long sloped stone revetment was observed on the right bank from Station 6600 to Station 6270. This revetment was documented in good functional and structural condition and appears to protect nearby residential property. There were no berms documented in this management unit.

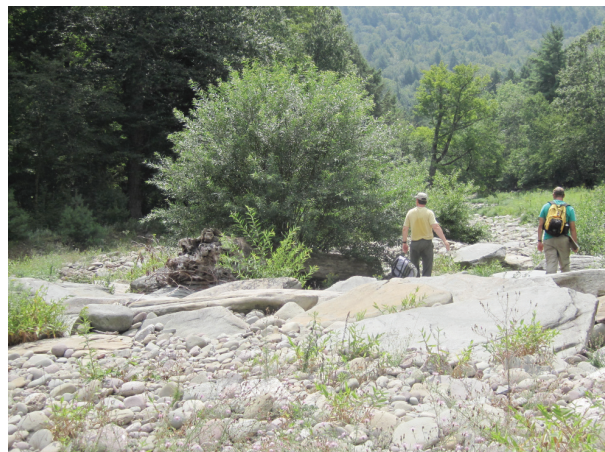
A 117-foot long placed boulder and log check dam was observed on the left bank from Station 6600 to Station 6483. The check dam is functioning as a grade control for the stream bank elevation and may have been designed to block flow from a side channel that cuts off the point bar, instead directing flow around the wide meander. The check dam was documented in good structural and functional condition. (B533) The forested floodplain that forms the inside of this meander bend is inundated during high flow events, as evidenced by numerous cobble bed flood chutes and woody debris piles. (A267), include in call-outs on Bing showing entire bend) The willows and sedges observed vegetating the point bar downstream of Station 6500 were documented as a possible plant source for restoration projects throughout the watershed. (A266)

Photo 4.4.3. 6 Check dam on left bank (B533)

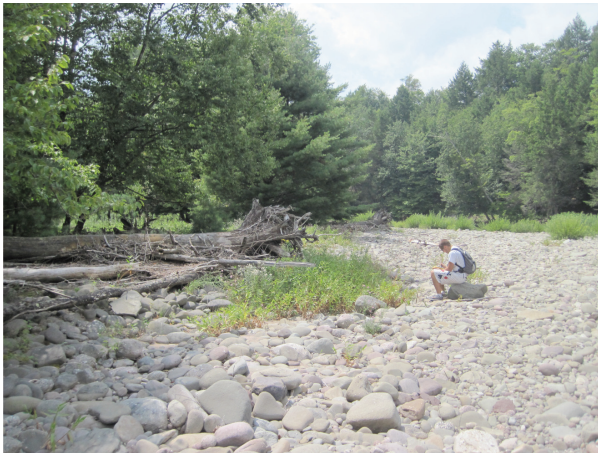
Cobble and debris on flood plain (A267)

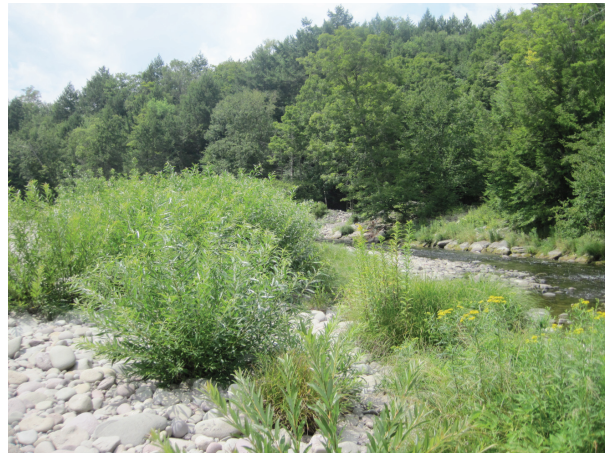
Willows on point bar (A266)
