Neversink River Main Branch

MANAGEMENT UNIT 4

MAIN BRANCH MANAGEMENT UNIT 4
BETWEEN STATION 11700 AND STATION 9300

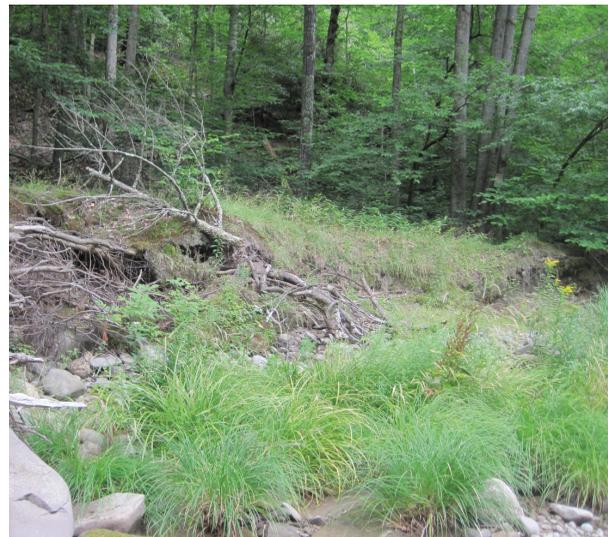
Station 10450 is the former location of the USGS gauging station 01435000 ‘Neversink River Near Claryville, NY’ formerly known as “Neversink River At Halls Mills Near Curry, NY” that was relocated to its current location slightly downstream of the covered bridge between 1949 and 1951. Directly downstream of the confluence is a transverse bar littered with woody debris piles that is pushing the thalweg against the right bank, leading to approximately 600 feet of erosion via fluvial entrainment (BEMS NMB4_9700). (A240) Aerial photos and photo points that were taken at the downstream extent of the eroding segment reveal that this bank is revegetating and will likely stabilize without treatment (*passive restoration*). It is recommended that this site be monitored for changes in condition using the available aerial images.

Erosion of right bank (A240)

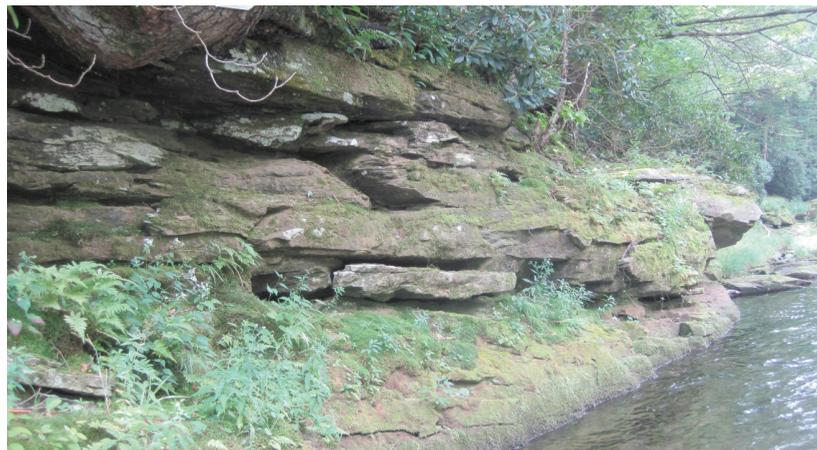
The stream feature survey restarted at Station 9760, the downstream extent of the eroding bank segment. At this location there is a depositional side bar forming that extends approximately 200 feet downstream. On the left bank at this location there is exposed bedrock controlling both the stream bed and bank. (B524) Based on the local topography and location of the main channel it is likely that this bedrock extends upstream from this location. The end of this bedrock was documented 840 feet downstream at Station 8920 in MBMU3.

Exposed bedrock on both bed and left bank (B524)

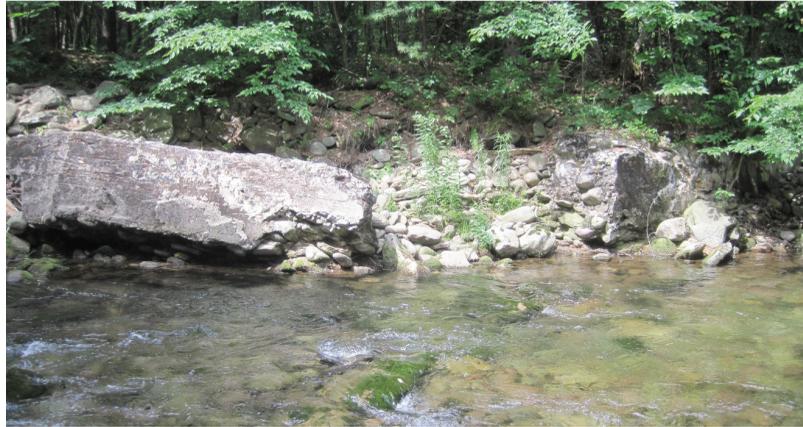
At Station 9550 there are two large boulders of native material that appear to be well eroded but were possibly placed to improve fish habitat, as evidenced by the cobble and gravel deposits upstream of the boulders and the relatively deep scour pools downstream. (B244). Features like this one were observed frequently on the main branch of the Neversink River. It is difficult

Large boulder on right bank, possible fish habitat (B244)

to decipher the original design objectives; they may have been designed to improve or enhance aquatic habitat or to protect banks. It is recommended that the history and original objectives of these features be investigated to better understand their current function and ongoing hydraulic effects.
