# Neversink River Main Branch

## MANAGEMENT UNIT 5

MAIN BRANCH MANAGEMENT UNIT 5  
BETWEEN STATION 14800 AND STATION 1170

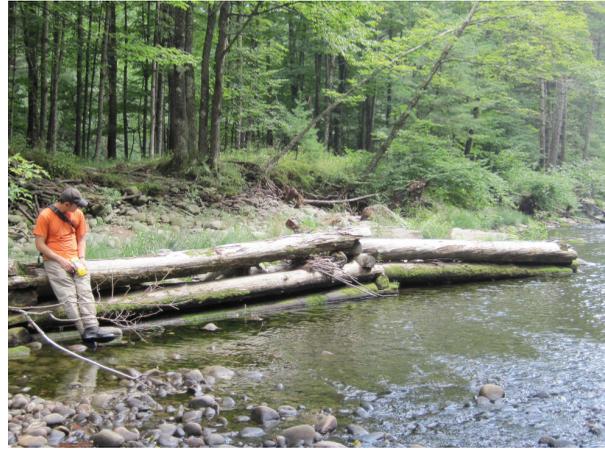
MBMU5 begins at Station 14800 as the main channel exits the wide meander to the right valley wall and continues in a relatively straight channel along exposed bedrock continuing from MBMU6 to Station 14050. This bedrock provides control on both the stream bed and bank. At Station 14600 on the left bank there is a 32-foot segment of log cribbing holding placed boulder rip rap below a terrace. (*B493*)

Structures like this one were observed frequently on the main branch of the Neversink River. It is difficult to decipher the original design objectives; they may have been designed to improve or enhance aquatic habitat or to protect banks. It is recommended that the history and original objectives of these structures be investigated to better understand the current function and ongoing hydraulic effects of these structures. The structural condition of the cribbing here was documented as fair; because the purpose and past use of the structures remain unclear the functional condition cannot be assessed.

*Log cribbing on left bank (B493)*

*“The cribbing you refer to as B493 was put in by my father. It is probably the second or even the third version of the cribbing in this particular spot. As a kid, my father had me moving stones out of the riverbed and into that cribbing or one just like it.”*

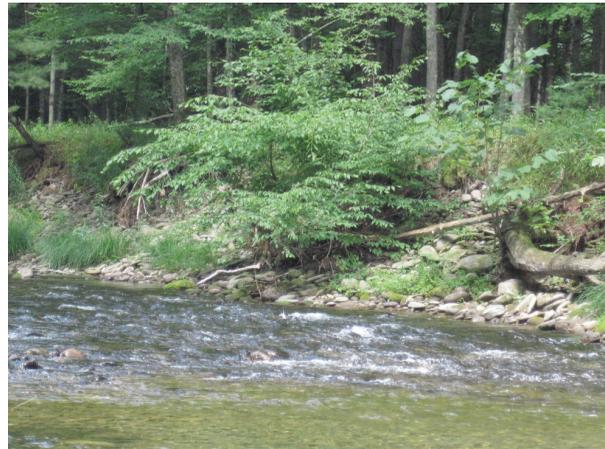
Approximately 100 feet downstream of the log cribbing there is a 40-foot segment of bank erosion into the terrace on the left bank from Station 14460 to Station 14420 (BEMS NMB5\_14400). Sedge and shrubs have established at various heights along the 5-foot high eroding bank indicating that the bank is beginning to stabilize. (B496) It is anticipated that this bank will revegetate and stabilize without treatment (*passive restoration*). It is recommended that this site be monitored for changes in condition.

*Sedge and shrub stabilizing left bank erosion (B496)*

**BANK EROSION** One area of erosion was documented during the stream feature inventory. This 40-foot segment of eroding bank is into the terrace on the left bank from Station 14460 to Station 14420 (NMB5\_14400). Sedge and shrubs have established at the at various heights along the 5-foot high eroding bank indicating that the bank is beginning to stabilize. It is anticipated that this bank will revegetate and stabilize without treatment (*passive restoration*). It is also recommended that this site be monitored for changes in condition.

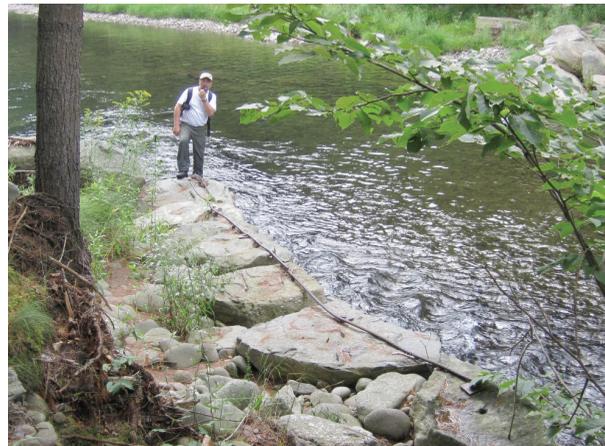
Approximately 20 feet downstream of the bank erosion site there are stacked rock revetments on both banks. The segment on the left bank, extending 30 feet from Station 14410 to Station 14380, is constructed of stacked rock with a line of rebar pinned to the top rocks.(B495). The structure is slumping in the middle, and scour was observed on the banks behind the stacked rock. (B497).The segment on the right bank, extending 55 feet from Station 14410 to Station 14355, is made of stacked rock without rebar reinforcement and angles downstream toward the thalweg of the main channel (A219). Both revetments were documented as in fair structural condition;

*Stacked rock with pinned rebar on left bank (B495)*

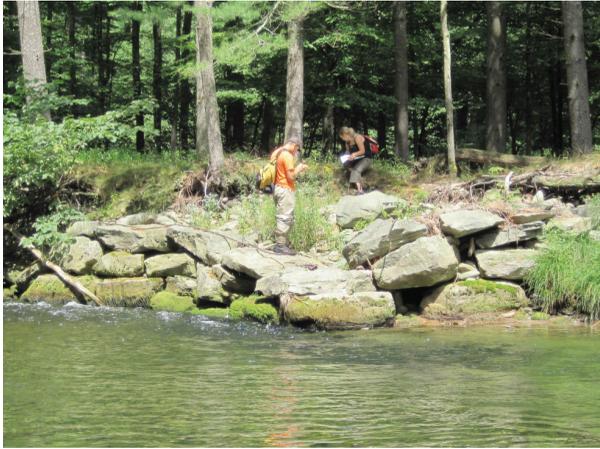
*Slumping revetment due to scour (B497)*

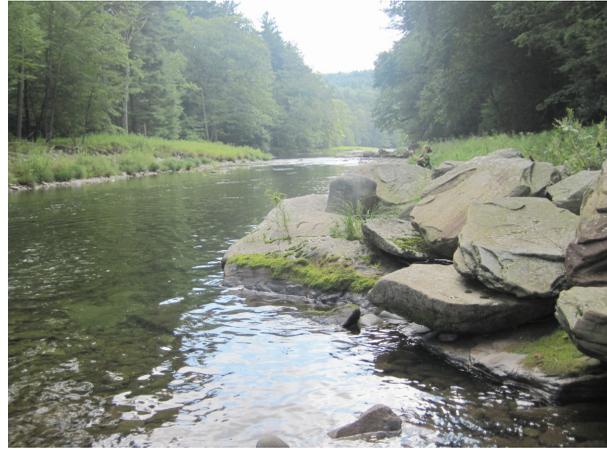
*Stacked rock revetment on right bank (A219)*

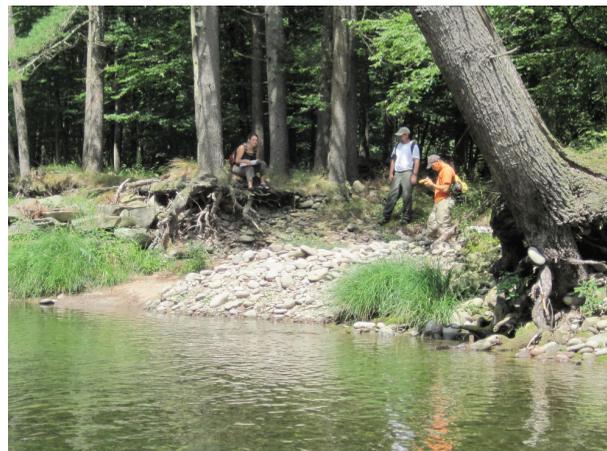
Downstream of the revetment structures the elevation of the terrace on the left bank declines as several flood chutes converge with the main channel from the floodplain on the left. These convergences, located at Station 14380 (B499), Station 14050 (B500) and Station 14000 (B501), confirm the description of this reach at *semi-confined*, which indicates that the main channel is constrained by the bedrock on the right bank while maintaining connectivity to the floodplain on the left bank during flood events.

*Convergence with left bank flood chute at Station 14380 (B499)*

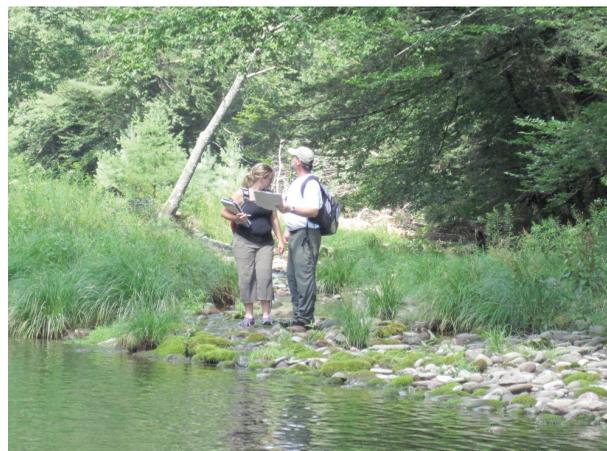
*Convergence with left bank flood chute at Station 14050 (B500)*

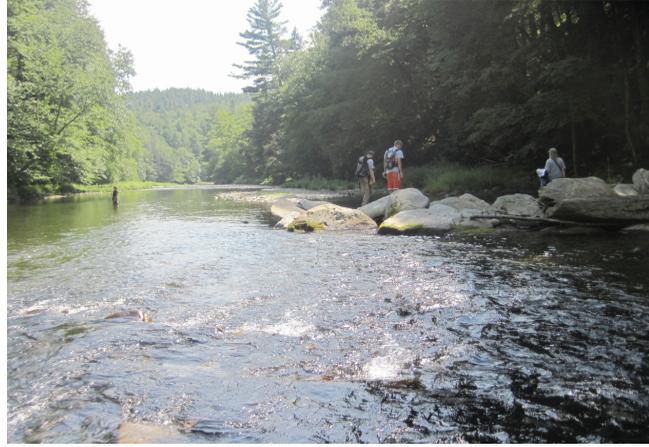
At Station 14080, 30 feet upstream of the end of the exposed bedrock, there is a 40 foot long boulder barb extending into the main channel from the right bank angled slightly downstream. This obstruction reroutes flow in the main channel upstream and has created a scour pool directly downstream, which could indicate that this barb was installed to create fish habitat. (A223)

*Boulder barb on right bank creating scour pool for possible fish habitat (A223)*
