Neversink River West Branch

MANAGEMENT UNIT 1

WEST BRANCH MANAGEMENT UNIT 1
BETWEEN STATION 0 AND STATION 2200

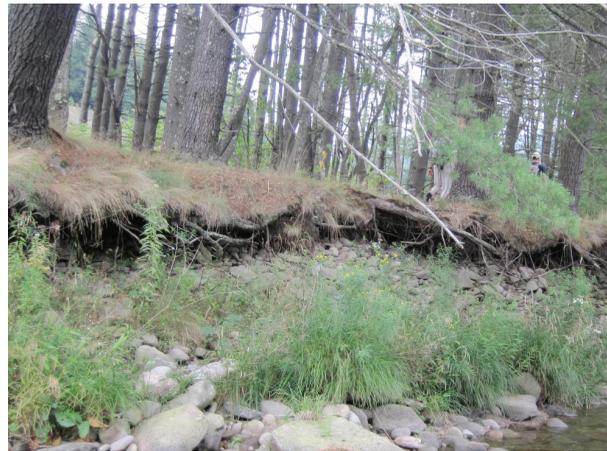
This bank segment extends 450 feet to Station 1500 (BEMS NWB1_1500). The bank site was documented as active; hydraulic erosion and fluvial entrainment are exposing stratified alluvial materials and undercutting the riparian vegetation on the top of the bank but up to 1 foot in some places. Vegetation and hardening with large boulder were observed. (B361)

Eroding segment on left bank (B361)

It is likely that the wide band of riparian forest with old hemlock growth between the main channel and Frost Valley Road will significantly slow erosion on this bank. Therefore, it is recommended that this bank be left to revegetate and stabilize without treatment (*passive restoration*) and that the site be monitored for changes in condition.

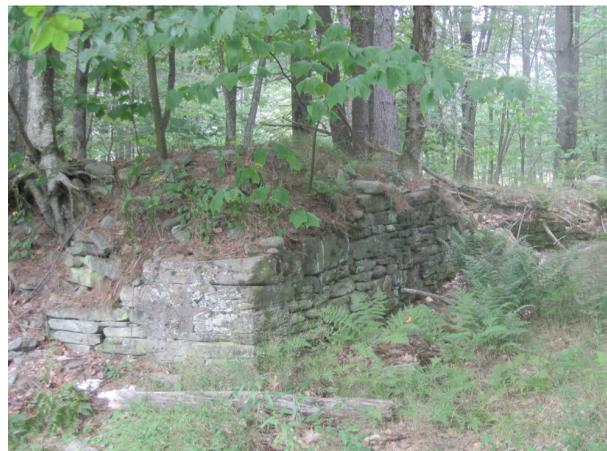
A toppled foundation was observed on the left bank at the end of this eroding bank segment near Station 1500. (B367, A24) According to the map of Forest Industries in the Catskills and the associated descriptions included in *The Catskill Forest: A History* by Michael Kudish (Purple Mountain Press, 2000), a sawmill with turning works was formerly located in in WBMU1 just above the confluence with the East Branch of the Neversink. It is possible that this foundation

Topped foundation on left bank (B367)

was part of the mill, which was believed to be operational through at least 1896. The headcut and pool observed in the main channel slightly downstream from the foundation near Station 1450 could also be indicators of the remains of a sawmill raceway or mill wheel. (A23)

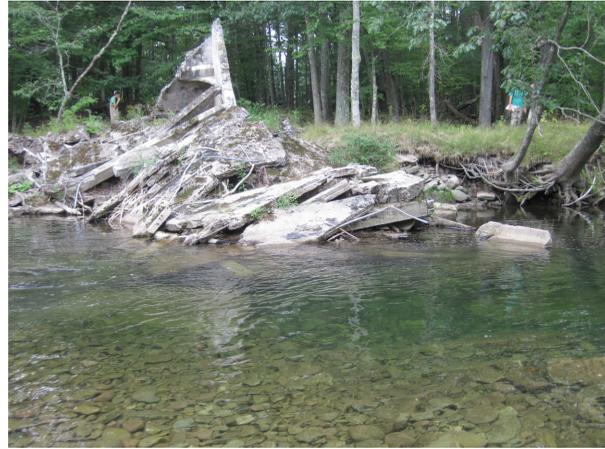
Construction debris (A24)

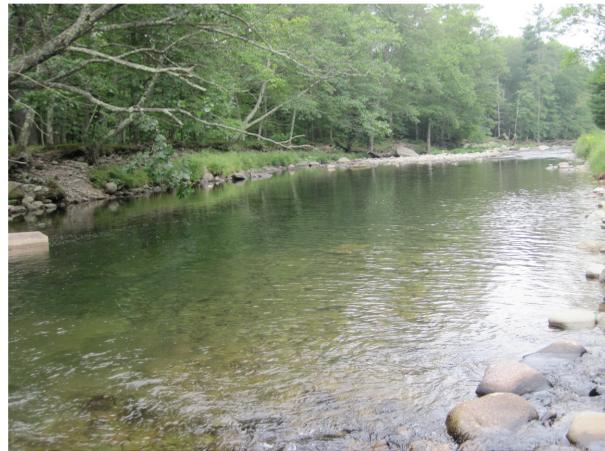
Pool at topple foundation site (A23)

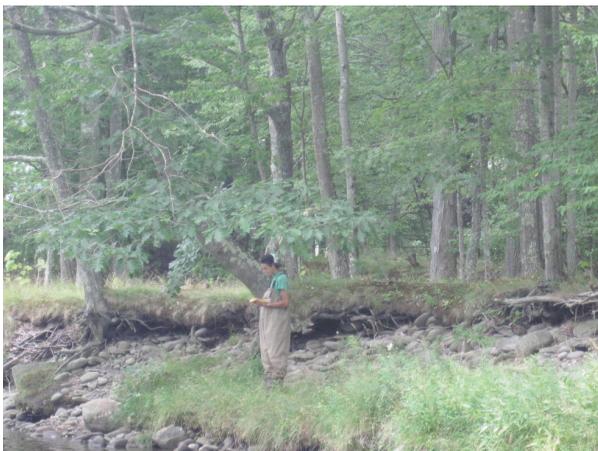
Actively eroding left bank segment (B370)

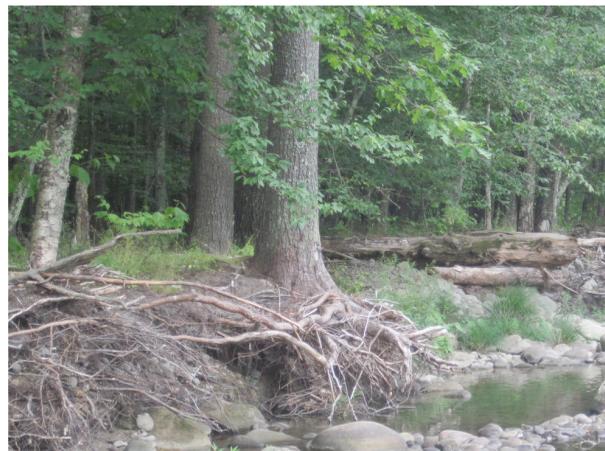
Woody debris jams increasing scour on left bank (B373)

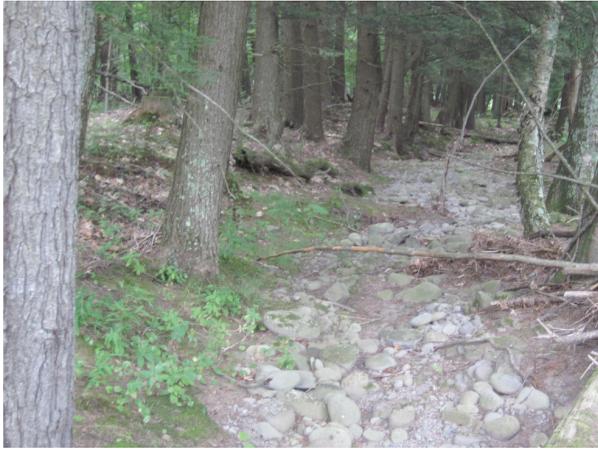
A flood chute was observed diverging into the floodplain on the left bank near Station 1000,

Flood chute on left flood plain (B375)

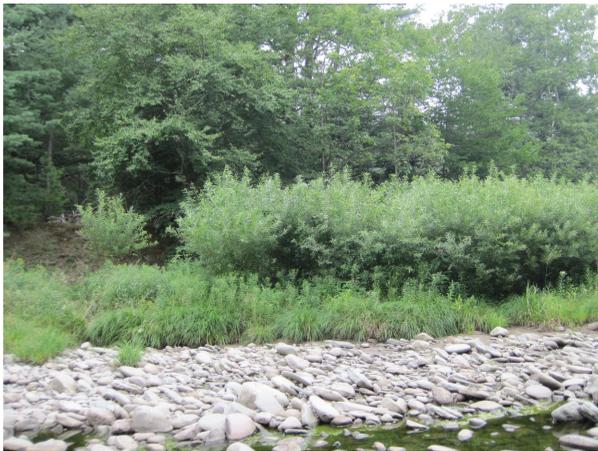
Potential willow harvest source (A29)

apparently diverted by a woody debris jam. Across from this divergence, a side channel conveying flow from the right floodplain joins the main channel around a cobble depositional bar vegetated with willow. This willow was documented as a potential plant source for restoration project in the watershed, and could potentially be used for assisted restoration of the eroding bank segment slightly upstream on the left bank. (B375, A29)

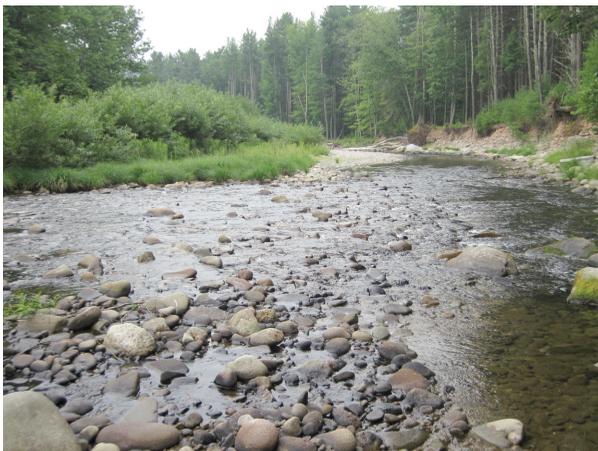
Transverse bar spanning channel width (A35)

Slightly downstream of this convergence a transverse bar was observed spanning the width of the cobble bed channel, directing flow in toward an eroding bank segment on the right bank. (A35) A cobble point bar begins on the left bank near Station 800, also forcing flow toward the eroding right bank. (B381)

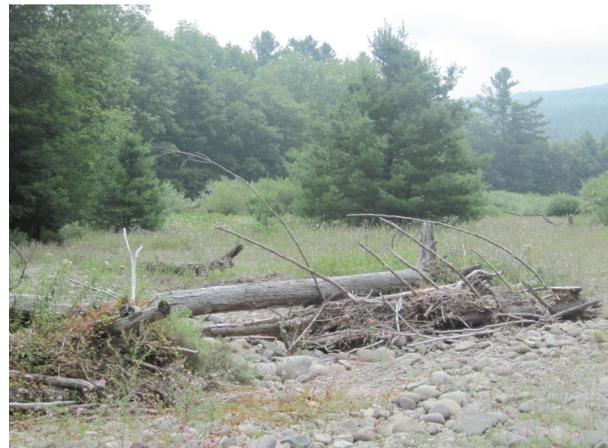
Cobble point bar on left side of channel (B381)

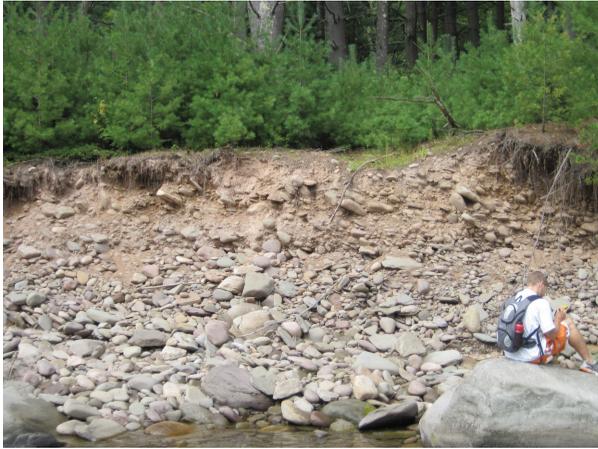
Eroding right bank segment (A42)

was documented as active; no vegetation was observed on the slope or at the toe and hydraulic erosion during high flow events appears to entrain fine sediments included in bank materials. This bank was documented as a potential source of fine sediments although it is not a significant source of turbidity. (A42)

Due to the increased pressure on the bank from the main channel at the outside of the meander bend and the scour aided by debris accumulation, recommendations for this site include *assisted restoration* using *bioengineering* techniques to increase bank stability and reduce entrainment of fine sediments.

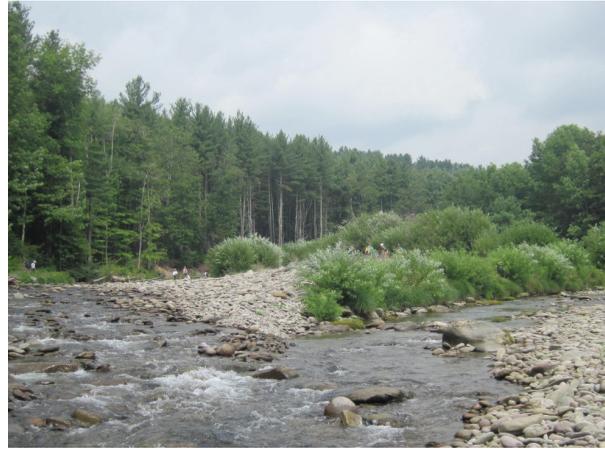
Delta bar (B383)

The remaining reach of the West Branch features significant sediment deposition and large woody debris accumulation due to backwatering from the convergence with the East Branch at Station 0. A delta bar with cobble, gravel and sand was observed between the two branches at the convergence. (B383) WBMU1 ends at this convergence at Station 0.
