Neversink River West Branch

MANAGEMENT UNIT 13

WEST BRANCH MANAGEMENT UNIT 13
BETWEEN STATION 49100 AND STATION 54200

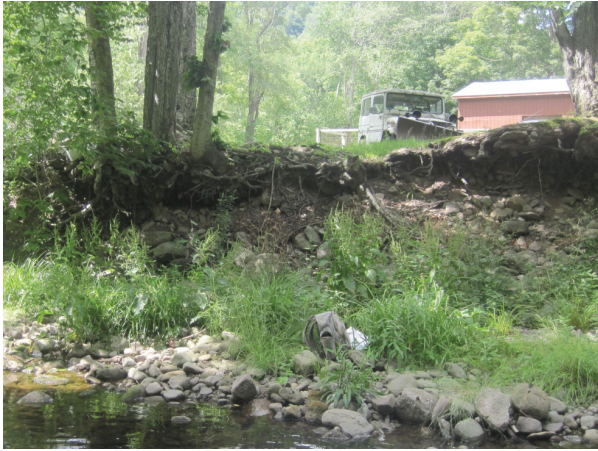
Left bank actively eroding (B793)

150 feet downstream of the bridge a water intake pipe for farm operations was observed on the left bank directly upstream of an active 35-foot long eroding bank segment on the right bank (BEMS NWB13_54000). (B793, B790) This eroding bank segment was documented as active with undercut banks caused by hydraulic erosion. Although evidence of hardening and vegetation at the top of the bank was observed, the lack of riparian buffer indicates that the erosion at the top of the bank will continue during high flow events. Recommendations for this site include *assisted restoration* using bioengineering techniques to stabilize the eroding bank and re-establish a healthy riparian buffer.

Station 54080 (BEMS NWB13_54000). Recommendations for this site include *assisted restoration* using bioengineering techniques to re-establish a healthy riparian buffer and stabilize the eroding bank.

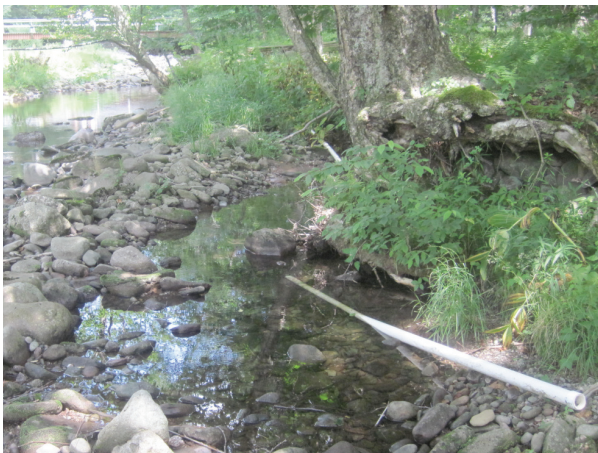
Irrigation piping for nearby farm (B790)

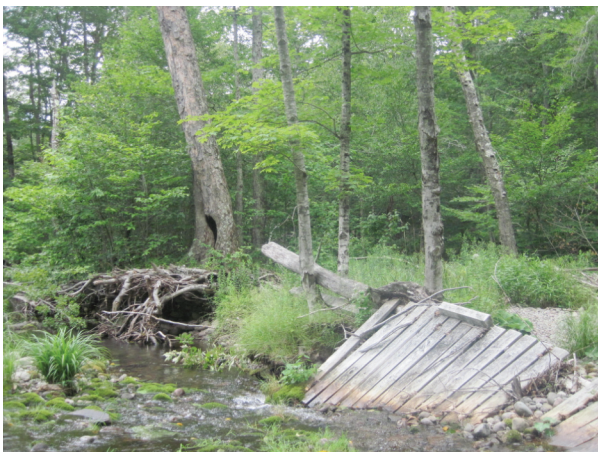
WBMU13 begins at a private timber footbridge that crosses the main channel near Station 52400 connecting an emu and ostrich farm on the right bank to the New York State land on the left bank. According to the landowner at the site, this bridge has washed out three times in the past ten years. This was corroborated by evidence of former bridge components (timbers and decking) in the banks and beds

Washed out bridge obstructing flow (A915)

A sediment storage reach begins near Station 53800 with a cobble side bar continuing downstream to a series of woody obstructions and divergences of side channels that begin near Station 53550. There is a transverse bar located at Station 53600 directly upstream of timber debris from the washed-out footbridge upstream. On the left bank at Station 53550 a large downed tree was observed on the right bank that has cut off flow toward the right bank and forced movement of the main channel towards the left bank at this location. (A915, A916)

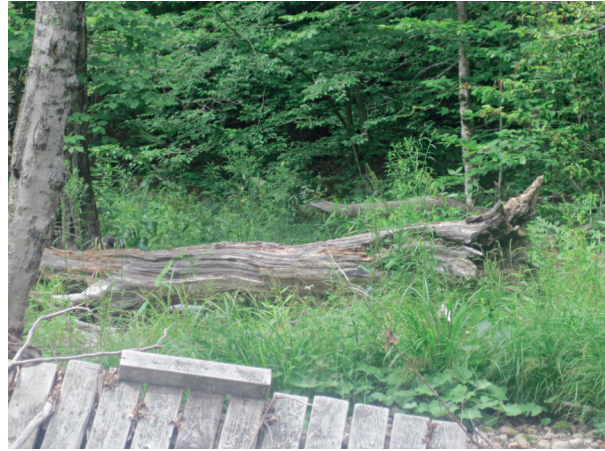
Downed tree cutting off flow to right bank (A916)

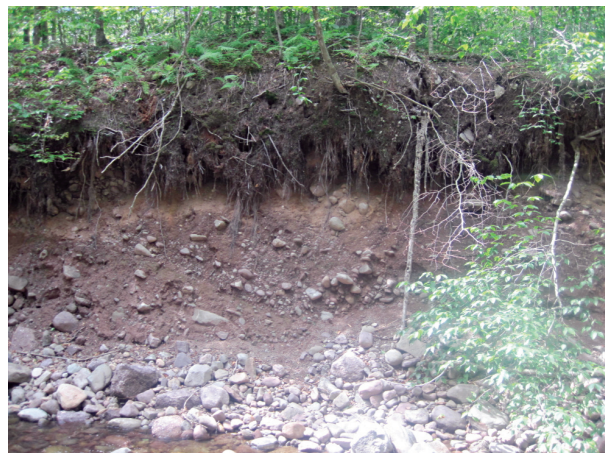
Large woody debris piles and sediment deposition areas were observed throughout the floodplain and side channels in this area indicating that the entire width of the valley floor is inundated and conveys flow during high flow events. This is further evidenced by an eroding bank segment observed on a side channel extending 150 feet from Station 53250 to Station 53150 (BEMS NWB13_53150). This bank site was documented as active with undercutting of trees on the top of the bank exposing stratified alluvial materials underneath a layer of sand and glacial till. This exposed sand was documented as a fine sediment source, although it is not a significant source of turbidity. (A922)

Stratified eroding bank (A922)

A second eroding bank segment was observed on a side channel extending 150 feet from Station 53250 to Station 53150 (BEMS NWB13_53150). This bank site was documented as active with undercutting of trees on the top of the bank exposing stratified alluvial materials underneath a layer of sand and glacial till. This exposed sand was documented as a fine sediment source, although it is not a significant source of turbidity. Due to the location of this site and conditions at the top of the bank, it is recommended that this bank be allowed to revegetate and stabilize without treatment (*passive restoration*). However, it is recommended that this site be monitored for changes in condition.

As evidenced by the adjustment in channel alignment throughout this segment of the river, this is a sediment storage reach, prone to extensive gravel deposits and lateral migration. In addition, this eroding bank segment is separated from the road by a thick forested bank and unlikely to be a major source of turbidity. It is recommended that this bank be allowed to revegetate and stabilize without treatment (*passive restoration*). However, it is recommended that this site be monitored for changes in condition.

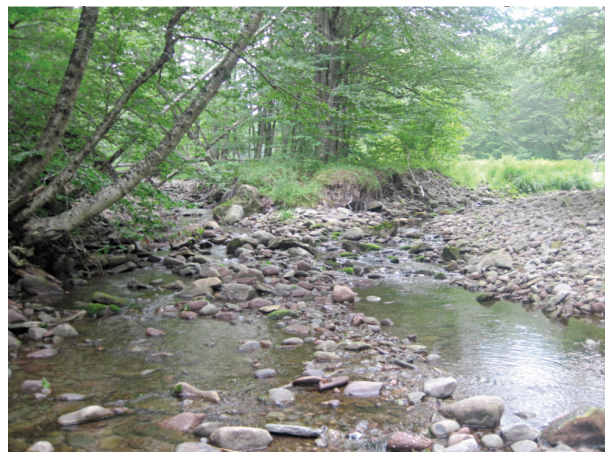
The two side channels flowing through the right floodplain converge with the main channel near Station 53100. (A926) Approximately 200 feet downstream near Station 52900 an intermittent tributary joins the main conveying flow from Frost Valley Road and the right valley wall. An eroding bank segment was observed 300 feet downstream on the right bank extending 75 feet from Station 52600 to Station 52525 (BEMS NWB13_52525).

Two side channels converging with main channel (A926)

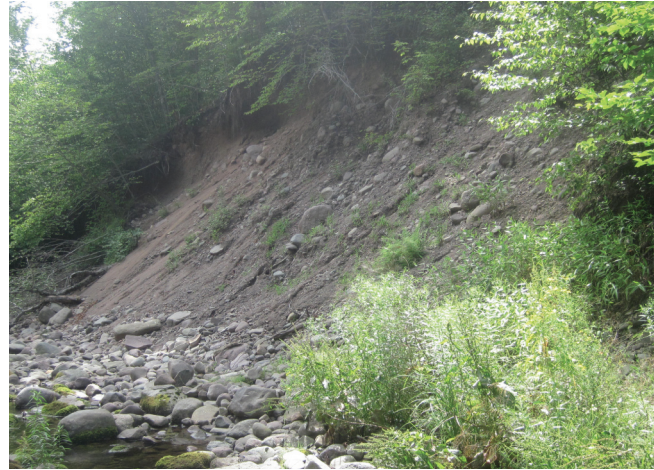
This eroding bank segment was documented as an active mass failure site caused by a combination of surficial piping and hydraulic erosion that is a likely source of fine source but not a significant source of turbidity.

Bank failure site (B808)

The final eroding bank segment in WBMU13 was observed on the right bank extending 75 feet from Station 52600 to Station 52525 (BEMS NWB13_52525). This eroding bank segment was documented as an active mass failure site caused by a combination of surficial piping and hydraulic erosion that is a likely source of fine source but not a significant source of turbidity. Recommendations for this site include further investigation of the cause of the bank failure, specifically an investigation of upslope drainage from Frost Valley Road and possible re-routing of drainage to converge with the main channel in a less sensitive location.

Recommendations for this site include further investigation of the cause of the bank failure, specifically an investigation of upslope drainage from Frost Valley Road and possible re-routing of drainage to converge with the main channel in a less sensitive location. Hardening and some vegetation was observed at the toe, so it likely that if the surficial piping is mitigated the bank will stabilize and revegetate without treatment (*passive restoration*). (B808)

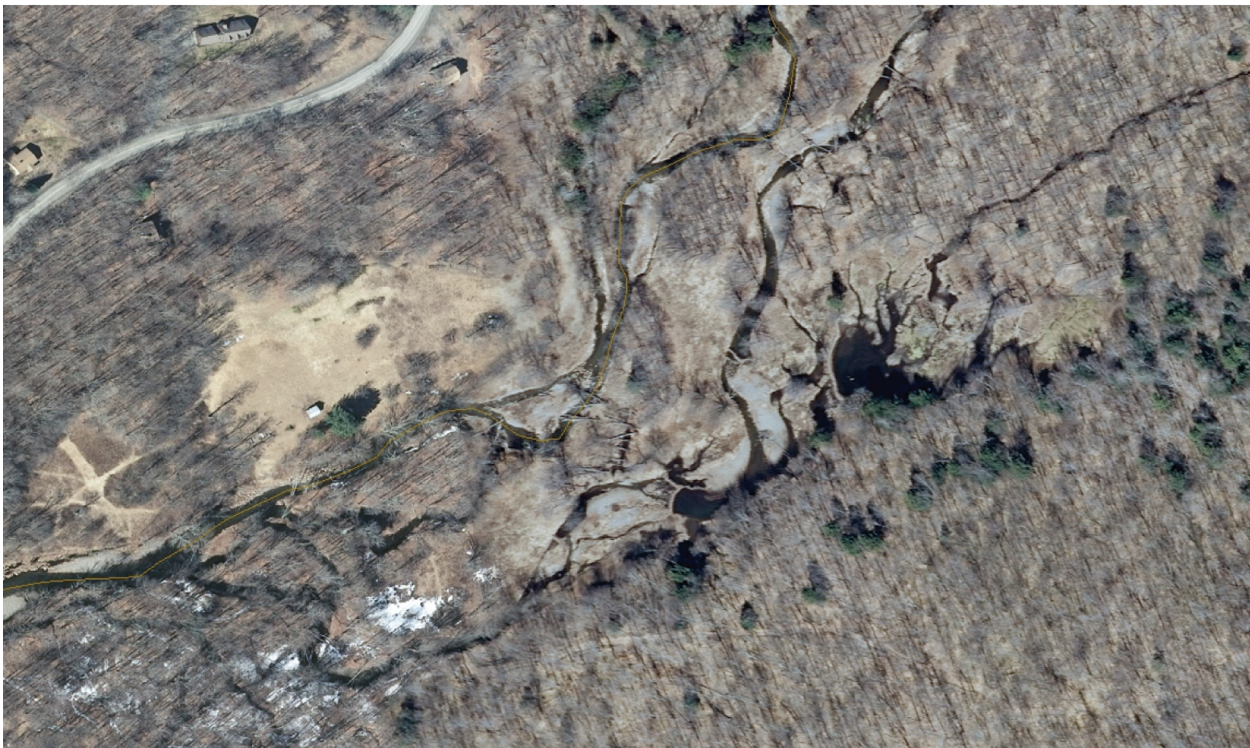
The divergence of a dry cobble-bed side channel from the main channel was observed near Station 52420, slightly upstream of the transition from private land to New York State land, in “forever wild” status, at approximately Station 52260; no recommendations are made for lands in forever wild status. (C100)

Braided shrub wetlands in WBMU13, aerial view (C100)

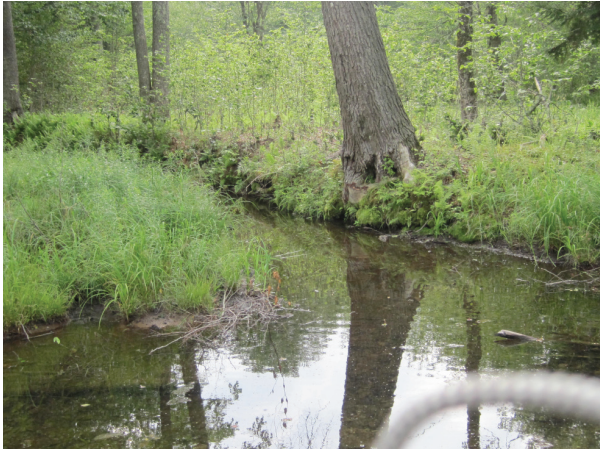
Side channels forming forested shrub wetland (B819)

Downstream of this location the floodplain widens considerably as the main channel continues to flow adjacent to a terrace on the right bank and while multiple side channels diverge to the left, forming a forested shrub wetland braided with side channels, flood chutes, and woody debris piles formed during high flow events. (B819, B826, A938)

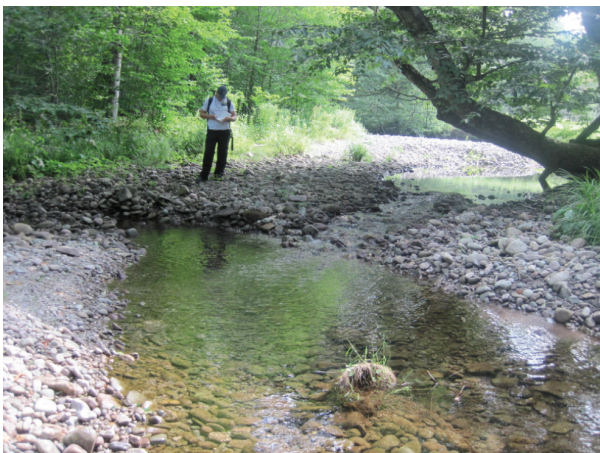
Braided side channel (A938)

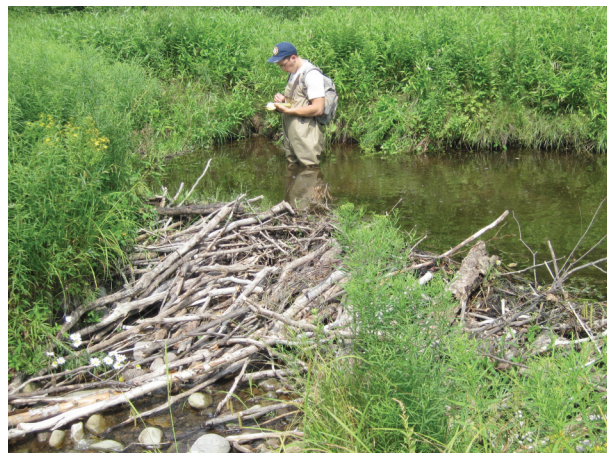
Beaver dam in left floodplain (B840)

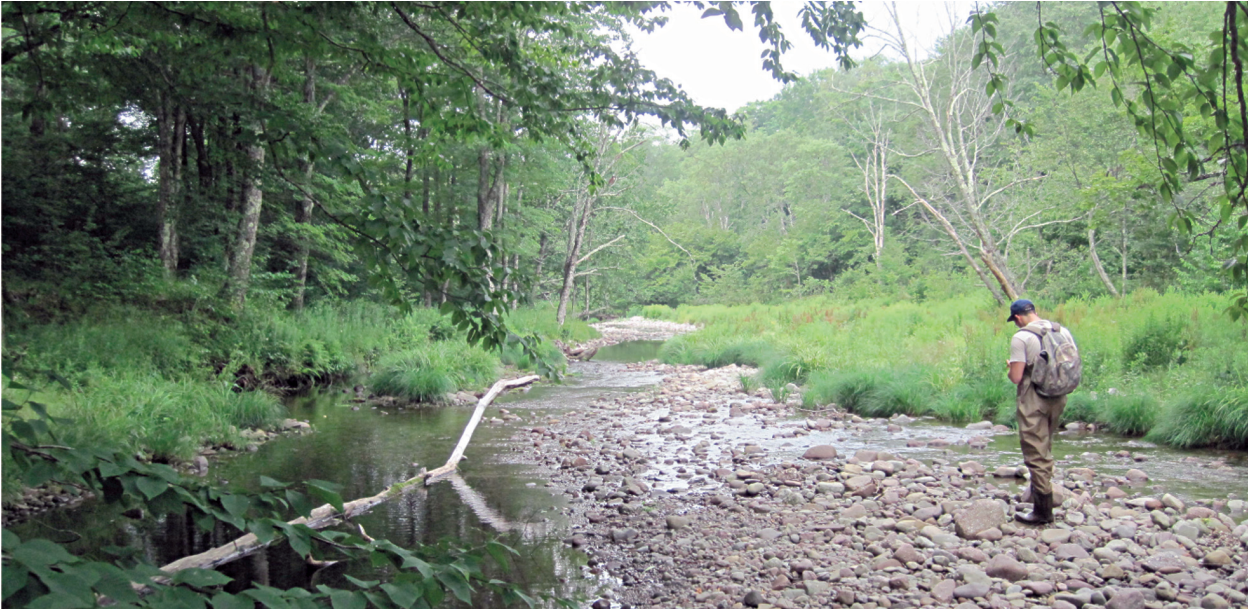
This channel form continues downstream onto Frost Valley YMCA land beginning at Station 51300, although the main channel meanders more towards the middle of the valley floor, resulting in the formation of braided shrub floodplains and emergent wetlands on both banks. A tributary was observed joining a side channel flowing adjacent to the left bank near Station 50400. The left floodplain in particular is riddled with control points formed by beaver dams, which lead to large open pools amongst shrubs and wetland vegetation. (B840). The valley floor narrows near Station 49800 as the main channel crosses back onto New York State land. All of the side channels from both banks converge with the main channel near Station 49600. (B850)

Convergence of side channels with main channel (B850)

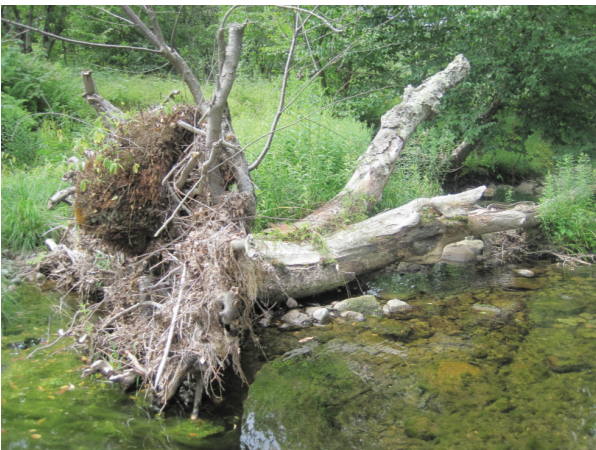
Root wad forming scour pool in main channel (A962)

MUWB13 ends at Station 49100 with a root wad forming a scour pool in the main channel. (A962, B961)

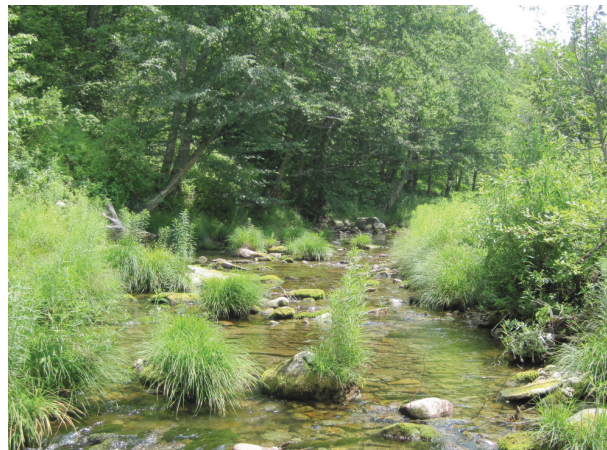
Transverse bar directing flow towards bank (B961)

A transverse bar was observed at Station 49520 which was directing flow towards bank scour on the low bankfull bench slightly downstream, and a cobble side bar was observed on the left bank near Station 49230.
