# Neversink River West Branch

## MANAGEMENT UNIT 16

WEST BRANCH MANAGEMENT UNIT 16  
BETWEEN STATION 69700 AND STATION 64300

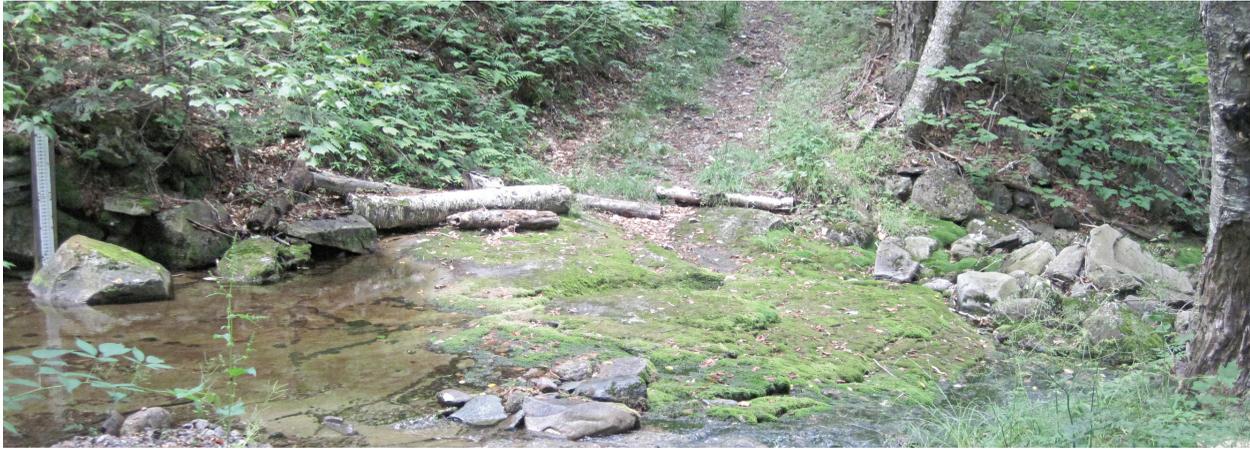
*Trail crossing through stream (B469)*

East Branch Trail which heads due south up the valley wall to connect to trails leading to the summit of Slide Mountain and other Catskills High Peaks. (B469)

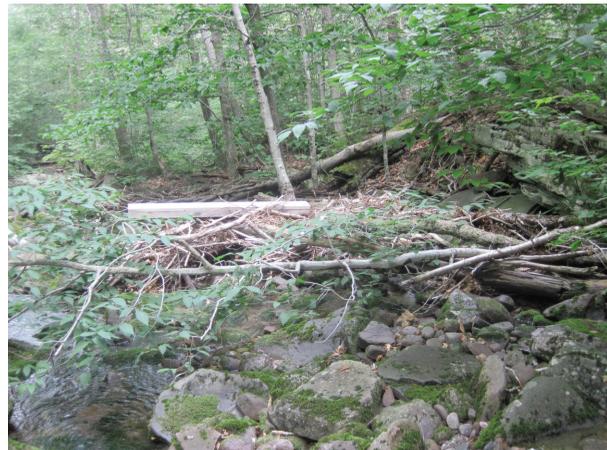
At Station 69480 a large woody debris jam was observed in the main channel. The dense forest surrounding the stream in this management unit and the river upstream provides a continuous source of large mature trees that can be blown down or washed into the stream during storm events. However, it appeared that some of the material in this debris jam was not natural and could have originated from nearby construction. The origin of this debris should be investigated. (A548) At Station 69420 an intermittent tributary joins the main channel which conveys runoff from the left valley wall. (B471)

*Construction and natural debris causing jam (A548)*

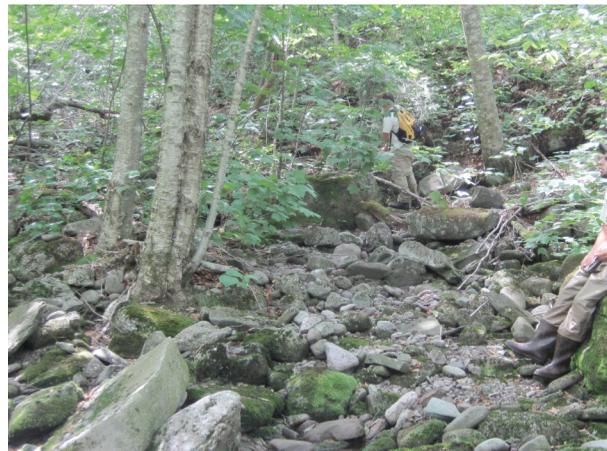
*Intermittent tributary (B471)*

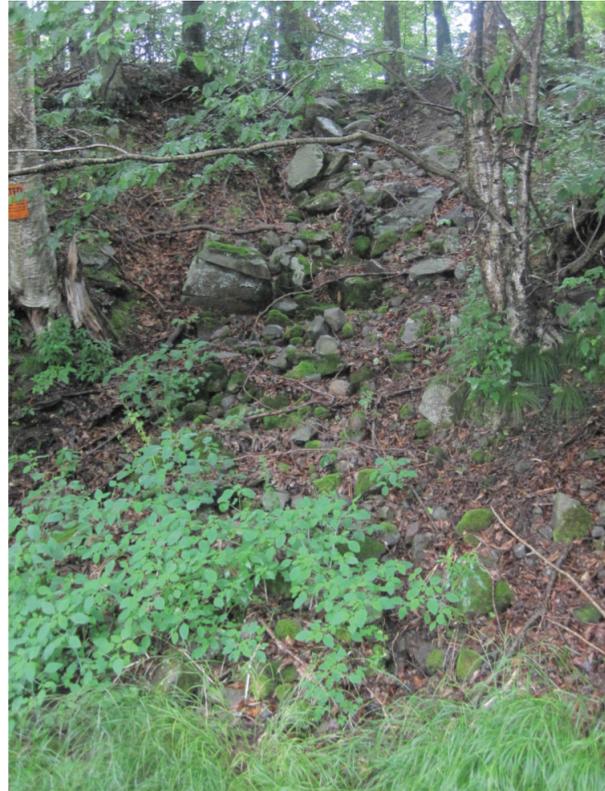
The first of these culverts was observed along the right side of road conveying flow from the right valley wall at approximately Station 69200. (A601) Coincident with this culvert placement, an earthen berm was observed between what appeared to be an old logging road at the main channel for 220 feet from Station 69220 to Station 69000. At the end of the berm a tributary joins the main channel from a 12 inch diameter smooth steel culvert which conveys flow from Frost Valley Road and the forested right valley wall. (B479)

*Culvert conveying flow from right valley wall (A601)*

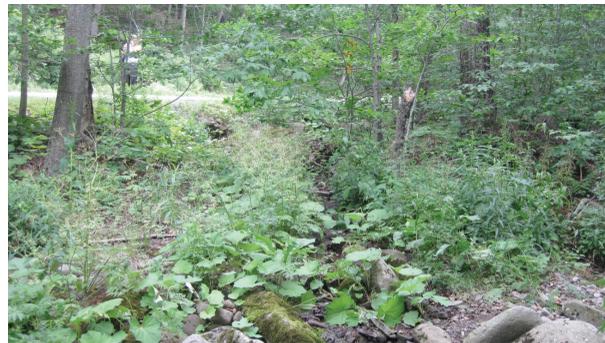
*Tributary entering through culvert (B479)*

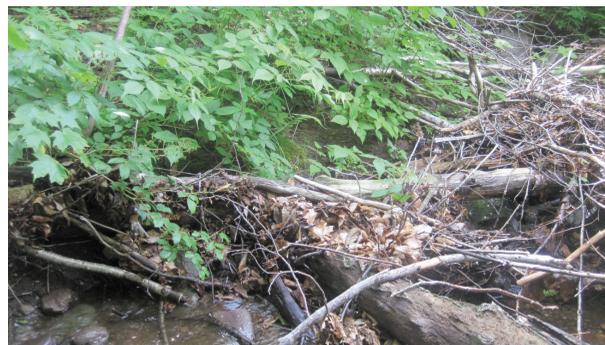
Downstream of this convergence the main channel splits around a vegetated center island near Station 68900. The right channel runs adjacent to Frost Valley Road where a 95 foot long eroding bank segment was observed from Station 68950 to Station 68850 (BEMS NWB16\_68800). This eroding segment appeared to be caused by hydraulic erosion of a bank that is sparsely vegetated with grass and sedge. (A550)

*Debris jam causing hydraulic erosion (A550)*

Recommendations for this site include *assisted restoration* using *bioengineering* techniques to stabilize the eroding bank and establish a more effective riparian buffer. This restoration effort should include an investigation of the contribution of road runoff to the bank failure and restoration design should include appropriate stormwater management practices if deemed necessary.

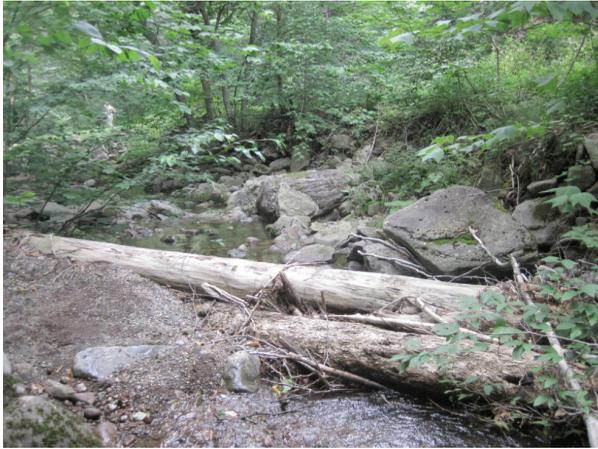
Downstream of the eroding bank segment along Frost Valley Road the side channel converges as the river makes a small meander to the left before again becoming laterally controlled by Frost Valley Road on the right. At Station 68690 there is a natural log weir that exaggerates the step-pool pattern of this segment of the river. Significant deposition of coarse gravel was observed upstream of the log and a scour pool was observed downstream. (A555, A554).

*Log weir causing deposition upstream (A555)*

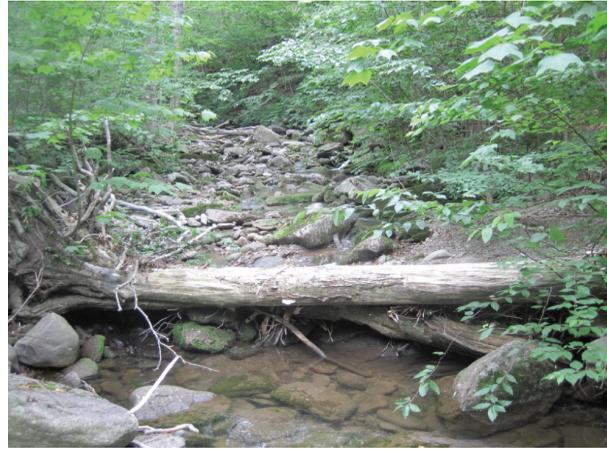
*Log weir causing scour downstream (A554)*

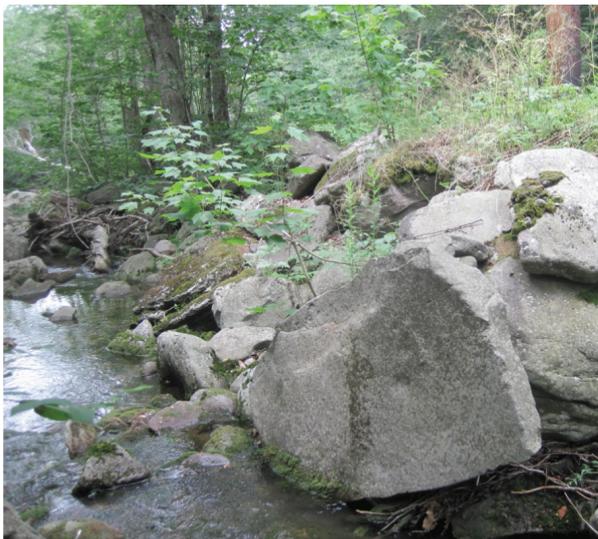
*Large boulder revetment that is slumping (A557)*

Directly downstream of the log weir the river flows adjacent to a 260 foot long stacked rock revetment along Frost Valley Road. This revetment was documented as in fair structural and functional condition; the stacked rock is slumping and there was scour around and behind the larger boulders. There was no riparian buffer between the revetment and the road in this location. (A557, A559). Recommendations for this site would include renovation of the revetment with bioengineering techniques to more effectively stabilize the bank, improvement of the riparian buffer and, potentially, placement of *flow deflection structures* to reduce erosive forces on this bank.

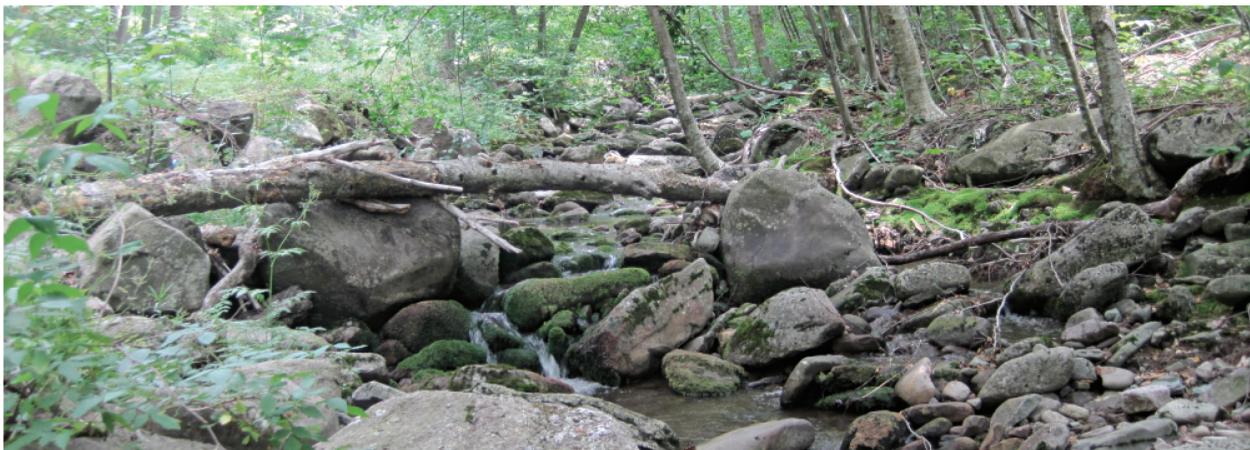
*No riparian buffer between revetment and road (A559)*

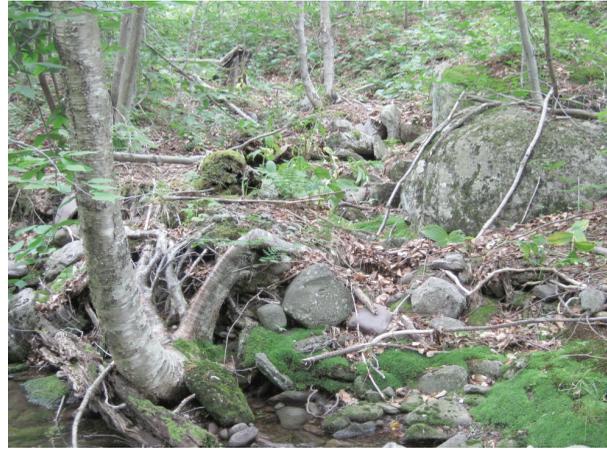
Across from the revetment on the left bank at Station 68510 an intermittent tributary joins the main channel. It appears that this tributary drains a perched wetland area slightly up slope although it was dry at the time of the stream survey. (B484) At station 68410 another woody debris jam in the main channel with additional logs and fallen branches was observed. (B487)

*Tributary draining perched wetland area (B484)*

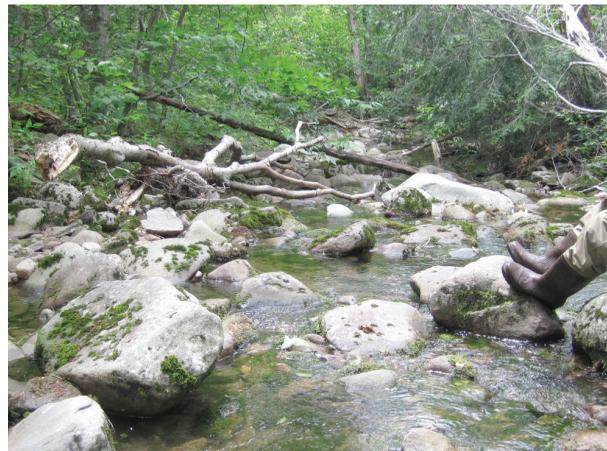
*Woody debris jam in main channel (B487)*

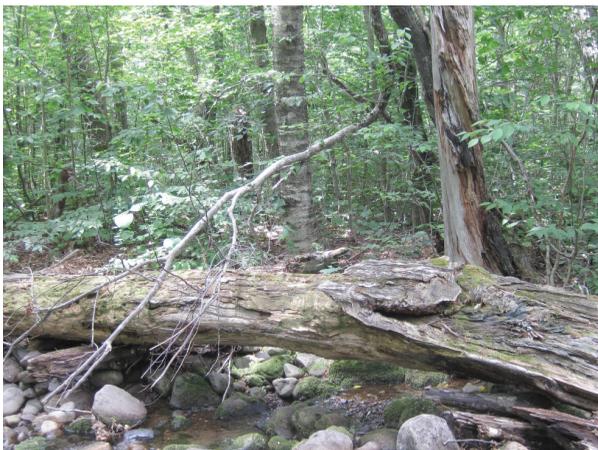
Around Station 68300, a large boulder constrains lateral movement of the main channel to the left, while on the right a forested, low-elevation floodplain that appears to be inundated during moderate flow events. (B492, B496) As the main channel is directed back toward Frost Valley Road by the boulder control the channel diverges around a forested center island near Station 68150. (A560) A side channel continues relatively straight while the main channel meanders towards the road and converges with a tributary from a culvert conveying flow from Frost Valley Road and the right valley wall. The side channel is littered with woody debris jams until it converges with the main channel at Station 67970. A 140-foot long segment of exposed bedrock provides lateral control for the side and main channel on the left bank centered around this convergence. (B505).

*Woody debris on right bank and floodplain (B492)*

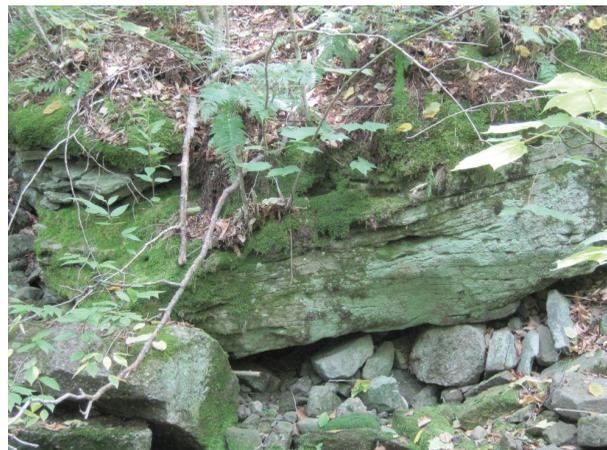
*Boulder constraining lateral movement (B496)*

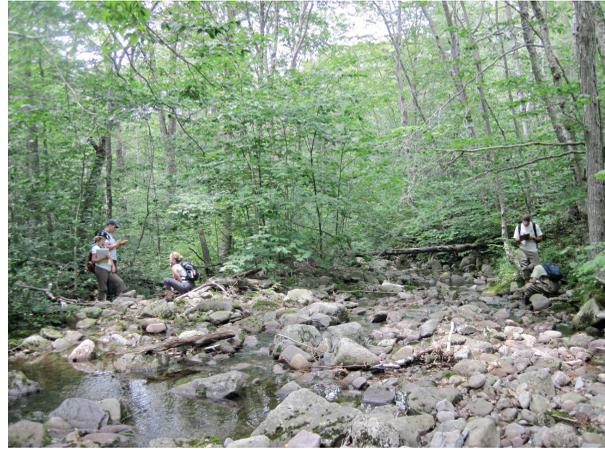
*Channel divergence around forested center island (A560)*

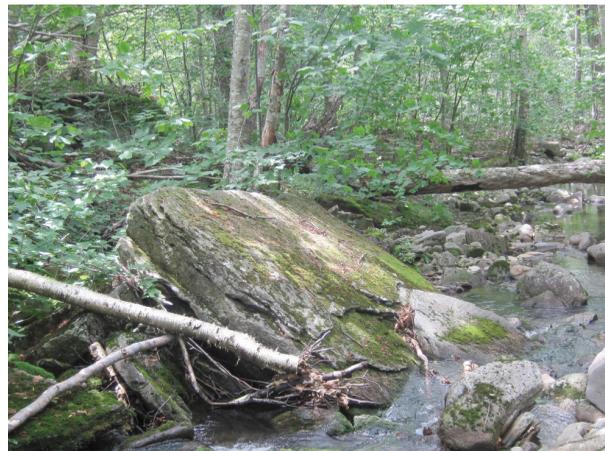
*Exposed bedrock providing lateral control (B505)*

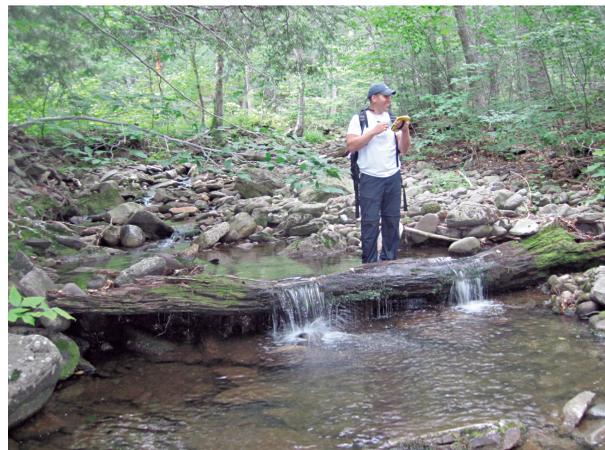
From Station 67840 to Station 67630 a stone berm was observed between the main channel and Frost Valley Road. It is likely that this berm was constructed for flood control as the right bank floodplain and road are at the same elevation at this location. The berm coincides with a sharp meander to the right in the main channel and a floodplain with a riparian buffer in poor condition. Near the end of the berm at Station 67640 there is a natural log weir across the main channel providing stream bed elevation control with deposition on the upstream side and a scour pool directly downstream. (A573)

*Natural log weir (A573)*

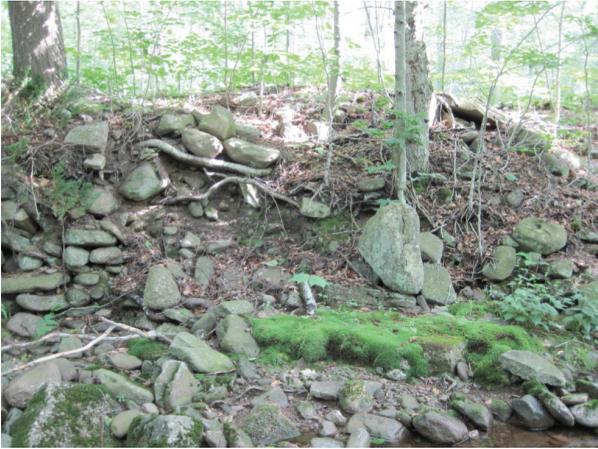
An undercut, eroding bank segment was observed on the right bank from Station 67140 to Station 67060 (BEMS NWB16\_67075), caused by hydraulic erosion. (A735) It is anticipated that this bank will revegetate and stabilize without treatment (*passive restoration*). However, it is recommended that this site be monitored for changes in condition.

*Eroding right bank (A735)*

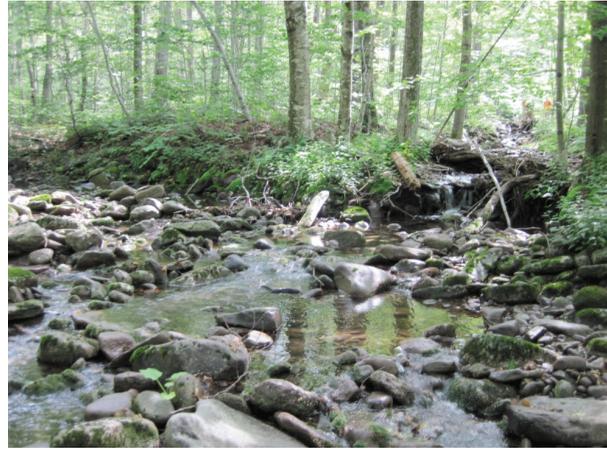
*Flood chute entering stream channel (A743)*

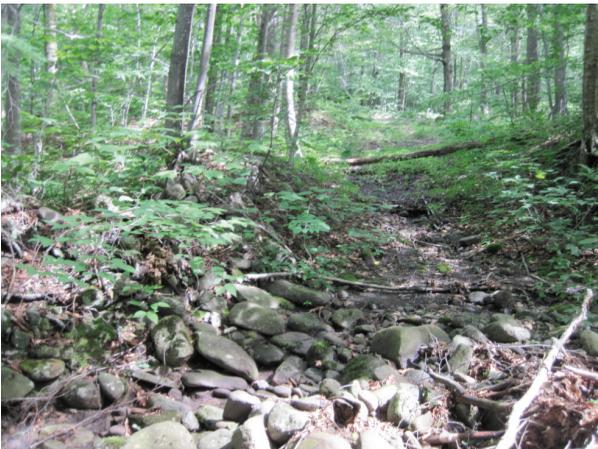
At Station 66610 another eroding bank segment was observed that appeared to be surficial failure caused by conveyance of road drainage from Frost Valley Road through the narrow floodplain on the right bank. (BEMS NWB16\_66600) (A739)

*Right floodplain conveying road drainage (A739)*

It is anticipated that this bank will revegetate and stabilize without treatment (*passive restoration*), however, it is recommended that this site be monitored for changes in condition.

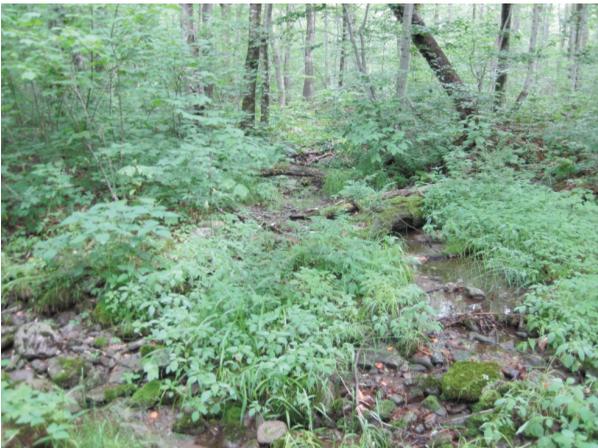
*Woody debris littering floodplain (A770)*

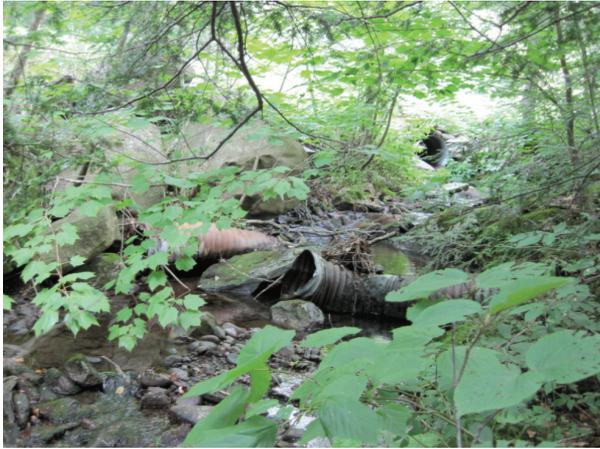
*Culvert conveying road drainage (A759)*

At Station 64710 an intermittent tributary conveying drainage from Frost Valley Road and the right valley wall joins the main channel. This drainage is conveyed under Frost Valley Road from the right valley wall by a 48" culvert. Scour was observed at the outfall of this culvert that was documented in poor condition. It is likely that this drainage is conveying fine sediments and other materials from the road directly to the main channel in this location. (A759)

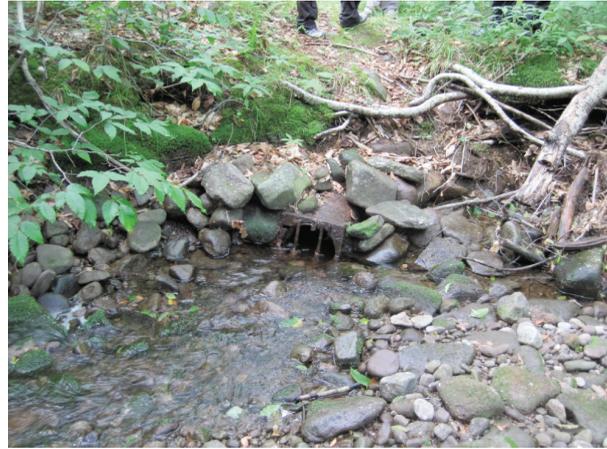
*Culvert conveying flow from side channel to pond (A764)*

At Stations 64600 and 64400 corrugated metal culverts documented in poor structural and functional condition convey flow from a side channel in the floodplain to the Shandaken Rod & Gun Club pond. (A764, A768) It is recommended that these culverts be evaluated for replacement. The pond, in turn, outlets into a small channel that rejoins the mainstem in Management Unit 15. With numerous cabins This off-line pond h

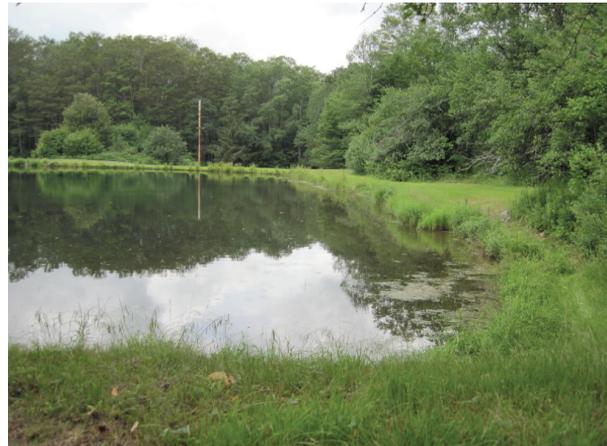
*Shandaken Rod & Gun Club pond (A768)*

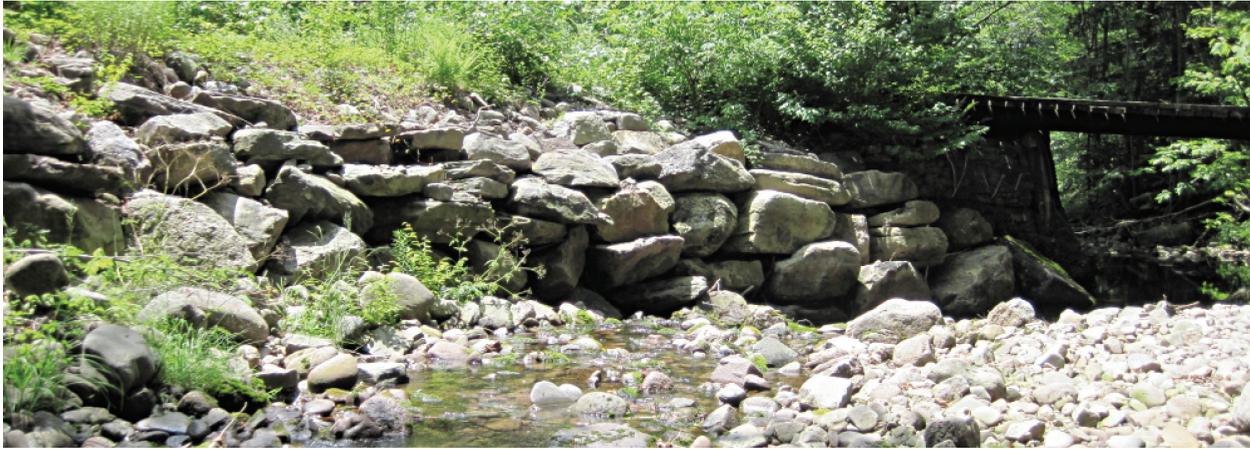
At Station 64300, at the end of WBMU16, the bridge for the Shandaken Rod and Gun Club driveway crosses the main channel. Stacked rock revetment was observed on the left bank for approximately 50 ft. upstream of the bridge. The revetment was documented in fair structural and functional condition as it was slumping throughout its length. (A773). The potential for improvement of the riparian buffer from Station 64500 to 64300 should be investigated.

*Stacked rock revetment on left bank (A773)*
