Neversink River West Branch

MANAGEMENT UNIT 8

WEST BRANCH MANAGEMENT UNIT 8
BETWEEN STATION 27500 AND STATION 32100

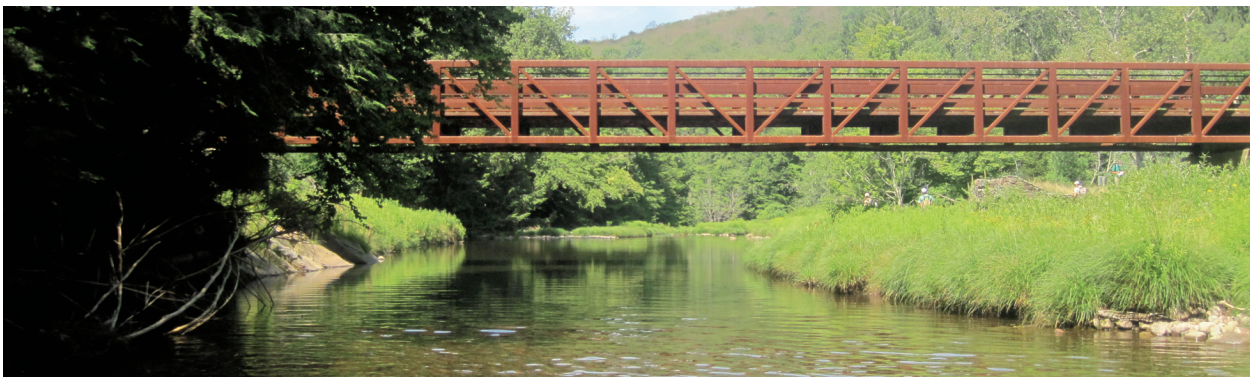
WBMU8 begins at a private bridge on the Frost Valley YMCA property. The bridge was constructed in 1995 and documented in good structural and functional condition. The *normal span* of the bridge is 100 feet and the *effective span* is 55 feet, with 10 feet of encroachment on the left bank and no encroachment on the right bank. Depositional features often form upstream of bridges where the bridge approaches restrict flows that would otherwise effectively transport sediment. The lack of sediment aggradation in the channel upstream and downstream of this bridge indicate that it may have been designed to avoid obstruction of floodplain flows. (A26) Portions of the left and right banks between Station 32000 and Station 31800 should be further assessed as potential buffer improvement sites (Figure 7).

Private bridge on Frost Valley YMCA property (A26)

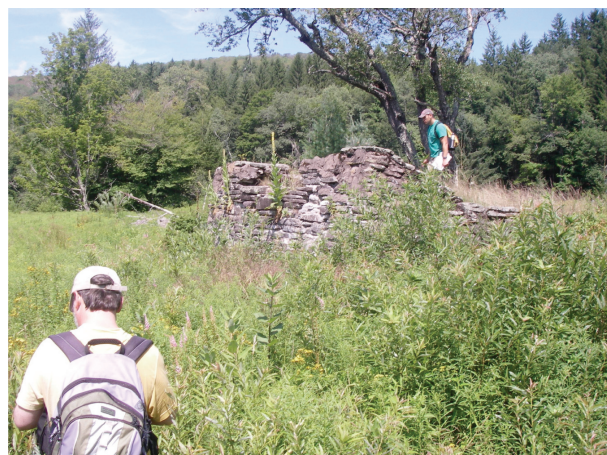
Potential willow harvest site (IMGP0306)

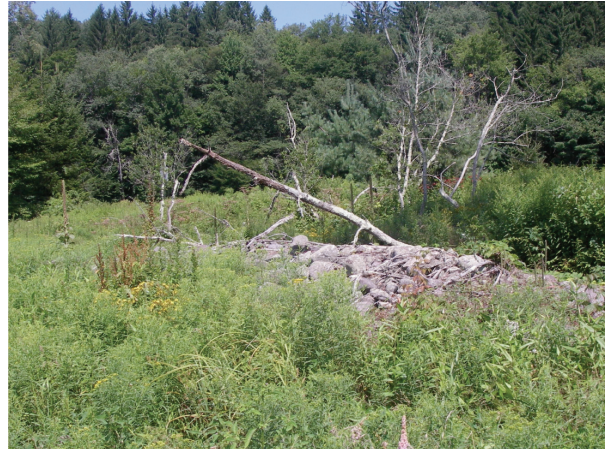
An abandoned bridge abutment was observed downstream of the current bridge on the right bank constructed of stacked rock in poor structural and functional condition. It is possible that there was a bridge in this location associated with the former sawmill located on the right bank downstream of the High Falls Brook Confluence. Willow was observed growing on this bank which could be a plant source for restoration efforts throughout the watershed. (IMGP0306) Slightly downstream of the old bridge abutment a 35-foot

long stacked stone berm was observed on the right bank. It is possible that the berm is composed mostly of sidecast from bulldozing on the road nearby or during the construction of the bridge. (IMG0310)

Relict bridge abutment in floodplain (IMG0310)

INFRASTRUCTURE An abandoned bridge abutment was observed downstream of the current bridge on the right bank constructed of stacked rock in poor structural and functional condition. Slightly downstream, near Station 31900, a 35-foot long stacked stone berm was observed on the right bank. It is possible that the berm was constructed mostly of sidecast from bulldozing on the road nearby or during the construction of the bridge.

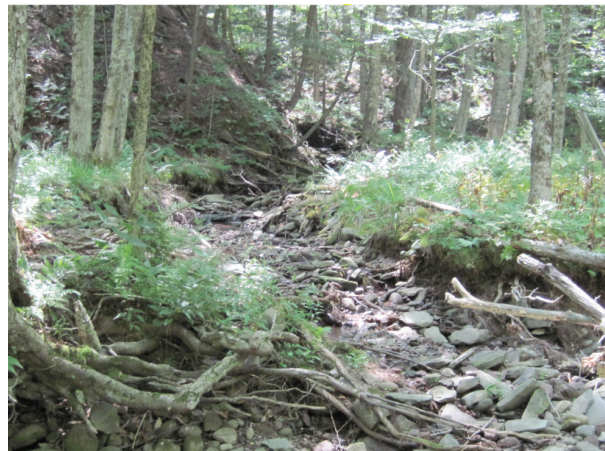
A side channel documented as conveying low flow diverges from the main channel near Station 31800. This side channel cuts directly through the forested floodplain on the left bank while the main channel makes a wide meander towards Frost Valley Road which follows the right valley wall. It is possible that this side channel was originally a raceway for the sawmill formerly located on the river in roughly this location according to Kudish and Beers' 1975 *Atlas*. While this side channel conveys the most flow through the floodplain, in some locations the flow is dispersed as it becomes braided due to many large woody debris jams leading to depositional features, scour pools and diverting flow throughout. (A43, A44)

Low flow side channel (A43)

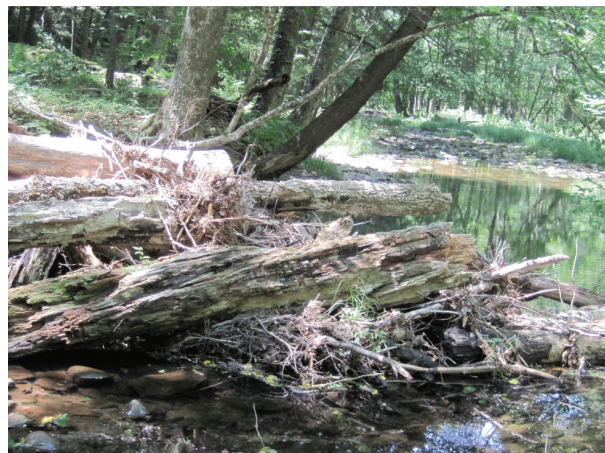
Woody debris jam in side channel (A44)

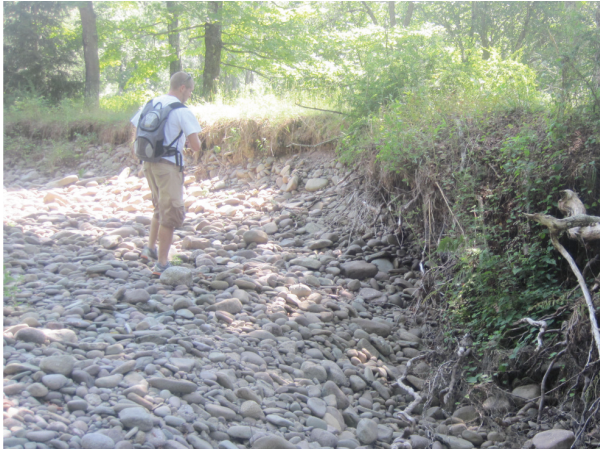
An eroding bank segment was observed in the side channel approximately 200 feet downstream of the divergence on the left bank extending 40 feet along a cleared field with no riparian buffer (BEMS NWB8_31500). The site was documented as active as hydraulic erosion is leading to bank scour and undercutting during high flow events. Recommendations for this site include *assisted* restoration to improve bank stability and establish a healthy riparian buffer. (A38)

Eroding left bank (A38)

An eroding bank segment was observed in aside channel approximately 200 feet downstream of the divergence on the left bank extending 40 feet along a cleared field with no riparian buffer (BEMS NWB8_31500). The site was documented as active as hydraulic erosion is leading to bank scour and undercutting during high flow events.

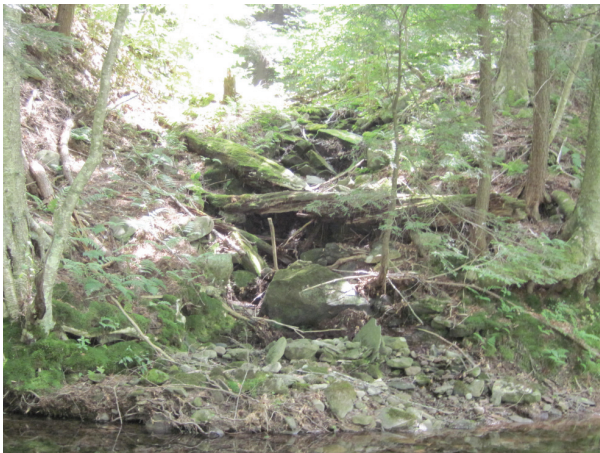
Tributary conveying flow from left valley wall (A52)

stream the side channel begins to flow adjacent to the left valley wall. A tributary conveying flow from the left valley wall joins the side channel approximately 300 feet upstream of the convergence. Exposed mudstone bedrock was observed acting as a stream bed grade control on the left bed for 650 feet extending 300 feet up the side channel from the convergence with the main channel and 350 feet downstream from the convergence on the left bed of the main channel. (A52, A61) The side channel converges with the main channel over 2,000 feet downstream from the convergence at Station 29500.

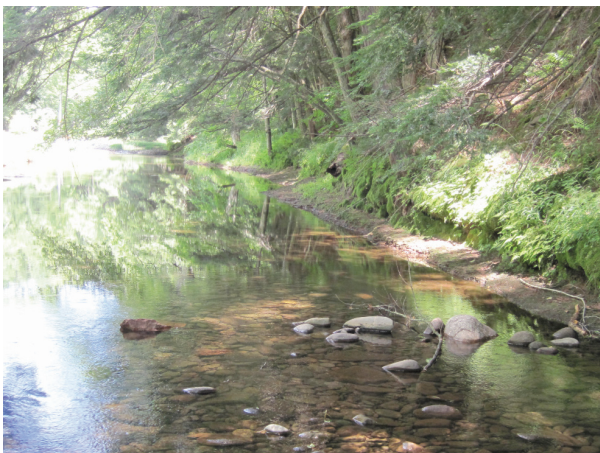
Exposed mudstone bedrock (A61)

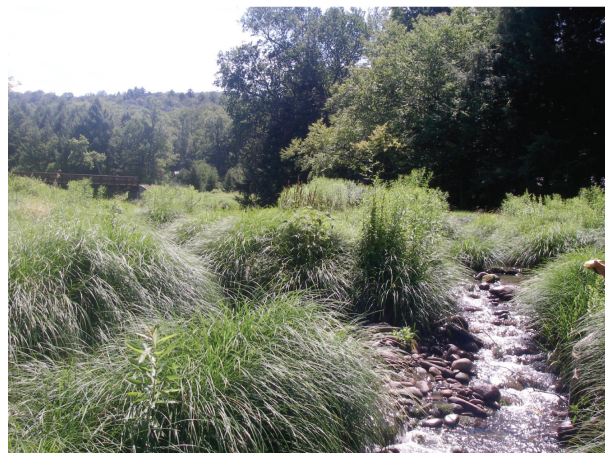
While the braided side channel conveys flow during high flow events in the left floodplain, the main channel flows within 50 feet of Frost Valley Road for approximately 900 feet from Station 31700 to Station 30800. Near Station 31700 flow in the main channel splits around a cobble center bar thickly vegetated with grass, sedge and willow. Two headcuts, at Station 31650 and Station 31500 were observed in the cobble channel on the right side of the bar near Frost Valley Road. (IMPG0323, IMPG327)

Headcut and vegetated center bar (IMPG0323)

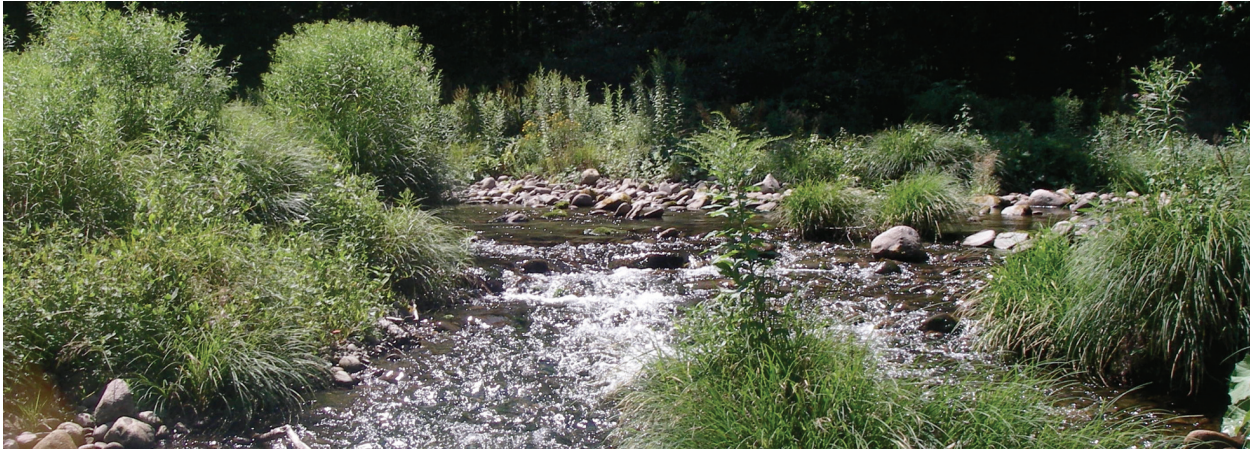
Headcut (IMPG0327)

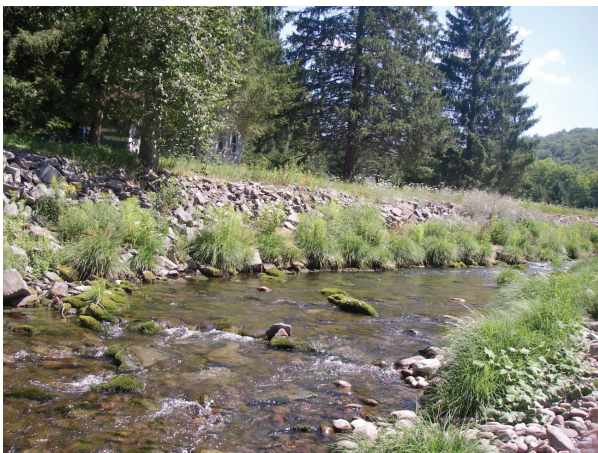
Dumped rip rap revetment (IMPG0331)

Downstream of Station 31600 the main channel flows directly adjacent to Frost Valley Road. A revetment composed of dumped rip-rap and slope stone was observed extending 800 feet from Station 31600 to Station 30800. The revetment was documented in in fair structural and functional condition due to structural failures and scour pools against the structure observed in several locations. *(IMGP0331 and IMGP0344)* This revetment should be further investigated for potential enhancement of the riparian buffer zone through interplanting.

A revetment composed of dumped rip-rap and slope stone was observed extending 800 feet from Station 31600 to Station 30800 immediately adjacent to Frost Valley Road. The revetment was documented in fair structural and functional condition due to structural failures and scour pools against the structure observed in several locations.

Recommendations for this site include a *full restoration* project from Station 31700 continuing 1,000 feet to Station 30700. This project would require geomorphic and sediment transport analyses of the reach and would likely include redesign and restoration of the revetment as well as placement of *flow deflection structures* to reduce erosive forces on the right bank at Frost Valley Road and finally possibly relocation of the channel to follow historic channel alignments further south in the left floodplain. The willows observed growing on the left bank downstream of the project site near Station 30500 are a potential source of plant materials for this restoration effort. In addition, the water quality impact of the flow conveyed from Frost Valley Road directly to the main channel should be further

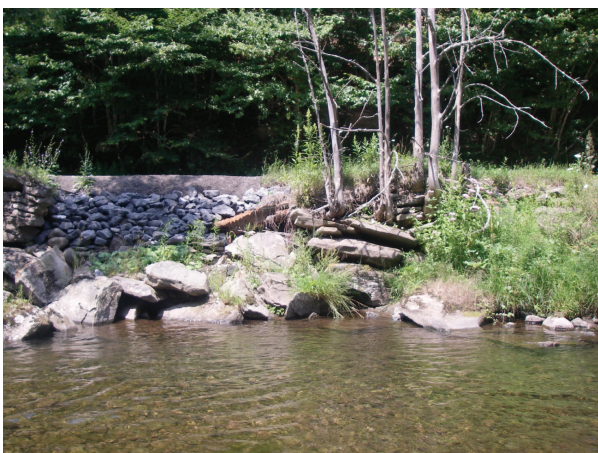
Sloped stone revetment (IMPG344)

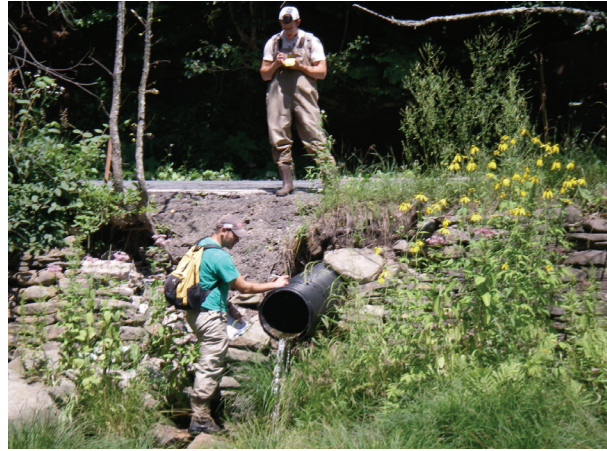
In addition, four piped outfalls were observed conveying drainage from Frost Valley Road and the right valley wall directly to the channel. The first piped outfall, located at Station 31270, is constructed of a plastic 2-foot diameter culvert with a 3-foot outfall and good outfall protection. The headwall supporting the culvert was failing. *(IMGP0338)* The second piped outfall, located at Station 31150, is also constructed of a 2-foot diameter plastic culvert with a 1-foot outfall and good outfall protection. *(IMGP0341)* The third piped outfall, located at Station 30980, is also a 2-foot diameter plastic culvert with a 1-foot outfall and good outfall protection. The headwall

Piped outfall conveying drainage from Frost Valley Road (IMGP0338)

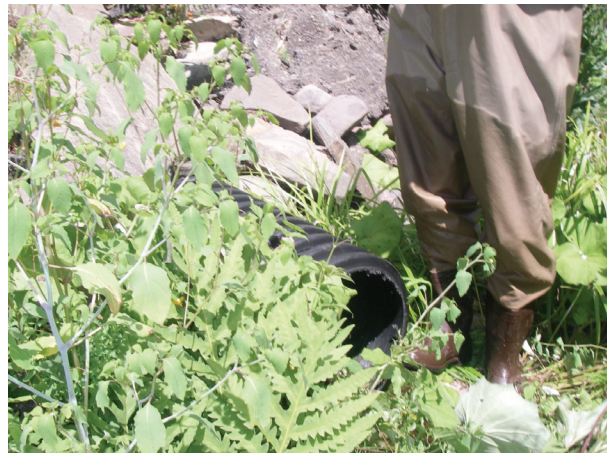
Piped outfall conveying drainage from Frost Valley Road (IMGP0341)

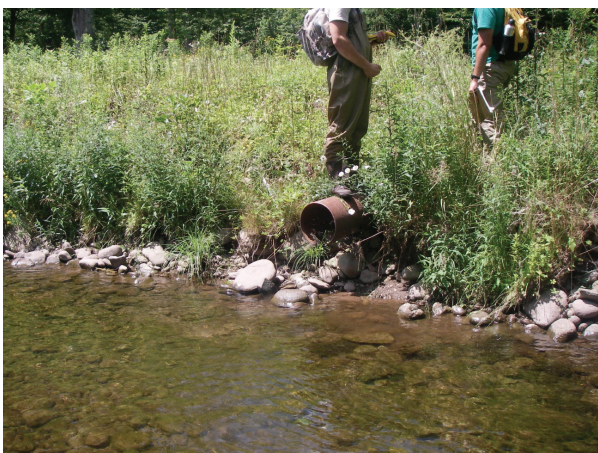
was documented in good condition. The final piped outfall, located at Station 30750 conveys road drainage through the unstabilized bank (downstream of the revetment as the main channel pulls away from Frost Valley Road) directly to the main channel via a 2-foot diameter smooth steel culvert with poor outfall protection and no headwall. The contribution of flow from this piped outfall marks the beginning of aggradation in the main channel. (IMGP0352, IMGP348)

Piped outfall conveying drainage through unstabilized bank (IMGP0352)

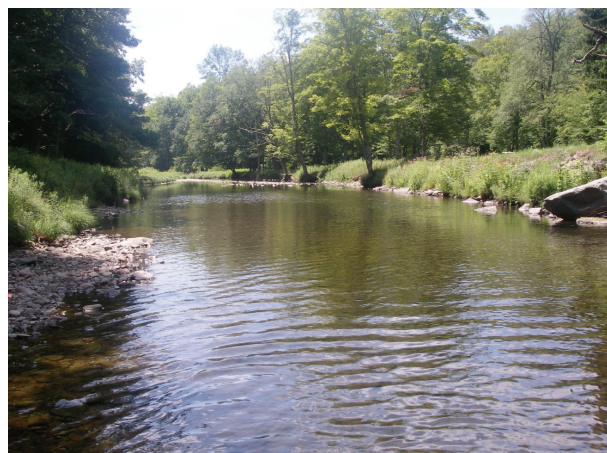
Aggradation in main channel (IMGP0348)

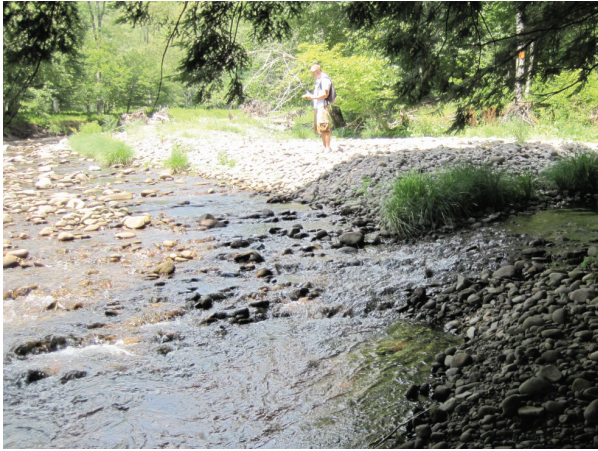
Convergence of side and main channels (A55)

A dry side channel diverges from the main channel around a thickly vegetated center bar near Station 30400 and converges among two woody debris obstructions near Station 30050 before converging with the long braided side channel discussed above near Station 29500. (A55)

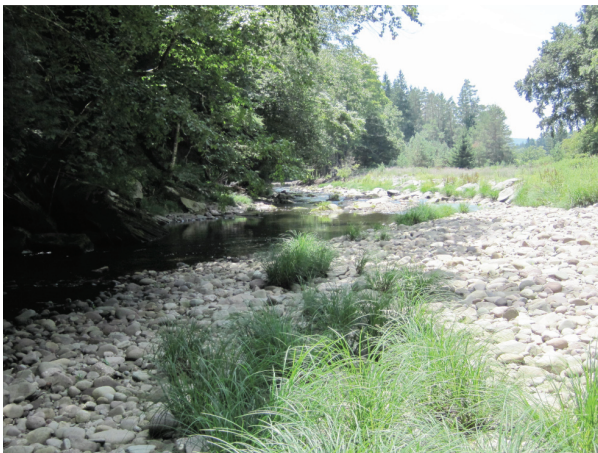
Downstream of the convergence and bedrock grade control on the left bank, a cobble point bar with no vegetation was observed on the left bed near Station 29100 and a cobble point bar with shrub vegetation was observed on the right bed near Station 28900 (A66). These depositional features continue the trend of aggradation in the main channel that began slightly upstream, and indicate lateral migration of the channel due to the low channel gradient in this management unit.

Cobble point bar (A66)

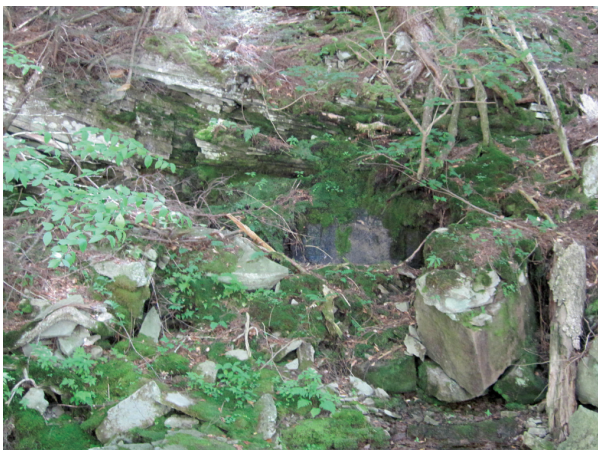
Groundwater seeps from left valley wall (A67)

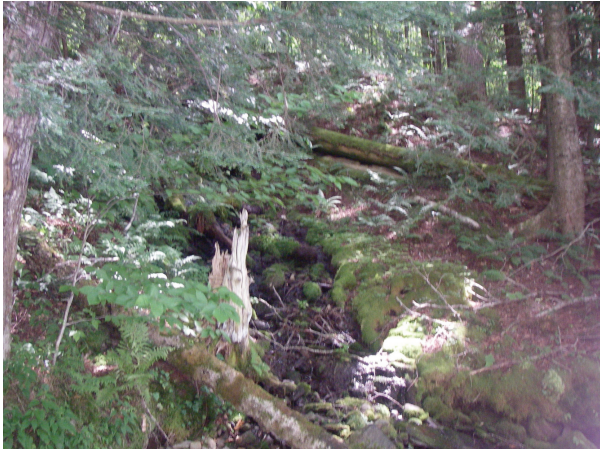
At Station 28890 and Station 28600 groundwater seeps or intermittent tributaries were observed on the left bank conveying flow from the left valley wall. (A366) A stacked rock revetment was observed on the right bank extending 340 feet from Station 28820 to Station 28480. The revetment was documented in good functional condition and good structural condition. It appeared to be designed to prevent flow in a dry cobble-bed channel which conveyed flow as the main channel as recently at 2001 based on the review of historic channel alignments. (A70, A71)

Intermittent tributary from left valley wall (A366)

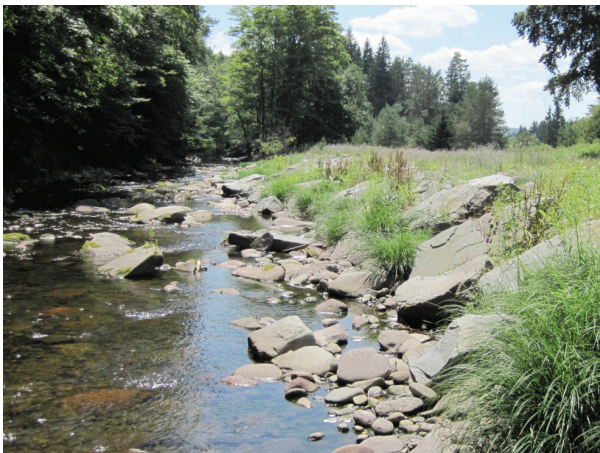
Stacked rock revetment on right bank (A70)

A stacked rock revetment was observed on the right bank extending 340 feet from Station 28820 to Station 28480. The revetment was documented in good functional condition and good structural condition. It appeared to be designed to prevent flow in a dry cobble-bed channel which conveyed flow as the main channel as recently at 2001 based on the review of historic channel alignments.

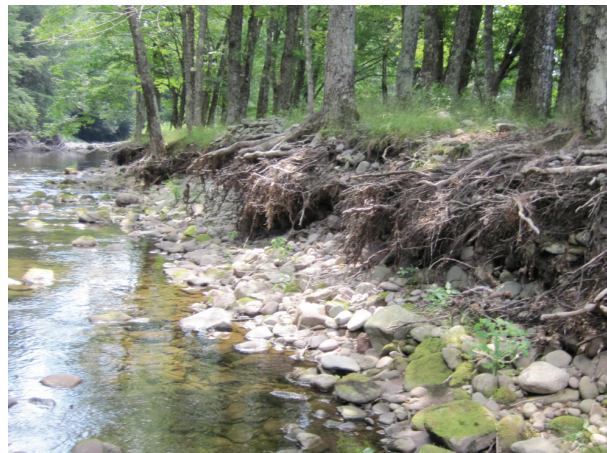
bank segment was observed on the right bank extending 240 feet from Station 28455 to Station 28225 (BEMS NWB10_28225). The site was documented as caused by hydraulic erosion leading to scour with exposed alluvial materials and undercut root wads. Some leaning trees from the forested riparian buffer at the top of the bank were also observed. (A75, A76) Bank retreat can be expected in this area as all flow was recently diverted into this channel leading to higher flows and the confinement by the left valley wall limits any lateral migration to the right bank. However, the wide band of riparian forest between the main channel

Eroding right bank leaving exposed root wads (A75)

Downstream of the revetment in the main channel an active eroding bank segment was observed on the right bank extending 240 feet from Station 28455 to Station 28225 (BEMS NWB10_28225). The site was documented as caused by hydraulic erosion leading to scour with exposed alluvial materials and undercut root wads.

and the emergent freshwater wetland on the right floodplain will significantly slow erosion. Therefore, it is recommended that this bank be left to stabilize without treatment (*passive restoration*) and that the site be monitored for changes in condition.

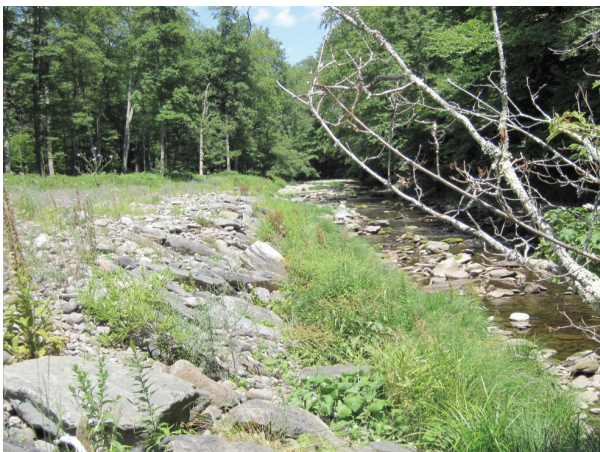
Stacked rock revetment on right bank (A71)

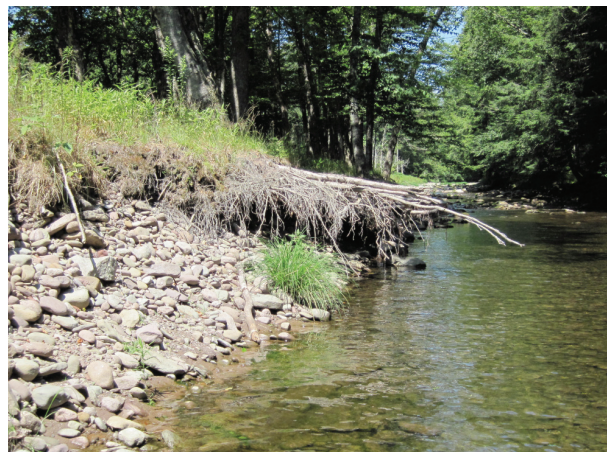
Hydraulic erosion undercutting right bank (A76)

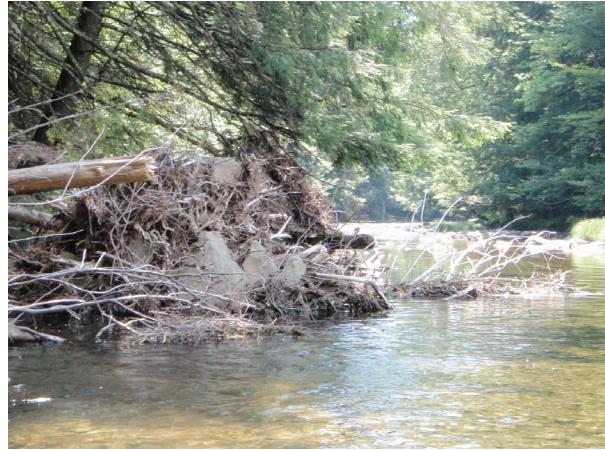
Another active eroding bank segment was observed on the right bank extending 80 feet from Station 28300 to Station 28220 (BEMS NWB10_28220). The site was documented as caused by hydraulic erosion leading to scour with exposed glacial till. This site was recorded as a fine sediment source due to the fluvial entrainment of the glacial till particles, although it is most likely not a source of turbidity in the main channel. No vegetation or hardening at the toe were observed on this eroding bank segment. A large woody debris pile at the end of the eroding segment appeared to be leading to additional bank scour. (P2760035, IMG0369, IMG0368)

Large woody debris pile causing scour (P2760035)

Recommendations for this site include *assisted restoration* using bioengineering techniques stabilize the eroding bank and prevent further entrainment of fine sediments. It is possible that this site is aggravated by the additional flow diverted to this channel when the dry side channel upstream was

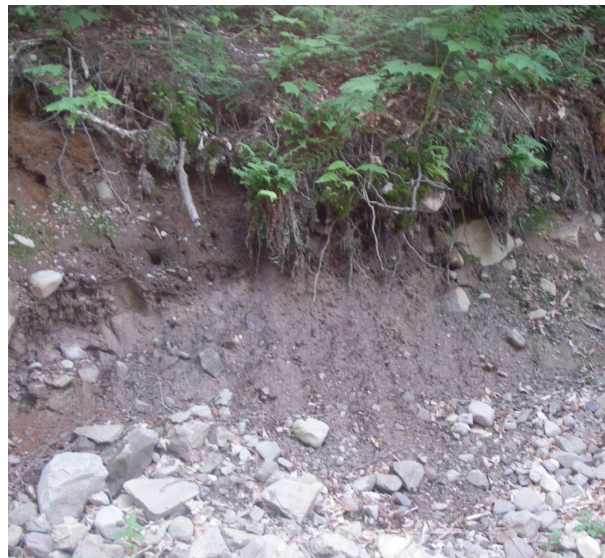
Actively eroding right bank (IMG0369)

Another active eroding bank segment was observed on the right bank extending 80 feet from Station 28300 to Station 28220 (BEMS NWB10_28220). The site was documented as caused by hydraulic erosion leading to scour with exposed glacial till. This site was recorded as a fine sediment source due to the fluvial entrainment of the glacial till particles, although it is most likely not a source of turbidity in the main channel. No vegetation or hardening at the toe were observed on this eroding bank segment.

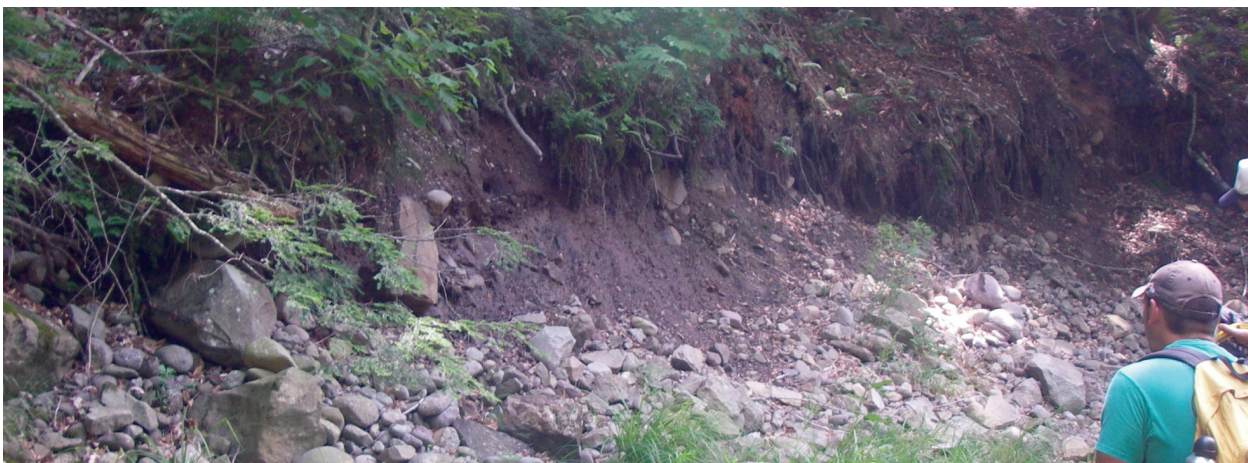
Actively eroding right bank (IMG0368)

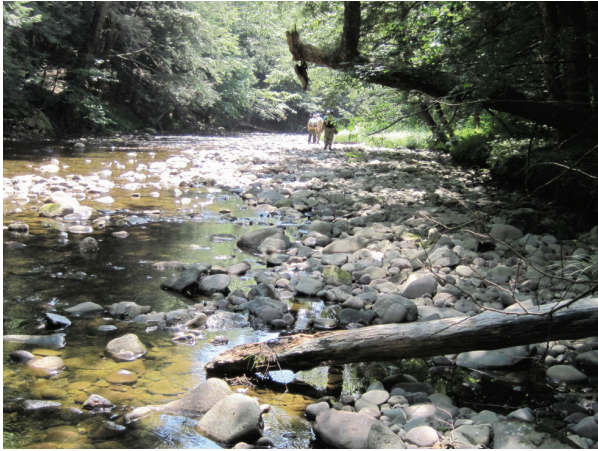
Cobble depositional bar (A79)

A depositional bar composed of cobble with some shrub vegetation was observed at Station 28100 followed by the beginning of an aggradational trend for the entire channel. (A79). At Station 27730 an intermittent tributary was observed joining the main channel from the left valley wall, and a cobble side bar was observed extending 200 feet from Station 27700 to Station 27500. (A80)

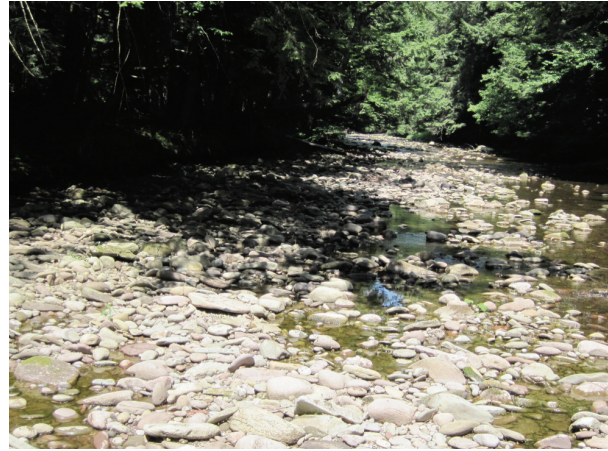
Cobble side bar (A80)
