BIG HOLLOW RESTORATION PROJECT - BATAVIA KILL -

IMPLEMENTATION & MONITORING REPORT

MAPLECREST
TOWN OF WINDHAM, GREENE COUNTY, NY

DRAFT
MARCH 2003

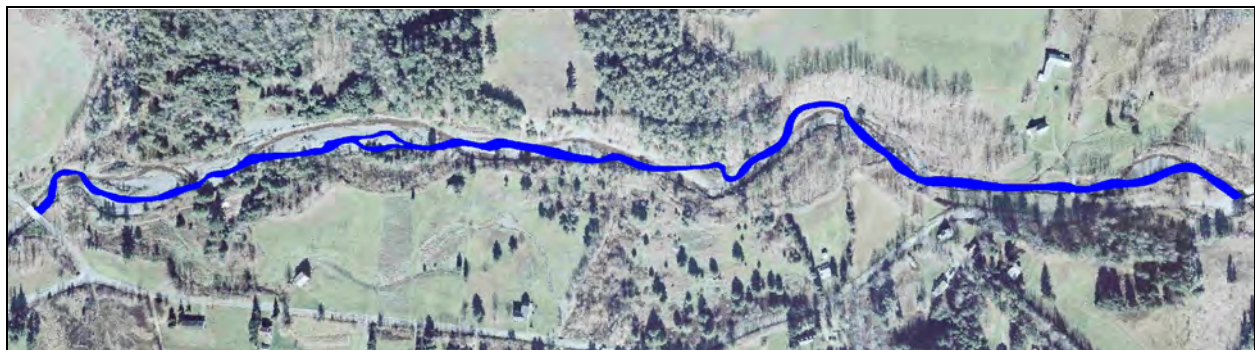
Figure 1: Overlay of the plan form changes through the Big Hollow reach. The shaded line represents the 1995 channel over a 2000 aerial photograph.

Channel migration is apparently caused by two integrated processes throughout the Big Hollow reach, rapid channel avulsion and lateral migration. Channel avulsion, which is usually associated with severe storm events, causes the rapid formation of channels. Lateral migration causes substantial channel shifts within the current channel boundaries at a slower, but measurable rate during varied flow events. The area located immediately downstream of county bridge #3-30287-0 has shown signs of minor erosion between 1959 and 1995. A healthy riparian area was present and channel migration appeared to be insignificant. Between May 1995 and December 1999, a substantial channel shift occurred in the area near cross section 1b (Appendix C, Photo D). The channel shifted approximately 80 feet to the north, which would equate to nearly 17'/year of migration. Most of the channel shift probably occurred during the September 1999 flood event.

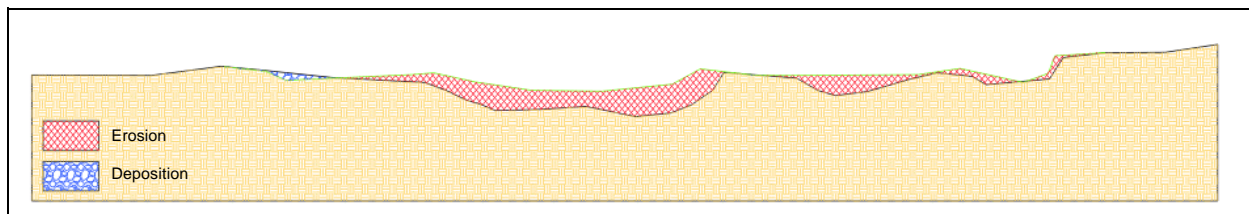
A large beaver dam was present 500 feet below the bridge, which contributed to several local instability problems (Appendix C, Photo G). The dam acted to flatten the local slope of the channel, resulting in stream channel aggradation upstream of the dam through cross section #2. The aggradation caused the stream to flow onto the adjacent floodplain, resulting in a divided channel around both sides of the beaver dam. Downstream of the beaver dam, the channel was actively down-cutting. The primary channel incised over 1 foot and the secondary channel incised over .5ft., through cross section #3. Further below the beaver dam, the channel showed signs of erosion and channel widening and had incised nearly 2.5 feet at cross section #4, figure 2.

Figure 2: Overlay of monitoring cross section #4, 1998 - 2000.

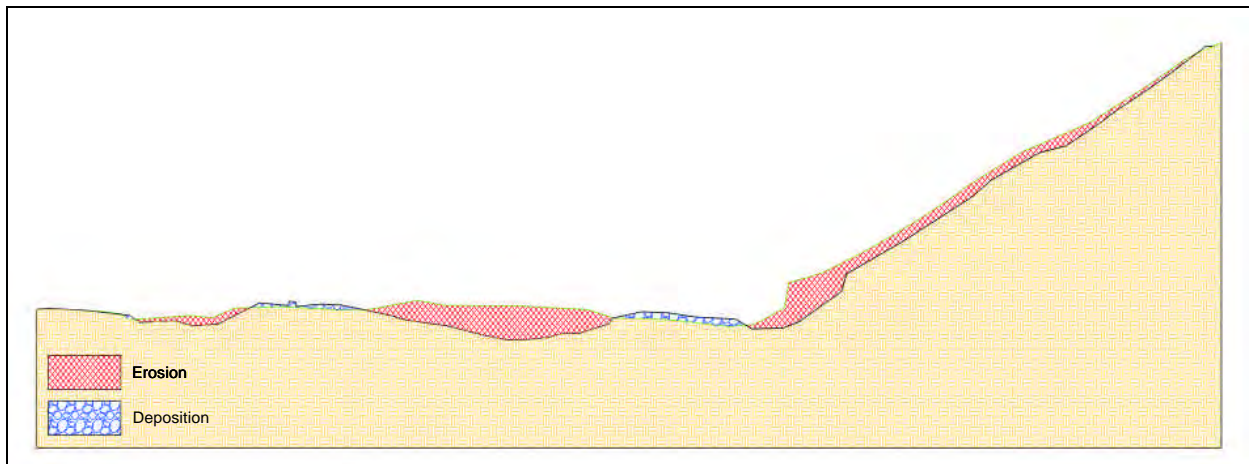
The alignment of the Batavia Kill directed stream flow against a portion of the high terrace, beginning near cross section #5 (figure 3) and continuing downstream approximately 1,075 feet. The terrace is comprised primarily of unconsolidated glacial till, which is highly erodible. The height of the bank averages about 50 feet above the stream bottom and runs along nearly 2,200 feet of the channel. Mass wasting of the high bank was primarily caused by incision of the stream channel paired with erosion along the bank toe. Multiple geotechnical failures resulted from the erosion including rotational failure, shallow sliding and slab type failure. Bank failures were compounded by the relative shallow rooting depth and density of the vegetation in relation to the bank height.

Figure 3: Overlay of monitoring cross section #5, 1998 - 2000.

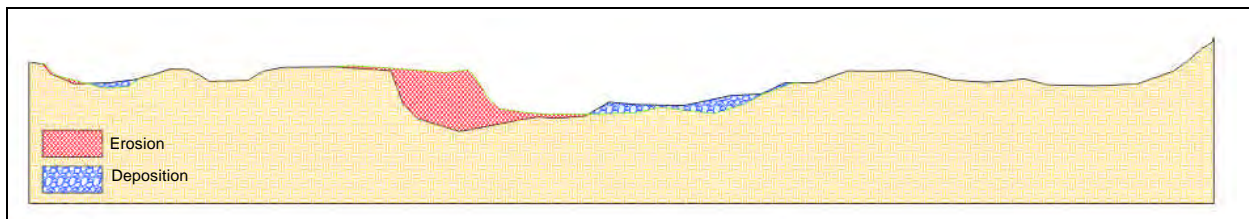
Figure 4: Overlay of monitoring cross section #8, 1998 - 2000.

Field verification of the lateral erosion was documented at cross section #8, which was first surveyed in the summer of 1998, figure 4. Minor erosion was noted during the first year of monitoring, with approximately 1 foot of stream bank lost. Between 1999 and 2000, the channel incised 2.6 feet and eroded 15 feet laterally along the left stream bank. The presence of several recently abandoned floodplain terraces, and evidence that the stream had attempted to build bankfull features at several elevations, verified that this area was continuing to actively incise. An active head-cut was observed between cross sections 8 and 9, causing the channel to incise nearly seven feet during the monitoring period.
