**Management Unit 5**  
Greene County - Town of Hunter  
Cross Section 90 to Cross Section 107

**Management Unit Description**

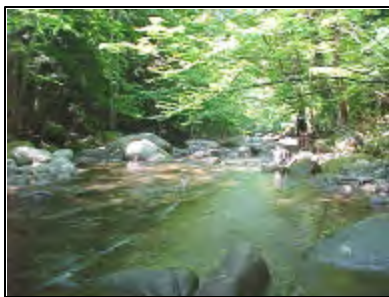
**Figure 7 Cross-section 92  
Stream Type C3b**

Continuing downstream, the stream reconnects with its floodplain for a 93 ft. of C3b stream (Fig. 7). Although there are many scattered boulders, dominant channel bed material remains cobble.

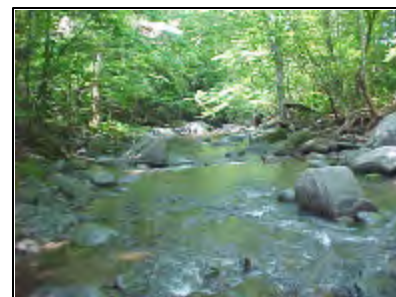
**Figure 6 Cross-section 91  
Stream Type F3b**

As channel slope steepens to 2.2%, stream type adjusts to F3b for the next 85 ft. of stream (Fig. 6). This reach remains entrenched.

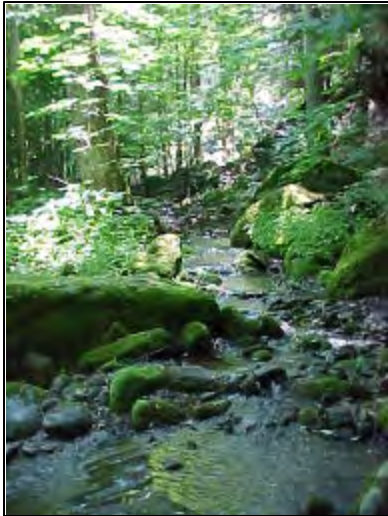
**Figure 9 Tributary**

Two tributaries enter in this reach. The first, shown in Figure 9, enters the Stony Clove Creek from the left bank at the very top of the reach.

This tributary is rated D under the NYS DEC best usage classification system. This is the lowest classification, indicating the water is only suitable for fishing. The second is a drainage tributary, which enters just downstream from the first tributary, from the middle of the right stream bank through a PVC pipe. This probably drains the upland residential area.

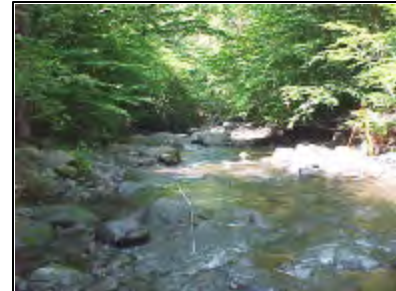
**Figure 8 Cross-section 93  
Stream Type B3**

As the stream becomes moderately entrenched, limiting its ability to overspill its banks, stream type transitions into B3 for the next 155 ft. of stream (Fig. 8).

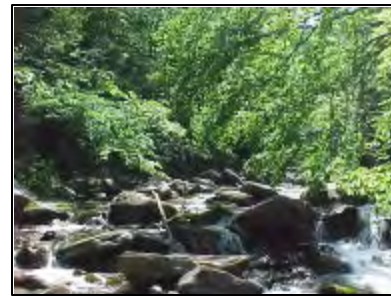
**Figure 10 Cross-section 97  
Stream Type F3b Looking Upstream**

Continuing downstream, the channel once again becomes entrenched, transitioning to F3b stream type (Fig. 10). The overall slope of this reach increases dramatically to 3.9%. The reach consists of a series of steep *cascades* each followed by a *run*. There is an abundance of large boulders in this reach but dominant stream channel material remains cobble. This 513 ft. reach is fairly stable until bank erosion monitoring site #12, near the end of the reach.

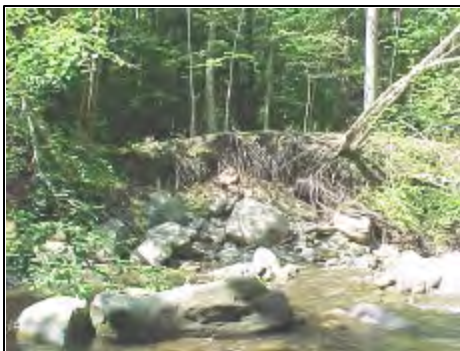
**Figure 11 Bank erosion site #12**

From the end of this reach to the Wright Road bridge, the stream shows indications of extreme instability. Monitoring at bank erosion monitoring site #12 (Inset H & Fig. 11) focuses on the left bank. During high flow events, this bank is subject to severe erosion due to the entrenchment of the stream channel. Adding to the instability of this reach, a *headcut* is migrating upstream between erosion sites #11 and #12, causing channel

*incision*. Although the top of this bank is heavily forested, the bank angle is over-steep, and vegetation appears to be disconnected from the water table. Erosion is active and numerous trees continue to be undercut. The morphology of this section is unstable and revegetation alone will not be sufficient to stabilize the bank. It is recommended that grade control be established throughout the reach to achieve more effective flood conveyance, and stream banks be graded and vegetated.

The Bank Erodibility Hazard Index (*BEHI*) score of site #12 is ranked “High”, the third highest prioritization category in terms of its vulnerability to erosion. Previous geologic mapping did not identify lodgement till or glacial lake clays at this site, and none were identified during the stream feature inventory. This bank erosion site is considered a medium priority for restoration because of its threat to infrastructure downstream but has a small eroding area (768 ft<sup>2</sup>) and does not threaten water quality.

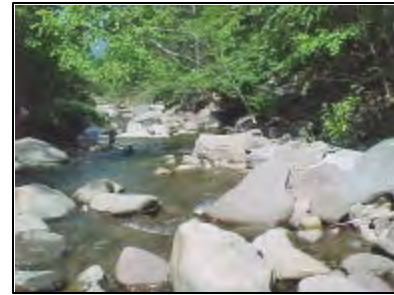
**Figure 12 Cross-section 98  
Stream Type B3a**

As the stream turns out of the meander bend, it becomes moderately entrenched and slope increases dramatically to 7.7%, for this short 69 ft. B3a stream reach (Fig. 12). Stream bank erosion continues along bank erosion monitoring site #11 on the left bank (Inset G). This twelve ft. high bank is exposed to high *shear stress*, or stream force during high flow events. This high stress has undercut the stream bank, causing the vegetation on the top of the bank to collapse.

The *BEHI* score of site #11 is ranked “High”, the third highest prioritization category in terms of its vulnerability to erosion. This bank erosion site is considered a medium priority for restoration because of its threat to infrastructure downstream but has a small eroding area (1006 ft<sup>2</sup>) and does not threaten water quality.

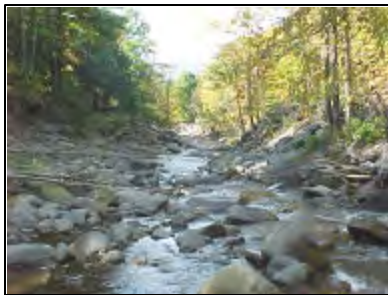
**Figure 13 Cross-section 99  
Stream Type B3**

Proceeding downstream, channel slope decreases but remains steep at 3.8%, as the stream type changes to B3 for the next 335 ft. reach (Fig. 13). The reach is characterized by steep cascades and pools. There is an abundance of large boulders in this reach but the dominant stream channel material remains cobble.

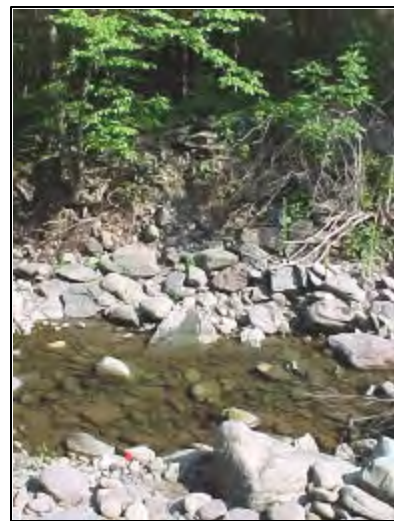
**Figure 14 Bank erosion site #13  
right bank**

(Inset F & Fig. 14). The stream reach is moderately entrenched with a 14 ft. high, devegetated left bank and 9 ft. high, rip-rapped right bank. The channel has incised into the streambed here. This incision has disconnected the channel from its former floodplain, and the stream is now widening to try to create a new floodplain within the entrenched condition. The rip-rap installed on 283 ft. of the right stream bank now has small trees growing through it, increasing the resistance of this side of the channel to erosive flood currents (Inset D). Downstream from this rip-rap a short section of the bank is experiencing erosion at a gap in the revetment.

The BEHI score of site #13 left and right bank is ranked “High”, the third highest prioritization category in terms of its vulnerability to erosion. Previous geologic mapping did not identify lodgement till or glacial lake clays at this site, and none were identified during the stream feature inventory. This bank erosion site is considered a medium priority for restoration because of its threat to infrastructure downstream but has a small eroding area (2102 ft<sup>2</sup>) and does not threaten water quality.

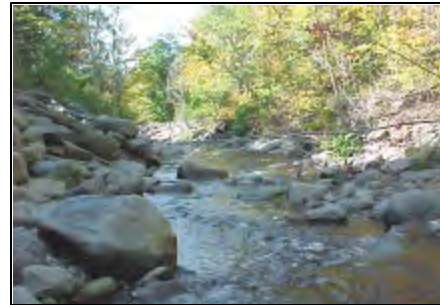
**Figure 15 Cross-section 100  
Stream Type F3b**

As the channel becomes more entrenched and slope decrease to 2.3%, stream type changes into F3b for the next 350 ft. of stream (Fig. 15). This reach has high banks on both sides, and has experienced severe erosion during past flood events. In efforts to protect their homes, both stream banks have been heavily armored with rip-rap by the landowners.

As shown in the figure 15, there is 102 ft. of rip-rap on the left bank at the upstream end of this reach.

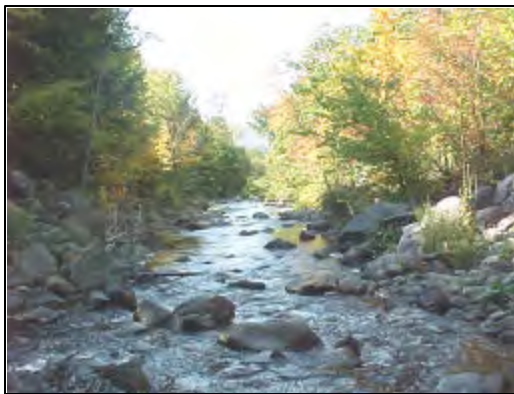
**Figure 16 Cross-section 102  
Stream Type F3**

As the stream approaches the Wright Road bridge (Inset B), the slope flattens to 1.7%, as the stream transitions into F3 stream type (Fig. 16). This Greene County bridge (BIN#3201070) was heavily damaged in the 1996 flood event. The Federal Emergency Management Agency (FEMA) provided \$201,893 to replace this bridge. The new bridge appears have adequate horizontal and vertical clearance to safely pass high flow events.

The reaches from cross-section 97 through 101 are trending toward increased instability, and without intervention, are unlikely to return to a stable form without significant consequence to adjacent residences. Access and dewatering difficulties complicate restoration efforts here. Full restoration is recommended at this site to mitigate potential flood-related erosion hazards. Restoration design should address both grade control and bank stability issues.

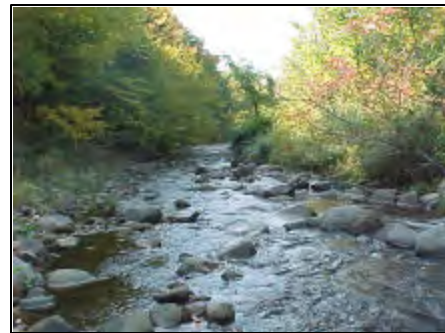
**Figure 17 Cross-section 105 Stream Type B3**

Proceeding downstream, the channel becomes moderately entrenched and slope increases slightly to 2.1% for a short 134 ft. reach of B3 stream type (Fig. 17).

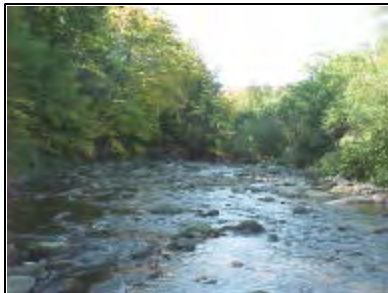
**Figure 18 Cross-section 106 Stream Type F3**

once again becomes entrenched and the slope decreases to 1.7% (Fig. 18). This 467 ft. reach has an overwide channel and is shallow. Overwide channels are considered unstable because they often *aggrade*, which eventually causes bank erosion by increasing stream velocity against the stream bank. Overwide channels also provide poor fish habitat due to filling of deep pools and warmer water temperatures.

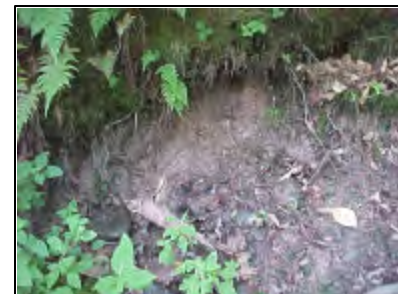
**Figure 19 Clay Exposure**

At the top of this reach, on the left bank, is a clay exposure, confirming Rubin's 1996 geologic mapping of lodgement till here (Fig. 19). Clay inputs into a stream are of serious water quality concern because they can increase *turbidity*, degrade fish habitat, and act as a carrier for other pollutants and pathogens.

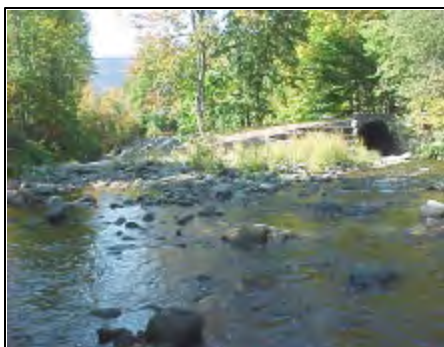
**Figure 20 Cross-section 107 Stream Type C3**

As the channel reconnects with its floodplain, stream type changes to C3 for the last 184 ft. reach in this management unit (Fig. 20). The channel begins to narrow and the slope remains consistent at 1.8%. At the top of this reach, there is another clay exposure located on the left bank.

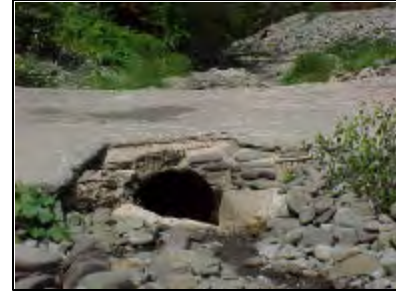
**Figure 21 Culvert under road crossing**

stream (Inset A). The majority of the stream passes through the culvert bridge on the right side of the stream at low flows. The remaining stream flow flows straight and falls into two smaller culverts which pass under the road crossing just above the stream grade level (Fig. 21). Higher flows spill directly across the roadway, rendering it impassable and requiring significant maintenance after flood flows ebb.

This overflow also occurs during smaller rain events, when debris clogs the two smaller culverts. This road crossing causes channel instability downstream by dividing channel forming flows and creating a barrier to sediment transport. Replacement of this road crossing with a single bridge, with an opening adequate to pass high flows, could alleviate this problem. Unfortunately, this is a very costly option not typically feasible for many private landowners.

Much of this management unit appears to be vertically unstable, with excess sediment transport capacity. The resulting incision is currently migrating upstream, destabilizing banks, and increasing the sediment load delivered downstream. Restoration activities in this management unit could therefore have beneficial impacts both upstream and downstream. Sediment transport should also be addressed at the stream crossing in Figure 21.

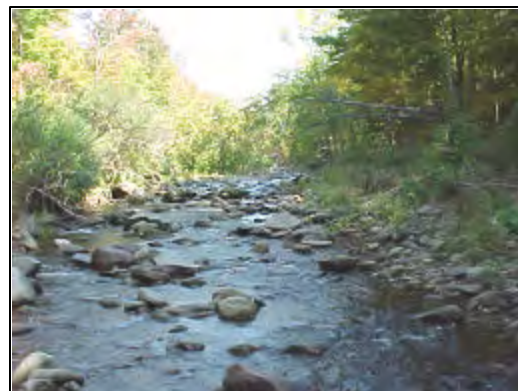
**Figure 24 Planting Site #22 looking upstream**

Planting site #22 is an in-channel planting area located between cross-section 103 and 104 (Fig. 24). This reach of stream channel is overwide and shallow. Overwide channels are considered unstable because they often aggrade, which eventually causes bank erosion by increasing the stream velocity against the stream bank. Overwide channels also provide poor fish habitat due to generally warmer water temperatures and a lack of deep pools. Willows have begun to establish along the right bank. There is some apparently inactive erosion on the left bank which should be treated with willow and other native plantings. If not planted, this reach should be monitored to determine the stream's capacity to re-vegetate on its own.

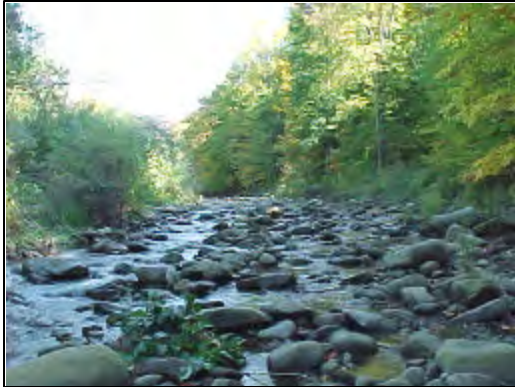
**Figure 25 Planting Site #24 looking upstream**

Planting site #24 is an in-channel planting area beginning between cross-sections 105 & 106 and ending at the bridge at the end of the management unit (Fig. 25). This reach of stream is overwide and shallow. Overwide channels are considered unstable because they often aggrade, which eventually causes bank erosion by increasing the stream velocity against the stream bank. Overwide channels also provide poor fish habitat due to generally warmer water temperatures and a lack of deep pools.

In-channel plantings of native willows and sedges is recommended along the toe of each bank. These plantings may allow the stream to narrow into a more stable morphology. Japanese Knotweed and *Multiflora Rose* (*Rosa multiflora*) are prevalent along the right bank. It is recommended to remove these species, which are invasive non-native species. Japanese Knotweed does not provide adequate erosion protection because it has a very shallow rooting system.

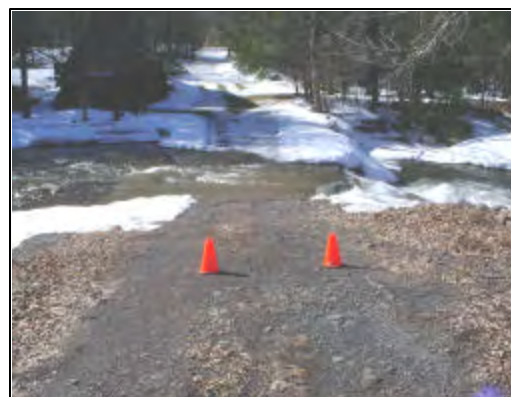
**Figure 27 Road Crossing**  
**March 21, 2003 (967cfs)**

The history of stream disturbance permits in this management unit indicates that the private bridge at the end of this management unit has been severely damaged in past flood events. During high flow events the stream flows over the road crossing, often causing damage. This overflow also occurs during smaller rain events, when debris clogs the two smaller culverts. This road crossing causes stream instability downstream due to the spilt channel. This road crossing should be replaced with a single bridge, with an adequate opening able to pass high flows. Figure 27 shows the bridge rendered impassable during a moderate flow event.
