**Management Unit 7**  
 Greene County - Town of Hunter  
 Cross Section 107 to Cross Section 116

**Management Unit Description**

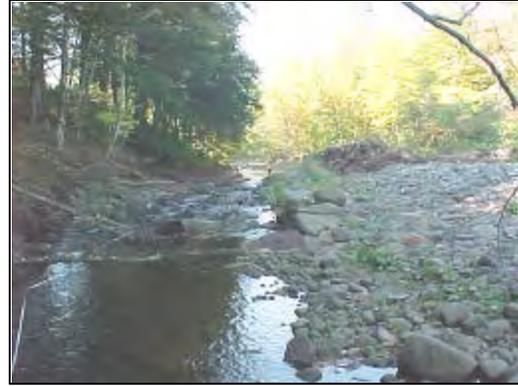
Management unit #7 begins with a short 75 ft. reach of C3b stream type (Fig. 8). Channel slope is fairly steep at 2.4%. A large gravel bar has formed on the right bank which is an active part of the stream's floodplain. The left bank is fairly high, with a house just downstream on the first terrace. Bedrock at the bottom of the slope extends into part to the channel invert, and probably continues to the right under the bar, maintaining grade control (Inset D). Although part of the stream bed and bank is bedrock, the dominant channel material is cobble due to the inclusion of the bar within the bankfull channel. This bedrock stretches 264 ft. downstream.

**Figure 8 Cross-section 116  
Stream Type C3b**

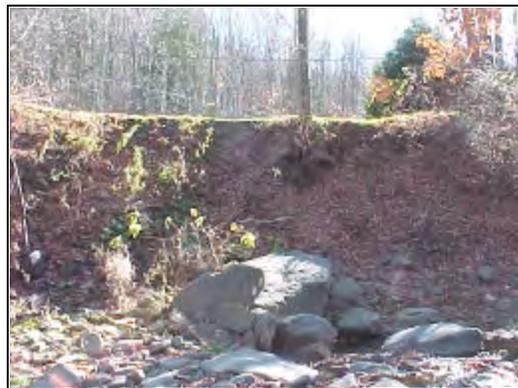
**Figure 10 BEMS site #15.5**

At the top of this reach is a large deep pool with half bedrock, half cobble bed material. As the bedrock ends, the stream begins to widen and *meanders* to the left. Bank erosion monitoring site #15.5 is located here on the left bank (Fig. 10 & Inset H).

The *shear stress*, or the force of flowing water, is eroding the toe of this bank during high flow events. This erosion has caused a 99 ft. long bank failure and left the bank raw and vulnerable. At the top of this 17 ft. high bank sits a private residence which is seriously threatened, as the bank continues to erode. According to the landowner, rip-rap was installed on this bank in the early 1980's, but has since been washed away. The landowner has also noted a significant lowering of the stream bed elevation since the 1980's. This observation is consistent with incision of entrenched stream systems, particularly downstream of bedrock controls, as in this setting.

The Bank Erodibility Hazard Index (BEHI) score of site #15.5 is ranked “Very High”, the second highest prioritization category in terms of its vulnerability to erosion. This bank erosion site is considered a high priority for restoration because of its imminent threat to the residence.

Recommendations to restore this site include moving the active stream channel away from the left stream bank, and installing a *rock vane* and a well vegetated bench and bank. Rock vanes are often used in stream restoration projects to direct stream flows away from the banks. In-depth survey and design would be required to plan a stream restoration project at this site.

Bank erosion monitoring site #15.5 represents an imminent threat to a residential structure. While a *natural channel design* remediation of the failing bank here would require in-depth survey and design, the size and scope of this project make the project feasible. Natural channel design treatment would be more effective than revetment at this location.

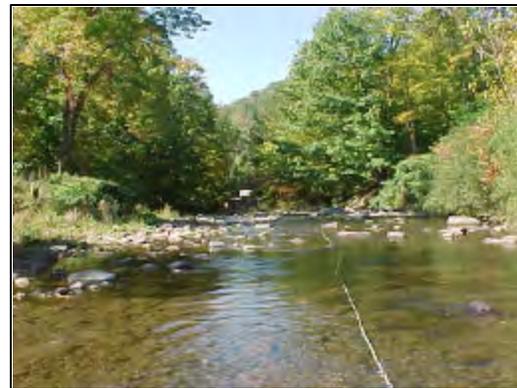
**Figure 11 Cross-section 118  
Stream Type F3**

There is 240 ft. *berm* along the right stream bank in this reach (Inset B). Berms prevent flood waters from spilling into the floodplain, which increases the stream velocity and

can cause *degradation* of the stream bed. It is likely this berm was created following a high flow event, after which cobble and gravel deposited in this reach was *sidecast* onto the stream bank to form the berm. The land behind this berm is forested. Insofar as no infrastructure would be threatened here by floodplain inundation, it is recommended that this berm be removed, to allow the stream to spread out into its floodplain during high flow events. This would help decrease bank and bed erosion along the stream channel.

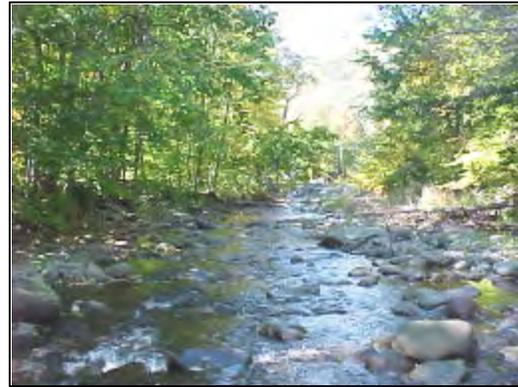
As stream type transitions to B3, the channel narrows and the entrenchment moderates, allowing some floodplain access (Fig. 12). This 229 ft. reach steepens to a 2.4% slope. At the top of this reach, along the left bank, there is a residence inside the 100-year floodplain, protected by another cobble berm (Inset F). Removal of the berm on the right bank upstream would allow the stream sufficient floodplain in this reach to lower flood elevations, without requiring the removal of the berm protecting this residence.

**Figure 12 Cross-section 119  
Stream Type B3**

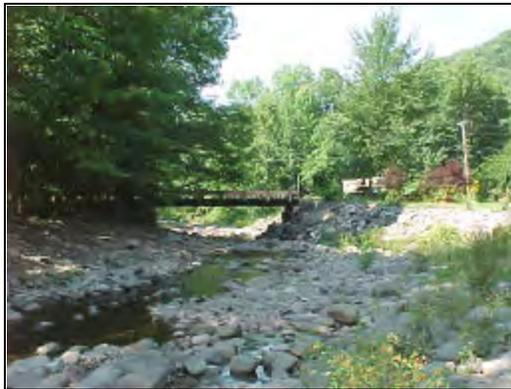
**Figure 13 Stream type B3c**

As the stream's slope decreases to 1.9%, stream type changes to B3c for the remaining 292 ft. of the management unit (Fig. 13). The stream meanders gently to the left towards the bridge at Jansen Road. On the right bank, 117 ft. of rip-rap has been installed to protect the lawn and driveway at a residence, as well as the right bridge abutment (Inset A).

Brook just downstream are causing *aggradation* upstream of the bridge. Gravel and cobble deposits upstream of bridges are commonly caused by inadequate sizing of bridge openings. An undersized bridge opening causes water to back up upstream of the bridge, reducing stream velocity, which results in sediment deposition. Tributary confluences can also disrupt *sediment transport* effectiveness, as appears to be happening here.

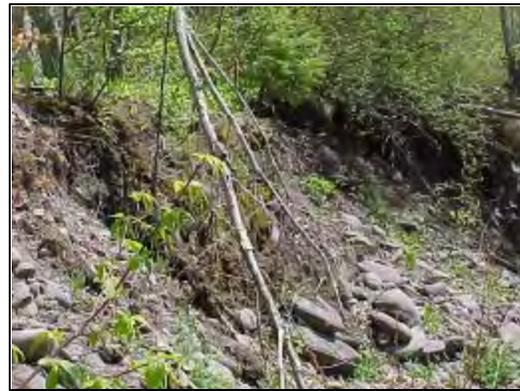
**Figure 16 Planting Site #27a**

The BEHI score of site #16 is ranked “Very High”, the second highest prioritization category in terms of its vulnerability to erosion. This bank erosion site is considered a medium priority for restoration because of its small size (691 ft<sup>2</sup>) and the absence of water quality or infrastructure threats.

Planting site #27a is located at bank erosion site #16 (Fig. 16 & Inset C). This erosion site is 108 ft. long with a 6 ft. high bank. The top of the stream bank is well vegetated with trees but the face has been stripped of vegetation.

This site may be able to be restored with vegetative measures. This would involve introducing topsoil to the stream bank and stabilization of the stream edge with plantings, such as native willows and sedges. Detailed site inspection and design would be required to plan a stream restoration project at this site, and consideration should be given to treating erosion sites # 15.5 and #16 together as a single project.

Recommendations for this site include stabilizing the toe of the bank with willow *fascines*. It will be necessary to prepare the stream bank for plantings by either importing topsoil or scalping topsoil from the top of the bank. The stream bank should be vegetated with native willows and shrubs, and the water's edge with native sedges.

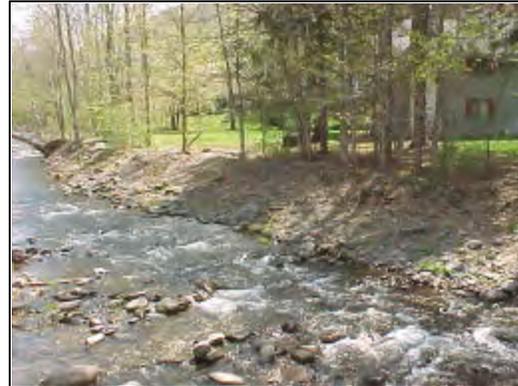
**Figure 18 Planting Site #28a**

Planting site #28a is located at the residence on the left bank, just upstream from Jansen Road Bridge (Fig. 18). The stream bank is comprised of exposed cobble and soil with a few trees and lawn area at the top of the bank. Native trees and shrubs should be planted along the stream bank to increase vegetation density and buffer width. Native sedge plantings near the water's edge would add both stability and esthetic benefits.

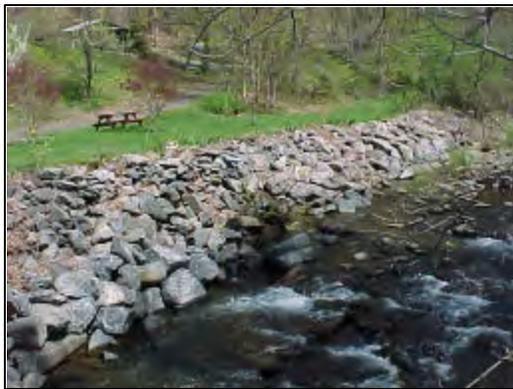
**Figure 19 Planting Site #28b**

Planting site #28b is located at the residence on the right bank, just upstream from the Jansen Road Bridge (Fig. 19). Rip-rap has been installed on this bank, beyond which is a grass lawn area.

Joint planting, the existing rip-rap, is recommended to strengthen and increase the longevity of this revetment. These plantings will also improve aquatic habitat by providing shade, resulting in cooler water temperatures.

Planting trees and shrubs, is also recommended, to create a riparian buffer. This planting can be designed to allow the landowner access to the stream.
