Management Unit 8
Greene County - Town of Hunter
Jansen Road to Cross Section 131

Management Unit Description

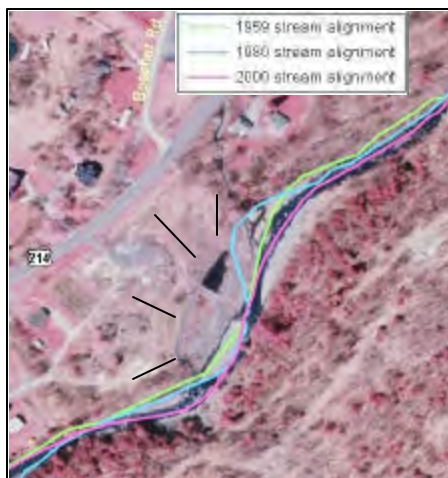
Figure 5 Historical stream channel alignments at bottom of Management Unit 8

The second reach, seen in Figure 5 on the right, is located near the bottom of the management unit, across from Beecher Road. This reach experienced a decrease in its *sinuosity* between 1959 and 1980. This change has pushed the stream channel against the high left bank, undermining the toe of the bank.

Following the flood of January 1996, the channel eroded laterally to the right, to approximately where the arrows point in Figure 5. In response to the flood, the landowner bermed and redirected the channel back to roughly its former location.

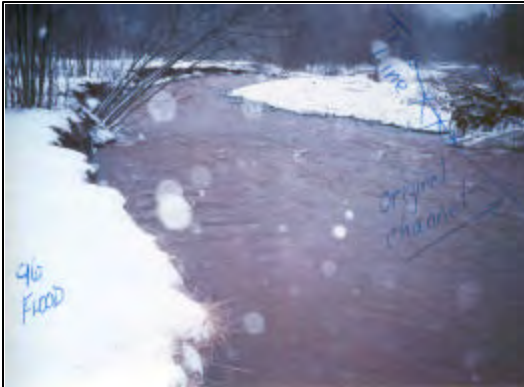
H). In 1996, Edward Benjamin was issued a permit to install rip-rap on the right stream bank and remove gravel (Inset C). In 1996, Walter Bono was issued a permit to repair rip-rap, restore the left stream bank with deposited stream material, and remove debris (Inset G). In 2000, Walter Bono was issued a permit to rebuild 50 ft. of the existing stacked rock wall (Inset F). In 1996, Robert Johnson was issued a permit to install rip-rap on the right stream bank and excavate 100 yd³ of gravel. There is currently no rip-rap along this bank, indicating the project was either never completed or the rip-rap has been

Figure 6 1996 Flood at Bono property

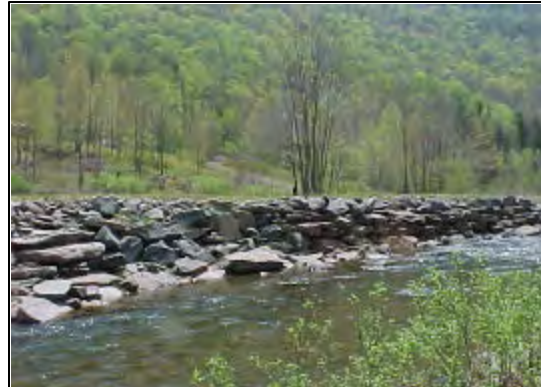
Figure 7 Stacked Rock Wall - Bono Property

the Bono residence. After this flood, the landowner installed a 791 ft. long stacked rock wall (Inset F), at the cost of \$30,000, to prevent erosion in the future.

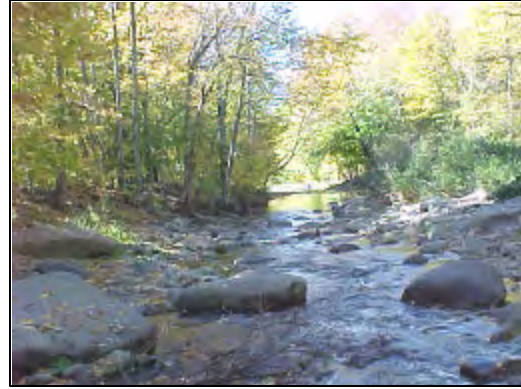
**Figure 9 Cross-section 120
Stream Type B3c**

Management unit #8 begins downstream from the Jansen Rd. Bridge, with a 188 ft. reach B3c stream type (Fig. 9). This stream reach is moderately *entrenched*, or usually confined within the stream banks during high flow events. Slope of the channel is fairly flat 1.9% and the dominant bed material is cobble.

On the left stream bank there is a 101 ft. long stacked rock wall (Inset H). On the right stream bank, the Hollow Tree Brook tributary enters (Inset D).

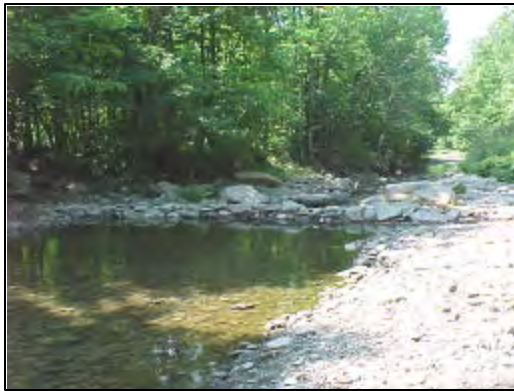
Figure 10 Dam

Immediately downstream from the tributary a small dam made from stream material has been constructed across the stream (Fig. 10). These small dams are commonly built to create swimming or wading areas. This practice can be detrimental to aquatic habitat if they block fish passage. In this reach, the blockage could prevent fish migration from downstream up into the Hollow Tree Brook. Construction of these dams is generally not recommended, and requires a stream disturbance permit from the NYS DEC.

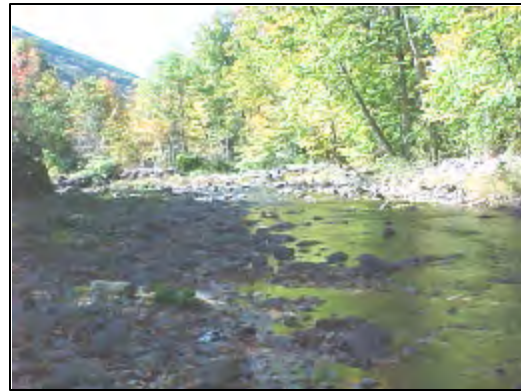
**Figure 11 Cross-section 121
Stream Type F3**

Continuing downstream, the channel widens as it transitions to a F3 stream type (Fig. 11). Throughout this 1,267 ft stream reach the channel is *entrenched*, or unable to spread out into the flood plain during high flow events, and the slope decreases to 1.5%.

As the stream begins to *meander* to the left, rip-rap has been placed on the right bank (Inset C). Stream bank erosion often occurs on the outer bank of meander bends, where the stream velocity is greatest during high flows. The landowners have installed 334 ft. of rip-rap here to prevent property loss due to erosion.

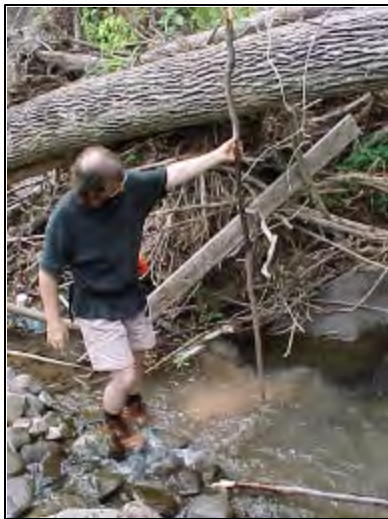
Figure 12 Clay Exposure

At the end of the rip-rap, there is a clay exposure in the channel near the right stream bank (Fig. 12). It is very likely that the clay is continuous with the clay upstream mapped by Rubin in 1996 (See Section 2.4). As shown in the photo, deep layers of clay underlie the channel. Clay inputs to a stream are a significant water quality concern because they increase *turbidity*, degrade fish habitat, and can act as a carrier for other pollutants and pathogens.

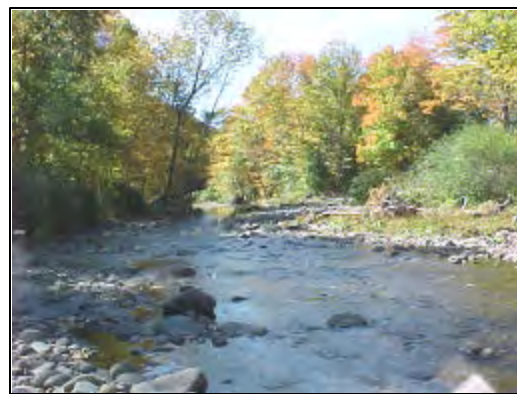
**Figure 13 Cross-section 124
Stream Type C3**

Moving downstream, the channel reconnects with its floodplain and the slope decreases to 1.4%, as stream type changes to C3 for the next 726 ft. (Fig. 13). This reach is overwide,

shallow, and straight, with no overhanging vegetation. Deposition of bed materials is common in overwide channels because they lose their ability to transport *bedload* supplied from upstream. In this situation streams often *aggrade*, or rise in stream bed elevation due to the excessive deposition. Overwide channels also provide poor fish habitat due to warmer water temperatures and filling of deep pools.

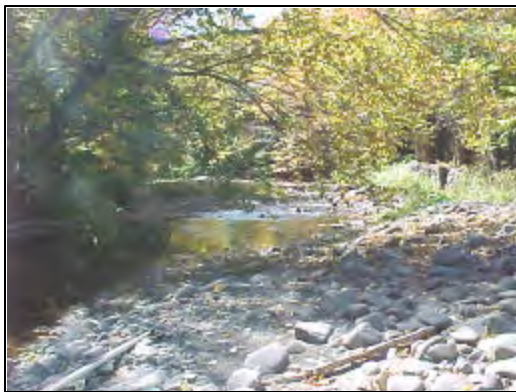
**Figure 15 Cross-section 126
Stream Type B3c**

becomes moderately entrenched, as the stream type changes to B3c for the next 514 ft. (Fig. 15). Channel slope remains fairly flat at 1.4%. At the beginning of the reach is a small unnamed tributary entering from the left stream bank. This tributary is not classified under the NYS DEC best usage classification system.

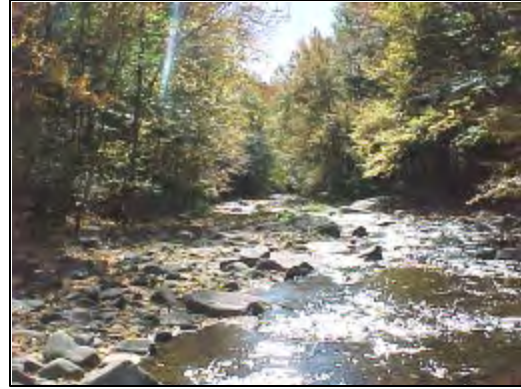
**Figure 16 Cross-section 127
Stream Type F3**

The channel then widens, becomes entrenched and steepens to 1.9% slope, for a short 267 ft. reach of F3 stream type (Fig. 16). This stream reach is overwide. A gravel bar is forming on the right, on the inside of the meander bend at the top of this reach. This bar

formation may help the stream narrow its channel and produce a more stable stream morphology.

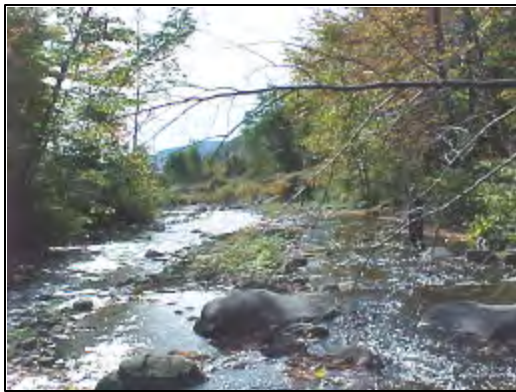
**Figure 17 Cross-section 129
Stream Type B3c**

As the channel entrenchment once again moderates and slope decreases to 1.5%, stream type transitions to B3c for the next 962 ft. reach (Fig. 17).

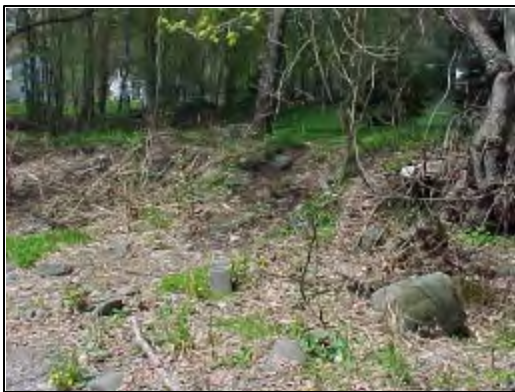
Figure 23 Planting Site #29

Planting site #29 on eight separate properties on the right stream bank, beginning downstream from Jansen Road (Fig 23). Presently there is a small buffer along the stream and upland grass lawn areas on these properties. There is small amounts of Japanese Knotweed present. It is recommended to plant trees and shrub along the stream bank to increase the density of vegetation on the bank. It is also recommended to increase the upland buffer width by at least 20 ft. This will increase buffer functionality and improve stream bank stability while still allowing a lawn area. Japanese Knotweed, which is an invasive non-native species, should be removed. Japanese Knotweed does not provide adequate erosion protection

because it has a very shallow rooting system. For the upland area, tree and shrub plantings are recommended to increase the density and functionality of the upland stream buffer.

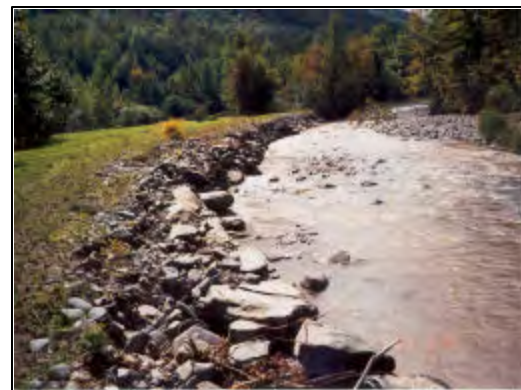
Figure 24 Planting Site #30

Planting site #30 is located on the right bank of the Bono property (Fig. 24). Along this stream bank is a 393 ft. long stacked rock wall (Inset F). At the top of this stacked rock wall is a large grass area.

Inserting plant materials into the soil between rip-rap rocks, or *joint planting*, is recommended at this site. Joint planting will strengthen and increase the longevity of this wall. These plantings will also improve the aquatic habitat by providing shade, thereby cooling water temperatures. It is also recommended to increase the stream buffer width at the top of the bank.

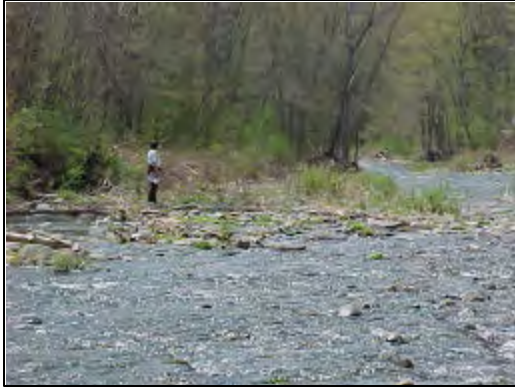
Figure 25 Planting Site #31

Planting site #31 is located in the stream channel along a stretch of overwide stream at the downstream end of the Bono property (Fig. 25). This channel is overwide, aggrading, and has little overhead vegetation to provide stream shading.

Native willow plantings along both side of the stream is recommended. These plantings may encourage the stream channel to narrow. These plantings will also improve the aquatic habitat by providing shade, thereby cooling water temperatures.

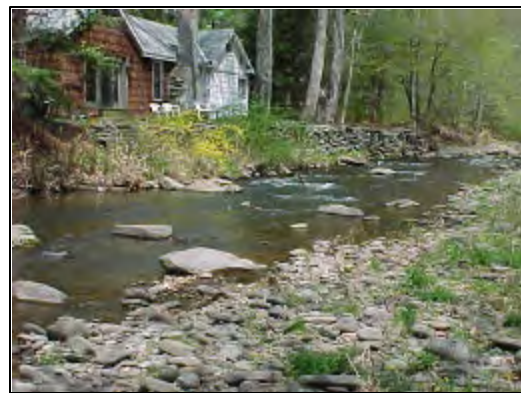
Figure 26 Planting Site #32

Planting site #32 is located in the stream channel beginning at the Whitelaw property (Fig. 26). This reach of stream is overwide and aggrading. Gravel bar development on the left streamside is forcing the streambank and *thalweg* to the right streambank.

In-channel plantings of native willows, along the right stream bank, is recommended. These plantings may encourage gravel deposition along the toe of the rock wall leading to a reduction *shear stress* on this streambank. These plantings will also improve the aquatic habitat by providing shade, thereby cooling water temperatures. Willow fascines should be installed at the toe of the stacked rock wall (Inset B). This planting will strengthen and increase the longevity of the wall.
