**Management Unit 8**  
Greene County - Town of Hunter  
Jansen Road to Cross Section 131

**Management Unit Description**

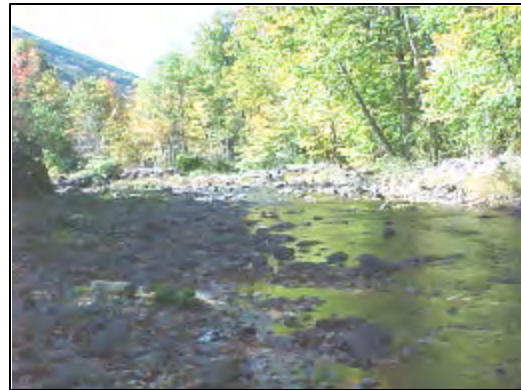
**Figure 11 Cross-section 121  
Stream Type F3**

Continuing downstream, the channel widens as it transitions to a F3 stream type (Fig. 11). Throughout this 1,267 ft stream reach the channel is *entrenched*, or unable to spread out into the flood plain during high flow events, and the slope decreases to 1.5%.

As the stream begins to *meander* to the left, rip-rap has been placed on the right bank (Inset C). Stream bank erosion often occurs on the outer bank of meander bends, where the stream velocity is greatest during high flows. The landowners have installed 334 ft. of rip-rap here to prevent property loss due to erosion.

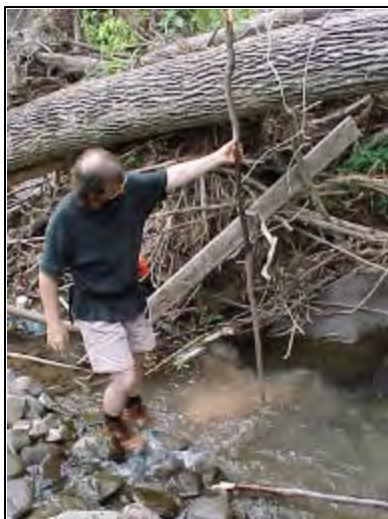
**Figure 12 Clay Exposure**

At the end of the rip-rap, there is a clay exposure in the channel near the right stream bank (Fig. 12). It is very likely that the clay is continuous with the clay upstream mapped by Rubin in 1996 (See Section 2.4). As shown in the photo, deep layers of clay underlie the channel. Clay inputs to a stream are a significant water quality concern because they increase *turbidity*, degrade fish habitat, and can act as a carrier for other pollutants and pathogens.

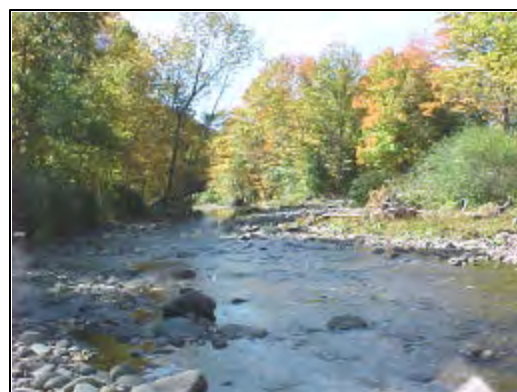
**Figure 13 Cross-section 124  
Stream Type C3**

Moving downstream, the channel reconnects with its floodplain and the slope decreases to 1.4%, as stream type changes to C3 for the next 726 ft. (Fig. 13). This reach is overwide,

shallow, and straight, with no overhanging vegetation. Deposition of bed materials is common in overwide channels because they lose their ability to transport *bedload* supplied from upstream. In this situation streams often *aggrade*, or rise in stream bed elevation due to the excessive deposition. Overwide channels also provide poor fish habitat due to warmer water temperatures and filling of deep pools.

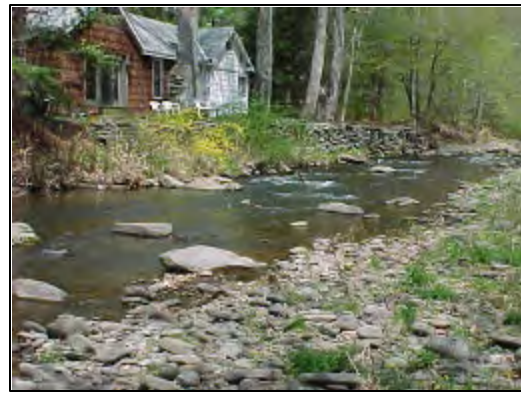
**Figure 26 Planting Site #32**

Planting site #32 is located in the stream channel beginning at the Whitelaw property (Fig. 26). This reach of stream is overwide and aggrading. Gravel bar development on the left streamside is forcing the streambank and *thalweg* to the right streambank.

In-channel plantings of native willows, along the right stream bank, is recommended. These plantings may encourage gravel depstion along the toe of the rock wall leading to a reduction *shear stress* on this streambank. These plantings will also improve the aquatic habitat by providing shade, thereby cooling water temperatures. Willow fascines should be installed at the toe of the stacked rock wall (Inset B). This planting will strengthen and increase the longevity of the wall.
