Management Unit 9
Greene County - Town of Hunter
Cross Section 131 to Cross Section 135

Management Unit Description

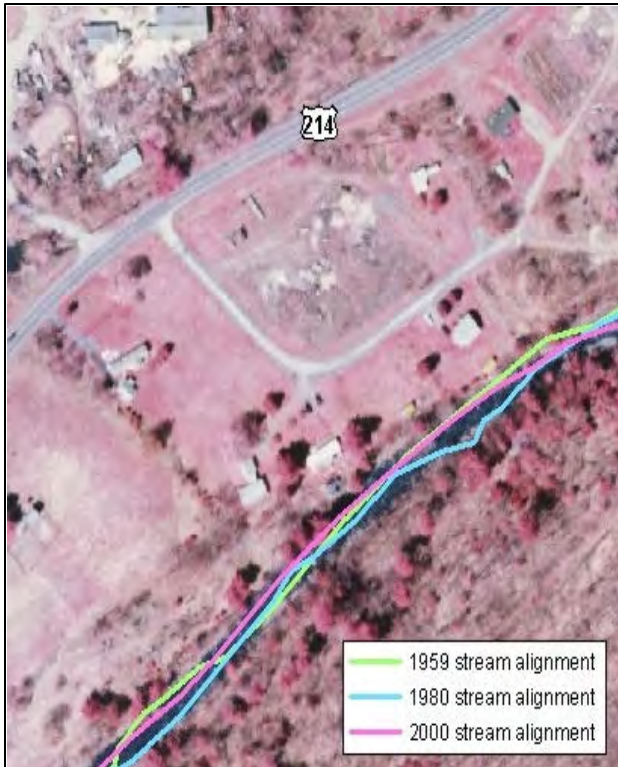
Figure 2 Historical stream channel alignments of Management Unit 9

As seen from the historical stream alignments, channel in this management unit has not exhibited significant lateral shifting in the period since 1959 (Fig. 2). There is some evidence of channel *incision*, or downcutting, in this part of the stream, however, with the elevation of the

stream channel is considerably lower than the adjacent terrace to the right.

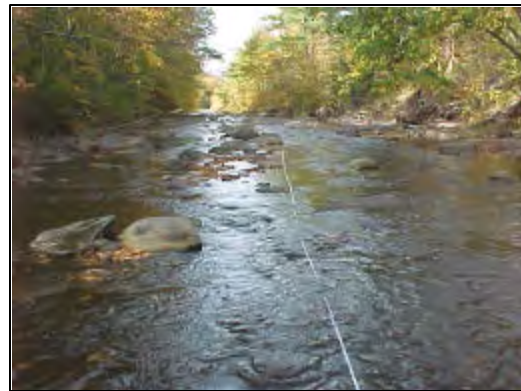
**Figure 4 Cross-section 132
Stream Type B3**

As channel entrenchment moderates, stream type changes to B3 for another short reach totaling 73 ft. in length. The slope of this reach increases significantly to 2.8%.

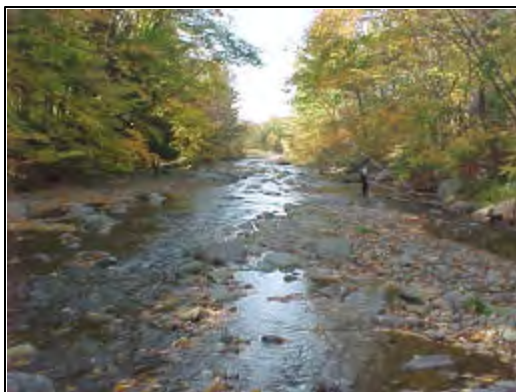
**Figure 5 Cross-section 133
Stream Type F3**

Continuing downstream, the channel once again becomes entrenched as it transitions back into a F3 stream type for the remaining 975 ft. of this management unit. The channel is overwide, shallow, and flat with a slope of 1.3%.

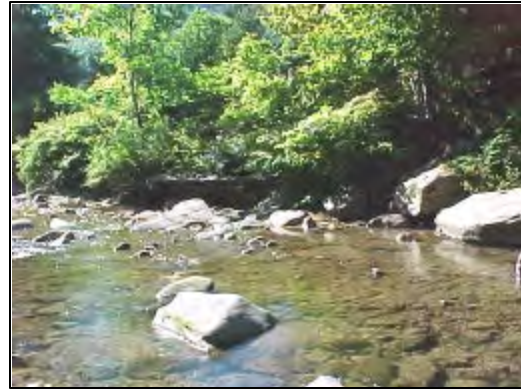
Figure 6 Cribwall

At the top of this reach, approximately 110 ft. of rip-rap has been installed along the right stream bank (Inset D). In the middle of this rip-rap is a cable suspended foot bridge used to access the land on the opposite side of the creek. At the top of right stream bank is a residence with mowed lawn to the stream's edge and a shed which is extremely close to the edge of the bank. At the toe of the right stream bank below this shed, the landowner has installed a wooden cribwall to protect the bank from erosion (Fig. 6).

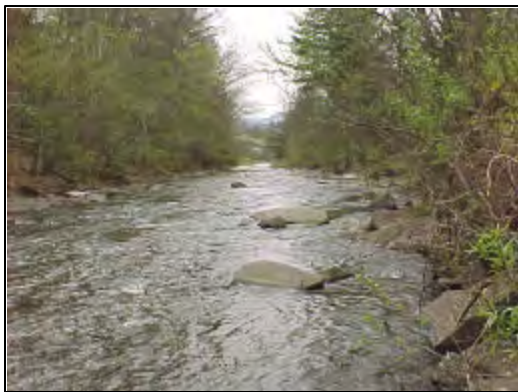
Figure 9 Planting Site #33

Planting site #33 is located on six separate residential properties on the right stream bank, beginning along Stony Road (Fig. 9). Presently there is scattered vegetation along the stream and upland grass lawn areas on these properties. It is recommended to plant native tree and shrub species along the stream bank to increase the density of vegetation. It is also recommended to increase the upland buffer width as much as possible. This will increase the buffer functionality and improve stream bank stability while still allowing a lawn area.

Along the stream bank of the first property, approximately 110 ft. of rip-rap has been installed (Inset D). Inserting plant materials into the soil between rip-rap rocks, or *joint planting*, is recommended. Joint planting will strengthen and increase the longevity of this wall. These plantings will also improve the aquatic habitat by providing shade, thereby cooling water temperatures.

The stream channel along this reach is overwide. Planting native willow and sedge species along both sides of the stream is recommended. These plantings will encourage the stream channel to narrow, improving stream habitat and function.
