## Management Unit 11

Ulster County - Town of Shandaken  
Bank Erosion Monitoring Site #18 to Cross Section 147

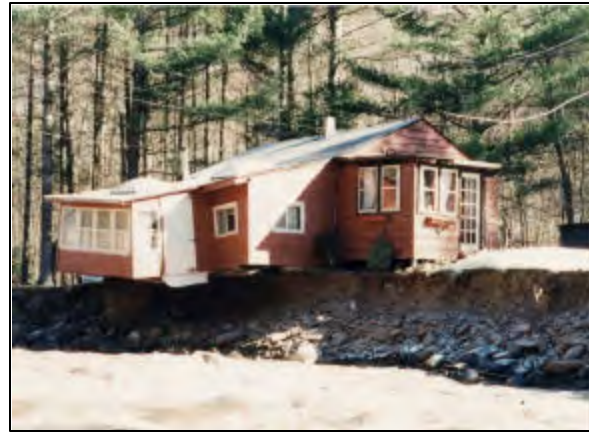
According to available NYS DEC records there have been six stream disturbance permits issued in this management unit. An emergency permit was issued to Christopher Lay after the 1987 flood event. The permit project description for this site is missing. Another emergency permit was issued for this property after the 1996 flood to remove 100 yd<sup>3</sup> of debris and gravel from the stream channel and place gravel on the eroded stream banks (Inset G). An emergency permit was issued to Edwin Schatzel after the 1996 flood event, to remove 25 yd<sup>3</sup> of gravel from in front of an intake structure and foot valve to restore water flow. An emergency permit was issued to Dorothy Zaharatos after the 1996 flood event, to replace the bridge abutment, wingwall and rip-rap at the Grubman Road bridge (Inset B). Later in 1996, another permit was issued to Dorothy Zaharatos to install rip-rap and associated gravel back fill along the stream bank. In 1999, a permit was issued to Anne Schatzel, to repair the headwall and wingwall of the Grubman Road Bridge (Fig. 5).

**Figure 4 House undermined by bank erosion during the January 1996 flood**

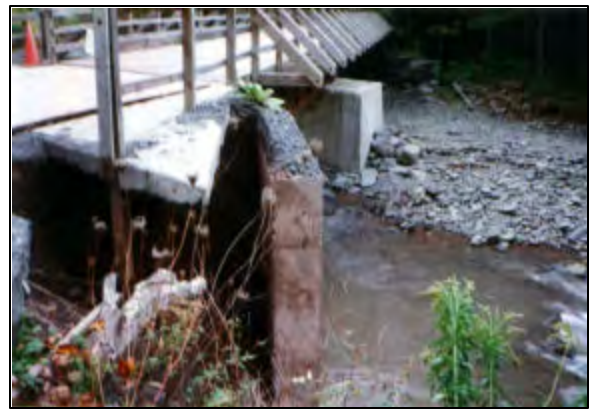
**Figure 5 1999 Grubman Road Bridge damage to abutment**

As described in the stream disturbance permit section, this bridge has experienced serious damages during flood events. The current bridge abutments appear to provide adequate width to pass bankfull flows, as well as ample conveyance of larger flood flows. A center pier divides the channel, with significant deposition to the left of the pier on the inside of the meander. Scour at the right bridge abutment, though not significant at the time of the stream feature inventory, has been an ongoing problem. The installation of a cross-vane structure upstream of the bridge to control the width and depth of the channel may alleviate this problem.

The Grubman Road Bridge is adequately sized, providing ample flood conveyance for bankfull and significantly larger flows. However, permit history indicates abutment scour and *backeddy* erosion are an ongoing problem. The addition of in-channel structures to redirect erosive forces away from stream banks and maintain proper channel dimension and grade may mitigate these flood related risks.

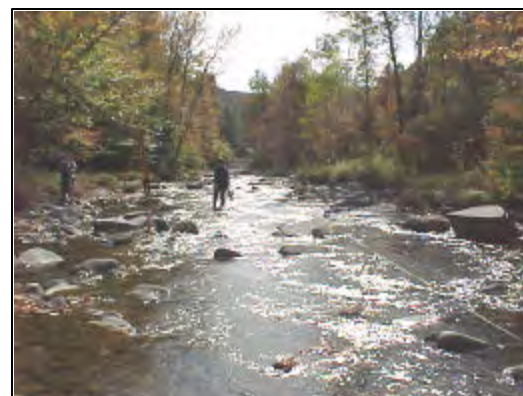
**Figure 7 Cross-section 140 Stream Type F3**

Management unit #11 begins slightly upstream of the Greene/Ulster County line, with a 347 ft. reach of F3 stream type (Fig. 7). This stream reach is *entrenched*, or confined within the stream banks during high flow events. Stream channel slope is quite flat, at 1.4%, and the dominant bed material is cobble. The channel runs along the toe of the NYS Route 214 road embankment, which is truncating its natural meander pattern. An 88 ft. rip-rap revetment along the right stream bank protects the embankment (Inset D). This revetment has some woody vegetation beginning to grow through it, providing some overhead cover and improving revetment longevity.

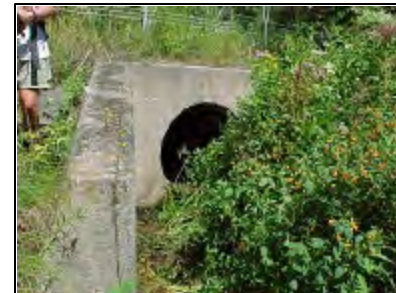
**Figure 8 Culvert**

There is a stormwater culvert with a concrete headwall on the right bank at the downstream end of the erosion site (Fig. 8). Approximately 150 ft. downstream is another smaller stormwater culvert with a concrete headwall on the right bank. Both of these culvert outlets are well vegetated with grass and shrubs and do not pose erosion concerns.

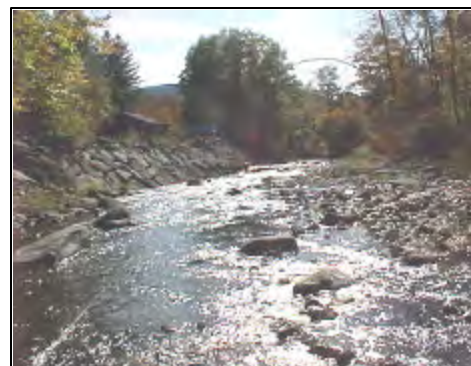
**Figure 10 Rip-rap left bank**

Beginning at the top of this reach, 135 ft. of rip-rap runs along the right stream bank to protect NYS Route

214 (Fig. 10 & Inset C). This revetment has some woody vegetation beginning to grow through it, providing some overhead cover and improving revetment longevity.

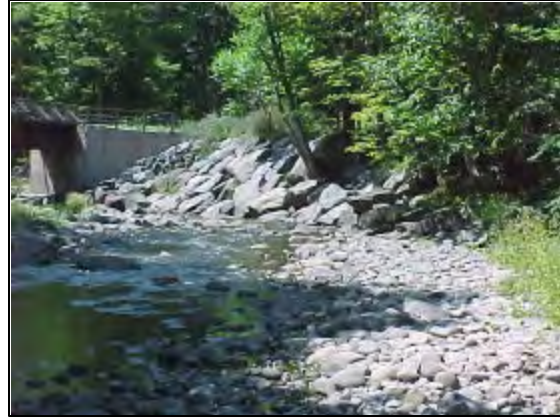
**Figure 13 Rip-rap upstream from bridge**

The channel begins to narrow as the stream approaches the bridge at Grubman Road, which crosses the Stony Clove at an oblique angle on a meander bend (Inset B). Rip-rap has been installed on the right stream bank, upstream and downstream from the bridge, totaling 202 ft. in length (Fig. 13).

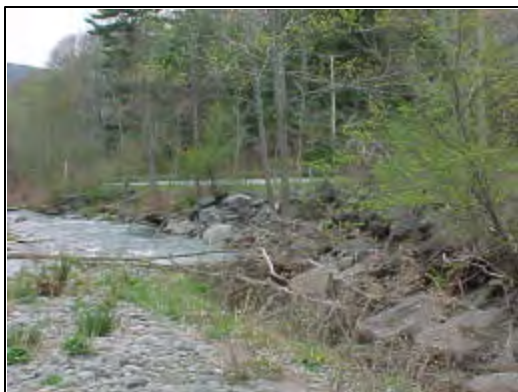
**Figure 17** Planting Site #35

Planting site #35 is located along the rip-rap at the top of the management unit, on the right stream bank (Fig. 17 & Inset D).

planting of the rip-rap requires coordination with the NYS DOT and Central Hudson Energy Group.

*Joint planting of the existing rip-rap is recommended, by inserting plantings into the soil between rip-rap rocks at this site. Willow fascines should be installed along the toe of the stream bank. These plantings will strengthen and increase the longevity of this rip-rap and improve the aquatic habitat by providing shade, thereby cooling water temperatures. The*

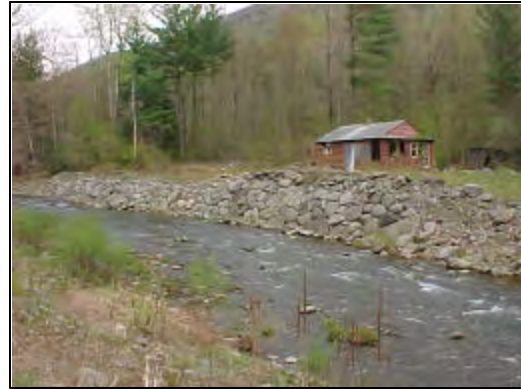
**Figure 18 Planting Site #36**

Planting site #36 is located along the rip-rap in the middle of this management unit (Fig. 18 & Inset G).

Inserting plant materials into the soil between rip-rap rocks, or *joint planting*, is recommended. Joint planting will strengthen and increase the longevity of this rip-rap, while adding aesthetic and habitat value. To improve the stream buffer, native trees and shrubs should be planted at the top of this bank, which is currently a large grassy area.

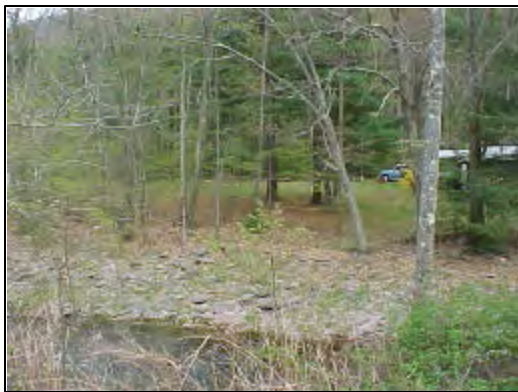
**Figure 19 Planting Site #37**

Planting site #37 is located along the left side of NYS Route 214 just south of Moggre Road (Fig. 19). This site is located on the right stream bank, on the outside of a meander bend. The stream bank is currently lined with small cobble material.

Plantings of native trees and shrubs are recommended along the stream bank and sedges at the toe of the stream bank. These plantings will help prevent erosion on this stream bank.

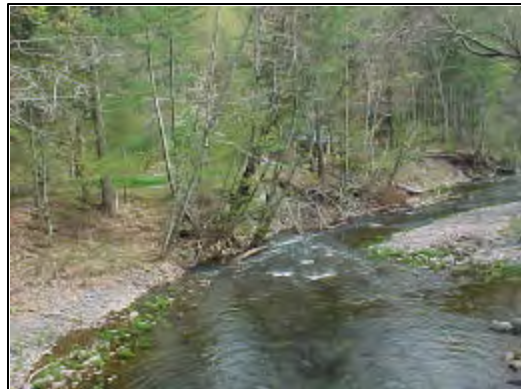
**Figure 20 Planting Site #38**

Planting site #38 is located along the right and left stream bank downstream from the Grubman Rd. Bridge (Fig. 20 & Inset B). While this site ideally would be treated by installing in-channel structures to redirect erosional forces away from the bank, vegetative treatments may defer the need for these measures.

Installing of willow fascines along the toe of both the left and right stream bank in conjunction with other structural *bioengineering* techniques, to try to stabilize this stream bank is recommended. In-depth survey and design would be required to plan a stream restoration project at this site.
