Management Unit 14
 Ulster County - Town of Shandaken
 Cross Section 153 to Weiss Road Bridge

Management Unit Description

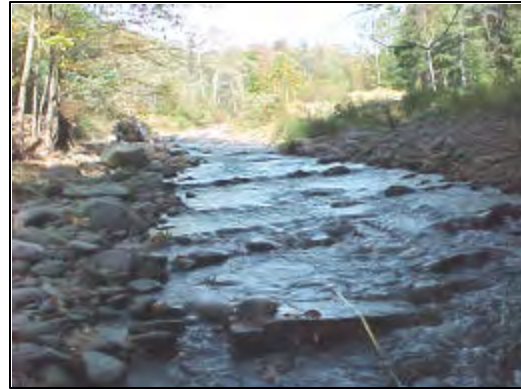
**Figure 7 Cross-section 155
Stream Type B3 Looking Upstream**

As the stream channel widens and becomes steeper, stream type transitions to a B3 (Fig. 7). This 224 ft. reach of stream remains moderately entrenched and overwide with a slope of 2.2%.

A large gravel bar has formed along the left stream bank. Gravel bars help maintain channel stability during flood events. In stable streams, the bars will erode away while the channel is in flood stage. The bars then are rebuilt as flow decreases, helping the stream maintain its stability by reestablishing its pools and riffles. If gravel bars are removed, these processes do not occur and instead, the flood water often dissipates its energy by eroding banks and scouring the stream bed. This gravel bar was graded after the 1996 flood to restore the lawn area. The gravel was used fill an overflow channel created during the flood.

In general, aggradational conditions are evident at the top of the unit, but appear to stabilize as the stream approaches the Weiss Road Bridge. The planform at cross-section 155 appears to have developed an unstable radius of curvature, which may lead to *backwatering* and contribute to the aggradation evident upstream. Indicators of sediment transport imbalances should be monitored in the bermed reach approaching Weiss Road for changes in response to the new berm and bridge installation.

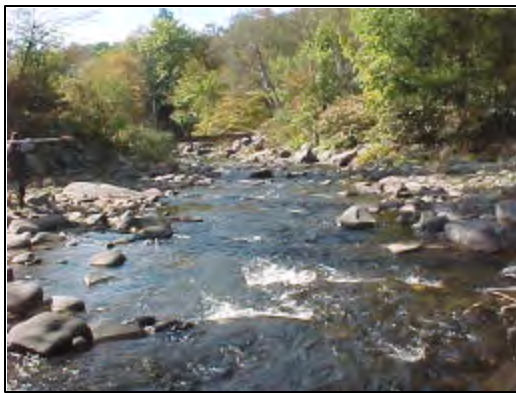
**Figure 8 Cross-section 157
Stream Type F3**

As the channel becomes entrenched, the stream type changes to F3 for the next 572 ft. of stream (Fig. 8). The slope of this reach decreases to 1%.

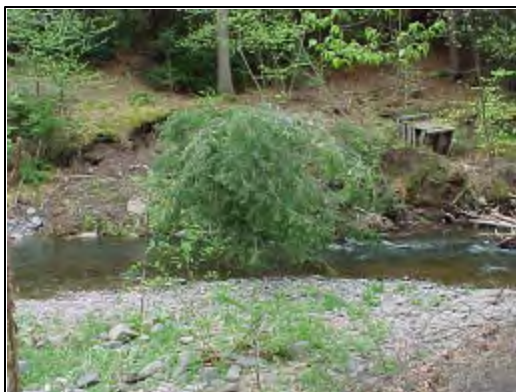
Figure 12 Planting Site #41 Left Bank

Planting site #41, which includes six properties on both the left and right stream banks, is located at the top of this management unit (Fig. 12).

On the right stream bank there is a sparsely vegetated low bench and some upland *old field* areas. On the left stream bank, there is a large gravel bar with extensive upland grass areas. This bank has experienced minor erosion in the past.

On the right stream bank, willows and other native shrubs should be planted on the low bench. Upland plantings of native trees and shrubs in the grass areas will increase the buffer functionality. On the left stream bank, willow *fascines* should be planted along the toe

to prevent erosion. Native trees and shrubs should be planted on the stream bank and in upland areas to improve bank stability and buffer functionality.

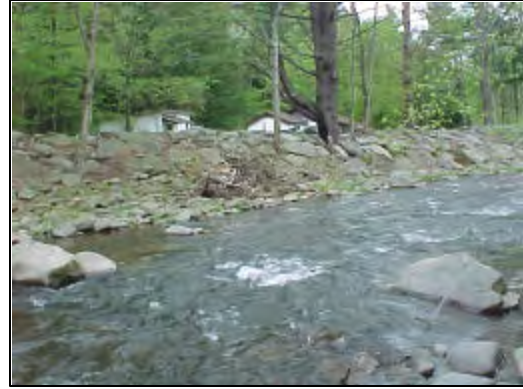
Figure 13 Planting Site #42 Left Bank

Planting site #42 is located on two residential properties, on the left and right stream bank, at the end of the management unit (Fig. 13). On the left stream bank a berm and rip-rap (Inset C) has been installed with a few trees along the top of the bank. There is a large grass lawn area behind the berm which extends to the edge of this bank. There is also rip-rap (Inset B) on the right stream bank with some trees and shrubs along the stream bank. At the top of the bank there is a grass area.

Recommendations for this site include *joint planting* the existing rip-rap on both banks, by inserting plantings into the soil between the rip-rap rocks. Joint planting will strengthen and increase the longevity of the rip-rap. These plantings will also improve the aquatic habitat by providing shade, which maintains cooler water temperatures. Upland plantings of native trees and shrubs in the grass areas will also improve the stability of these banks and increase the buffer functionality.
