Management Unit 14
 Ulster County - Town of Shandaken
 Cross Section 153 to Weiss Road Bridge

Management Unit Description

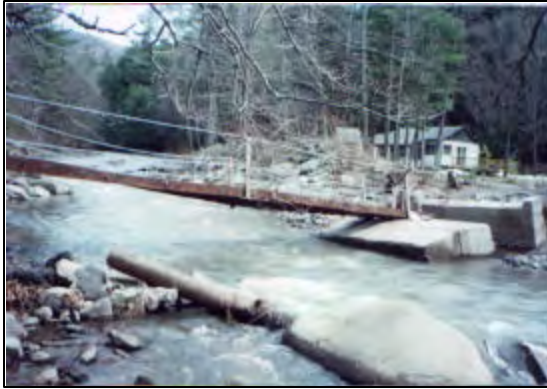
Figure 4 Bridge At Weiss Road April 24, 2000

From 2000-2003, the Chichester Property Owners Association was issued a permit to replace the existing bridge at Weiss Road with a temporary bridge constructed of two steel beams and wood decking, supported by a rip-rap wall (Fig. 4).

As detailed in the stream disturbance permit section, past flood events have seriously damaged the private bridge at Weiss Road. A new bridge has recently been installed and may help to relieve this threat. The bridge should be evaluated to determine if the new opening is of adequate width to pass bankfull flows without backwatering.

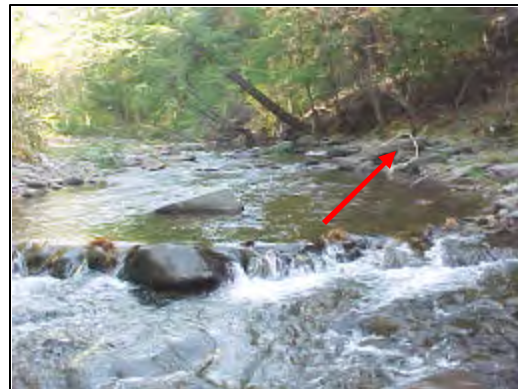
**Figure 9 Cross-section 156, minor toe erosion
Stream Type F3 Looking Upstream**

At the top of this reach, the left stream bank has experienced minor toe erosion (Fig. 9). The *shear stress*, or the force of the flowing water, has eroded the toe of this bank during high flow events. As shown in Figure 9, this erosion has compromised some of the existing mature vegetation. Stream bank erosion often occurs on the outside of meander bends where the stream velocity is greatest during high flows.
