Management Unit 16
 Ulster County - Town of Shandaken
 Warner Creek to Silver Hollow Bridge

Management Unit Description

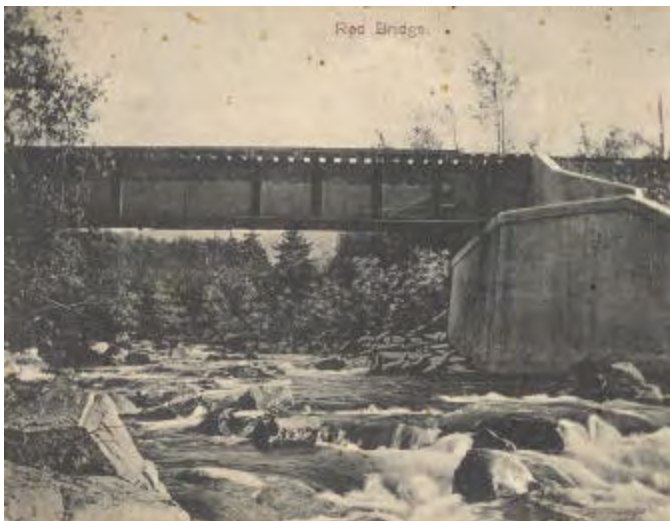
Figure 3 Looking upstream under the railroad trestle, toward Warner Creek, Courtesy of the Gale Collection

The Stony Clove and Kaaterskill Railroad began operations in 1883, and it is likely that construction of the bridge abutments involved blasting at the stream margin for the footings (Fig. 3).

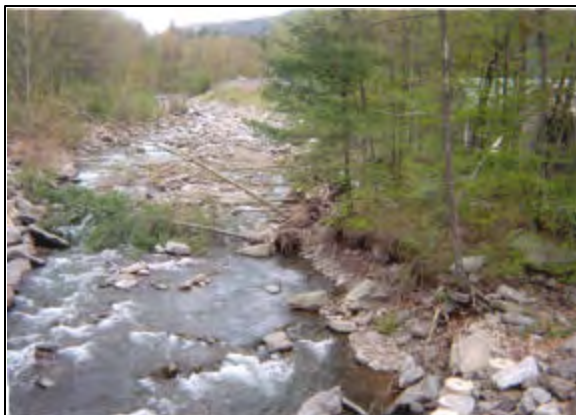
Figure 6 John Horn's property after 1996 Flood

In 1989, near the top of the management unit, The Town of Shandaken was issued a permit to install 90 ft. of rip-rap on the left bank to stabilize an eroding embankment on Silver Hollow Road. After the 1996 flood, an emergency permit was issued to James Ferguson to install rip-rap and remove 100 yd³ of gravel and debris. In 1997, John Horn was issued a permit to repair 240 ft. of rip-rap wall (Inset F & Fig. 6).

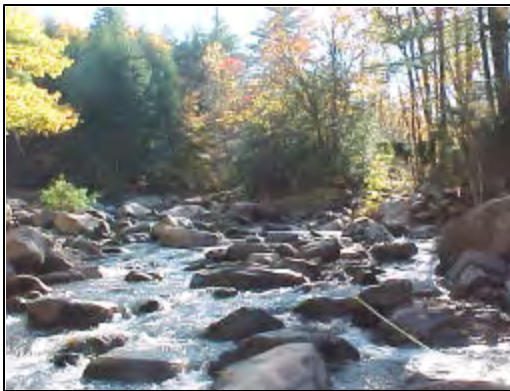
Figure 8 Cross-section 163 Stream Type F3b looking upstream

Management unit #16 begins with a 160 ft. reach of F3b stream type (Fig. 8). The channel is *entrenched*, or confined within the stream banks during high flood events. The slope of the stream channel is extremely steep at 4.1%. The dominant bed material is large cobble, but there are many large boulders.

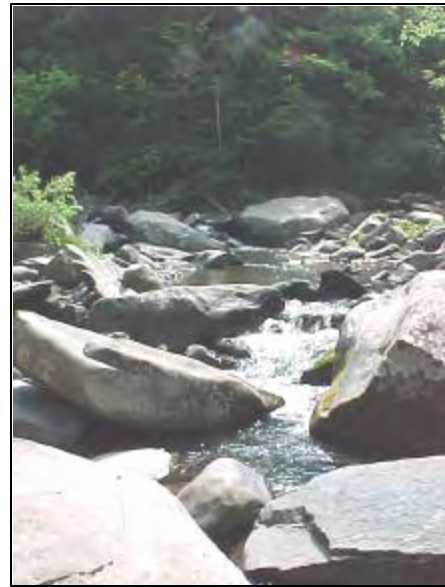
Figure 9 Warner Creek

At the top of this reach, the Warner Creek tributary enters the Stony Clove Creek from a split channel on the left stream bank (Fig. 9 & Inset D). Warner Creek is the largest Stony Clove Creek tributary, its headwaters originating on Plateau Mountain in the Town of Hunter, and running 10.1 miles along Silver Hollow Road into the Town of Woodstock. After flowing through a section of undeveloped state land, it enters into the Town of Shandaken, running along Silver Hollow Road before entering the Stony Clove Creek just before Chichester.

Significant turbidity contributions from Warner Creek are apparent during even small storm flows, when visible contrast is evident where Warner Creek's more turbid flow enters the Stony Clove's. Downstream from the Warner Creek confluence, approximately 126 ft. of stacked rock wall has been installed on the left stream bank (Fig.10).

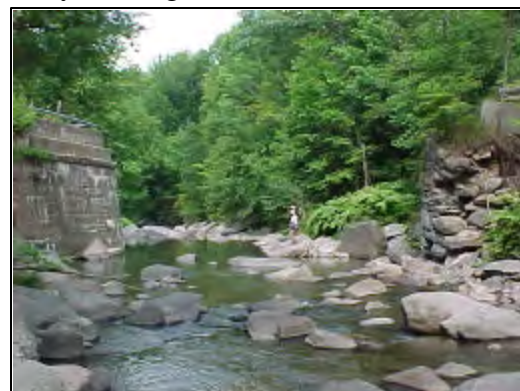
Figure 11 Abandoned Railroad Abutments

At the top of this reach the stream passes between two relic railroad abutments built for the Stony Clove and Kaaterskill Railroad, which ran through the valley from 1883 to 1939 (Fig.11). At the top of the left abutment is a small parking area. The public uses a path adjacent to this abutment to access the creek. Foot traffic combined with runoff from the road is slowly eroding the stream bank.

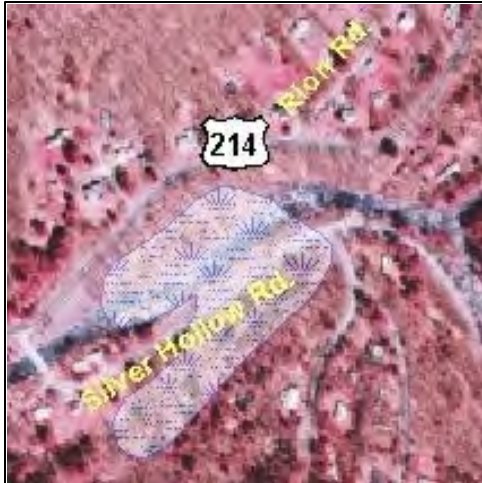
Figure 12 Federally Designated Wetland

As the stream passes the abutment it bends to the left, and 5.1 acres of riparian area here have been designated by the U.S. Fish and Wildlife Service as wetland, classified as palustrine, forested, broad-leaved deciduous, and temporarily flooded (Fig. 12). The extent of this wetland, however, has been modified by infrastructure maintenance. Wetlands are recognized as important features in the landscape that provide numerous beneficial functions, including protecting and improving water quality, providing fish and wildlife habitats, storing floodwaters, and maintaining surface water flow during dry periods. (See Section 2.6 for wetland type descriptions and regulations)

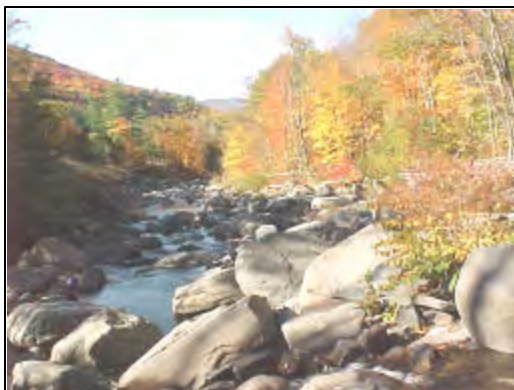
Figure 13 Cross-section 164 Stream Type F3b

At the end of the erosion site, the channel becomes entrenched, as stream type transitions back into F3b for the remaining 763 ft. of this management unit (Fig.13). Channel slope in this reach decreases but remains steep at 2.5%. Dominant bed material decreases to cobble but large boulders remain abundant.

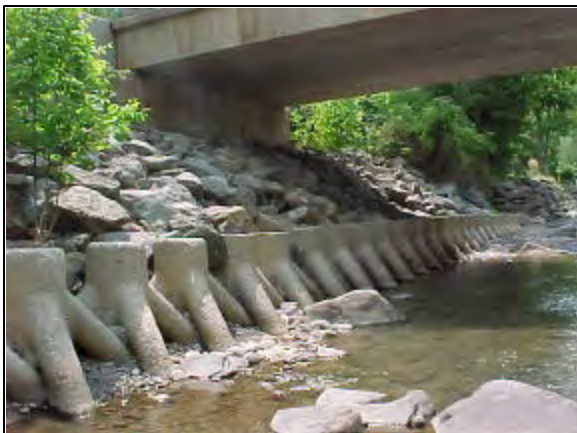
Figure 14 “Ajack” structures

At the end of this management unit the channel passes under Silver Hollow Road Bridge (BIN #22244560), replaced in 1983 by NYS DOT (Inset E). Concrete “ajack” structures were placed at the water’s edge to secure the toe of the bank and control abutment scour (Fig.14). The channel flattens as it passes under the bridge.

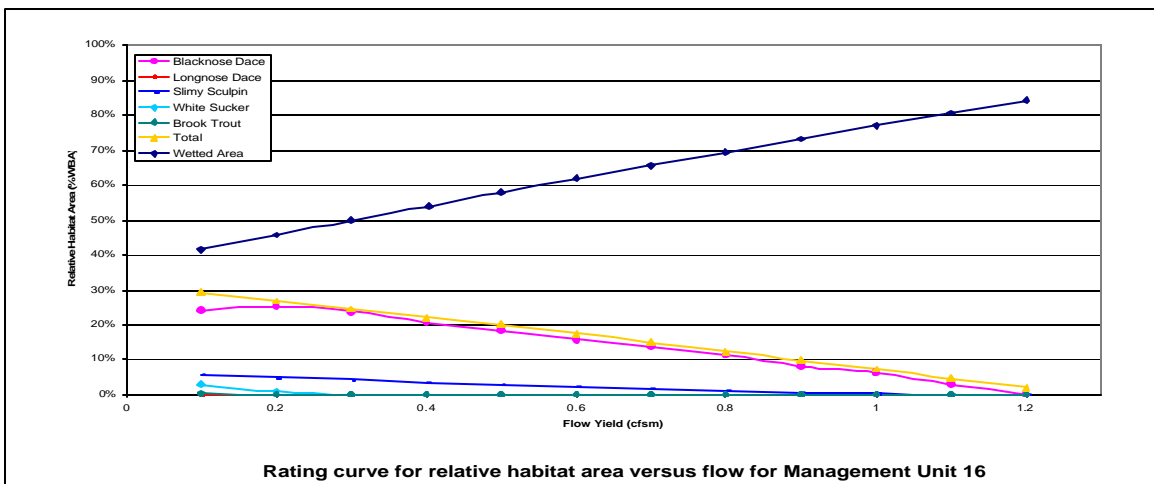
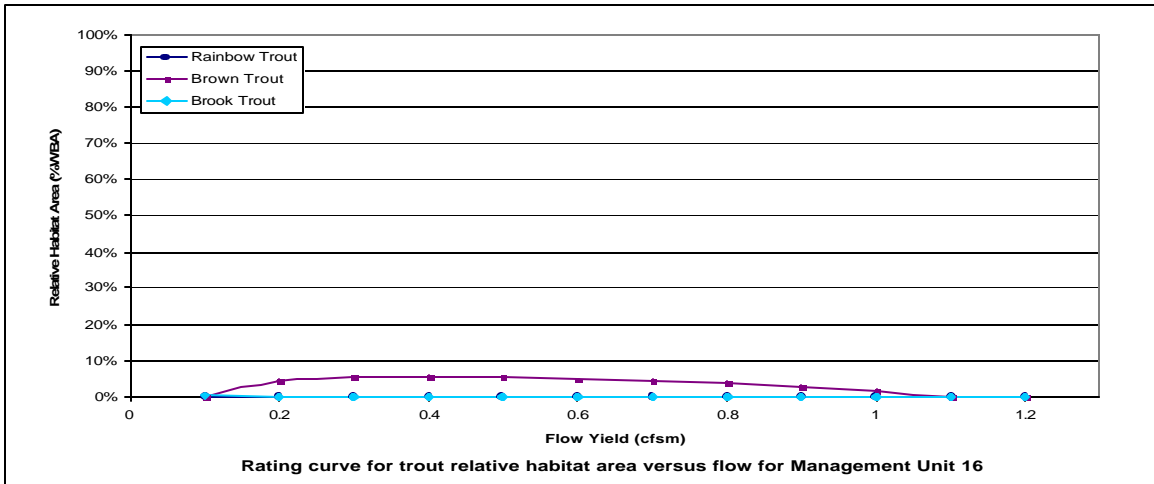
Figure 17 MesoHABSIM habitat rating curves for Management Unit 16

Management unit #16 is much deeper and somewhat faster than the other units, with highly diverse hydraulics (Fig.17). Boulders are abundant and no shallow margins exist. *Wetted area* covers 80% of bankfull wetted area and increases constantly with flow. This unit, like management unit #15, has a steep, entrenched channel, where habitat becomes more uniform in response to flow increases beginning at 0.1 cfs. As a result, of the target community, only blacknose dace and slimy sculpin are supported, and only at the lowest observed flows. Habitat even for these two species falls to zero with increasing flows. Rainbow and brown trout have only minute amounts of suitable habitat through the entire range of flows. Barely any habitat overlaps exist in this unit. This unit represents the least suitable habitat for the target community in the entire study area.

The unit is characterized by physical (and potentially thermal) low flow barriers. Recommendations for habitat improvements in this unit include 1) developing step pool structures which facilitate passage at low flows and increase the quantity of shallow margins, and 2) establishing a stable bankfull bench vegetated with native trees and shrubs to provide overhead cover and shading. (See Section 6.6)
