## Management Unit 19

Ulster County - Town of Shandaken  
Chichester Bridge to Between Cross Section 186 & 187

### Management Unit Description

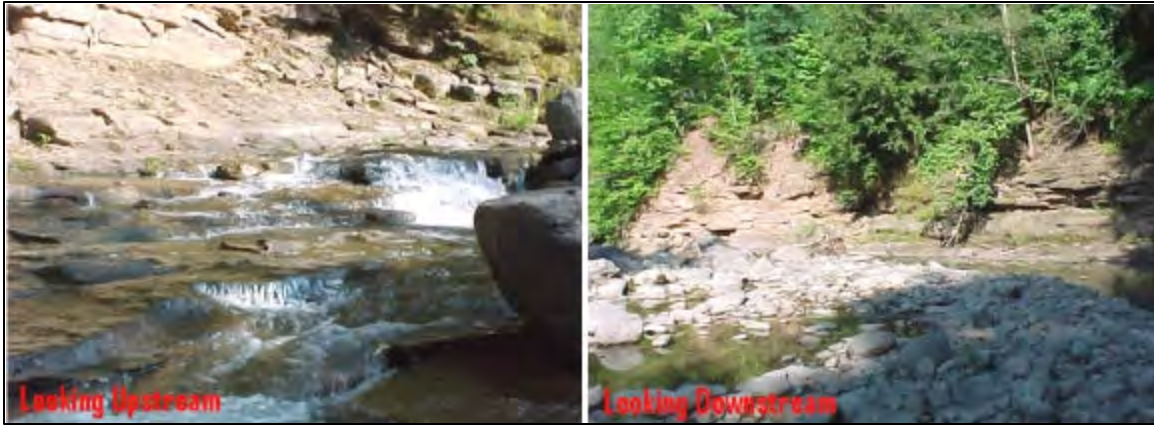
As the stream reconnects with its floodplain on the left, stream type transitions to C3b for the next 394 ft. reach. The slope of this reach increases to 2.6%. As seen in Figure 6 looking downstream, a mid-channel bar has begun to form near the top of this reach. This channel *aggradation* is likely resulting from a backwater effect caused by the hard bend to the left just downstream. The stream channel is beginning to widen and may eventually lead to increased bank erosion in this area. On the left stream bank there is an overflow channel which conveys water during high flow events.

**Figure 6 Bedrock**

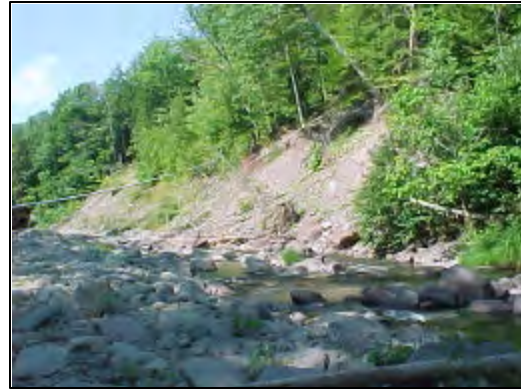
**Figure 12 Bank erosion site #25**

reach (Inset C). The stream flows directly against the valley wall, increasing the *shear stress*, or force of flowing water, on the stream bank during high flow events. This hillslope, composed primarily of lodgement till, is being undermined by toe erosion, resulting in the mass wasting of the bank. Compounding this erosion problem, the face of the stream bank has been stripped of vegetation, leaving it vulnerable to erosion resulting from runoff from the steep hillslope above. The exposed lodgement till has a high silt and clay content, and contributes significant suspended sediment loads during high flow events. Clay inputs into a stream are a serious water quality concern because they increase *turbidity*, degrade fish habitat, and can act as carriers for other pollutants and pathogens.

The Bank Erodibility Hazard Index (*BEHI*) score of site #25 is ranked “High”, the third highest prioritization category in terms of its vulnerability to erosion (Fig. 12). This bank erosion site is considered one of the highest priorities for restoration due to its large eroding area, high shear stress, and its significant threat water quality.

Bank erosion monitoring site #25 is located along 506 ft. of the right stream bank of this

From visual observations, it appears this bank erosion site is growing in severity and areal extent with each heavy rainfall. During the 2001 survey, it was estimated that the total erosion area of this site was 27,572 ft.<sup>2</sup>, qualifying it as the largest eroding area along the Stony Clove Creek.

Recommendations to restore this site would include stabilizing the toe of the right stream bank, and installing a bioengineered treatment of the hillslope. In-depth survey and design would be required to plan a stream restoration project at this site.

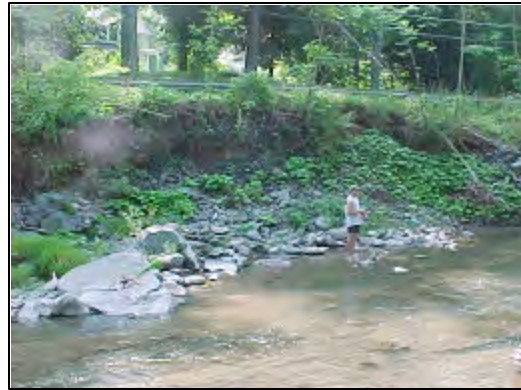
**Figure 14 Bank erosion site #26**

While the right stream bank is armored with bedrock, along the left stream bank the NYS Route 214 embankment is experiencing erosion. Bank erosion site #26 (Inset B) begins at the top of this reach and extends 304 ft. along this stream bank. Shear stress during high flow events has severely eroded the toe of this road embankment, and presents an imminent threat of road failure.

The BEHI score of site #26 is ranked “High”, the third highest prioritization category in terms of its vulnerability to erosion (Fig. 14). This bank erosion site is considered a

medium priority for restoration due its threat to infrastructure and water quality from eroding clay.

Recommendations to restore this site include regrading the stream bank and installing a low floodplain bench planted with appropriate native shrubs. Willow fascine and sedges should be installed along the toe of the bench to reduce erosion susceptibility. If necessary, rock vanes could be used to redirect shear stress away from the stream bank. In-depth survey and design would be required to plan a stream restoration project at this site.

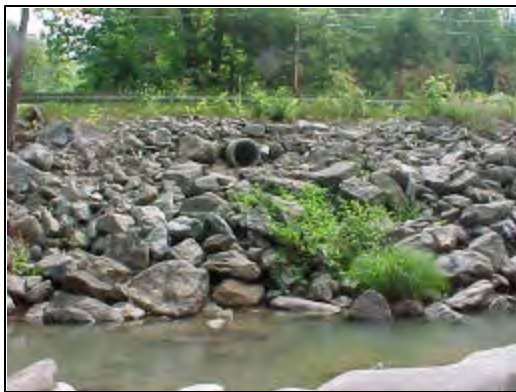
**Figure 15 Rip-Rap and Culvert**

For the next 354 ft., channel slope decreases to 1%, as the stream transitions to an F3 stream type. Beginning at the top of this reach, the NYS DOT has installed 611 ft. of rip-rap (Inset E) along the left stream bank to protect the NYS Route 214 embankment (Fig. 15).

Two stormwater culverts outfall along this rip-rap. Both culverts outlet on the rip-rap, reducing the risk of erosion from stormflow.

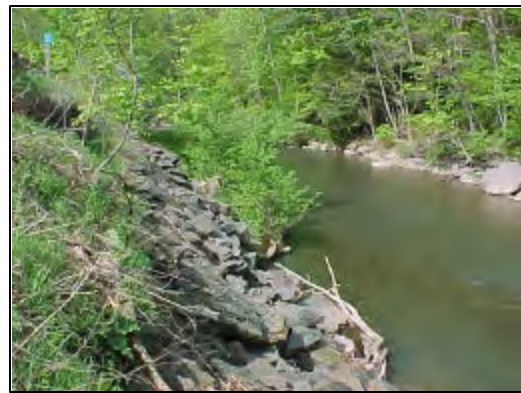
**Figure 18 Planting Site #50**

Planting site #50 is located near the top of the management unit along NYS Route 214 (Fig. 18 & Inset F). Some failure is occurring at the toe of rip-rap installed on a steep slope. Japanese Knotweed has begun to grow through this rip-rap.

Recommendations at this site include *joint planting* the existing rip-rap, by inserting plantings into the soil between the openings in the rip-rap rocks. Joint planting will strengthen and increase the longevity of this rip-rap. These plantings will also improve the aquatic habitat by providing shade, resulting in cooler water temperatures. This planting requires coordination with the NYS DOT, as they are responsible for the maintenance of the rip-rap. It is also recommended to remove the Japanese Knotweed, which is an invasive non-native species. Japanese Knotweed does not provide adequate erosion protection because it has a very shallow rooting system.

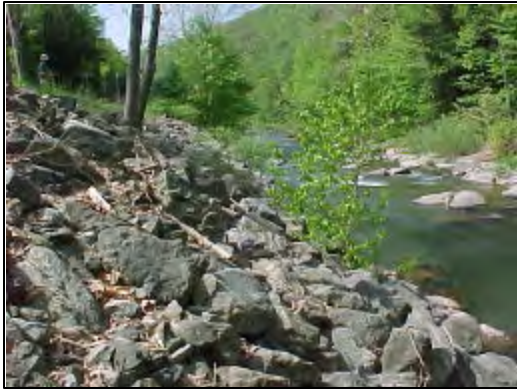
Figure 20 Planting Site #52

Planting site #52 is located at the rip-rap along NYS Route 214 near the bottom of the management unit (Fig. 20 & Inset E). This rip-rap is on a steep slope with two invasive species, Japanese Knotweed and Honeysuckle, present.

*Joint planting* of the existing rip-rap and removal of the invasive species is recommended. The planting of this rip-rap requires coordination with the NYS DOT, which is responsible for maintenance of the rip-rap.

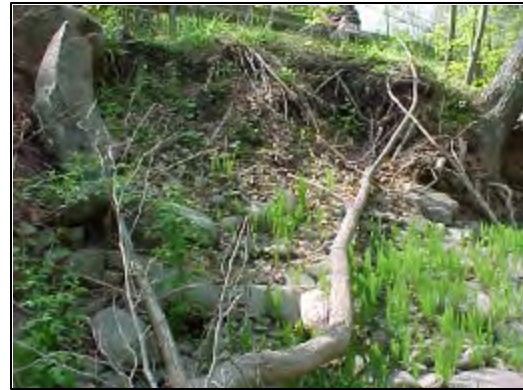
Figure 19 Planting Site #51

Planting site #51 is located at bank erosion site #26 ( Fig. 19 & Inset B). This site is experiencing minor erosion with loss of vegetation. Stabilization of this site is critical for protection of the NYS Route 214 embankment.

Recommendations to restore this site include regrading the bank and installation of a low floodplain bench, planted with appropriate native shrubs. Willow fascine and sedges should be installed along the toe of bench to reduce erosion risk.
